Transmission Expansion Advisory Committee: AEP Supplemental Projects

February 07, 2023

AEP Transmission Zone M-3 Process Conesville – Bixby 345 kV

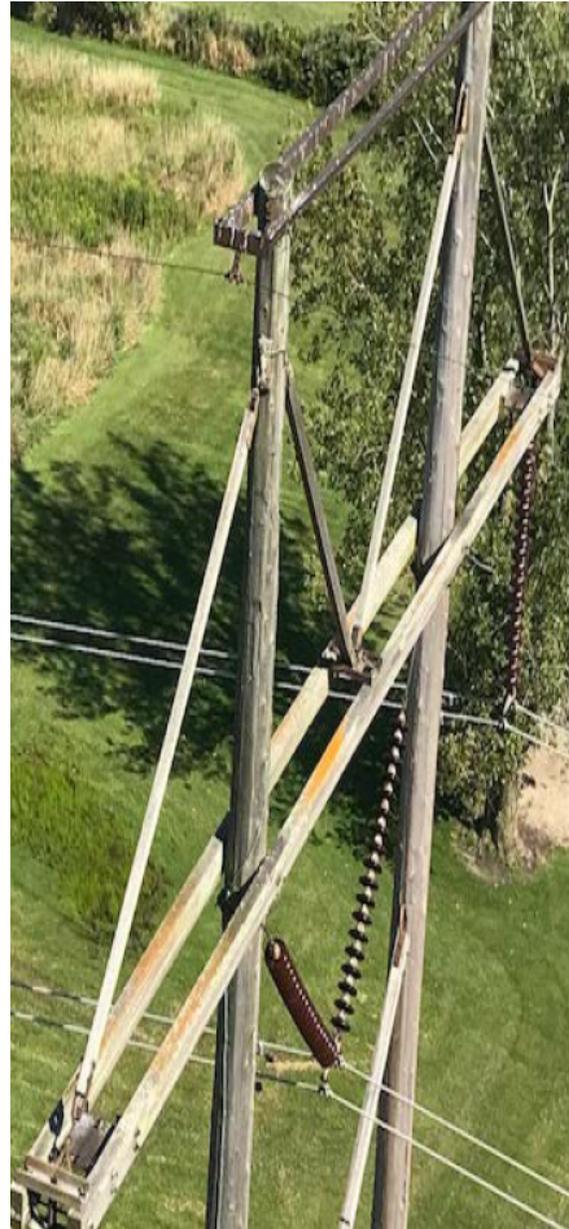
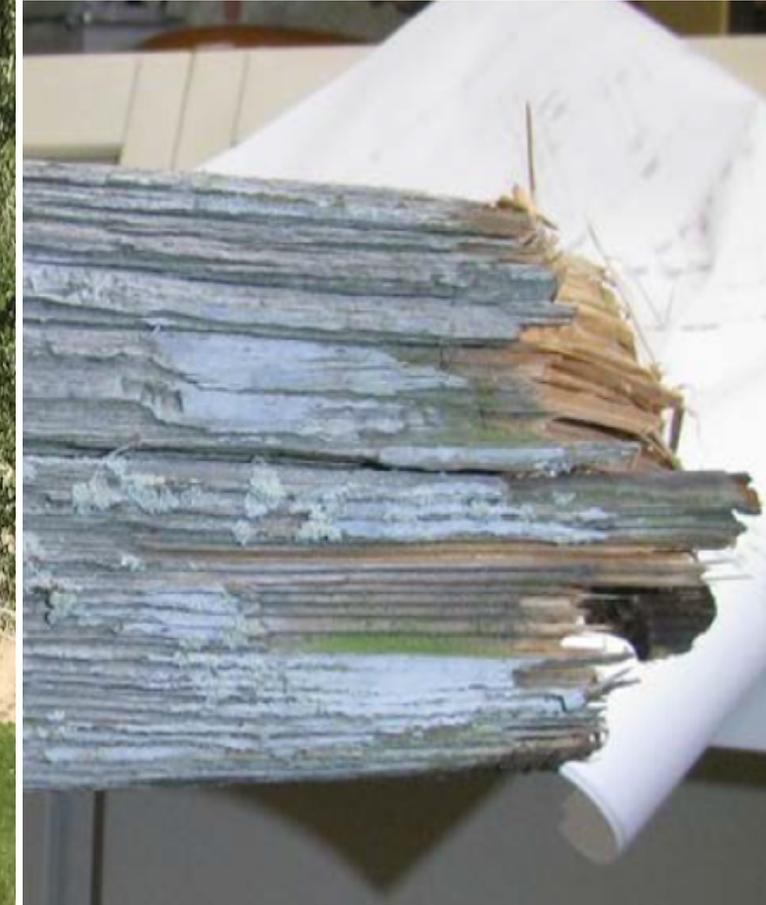
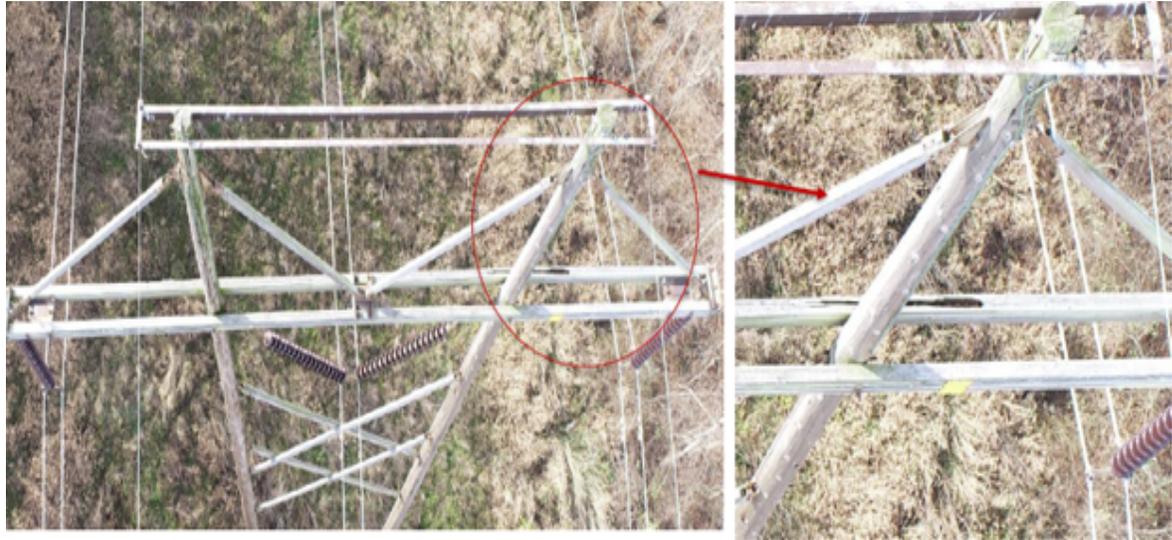
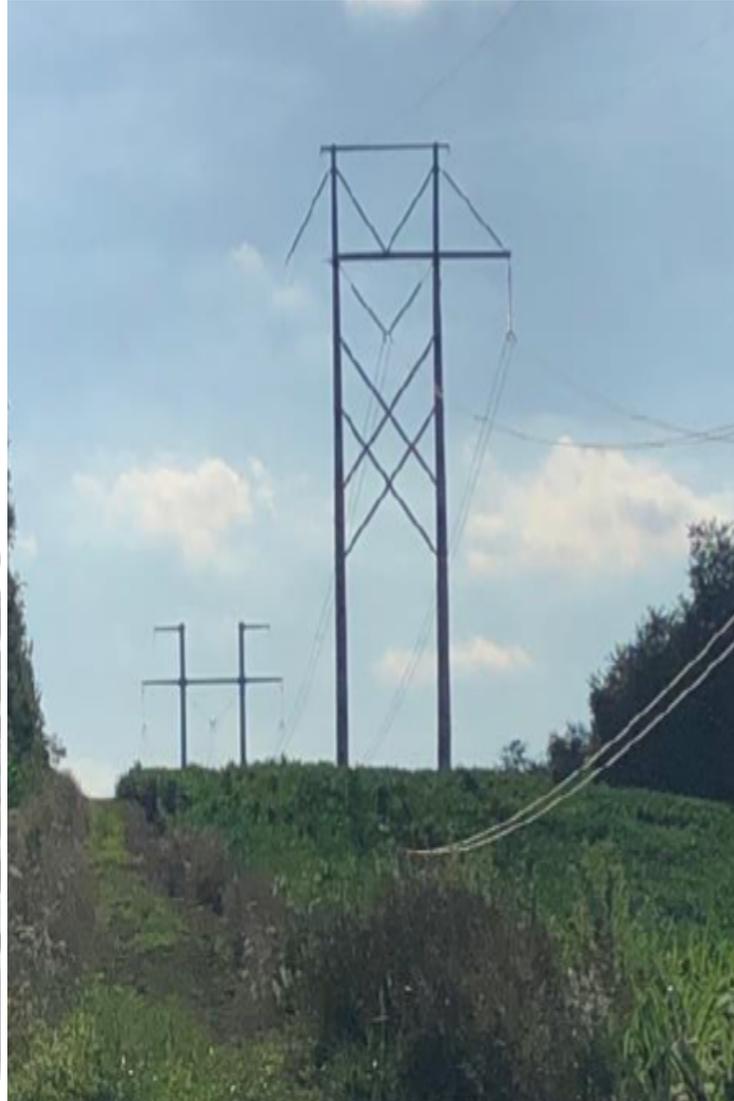
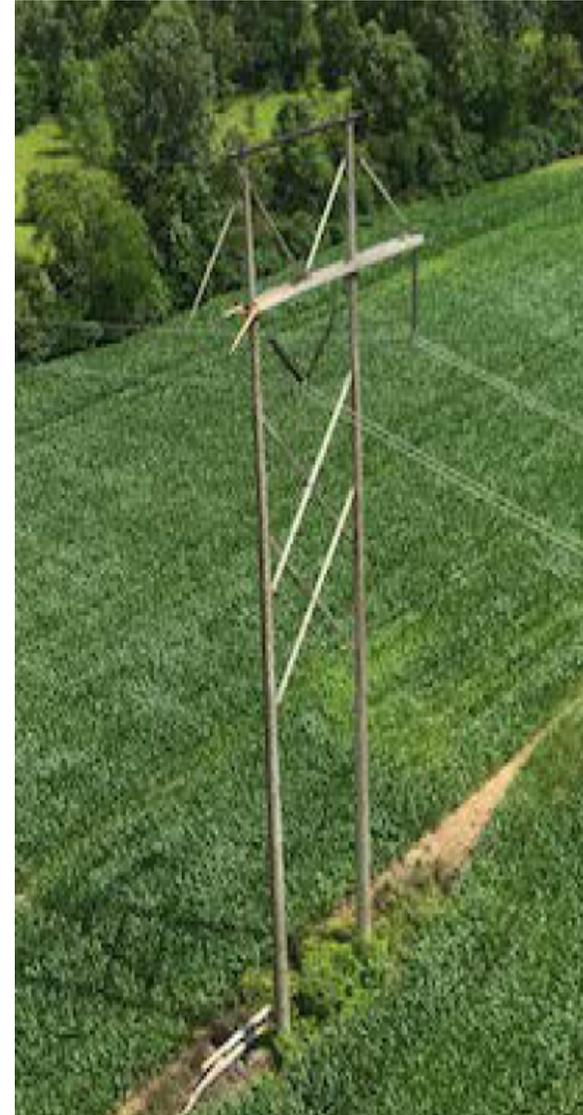
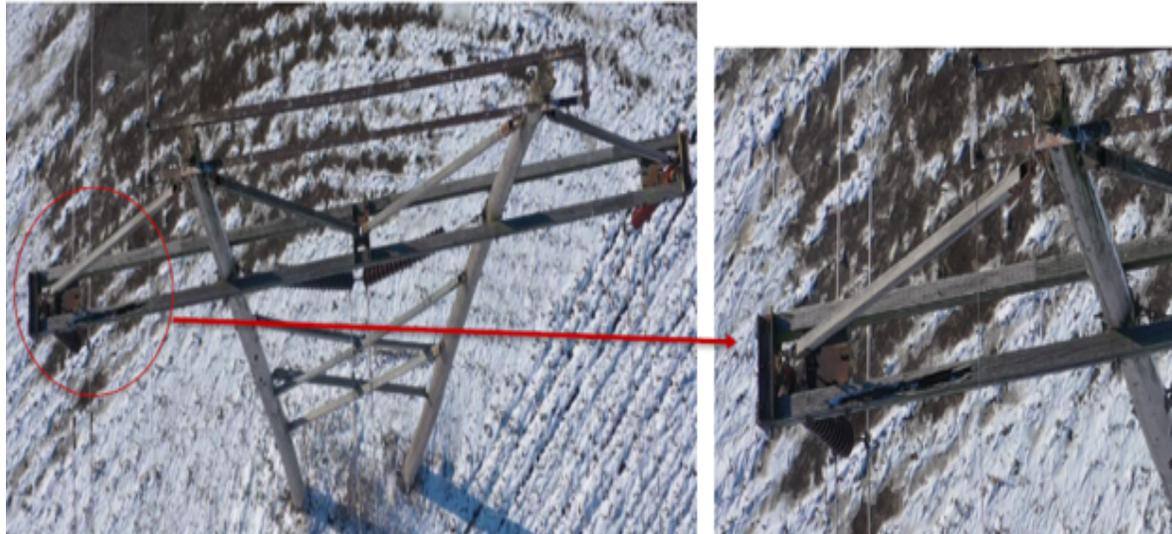
When the 345 kV line was constructed in the 1970's, it was done so utilizing an H-frame design with wood poles that involved the use of laminated crossarms rather than solid wood crossarms. Recent inspections have revealed signs of noticeable deterioration of the laminated crossarms. The green decay and orange rot as shown in the pictures is irreversible wood decay on the laminated crossarms.

There are limited inspection techniques available to identify areas of concern in laminated crossarms before a loss in functionality occurs and causes a permanent outage. Various industry organizations have attempted to analyze the stages of crossarm decay with varying degrees of success. This is the last line left on AEP's eastern footprint with this type of crossarm design.

AEP's experience with these laminated cross arms is that over time, due to the decay and delamination issues associated with the crossarm design, along with limitations to determine loss of functionality, failures on the line have historically been catastrophic in nature.

- Conesville-Bixby 345kV Line (Bixby-Ohio Central & Ohio Central-Conesville Circuits): Rebuild ~46.1 miles of the ~51.1 miles of line using 954 kCM ACSR bundled conductor & install OPGW fiber on new line rebuild. Newer steel poles on the line will not be replaced.
