Sub Regional RTEP Committee PJM West

March 9, 2018

Baseline Reliability and Supplemental Projects

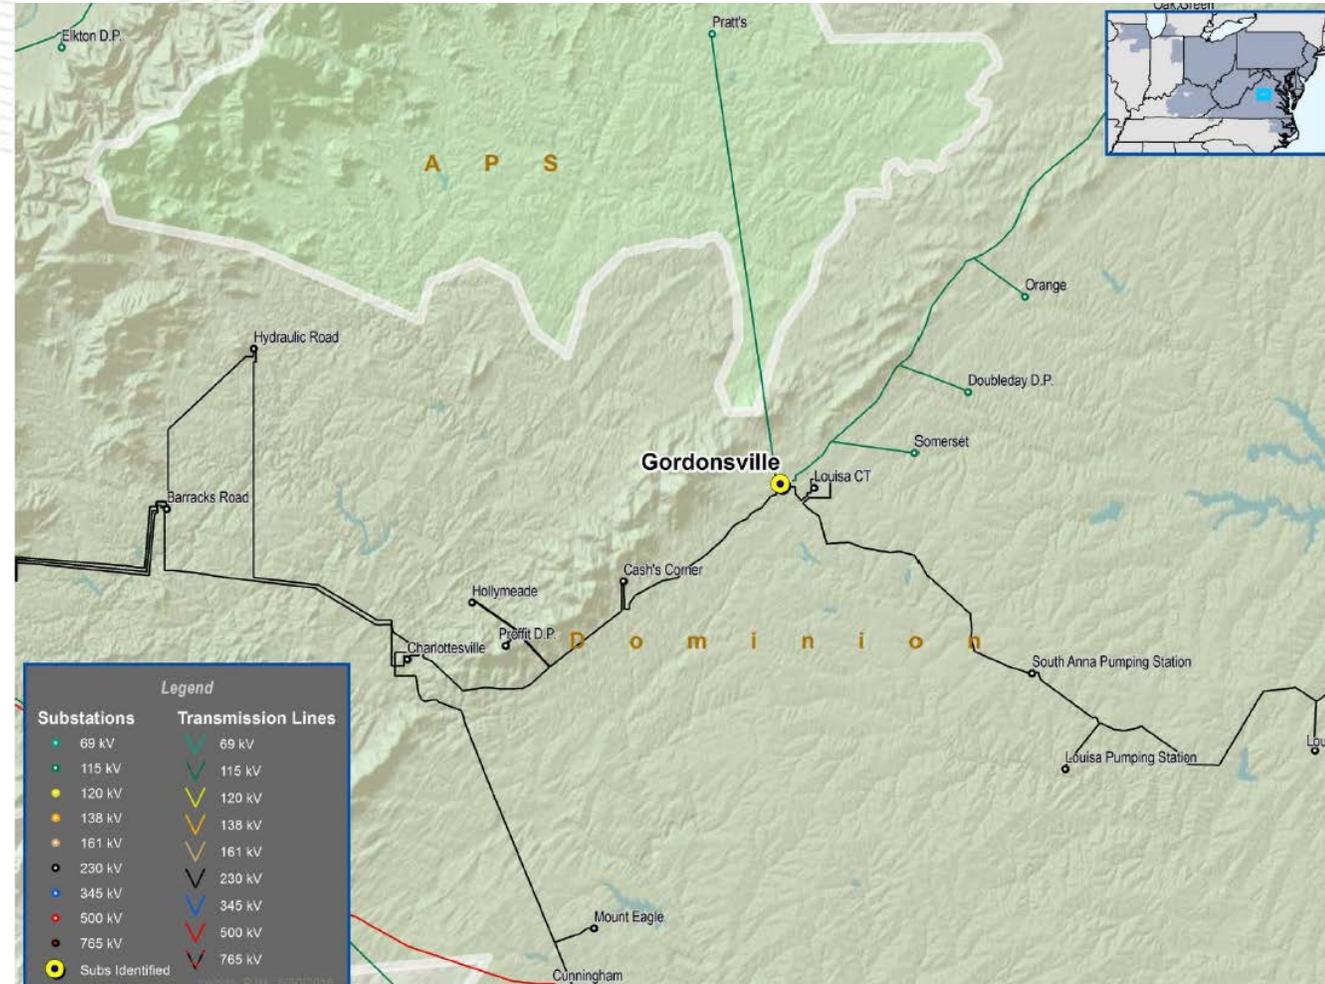
B2747: Install a Motor Operated Switch and SCADA control between Dominion's Gordonsville 115kV bus and FirstEnergy's 115kV line. (Presented in 7/26/2016 South SRTEP)

FE Scope: Relocate the FirstEnergy Pratts 138 kV terminal CVTs at Gordonsville substation to allow for the installation of a new motor operated switch being installed by Dominion. (B2747.1)

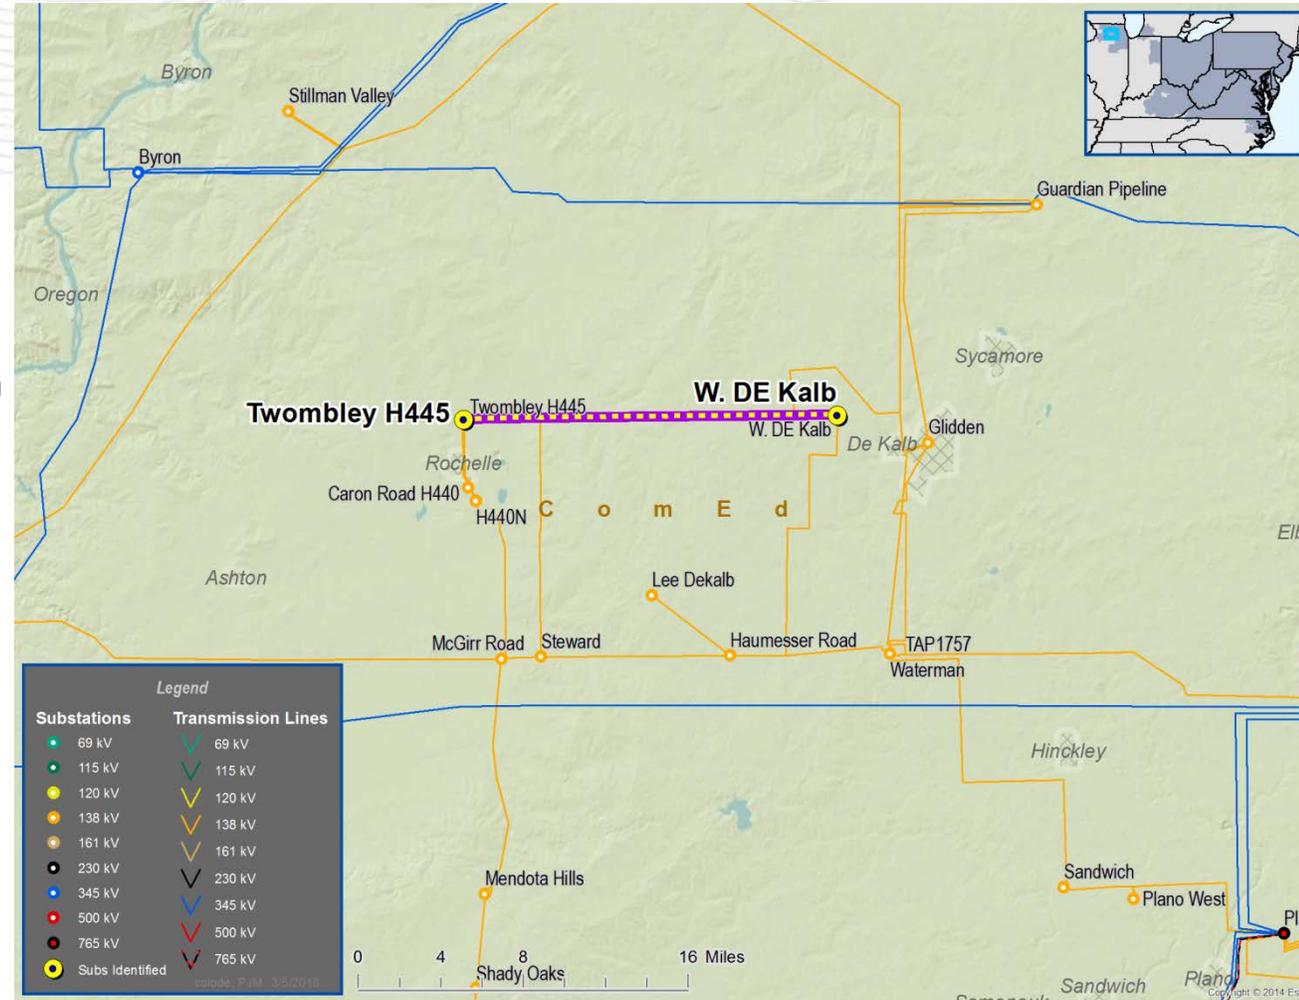
Rochelle Municipal Utilities (RMU) currently has two 138 kV lines serving its load; the TSS 169 (McGirr Road)/TSS 186 (Steward) – H440 (Caron Road) 138 kV line and the RMU H445 (Twombly) – Steward 138kV line. These lines are fairly close together and are electrically from the same source; they both run south to north. A severe storm could potentially take out both lines simultaneously, which would result in an unacceptably long outage during line reconstruction. For example, on Nov. 17th, 2013, a tornadic wind shear took down 22 poles on the transmission system at the same time a ComEd planned outage had RMU down to one line, resulting in a system interruption.

Construct a new line from the Twombly Road substation to a tap of the West DeKalb to Glidden 138 kV line just outside the West DeKalb 138 kV substation. The new 138 kV line would provide a diverse source to RMU and would also provide another path to ComEd for serving load in the DeKalb area.

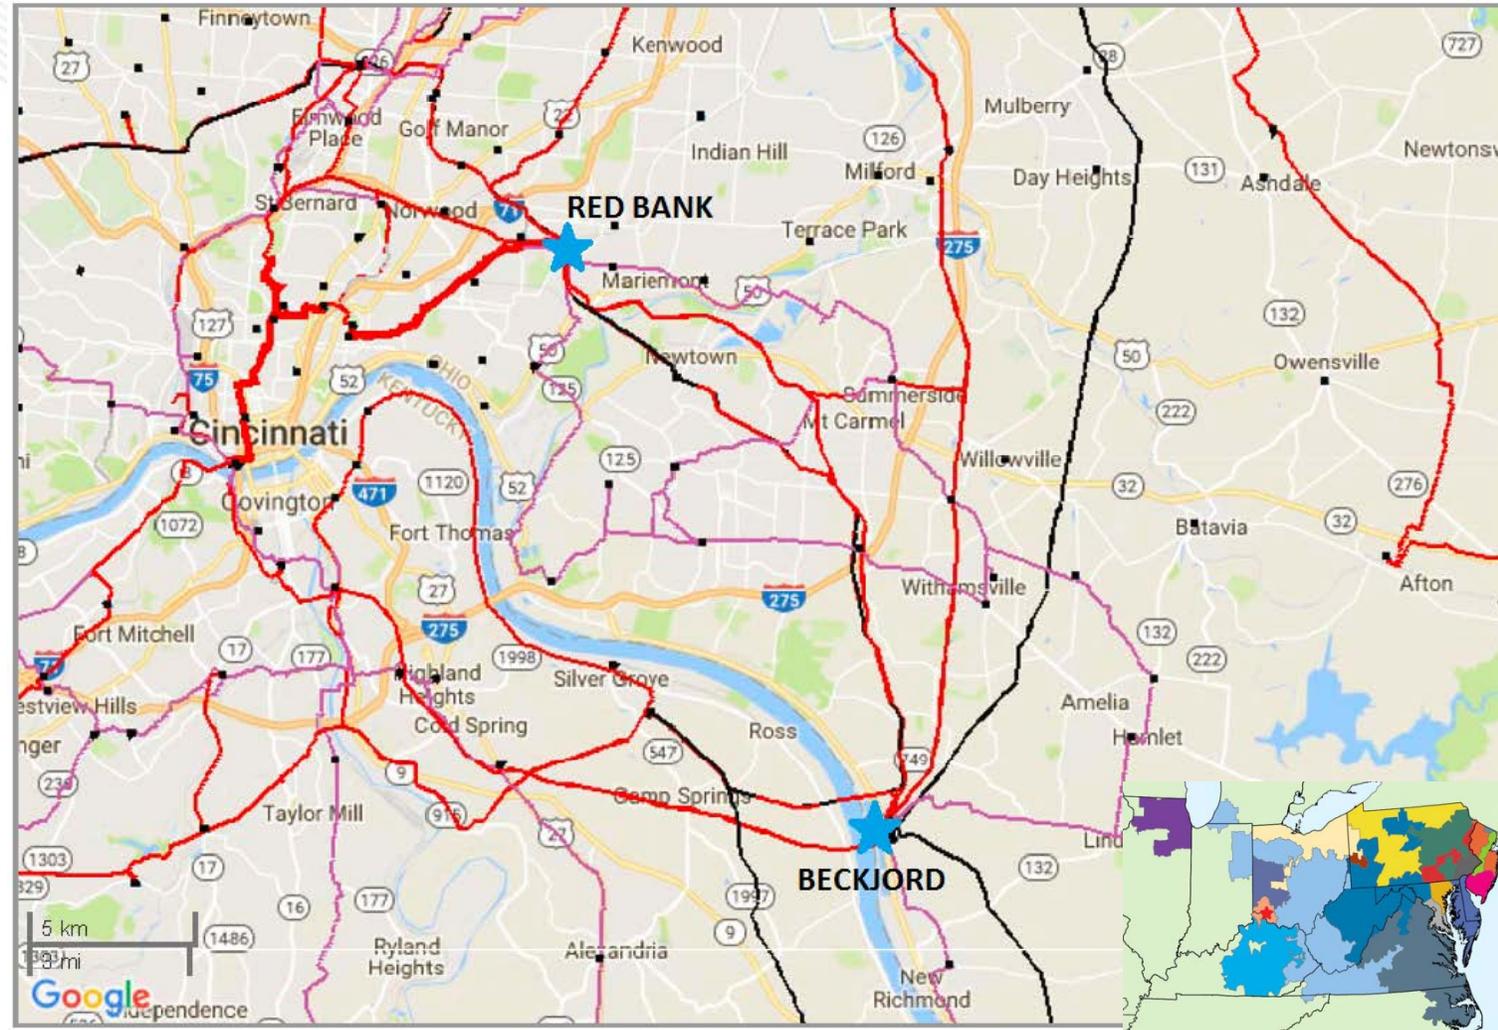
The breakers at each end of a 138kV line connecting Beckjord and Red Bank are vintage 1973 and 1981 respectively, obsolete, oil filled breakers.

Replace the breakers, breaker disconnects, and metering equipment. Branch rating will increase to 340 MVA (conductor limited).

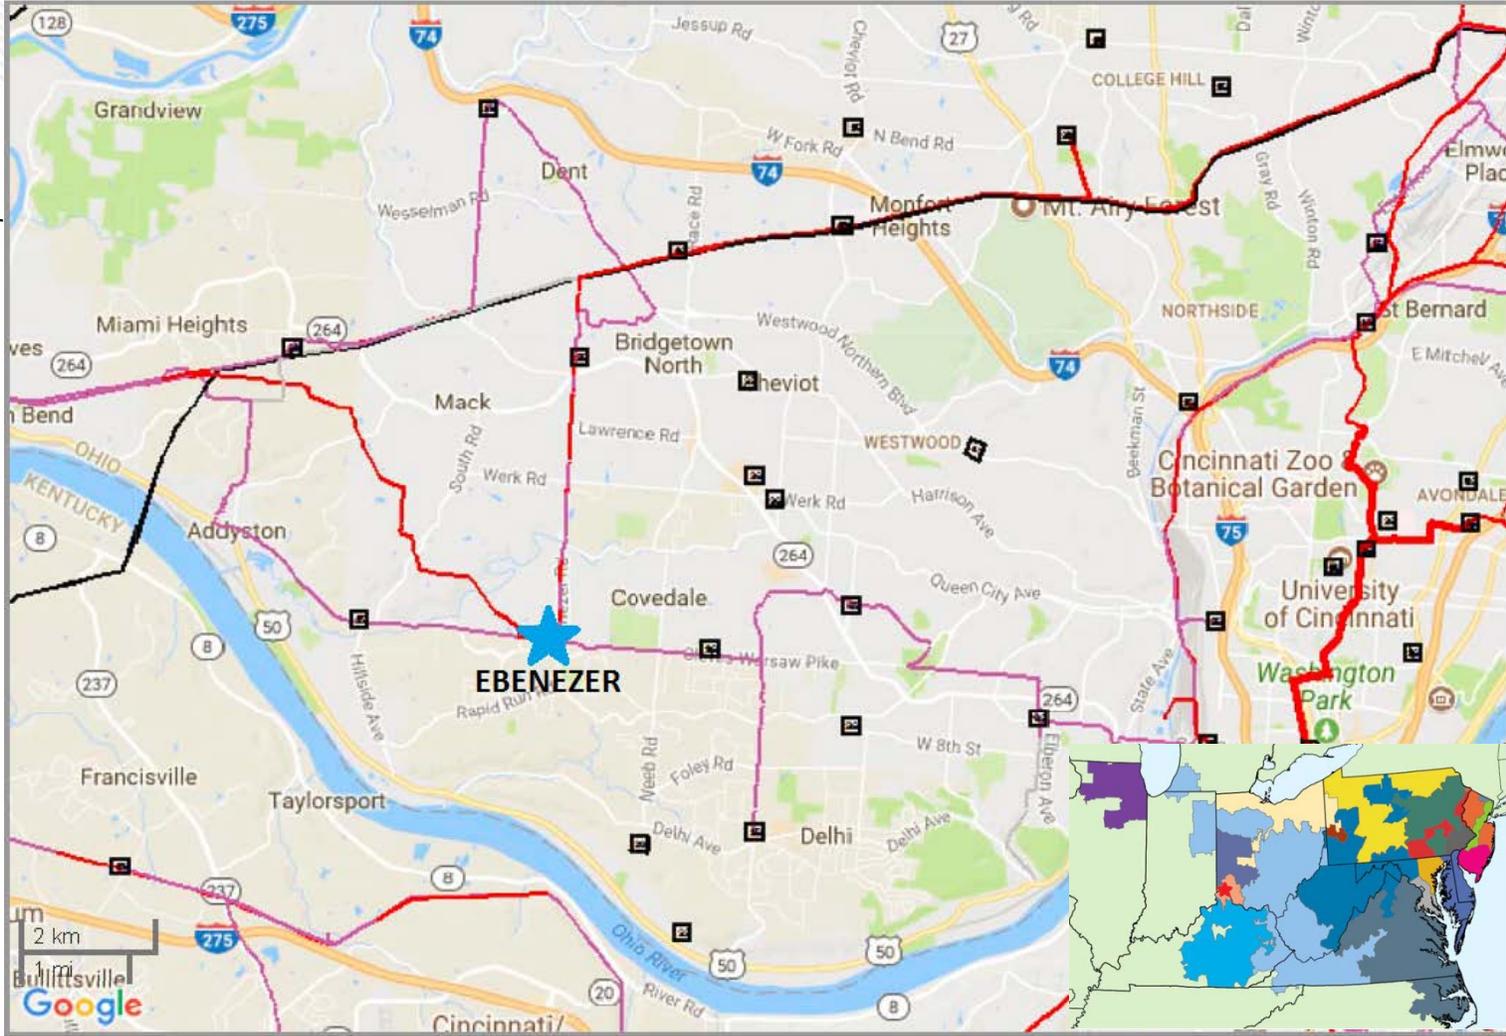
The 13kV switchgear at Ebenezer is obsolete and in deteriorating condition. Space limitations for new gear require 69/13kV TB4 to be moved.

Replace the switchgear. Due to its age, 50 years, and the expense of moving TB4, replace with a new transformer.

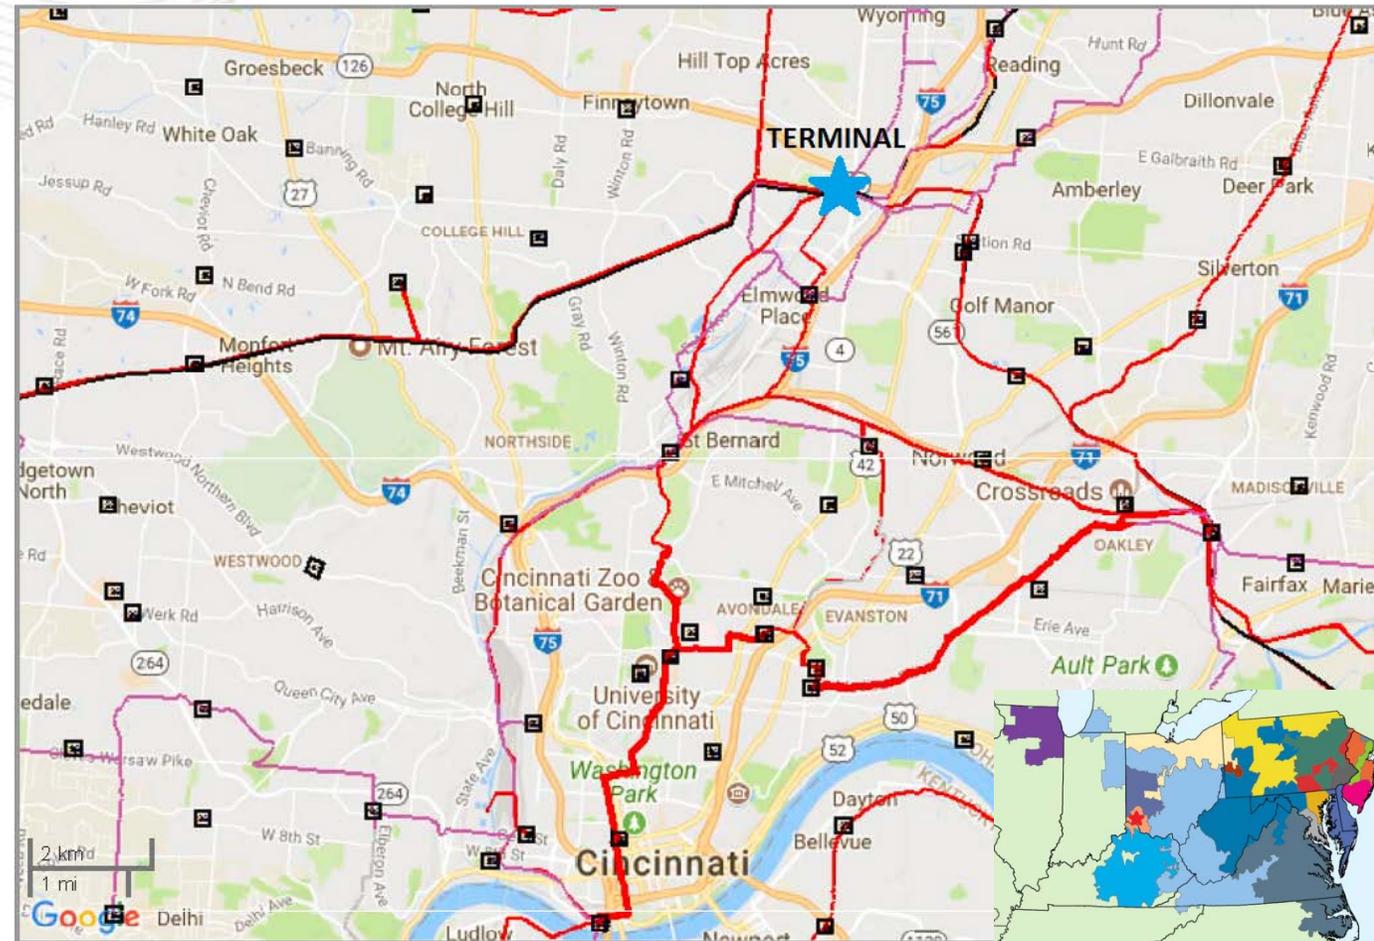
Terminal TB2 is a 100 MVA 138/69 kV transformer. It was taken out of service due to oil pump failure. After the pump replacement the transformer would not hold vacuum. During inspection it was found to have multiple leaks, shifted windings and spacers, broken spacers, broken bolts, and insulation and other material was dispersed throughout the tank. Due to the found condition the transformer will not be put back into service. TB2 is 67 years old and was being considered for replacement depending on condition on what was then the future inspection.

Replace the transformer with an existing 100 MVA spare from the Indiana system.

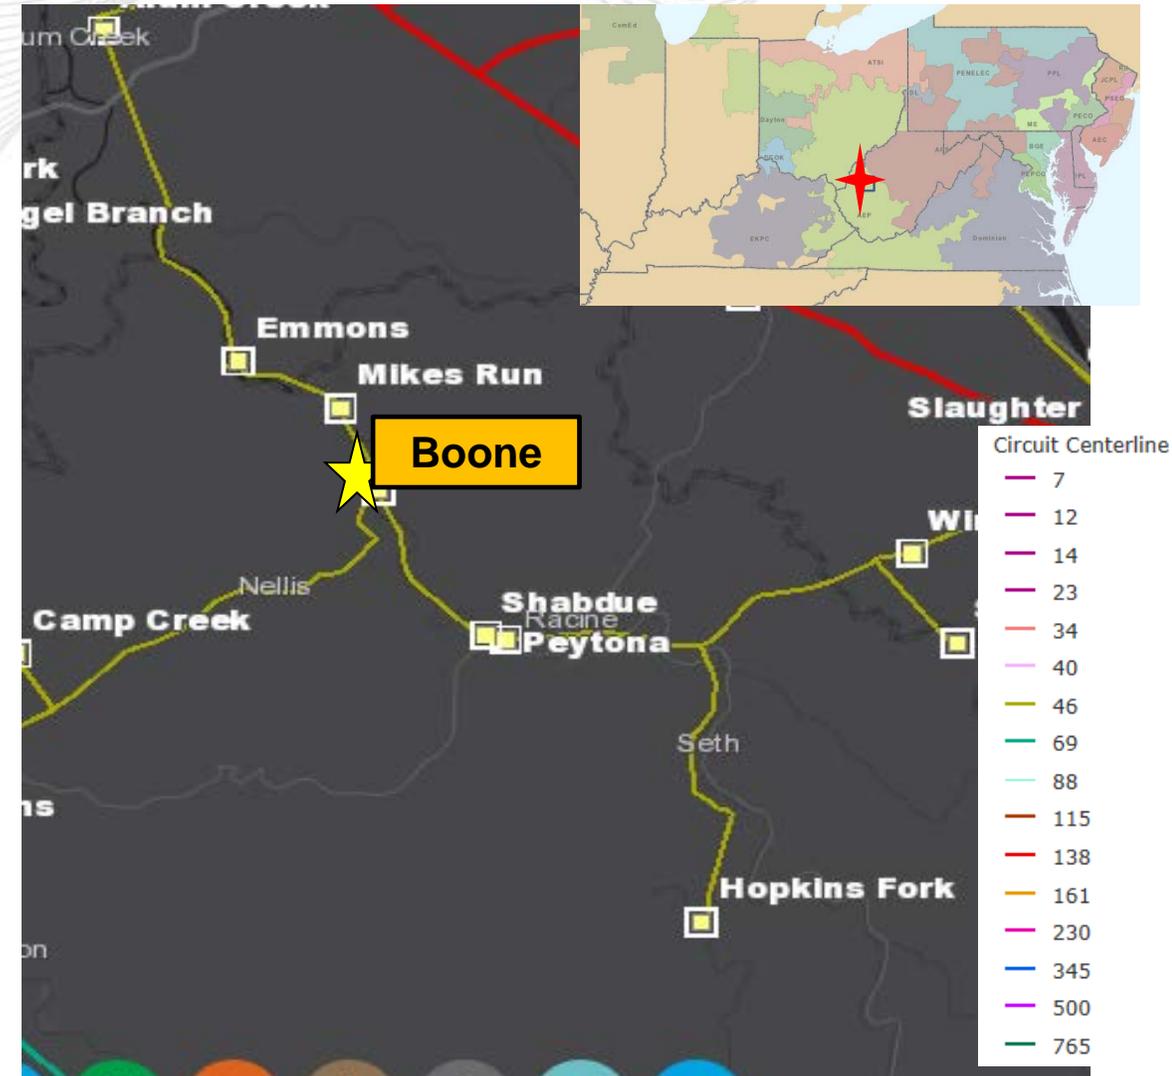
Boone 46 kV CB's "A", "B", and "C" (vintage 1972) are 1200A 20 kA oil filled circuit breakers without oil containment. Oil breakers have become more difficult to maintain due to the required oil handling. There is an increased potential for oil spills during routine maintenance and failures with these types of breakers. These circuit breakers have operated for 135, 177, and 58 faults respectively. The manufacturers recommended number of fault operations is 10.

Replace three existing 1200 A 20 kA 46 kV circuit breakers "A", "B", and "C" with new 3000 A 40 kA 69 kV circuit breakers.

A ring bus configuration was considered, however the existing bus/steel is not showing any signs of deterioration and did not warrant being replaced. Re-configuring the station into a ring configuration would have been cost prohibitive.

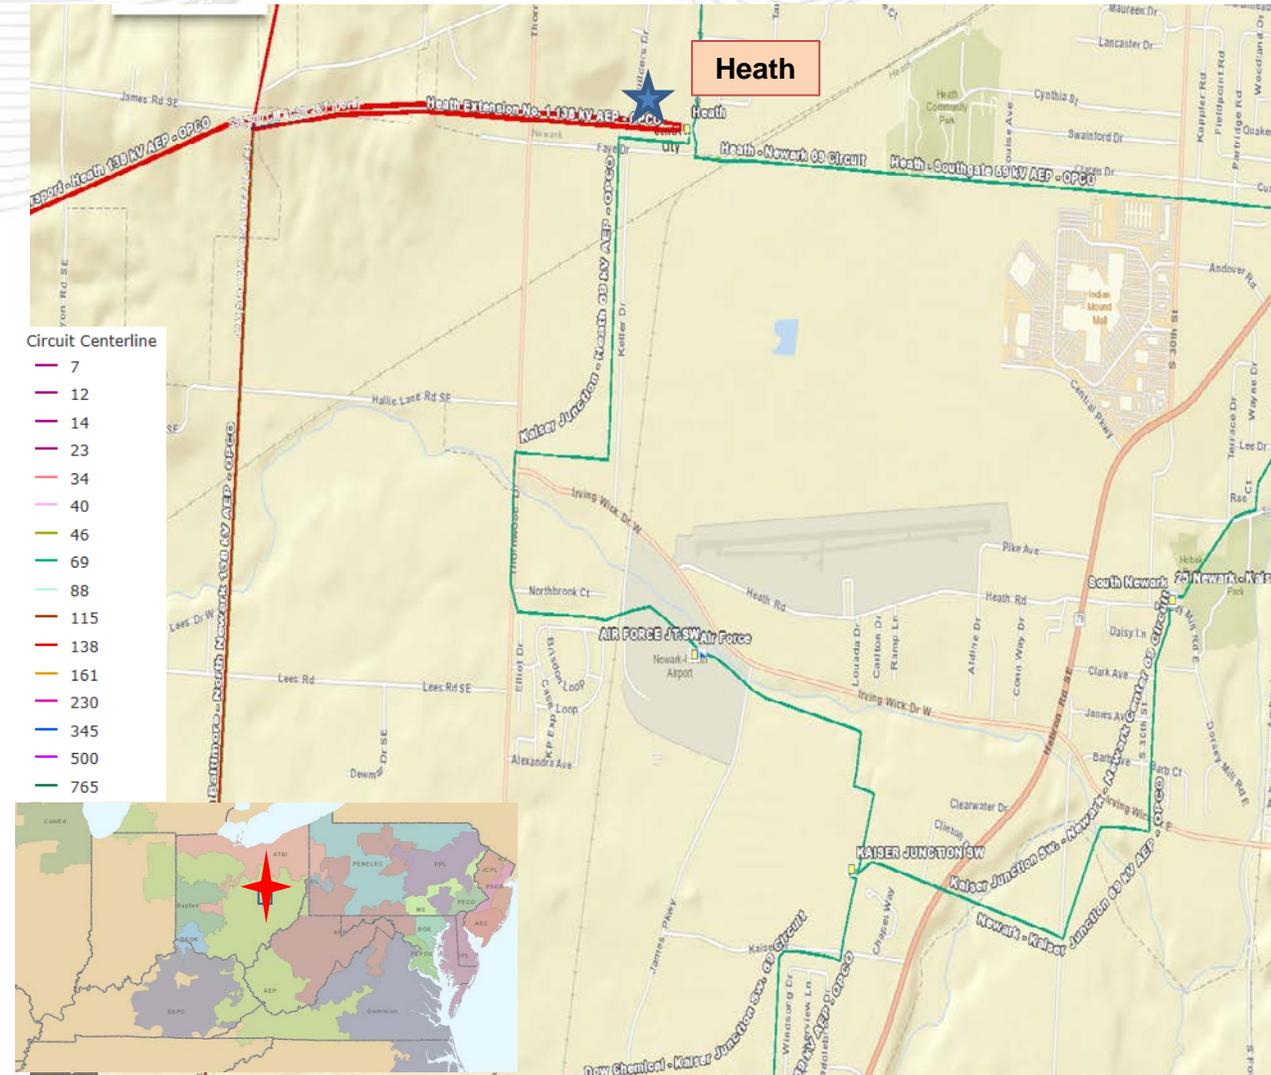
Several 69 kV circuit breakers at Heath station are showing signs of deterioration. These breakers are all 1200 A 20 kA oil breakers manufactured in 1962 and 1973. Oil breaker maintenance has become more difficult due to the oil handling required to maintain them. Oil spills are frequent with breaker failures and routine maintenance and can become an environmental hazard. The 69 kV circuit breakers "A", "B", "C" and "D" have fault operations of 16, 28, 58 and 70 respectively.

Replace 69 kV circuit breakers "A", "B", "C" and "D" with 2000 A 40 kA circuit breakers. Expand the DICM. Remove the 138/34.5 kV 25 MVA transformer #5.

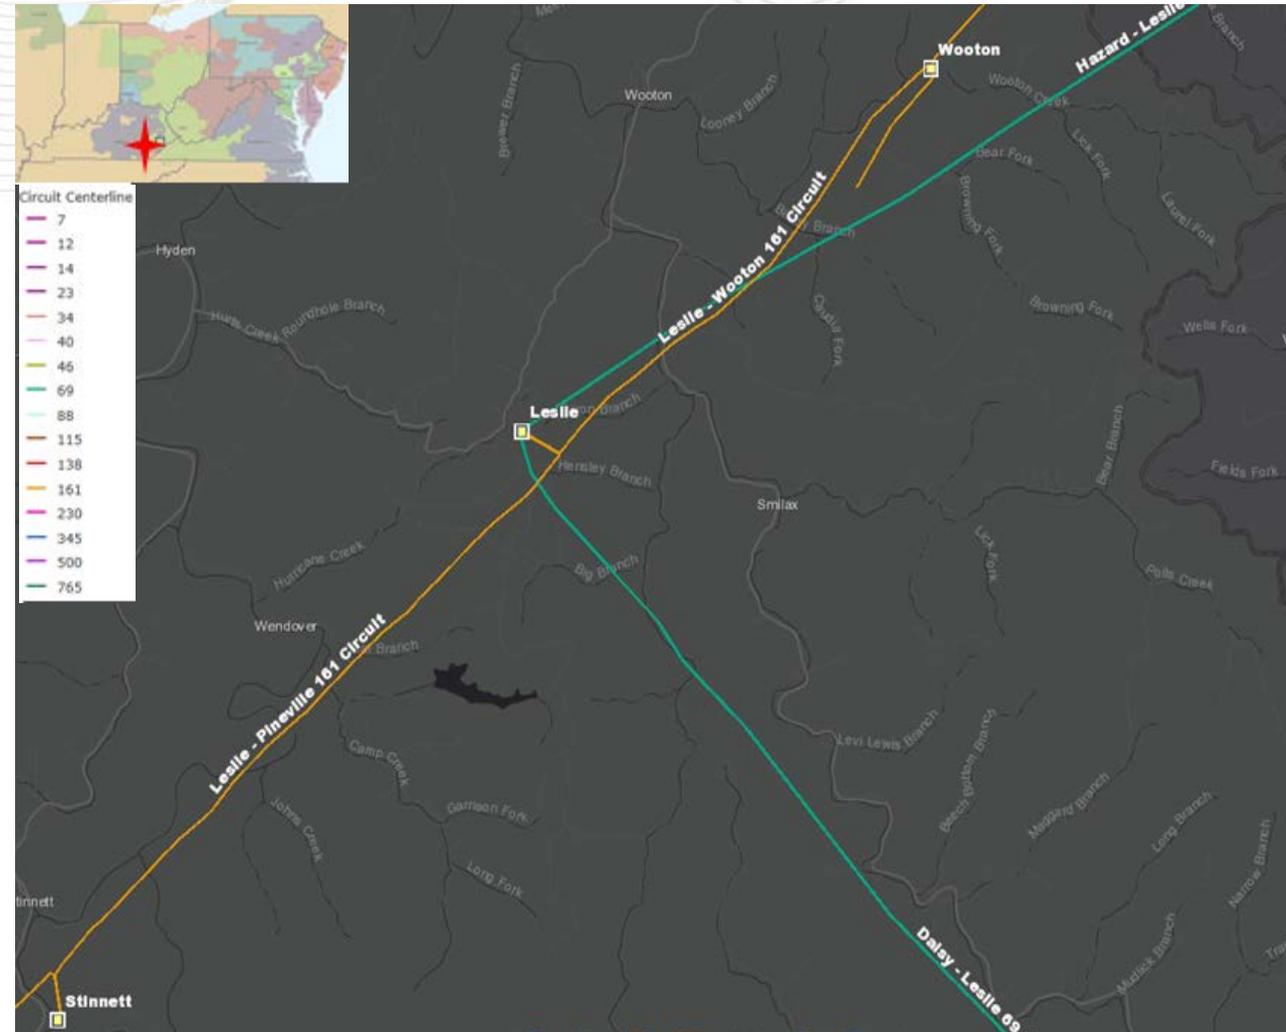
The 161/69 kV transformer at Leslie is 36 years old and shows an upward trending of oil moisture content resulting in downward trending to the oil dielectric strength. Increasing moisture content is a result of water ingress and break down of paper insulation of TF windings. Short circuit strength breakdown caused by through fault events has lead to gassing of the unit, and carbonization of the insulating paper. All of this indicates that the transformer is in need of replacement. A spare transformer (non-switchable) for the station is also being purchased as this is the sole 161/69 kV transformer on AEP's eastern footprint.

161 kV circuit breaker "K" at Leslie station is a HVB242 type breaker. HVB's have a history of slow reclosing due to documented issues associated with their air receivers and control valves. Currently there are only nine breakers of this type in service on the AEP system. Parts for the breaker are hard to come by and are no longer available through the manufacturer. The breaker in question has external rust issues which resulted in a failure to reclose properly in the past. The breaker has experienced 141 fault operations exceeding the manufacturer recommendation number of 10.

Replace existing 90 MVA 161/69 kV transformer with a new 130 MVA 161/69 kV transformer. A second 161/69 kV transformer will be purchased as a non-switchable spare on site. 161 kV 3000 A 50 kA circuit breaker "K" will be replaced with a new 3000 A 40 kA 161 kV circuit breaker.

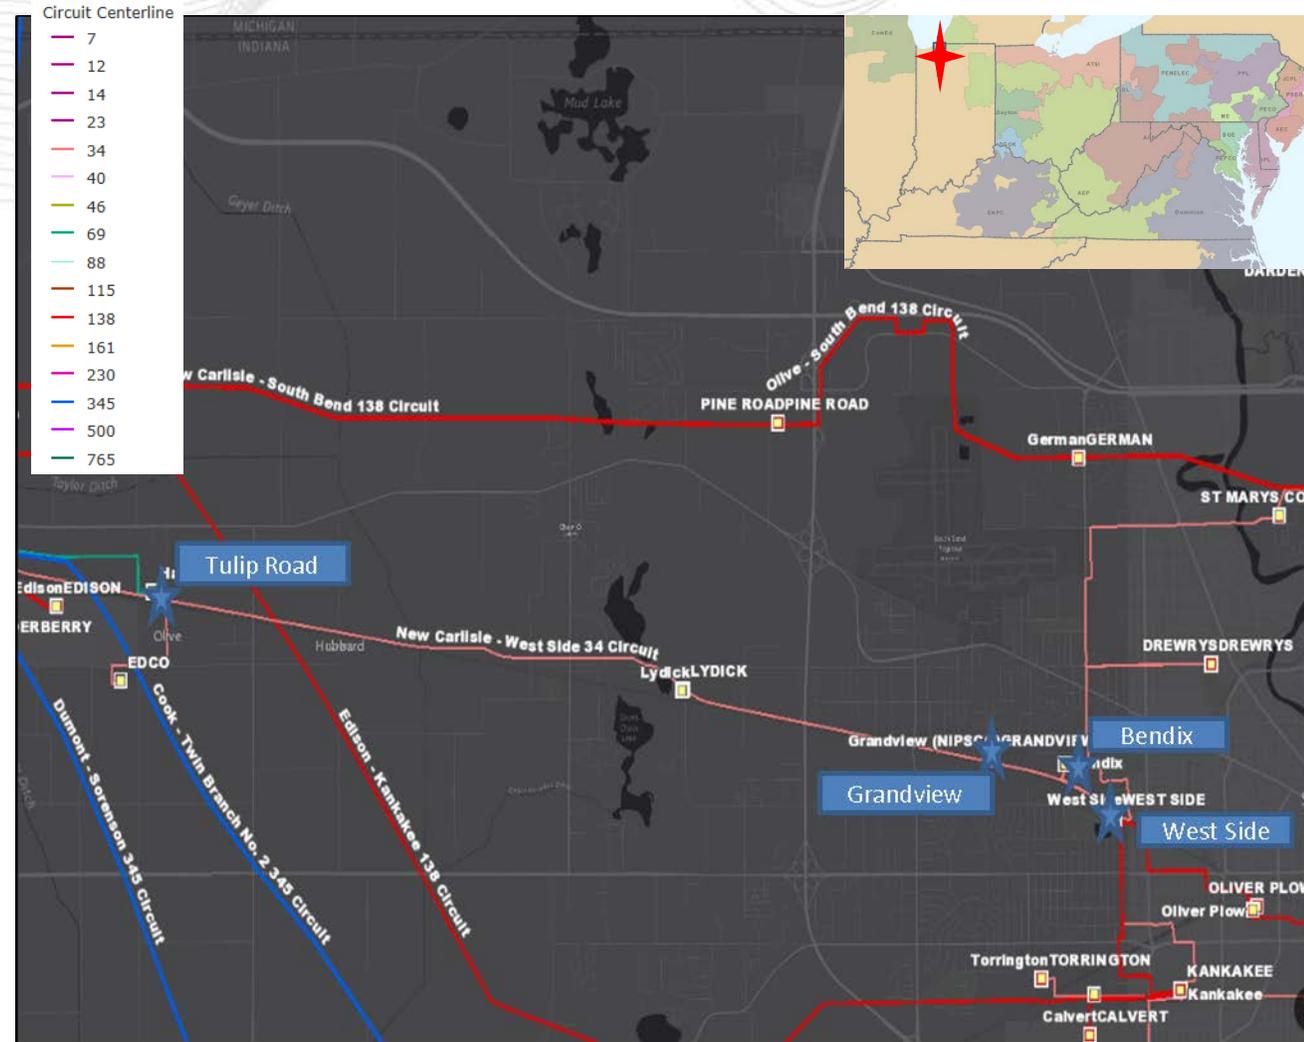
On the Tulip Road-West Side 34.5 kV line is estimated to be around 1934 vintage, constructed with 4/0 copper and 336 aluminum conductor (27 MVA rating). It is constructed from wood poles which are currently subject to 160 conditions including but not limited to, broken conductor hardware; broken, top rotted, split and twisted crossarms; broken and missing ground lead wires; damaged insulator; and damaged, leaning, rotted and split poles;

Grandview is currently hard tapped on the Tulip Road – West Side line. This means that any time AEP wants to maintain this line, the Grandview interconnection would have to be disconnected. While this project does not eliminate the tap, it sets the line up so that it can be replaced with a switching structure in a future project while simultaneously reducing the length of the line exposed to the hard tap.

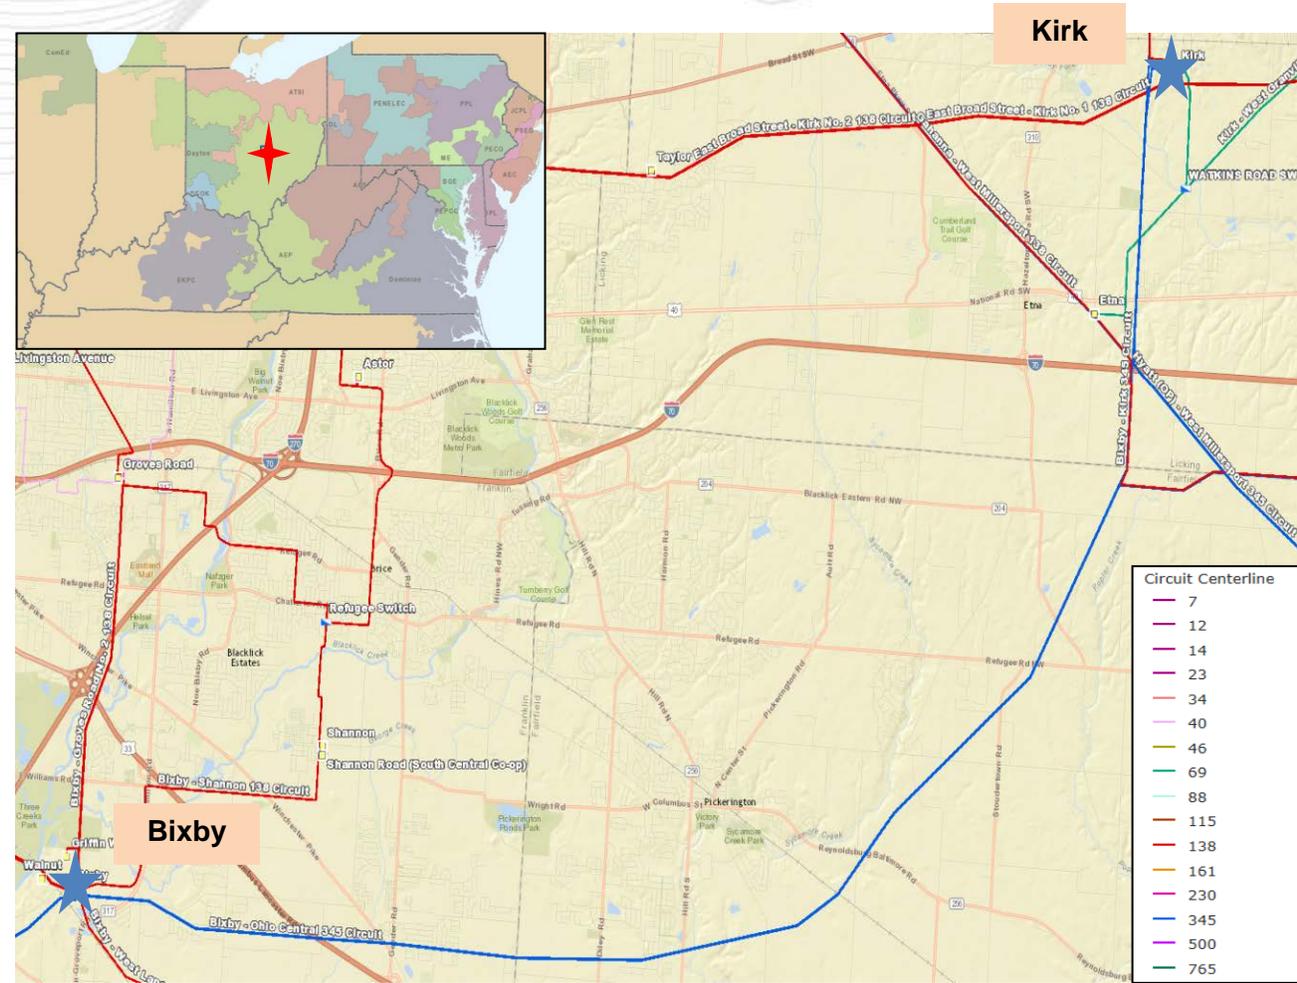
At Kirk, Install 4-345kV 3,000A CB's & end bus and complete the 345kV breaker and a half configuration. Replace 345/138kV XF with 675 MVA unit. Connect in different 345kV bay and on new 138kV string before removing old unit. Upgrade 2-138kV 4,000A CB's & retire 1 CB on 102 string. Install 2-138kV 4,000A CB's on new 104 string. Install 3 new 3,000A 138kV CB's and complete 103 & 105 strings. Upgrade 3-138kV CB's with 3,000A on 106 string. Separate 138/69 & 138/34kV XF connections and install 1-138kV ckt switcher on distribution bank.

Replace 138/34kV XF and 2-34kV CB's. **(S1510.1)**

At Bixby, replace Kirk 345kV line risers and line switch and upgrade relaying **(S1510.2)**

In order to protect a XF#4 fault condition involving a breaker failure scenario on any of the three 345kV breakers, a high speed ground switch on the 345kV (Z4) is required. Intentionally putting faults on the 345kV system is not desirable and non-standard.

A breaker failure on CB-102C, CB-102N, CB-E, CB-D, or CB-C will outage all of Kirk's 345kV. This is not desirable as Kirk is a critical station in the East Columbus area.

Kirk-Bixby 345kV line is limited by various line risers at Kirk and Bixby as well as thermal relay limits at Kirk. Relaying and line risers at Kirk will be replaced with the replacement of transformer #4 and the new 345kV CB's. Line risers at Bixby also need to be replaced under the same line outage to maximize the benefit of the outage. The next limiting factor for the circuit is a line switch at Bixby. Replacing this switch now further increases the SN line capability by approx. 49 MVA and allows for a potentially larger rating increase without an additional outage if a future sag study is done on the line.

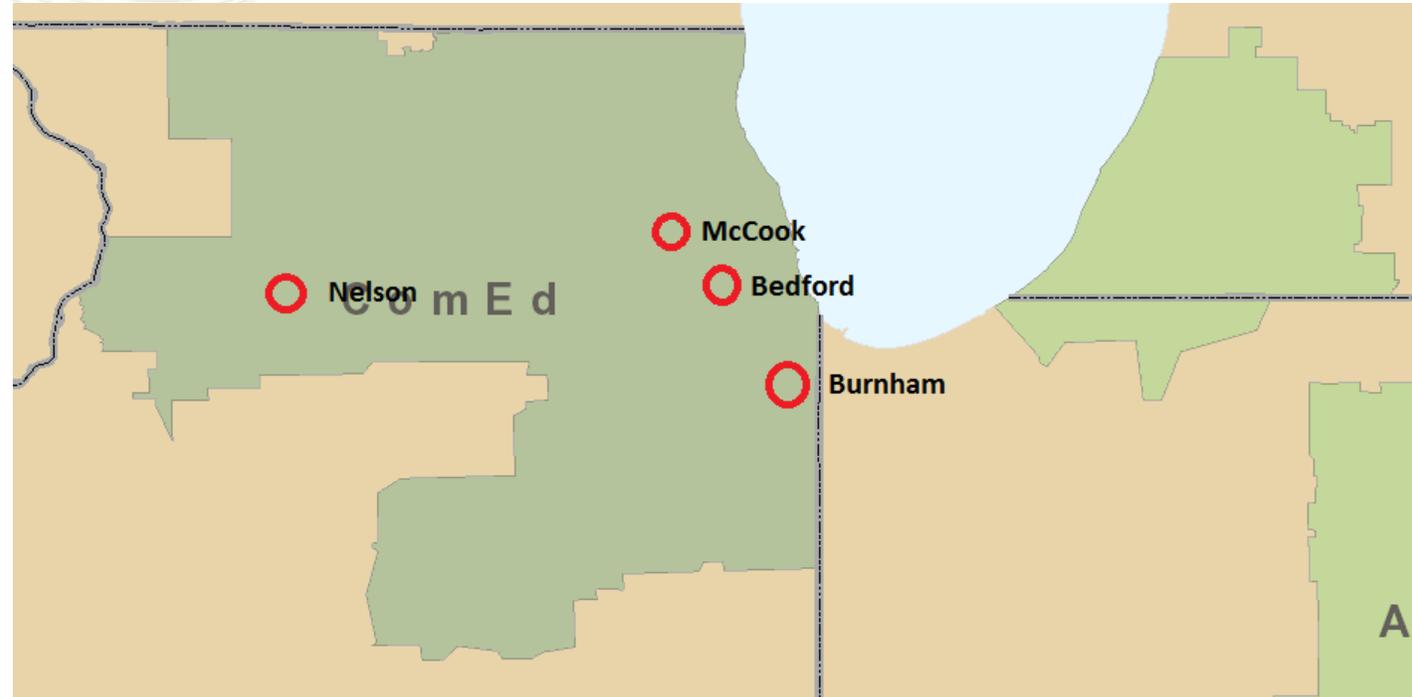
138kV line 17712 wave trap needs to be replaced due to material condition.

Replace the wave trap at the Burnham substation for 138kV line 17712 (Wildwood – Burnham-Hegewisch) (**\$1556**)

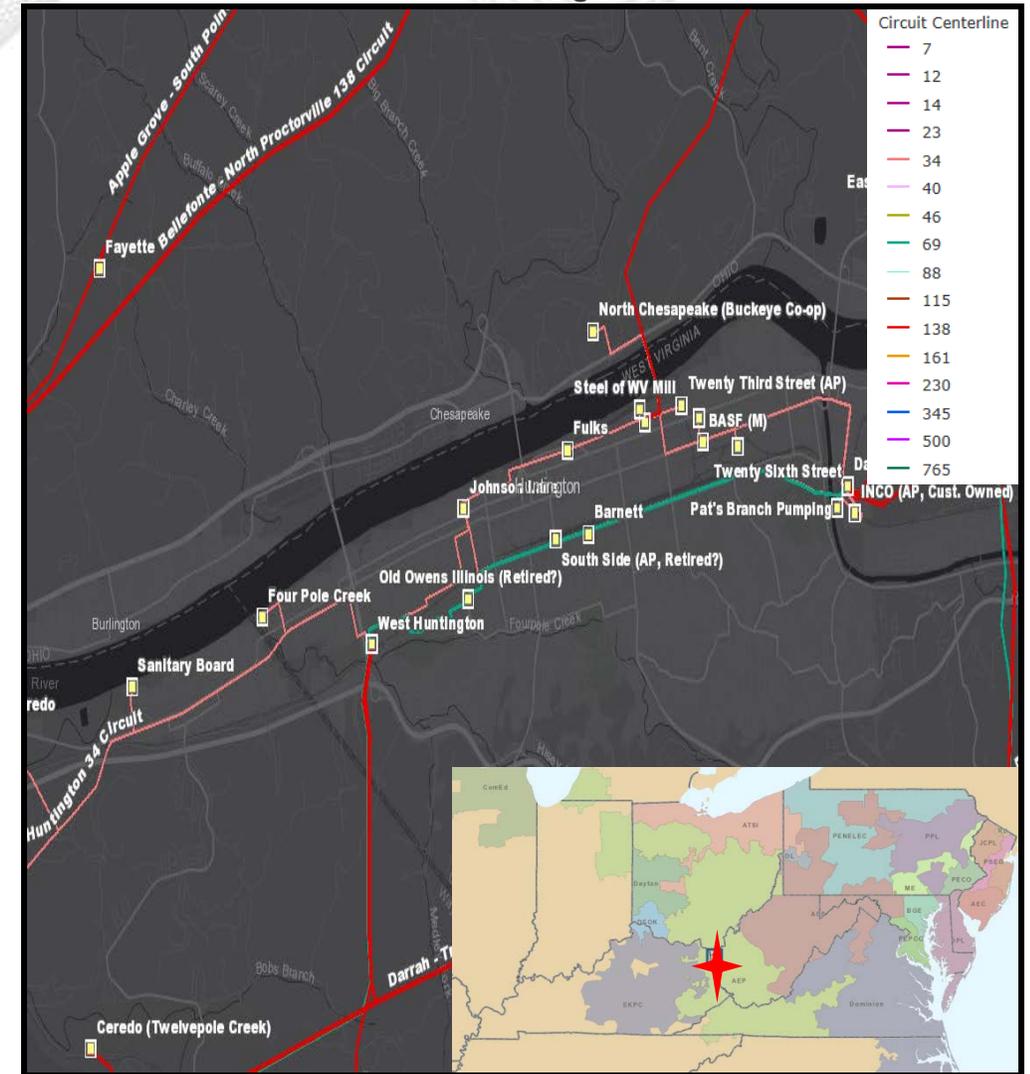
138 kV circuit breaker "E" at West Huntington is FK type breakers that are both over 67 years old. It is oil breaker that has become more difficult to maintain due to the required oil handling. There is an increased potential for oil spills during routine maintenance and failures with these types of breakers. Other drivers include PCB content, damage to bushings and number of fault operations exceeding the recommendations of the manufacturer. West Huntington breaker "E" have experienced 89 and 18 fault operations. The manufacturer's recommendation for this type of breaker is 10.

69 kV circuit breaker "C" and 34.5 kV circuit breaker "J" at West Huntington are FK type oil breakers that are over 46 years and share the same concerns listed for the 138 kV breakers above. Circuit Breakers "C" & "J" have experienced 23 and 40 fault operations. The manufacturer's recommendation for this type of breaker is 10.

Capacitor switcher "AA" at West Huntington is a VBM type switcher. Joslyn Varmaster VBM-34's have a double stack interrupter design requiring simultaneous operation for rated current interruption; any delay between the two stacks would cause the full electrical stress of the operation to be placed on one stack. This could lead to capswitcher and/or cap bank failure. Like Mark V switchers, new control integration is difficult.

138 kV circuit breakers will be added to the high side of the transformers at West Huntington to separate dissimilar zones of protection.

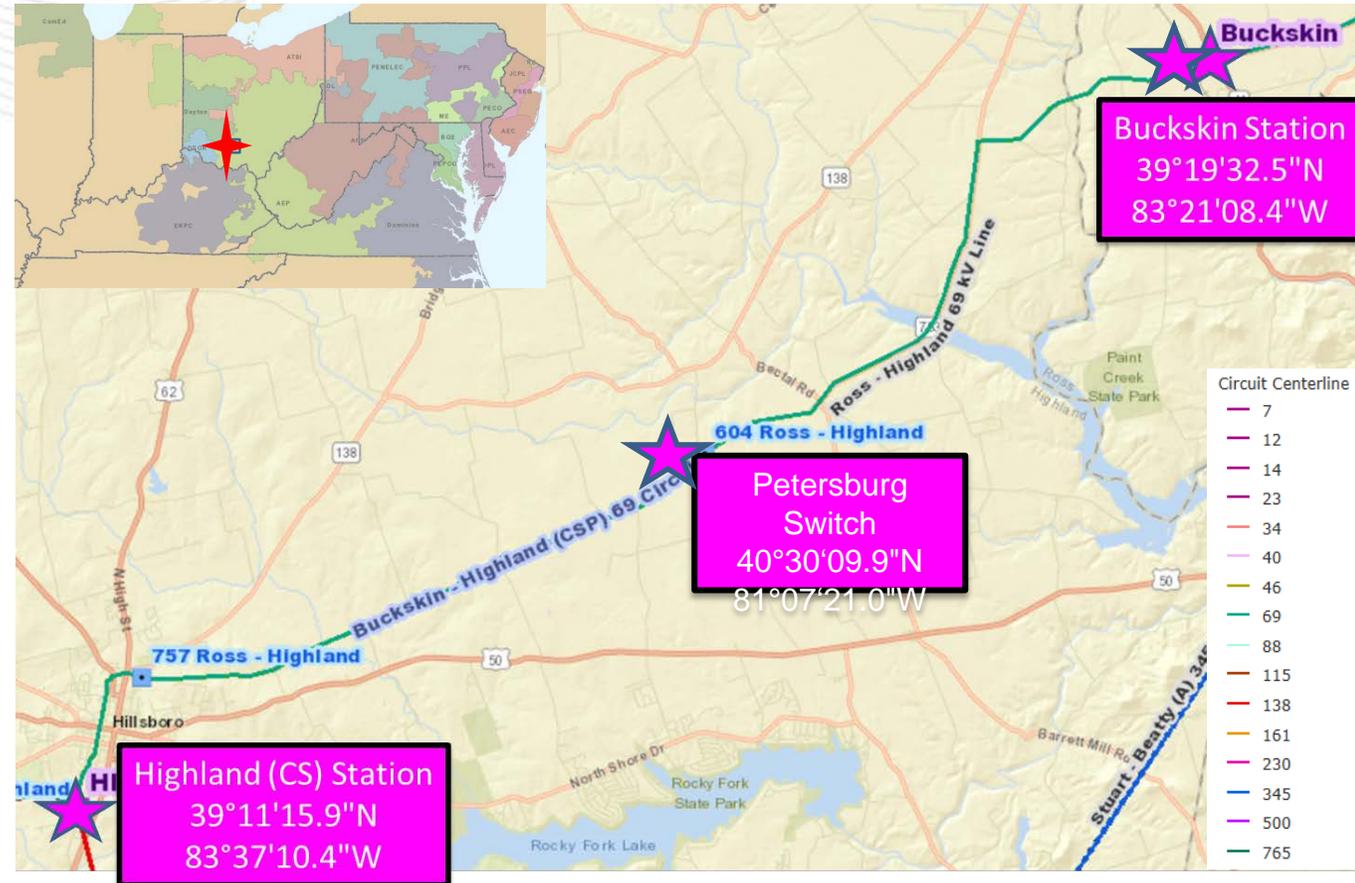
Selected Solution:

Replace Petersburg Switch (S1559.2)

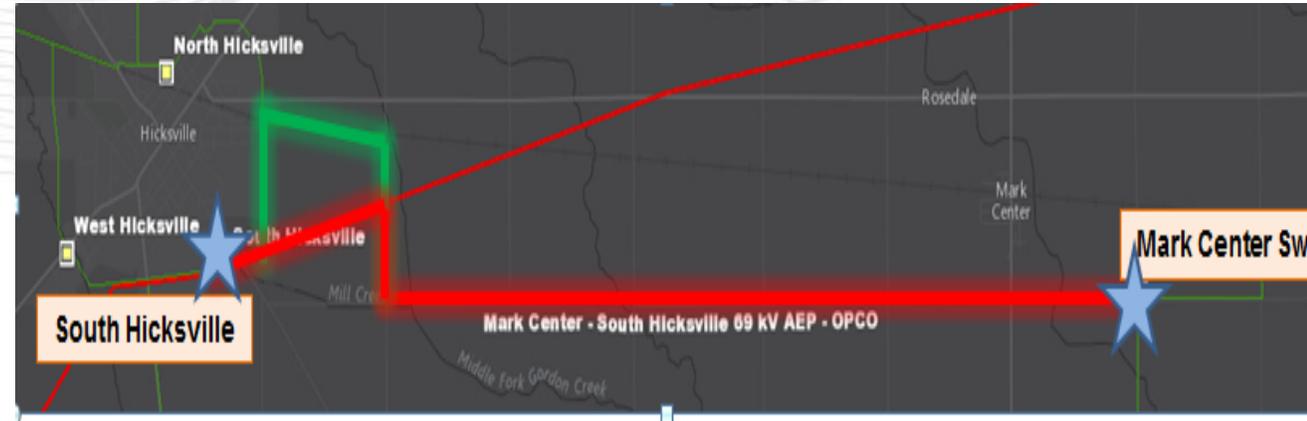
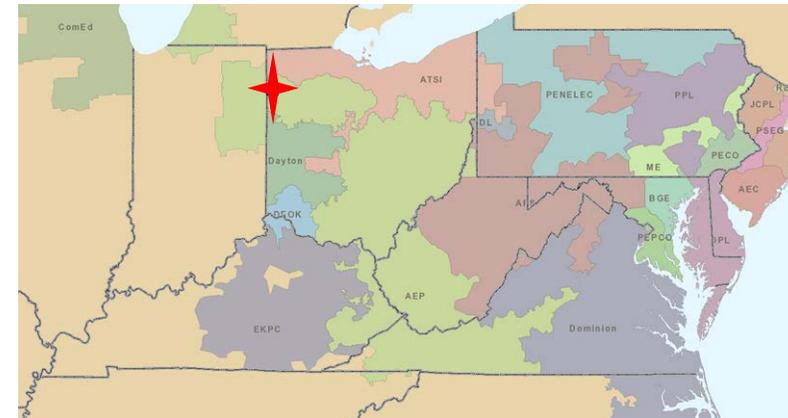
**Existing Mark Center – South Hicksville 69 kV Line is highlighted in green;
Proposed rebuild is highlighted in red.**

The Mark Center-South Hicksville line was originally constructed in 1957 with 336 ACSR conductor (73 MVA rating). There are 119 open conditions on this 8.8 mile long circuit. The existing line is almost entirely crossarm construction with suspension insulator assemblies, which is not the current AEP standard; the existing crossarms and braces are typical for distribution construction, not transmission construction. End splitting and failure is an elevated risk. Many arms fail periodic inspection; quantity failing inspection is abnormally high. Undersized braces are prone to end fittings becoming separated and arms rotating. Some existing wood pole structures have bay-o-nets supporting the shield wire. At least once in the last year the line experienced a cascading failure of multiple poles in a row. Existing grounding is only every other structure. The line is double-circuit construction for several spans near South Hicksville Station. Structure failures in the double-circuit section jeopardize system stability in the Hicksville, OH area, elevating the risk of an area-wide outage. Some of the line has distribution underbuild, which mechanically consumes pole strength. Legacy underlying easement rights for a line of this vintage are typically inadequate by present day AEP Transmission standards.

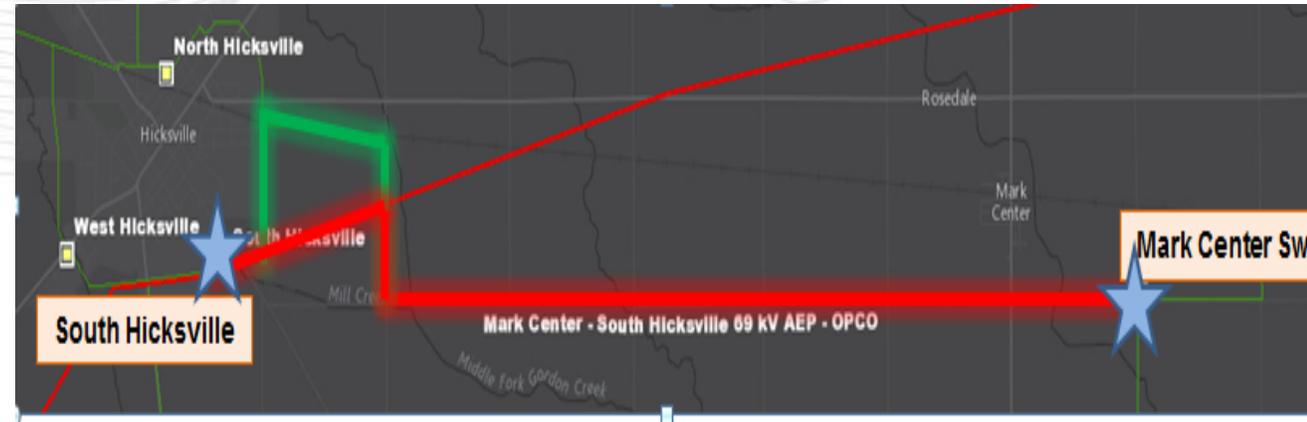
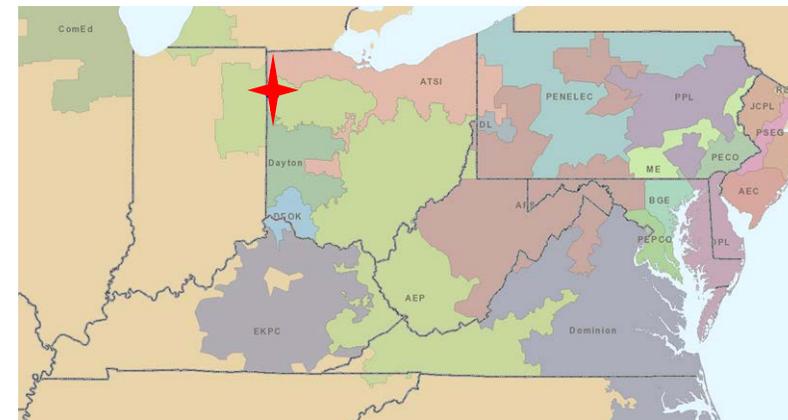
Existing Mark Center – South Hicksville 69 kV Line is highlighted in green;
Proposed rebuild is highlighted in red.
