PJM Western Sub-Regional RTEP Committee AEP Supplemental Upgrades

March 25, 2019

Needs

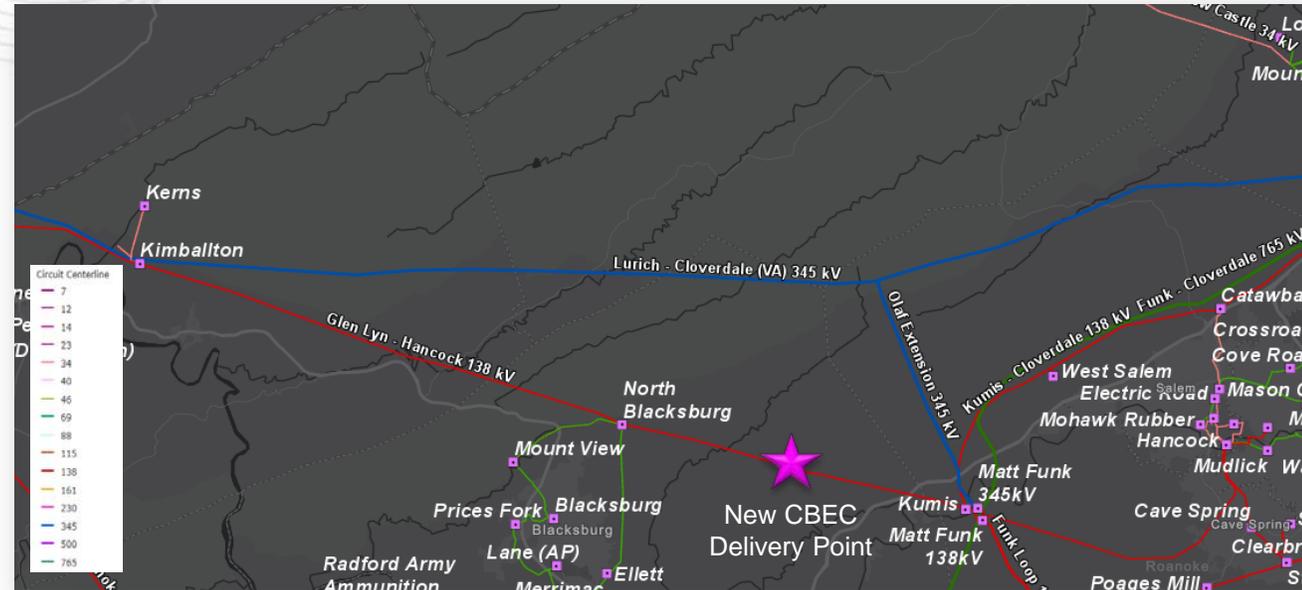
Craig-Botetourt Electric Cooperative (CBEC) requested a new delivery point from AEP to be located in Montgomery County, Virginia. The new station will serve approximately 10 MVA.

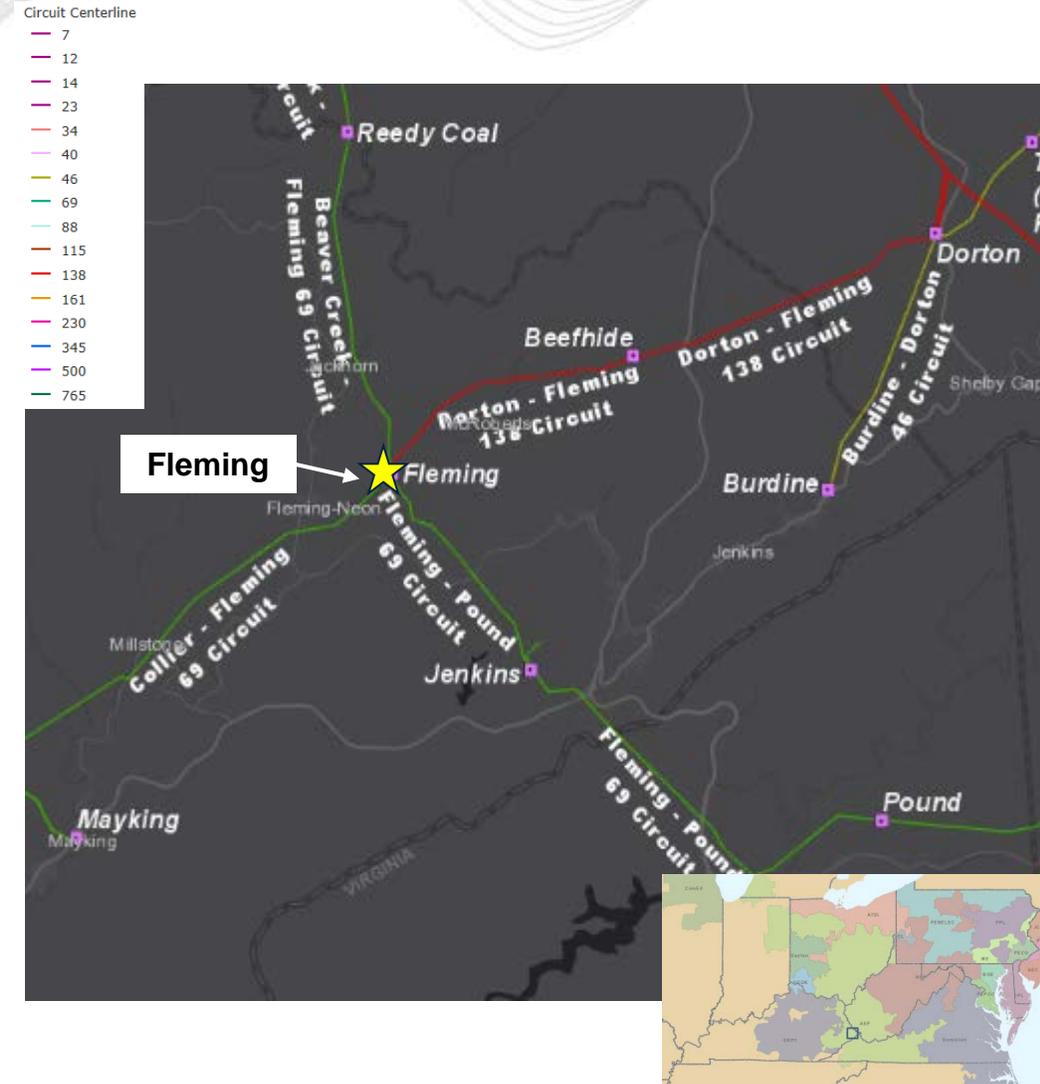
Fleming Station

- 138/69 kV Transformer #1
 - 1984 vintage transformer.
 - Shows signs of dielectric breakdown (insulation), accessory damage (bushings), and short circuit breakdown (due to through faults).

- Reports from the field show active oil leaks from the gaskets and slight leaks from the unit's welds.
 - Utilizes a ground switch MOAB scheme as part of the high side transformer protection.

- 69/12 kV Transformer #3
 - 1979 vintage transformer.
 - Shows signs of dielectric breakdown (insulation), accessory damage (bushings), and short circuit breakdown (due to through faults).

- 69 kV Circuit Breakers B, E, and F
 - CF-48 type oil breakers. (1965, 1968, and 1967 vintage)
 - These are oil breakers are difficult to maintain due to the required oil handling. There is an increased potential for oil spills during routine maintenance and failures with these types of breakers.

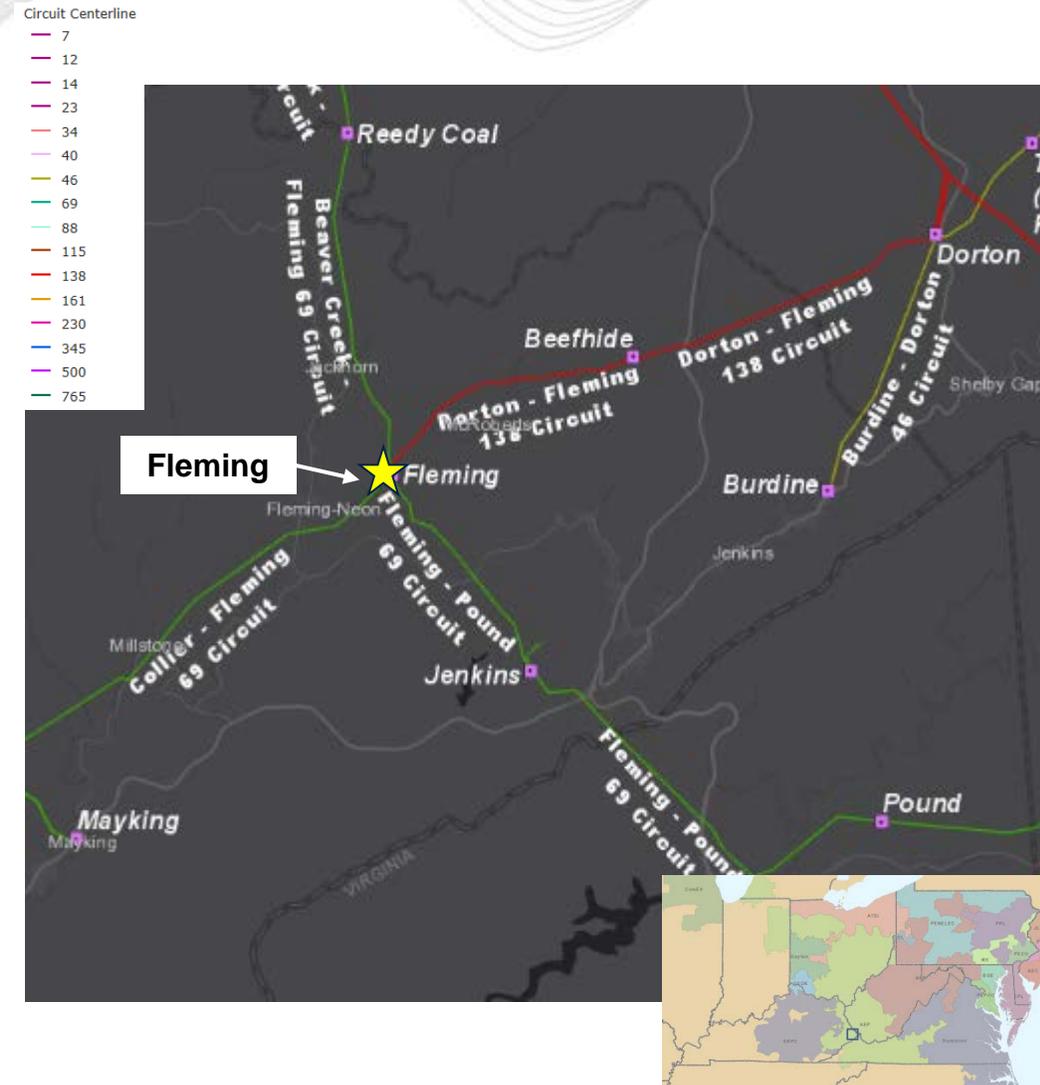
Fleming Station

- S&C Circuit Switcher 'AA'
 - No gas monitor, sister units on the AEP system have a history of gas loss, interrupter failures, and operating mechanism failures.

- 12 kV Circuit Breakers C and D
 - ES type oil breakers. (1979 vintage)
 - These are oil breakers that have become more difficult to maintain due to the required oil handling. There is an increased potential for oil spills during routine maintenance and failures with these types of breakers.

- Have experienced 36 and 19 fault operations respectively. The manufacturer's recommendation for this type of breaker is 10.
- 69 kV Circuit Breaker A

- 72EPB-31.5-20 SF6 type breaker with known gas leaks. (1990 vintage)
 - 18 malfunction records for this breaker since 2009 related to low gas alerts.
 - 1 of 12 remaining breakers of this type on the AEP system.

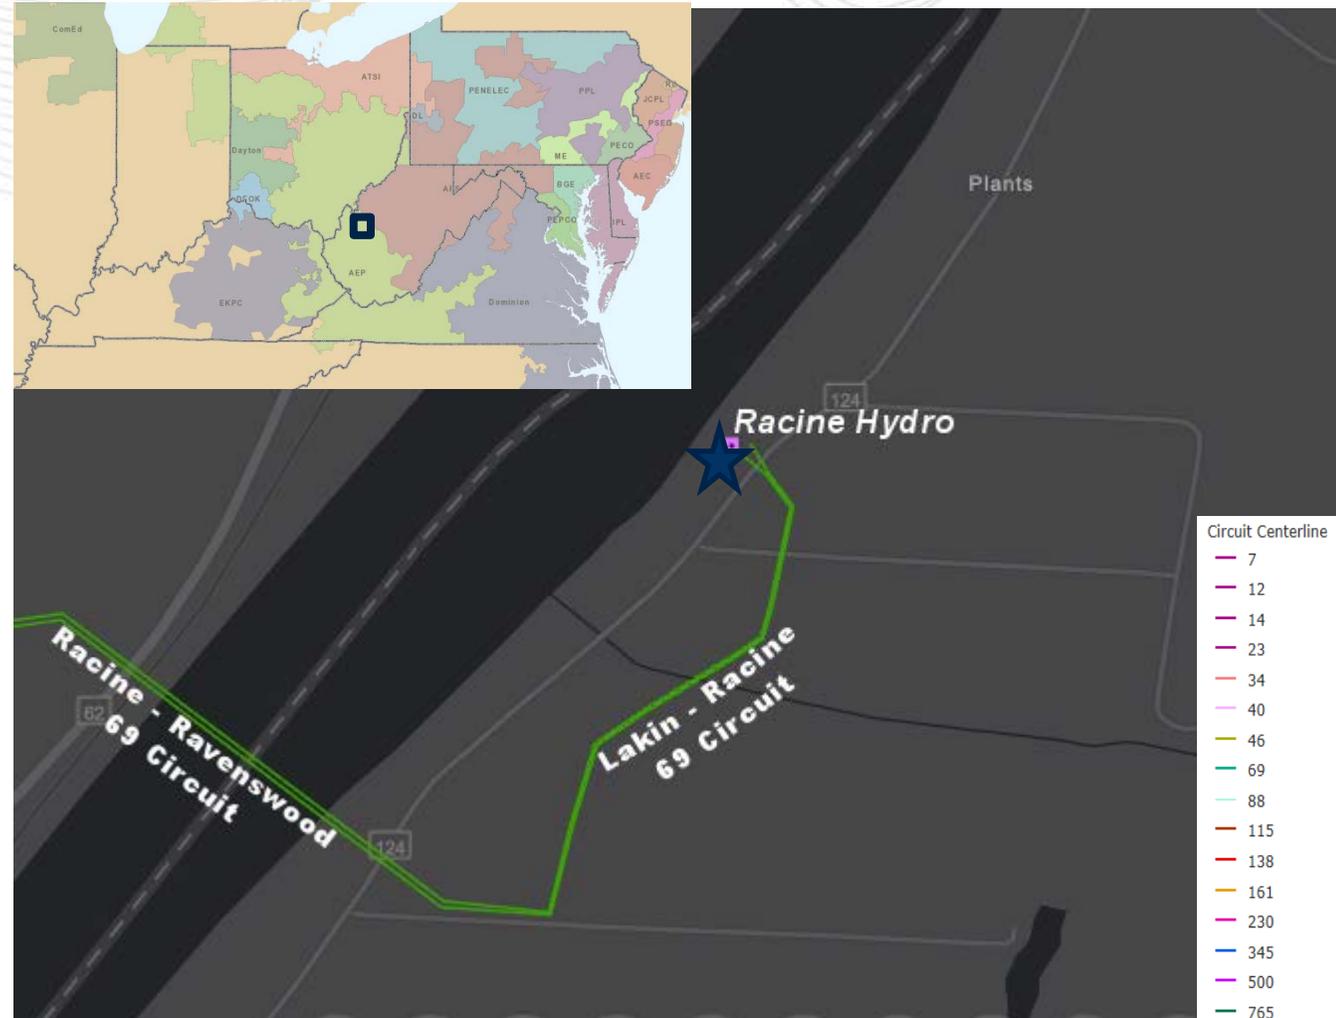
Racine 69 kV circuit breaker B

- CG-48 oil type breakers that was manufactured in 1980.
- Oil breakers are more difficult to maintain as oil spills have the potential to occur during maintenance which can be an environmental and safety hazard.
- Experienced 43 fault operations, exceeding the manufacturer's designed number of fault operations of 10.

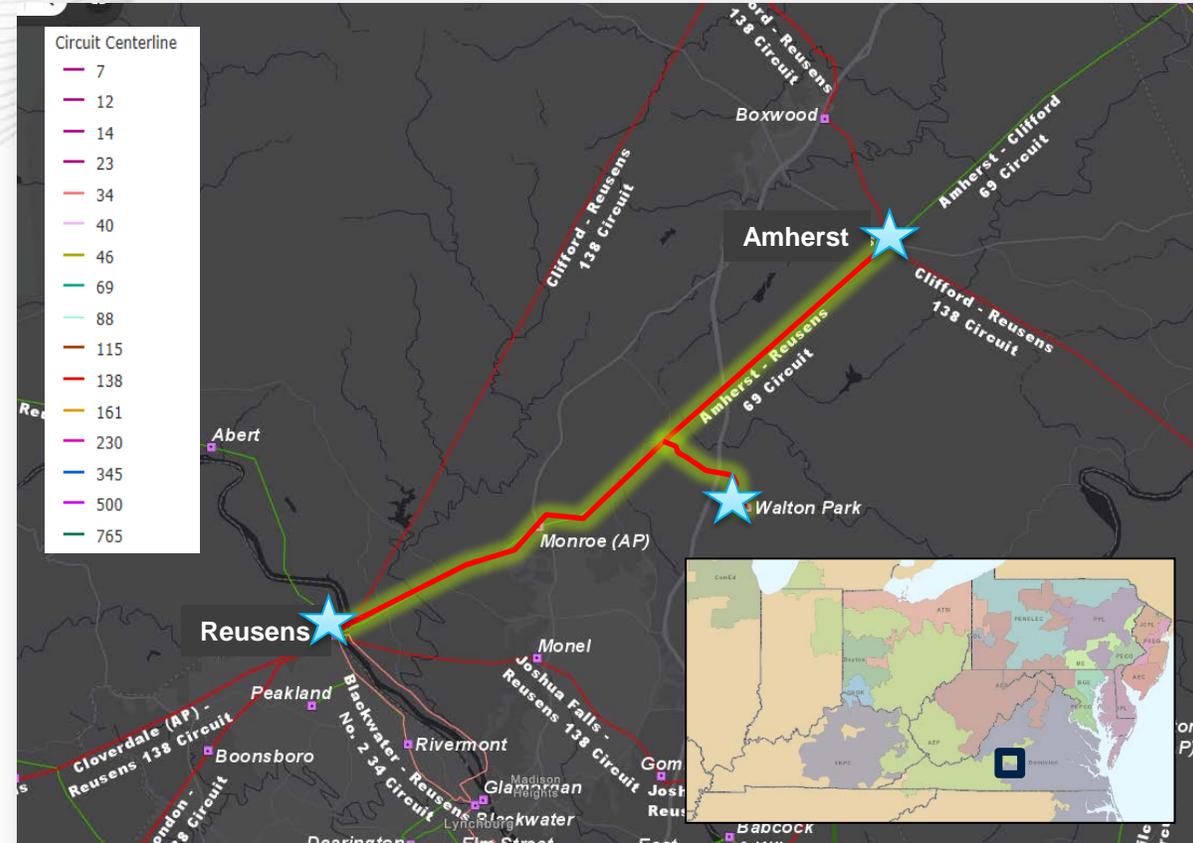
Problem Statement:
 The 14.2 mile long Amherst-Reusens 69 kV circuit was originally constructed in 1946 using wood pole structures with the lack of shielding on most (98%) of the circuit. Within the last 3 years it has experienced 33 momentary outages and 3 permanent outages with an average outage duration of 78.4 hours. The circuit currently has 26 open conditions. The majority (84.1%) of overhead conductor consists of 4/0 ACSR, also from 1946.

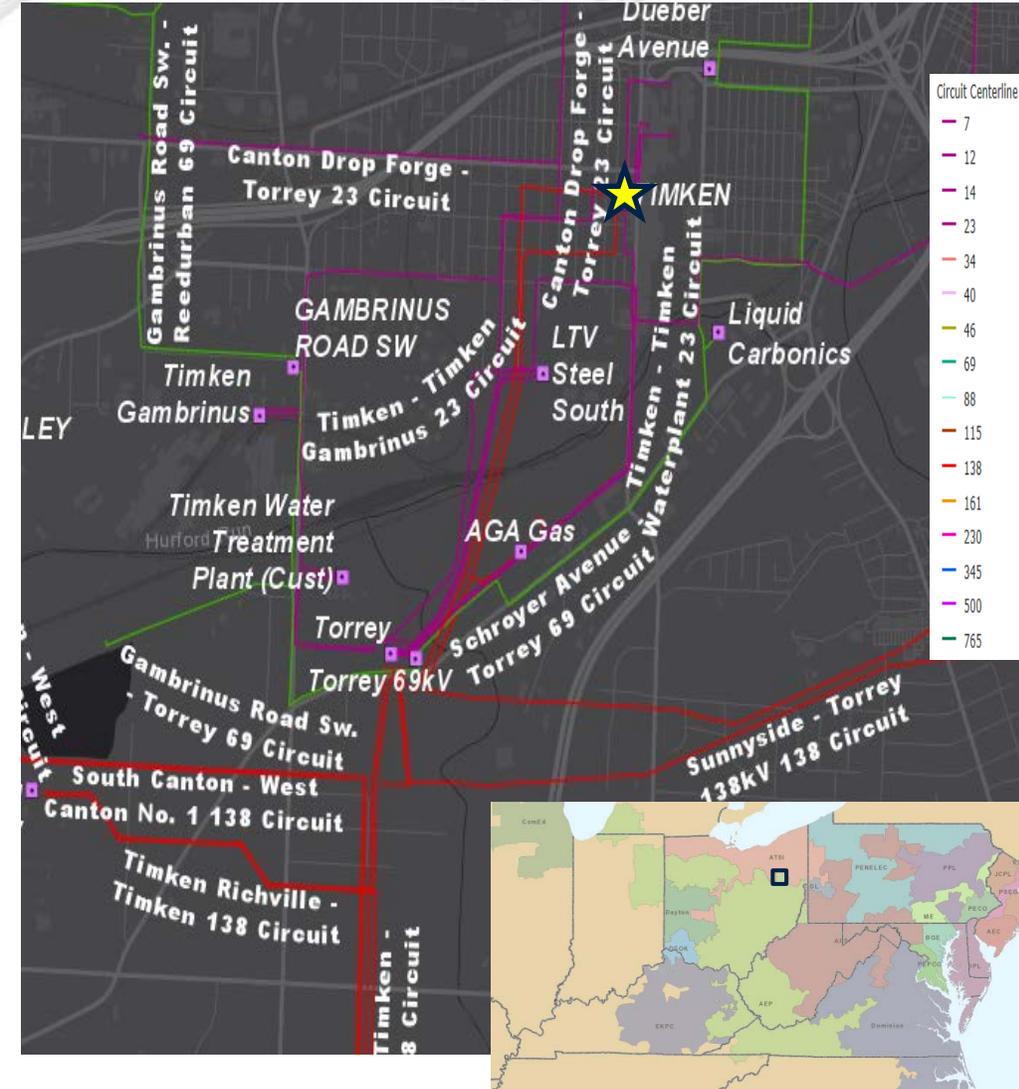
- Timken 138/23kV Station (vintage 1966) has many asset renewal issues, which is a concern, as the Station serves one of AEP's largest industrial customers.

- Timken is a 3 breaker Station in a straight-bus configuration (2- 138kV sources, 4- 138-23kV transformers). This configuration has several instances of dissimilar zones of protection (bus, line, and transformer) which can cause miss-operations and over tripping. In addition, a lack of sectionalizing makes maintenance a concern from an customer outage perspective.

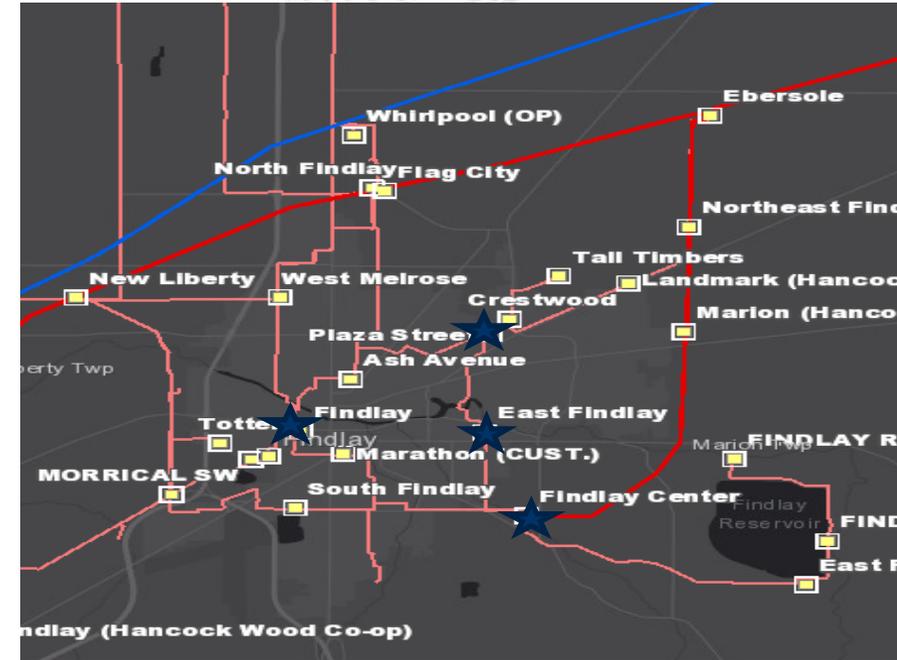
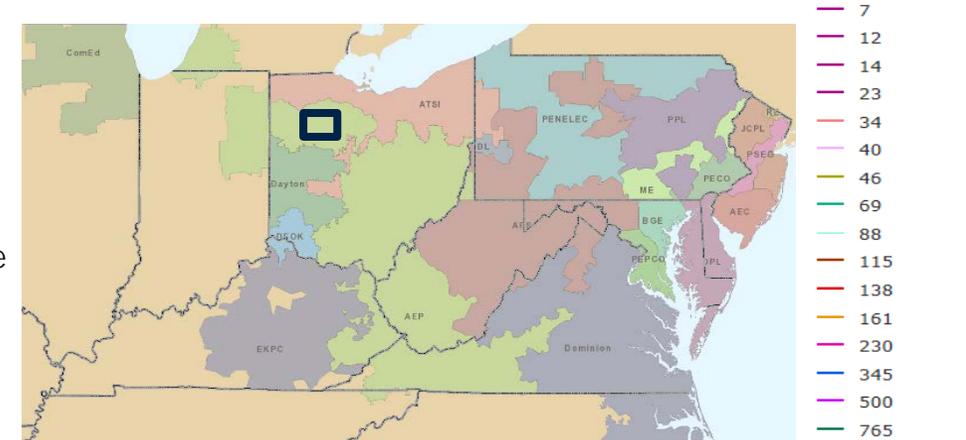
- 34.5 kV CB's A, B, C, and D are oil type breakers (vintage 1962). Many of these breakers have exceeded the manufacturers recommended number of fault operations (10): "A" (37), "B" (7), "C" (6), and "D" (39).
- 34.5 kV cap switcher AA is a MARK-V model (2004) which has been identified for replacement due to lack of spare parts, operational and reliability concerns, and maintenance issues.

- 34.5 kV CB's A, B, D, and E are oil type breakers (vintage 1953– 1955). Many of these breakers have exceeded the manufacturers recommended number of fault operations (10): "A" (20), "B" (33), "D" (41), and "E" (3).
- 34.5 kV cap switcher AA is a VBM model (1988) which has been identified for replacement due to lack of spare parts, operational and reliability concerns, and maintenance issues.

- 34.5 kV CB A is an oil type breaker (vintage 1948). This breaker has exceeded the manufacturers recommended number of fault operations (10): "A" (13).

- The three-way switch (1958) has ongoing difficulties maintaining proper alignment of switches. The insulators are cap-and-pin type which often physically failing during switching operations.

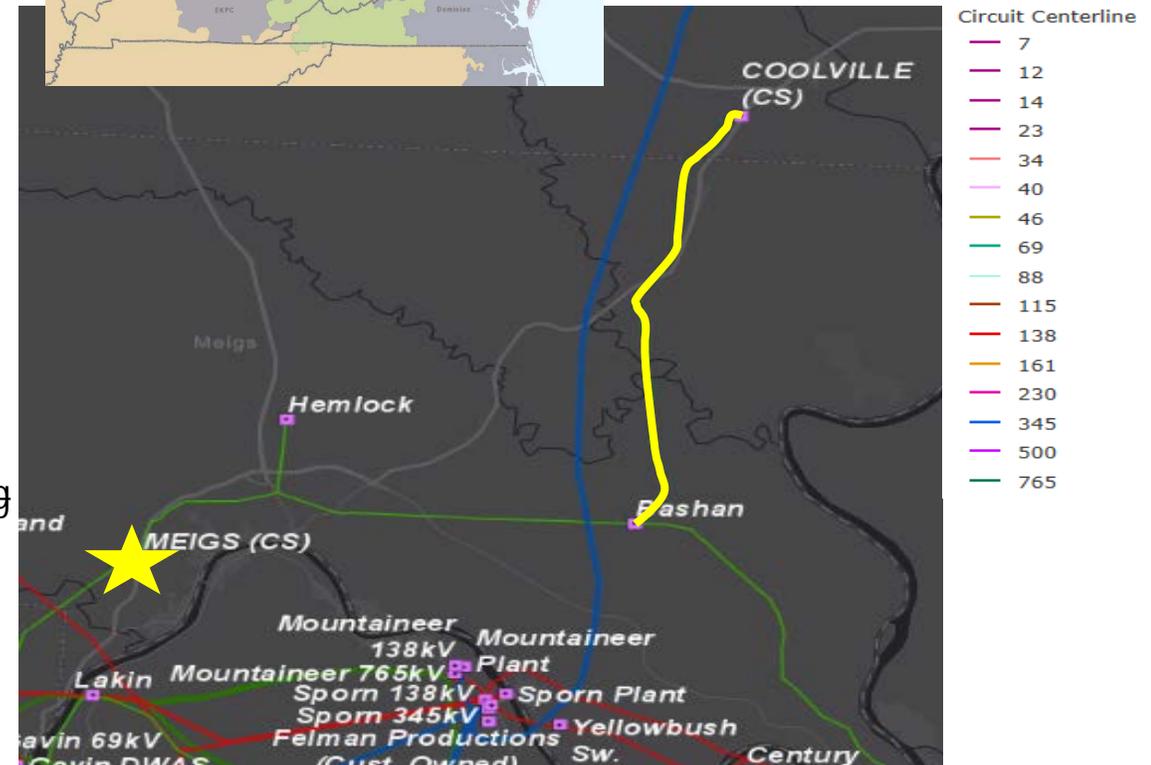
- Meigs 69 kV CB "1" is a 1954 oil-filled circuit breaker. Oil breakers are difficult to maintain due to oil handling requirements and risk of oil spills during maintenance and failures. This model (G.E. FK-439-69-1000-4) is also recommended for replacement due to reliability issues, lack of vendor support, and lack of spare part availability. In addition, this CB has exceeded the manufacturers recommended number of fault operations: CB 1 (20).

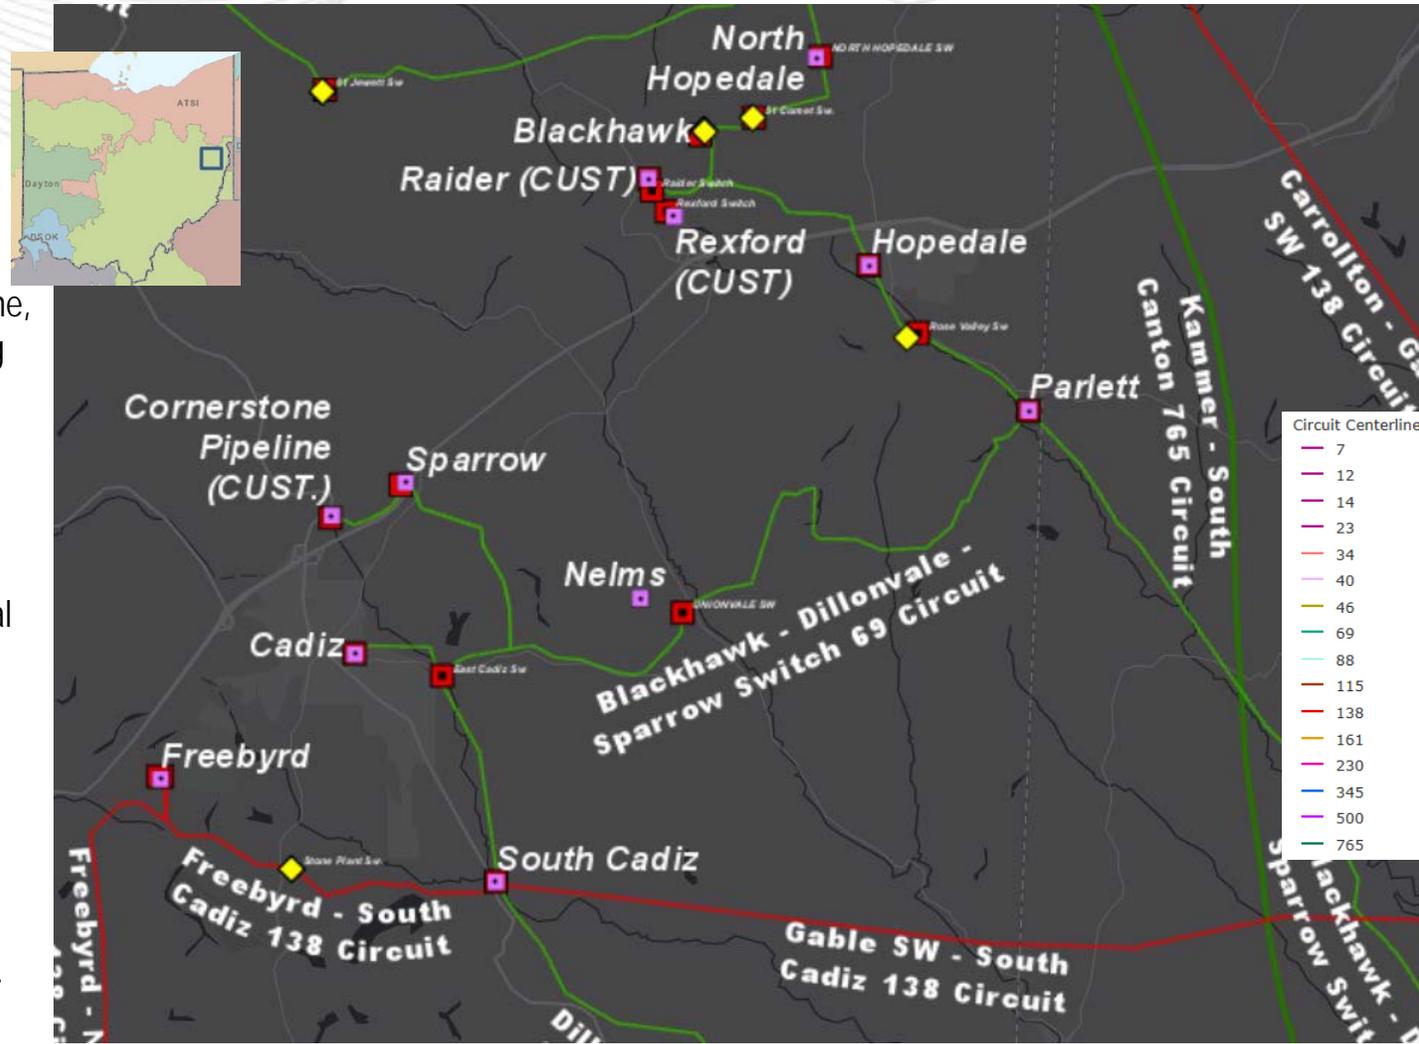
- East Cadiz Switch (1950's) serves Cadiz station on a mile long radial line, which is in a remote part of our system. In addition, this switch is sitting in an area prone to flooding.

- The Parlett-East Cadiz 69kV line, approximately 8 miles long, is comprised of deteriorated 1929 vintage wood structures and still has original 1/0 Cu and 4/0 ACSR conductor on it.

- The South Cadiz-East Cadiz 69kV line, approximately 2 miles long, is comprised of deteriorated 1954 vintage wood structures with the original 4/0 ACSR conductor on it.

- The Parlett-South Cadiz 69kV line has 190 open conditions.
- All load at Nelms Station has been removed.
- The Blackhawk – Miller Switch 69 kV line section, approximately 2.5 miles long, has some of the original 1918 conductor still on it (1/0 Cu). More than half of the wood pole structures on this sections are of pre-1980 vintage and are affected by heavy rot, woodpecker, & insect damage through the years. There are 22 open conditions on this circuit.

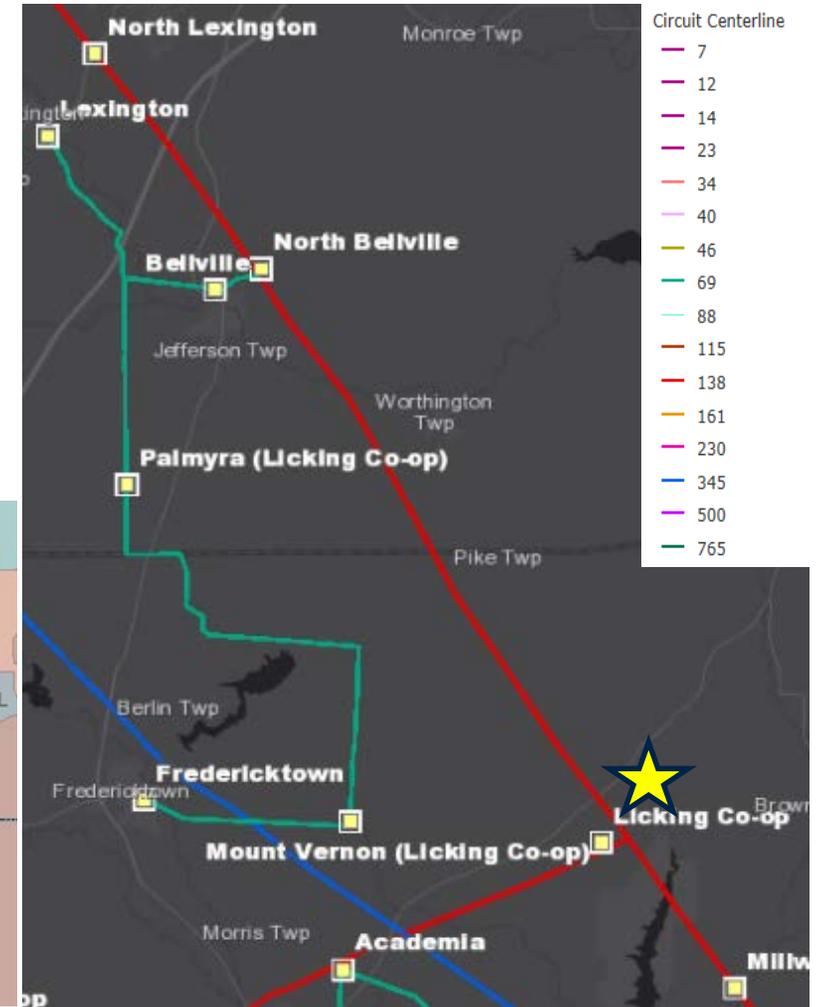
- The Apple Valley (Licking Co-op) 138 kV delivery point serves approximately 2,300 customers with a peak demand of 6.5 MW. Apple Valley isn't 100% transferrable during all times of the year and can take several hours to complete the required switching. This delivery point has experienced 971,280 customer minutes of interruption.
- This delivery point is connected with a hard tap which limits sectionalizing during outages and maintenance. In addition, relay coordination can be difficult with hard taps.

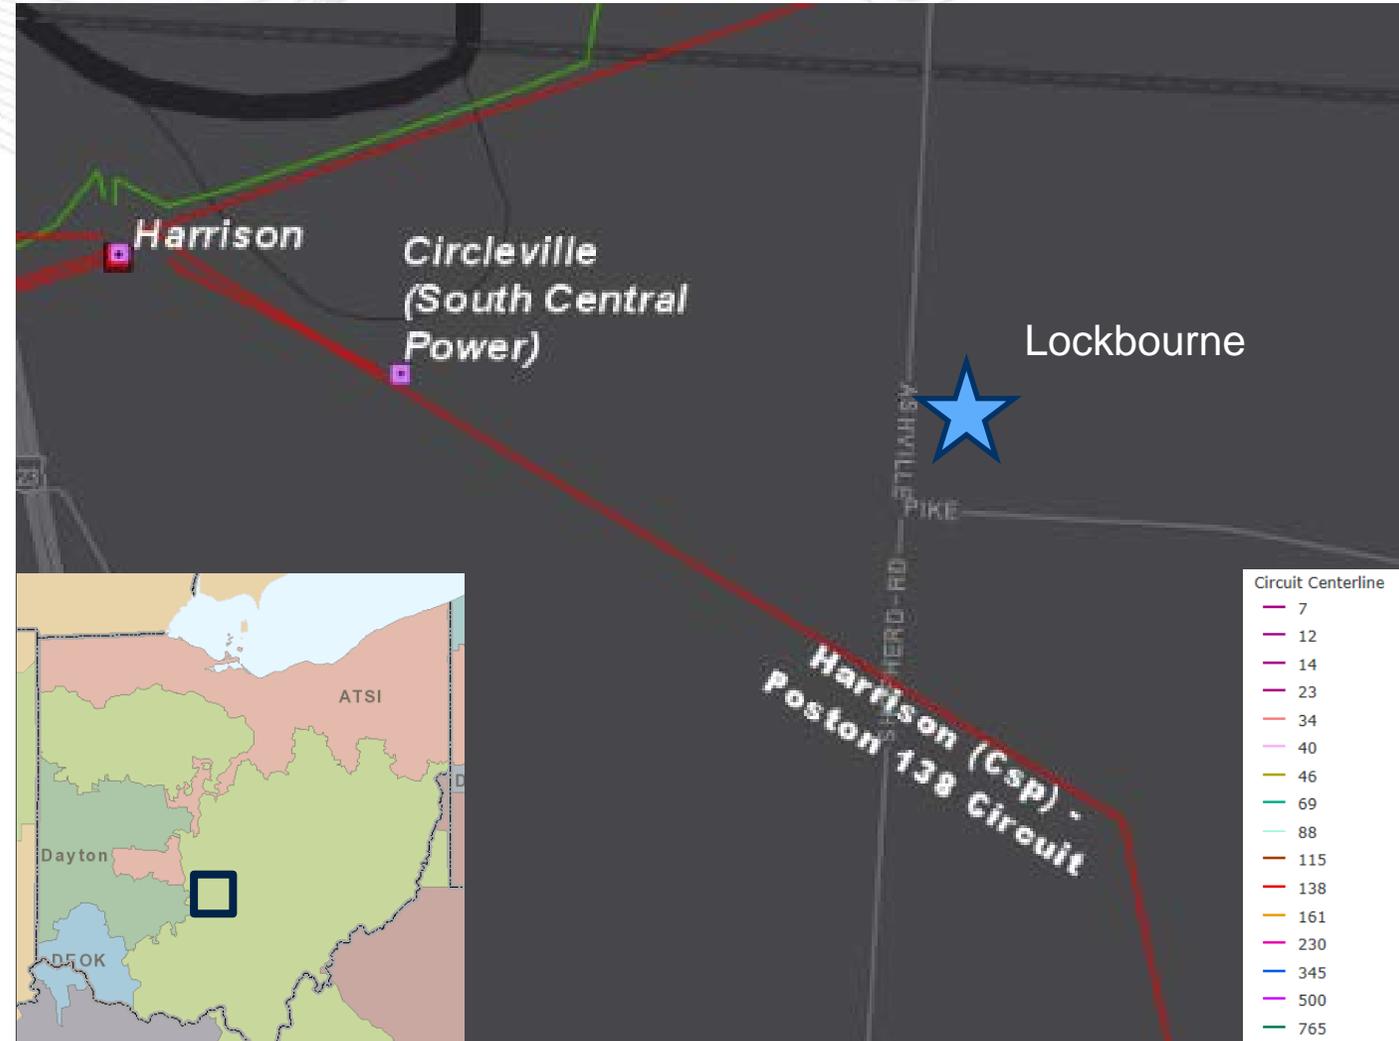
- South Central Power is rebuilding Lockbourne 138kV Station due to asset renewal conditions. Lockbourne is currently radially served via AEP's Harrison Station, this line is partially owned by AEP and South Central Power with the point of ownership change being Circleville. The current loading on this radial line is 65MW with plans for increased load. Total CMI 2.7M over 3 year period. (2015-2018).
- Radial service restricts the ability to perform routine maintenance and can cause extended outages to customers. The maintenance of radial transmission lines often requires cost-prohibitive temporary facilities or other labor-intensive measures.

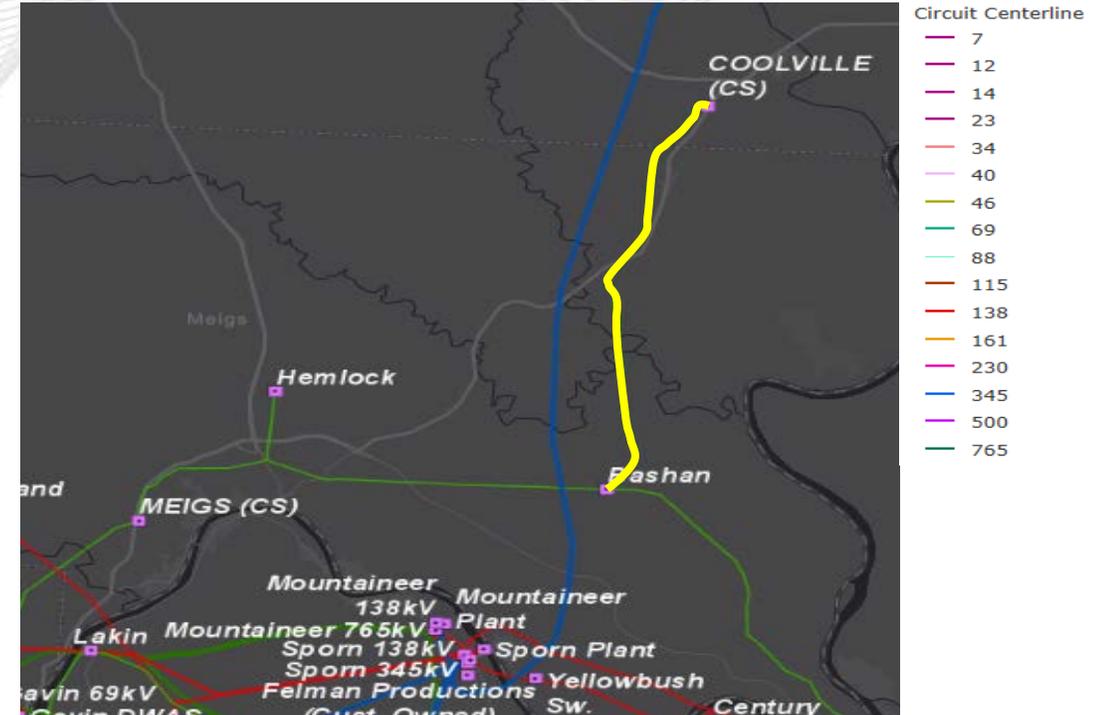
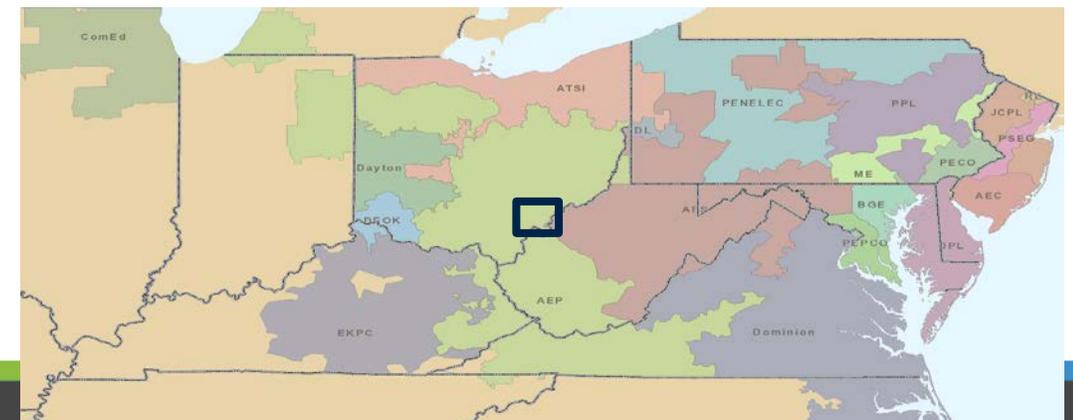
- Coolville 69kV station is radially served on a 1954 vintage line (~12.6 miles) utilizing 4/0 ACSR 6/1 (Penguin) conductor (50/63 MVA SN/WN). This radial line has 84 structures, 22 of which have pole related open conditions and 28 of which have ground lead wire issues/concerns. It has experienced 4.4 million CMI over the last three years. Radial lines restricts the ability to perform routine maintenance and restoration activities.

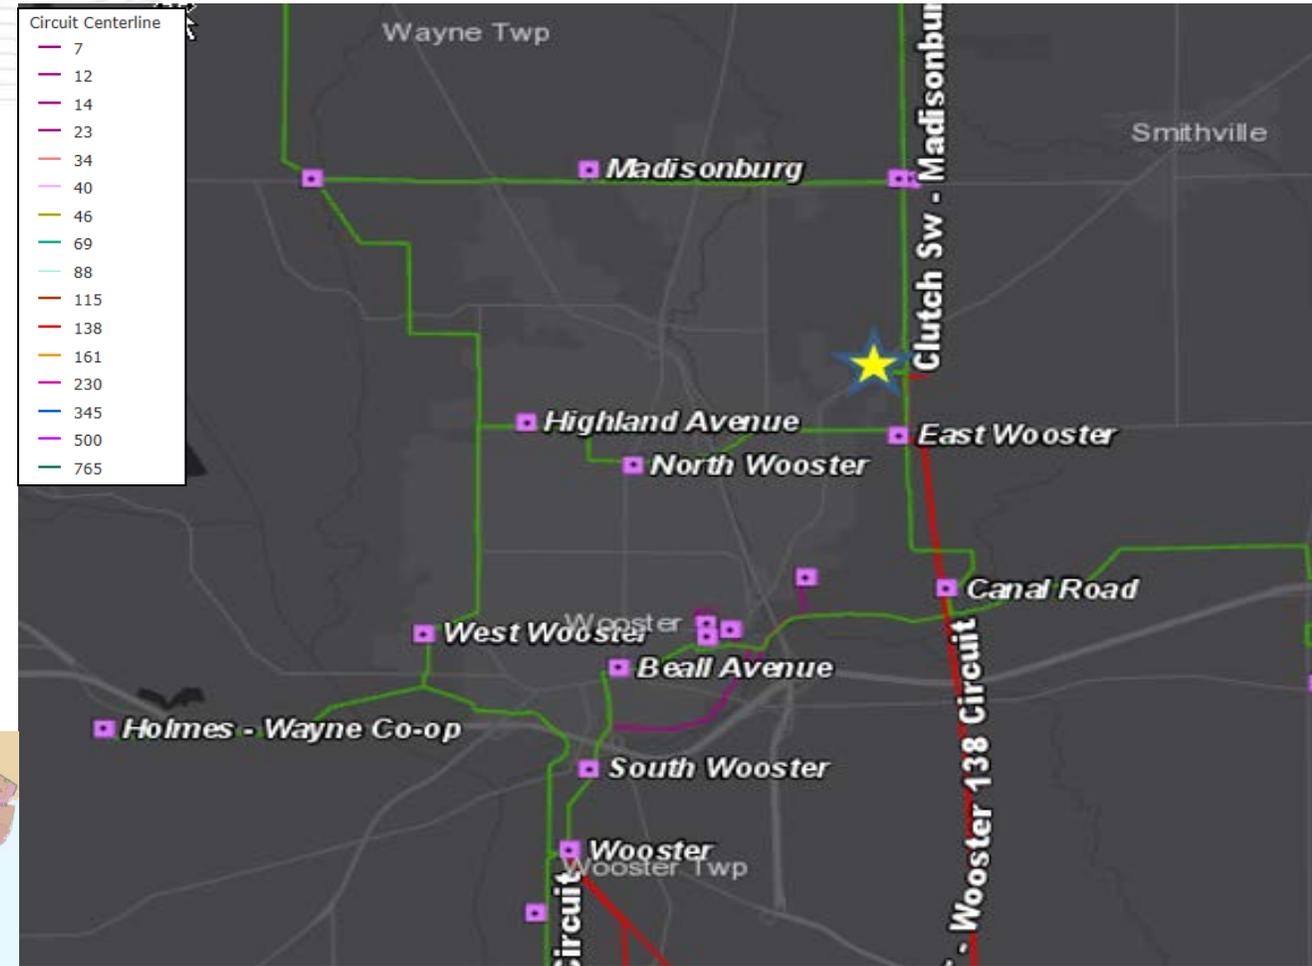
A transmission customer has requested new 69kV service on the northeast side of Wooster, Ohio. The total peak demand is 11 MVA. The customer is paying to install a 2nd 69kV power transformer in their station and need a 2nd 69kV service point from AEP Transmission.

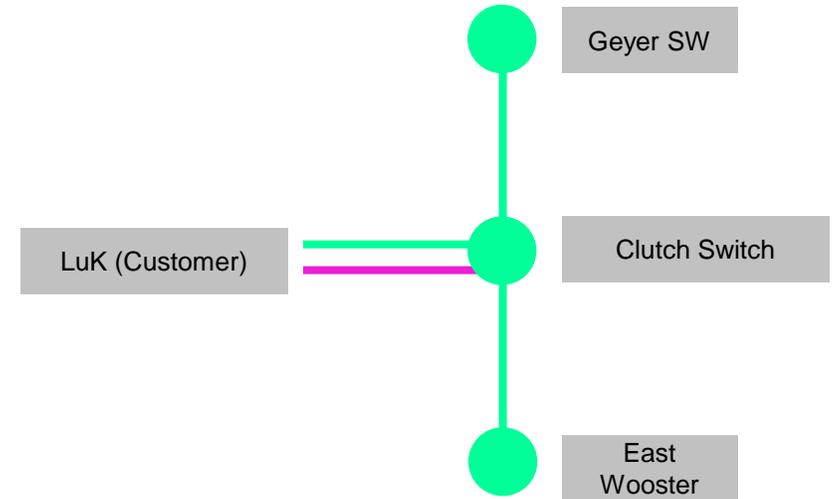
Clutch Switch 69kV:

Extend a 2nd 69kV service to the customer (1 span) to serve their 2nd transformer. Install a 2nd set of 69kV revenue metering equipment. Install a 69kV bus-tie breaker at Clutch Switch station, separating the two feeds to the customer.

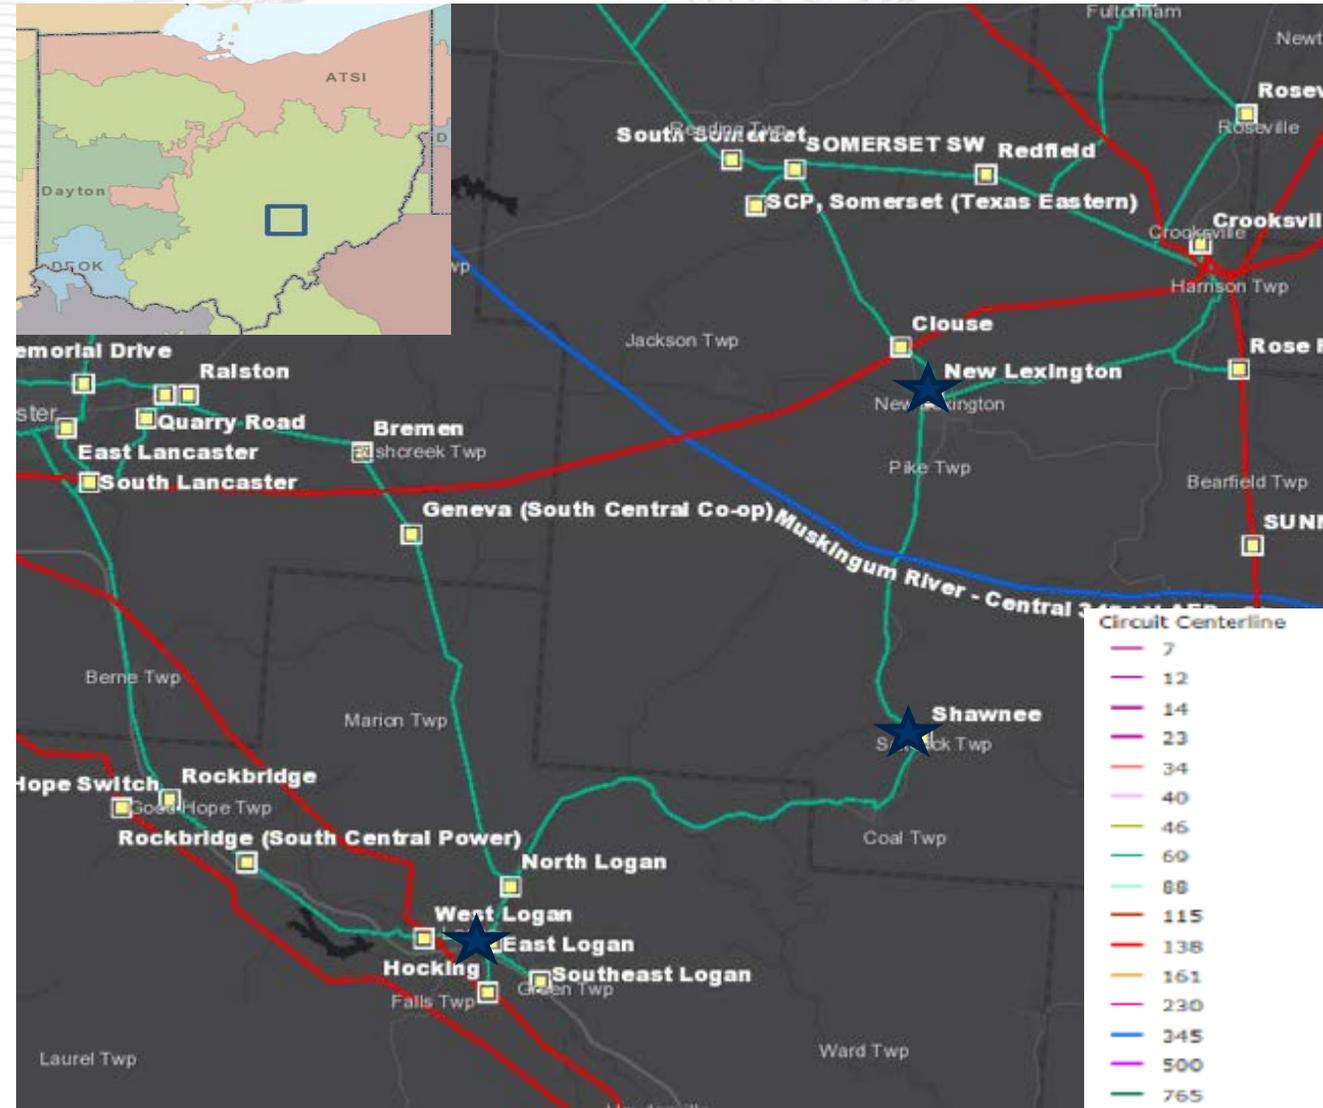
- The New Lexington – East Logan 22.3 mile 69 kV (vintage 1916) was built using wood pole structures with conductors ranging from #1 Copper 3 conductor (31 MVA rating) to 336.4 KCM ACSR 18/1 (73 MVA rating).
- There are 333 open A conditions on this line, including burnt/broken conductors, and broken structures. The New Lexington – East Logan 69 kV circuit has experienced over three million customer minutes of interruption in the past three years.

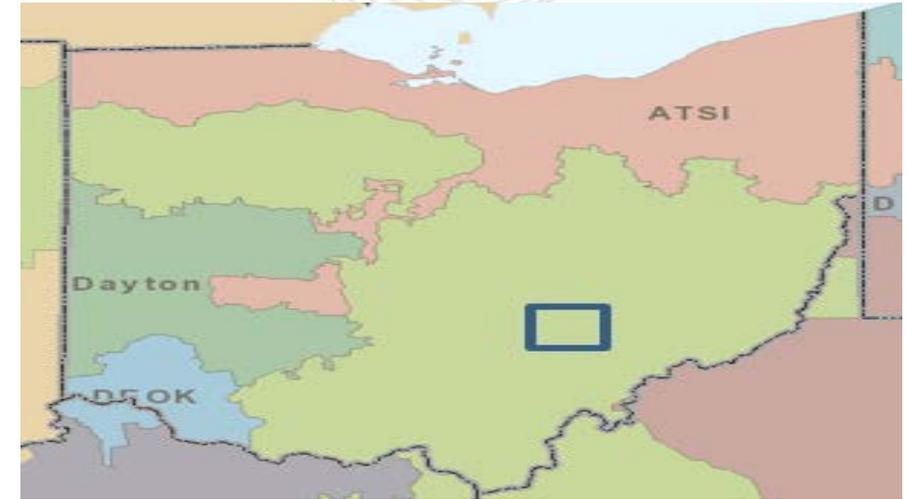
Existing:

- Rebuild approximately 8.7 miles of the East Logan-New Lexington 69 kV circuit between New Lexington and Shawnee with 795 ASCR 26/7.

- Replace the Shawnee 69 kV Moab 1200A switches with 2000 A switches.
- Replace the New Lexington 69 kV line riser towards East Logan.
- Replace the New Lexington 600 A breaker disconnects for CBs "A" with 2000 A switches.

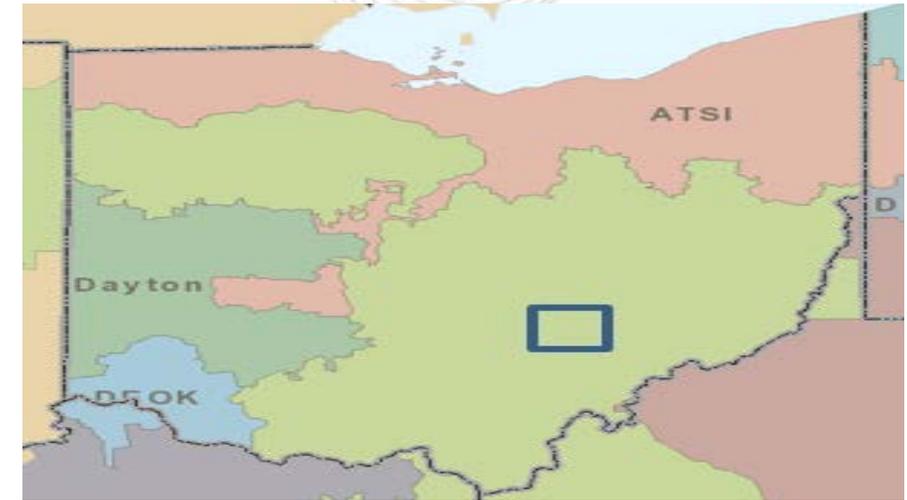
Existing:

- Rebuild approximately 8.7 miles of the East Logan-New Lexington 69 kV circuit between New Lexington and Shawnee with 795 ASCR 26/7.

- Replace the Shawnee 69 kV Moab 1200A switches with 2000 A switches.
- Replace the New Lexington 69 kV line riser towards East Logan.
- Replace the New Lexington 600 A breaker disconnects for CBs "A" with 2000 A switches.
