SRRTEP Committee Western AEP Supplemental Projects

November 22, 2019

AEP Transmission Zone M-3 Process Western Ft. Wayne, Indiana Area

Need Number: AEP-2019-IM020

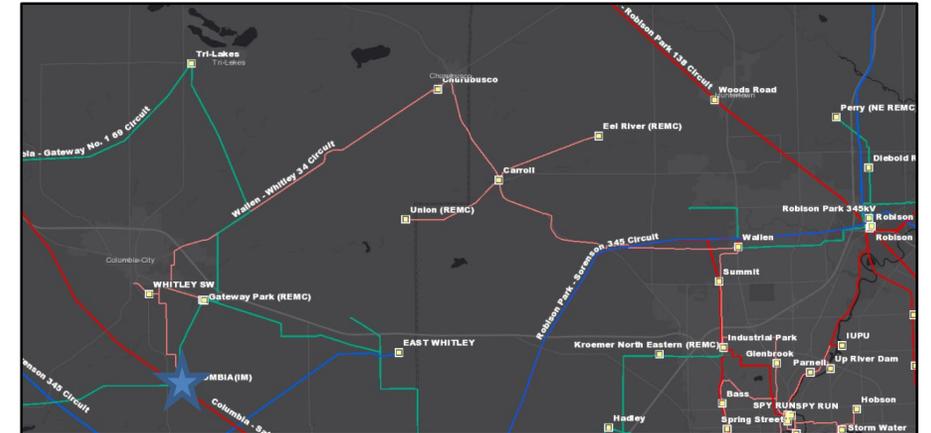
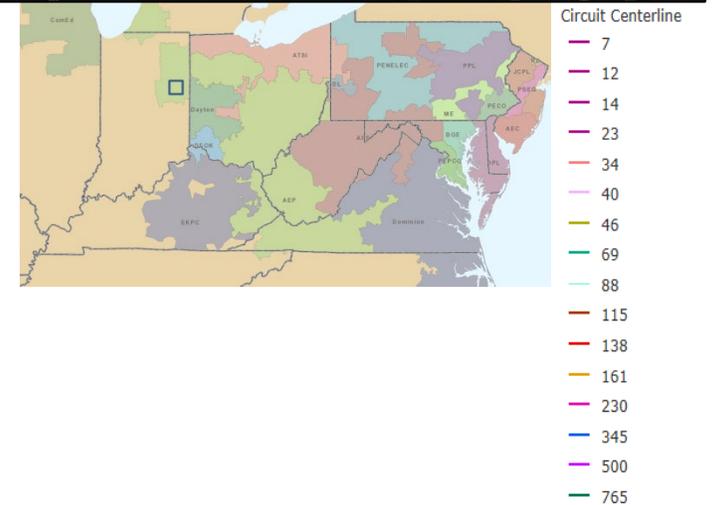
Gateway 69/34.5kV Station

34.5kV CB C.

- 1952 FK Oil breaker
- Fault Ops: C(10) – Recommended:10

69/34kV XFR 1

- 1975 unit with IEEE level 4 CO2 and level 2 CO
- Documented leaks and insulating paper deterioration

Columbia 138/69/34.5kV Station

69 CB's K.

- 1985 FK Oil breaker
- Fault Ops: K(22) – Recommended:10

34.5kV CB B

- 1951 FK Oil breaker
- Fault Ops: B(20)– Recommended:10

Whitley 34.5kV Station

34.5kV CB D & B.

- 1954 & 1963 FK Oil breaker
- Fault Ops: D(20) B(69) – Recommended:10

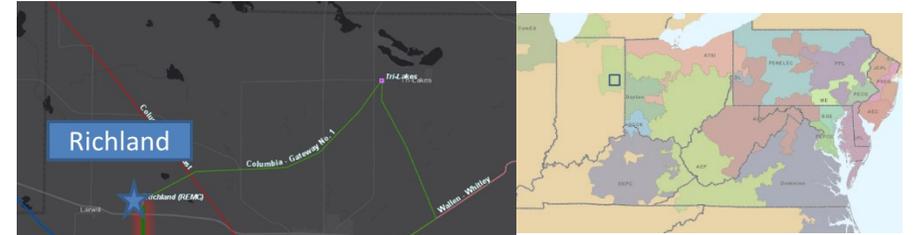
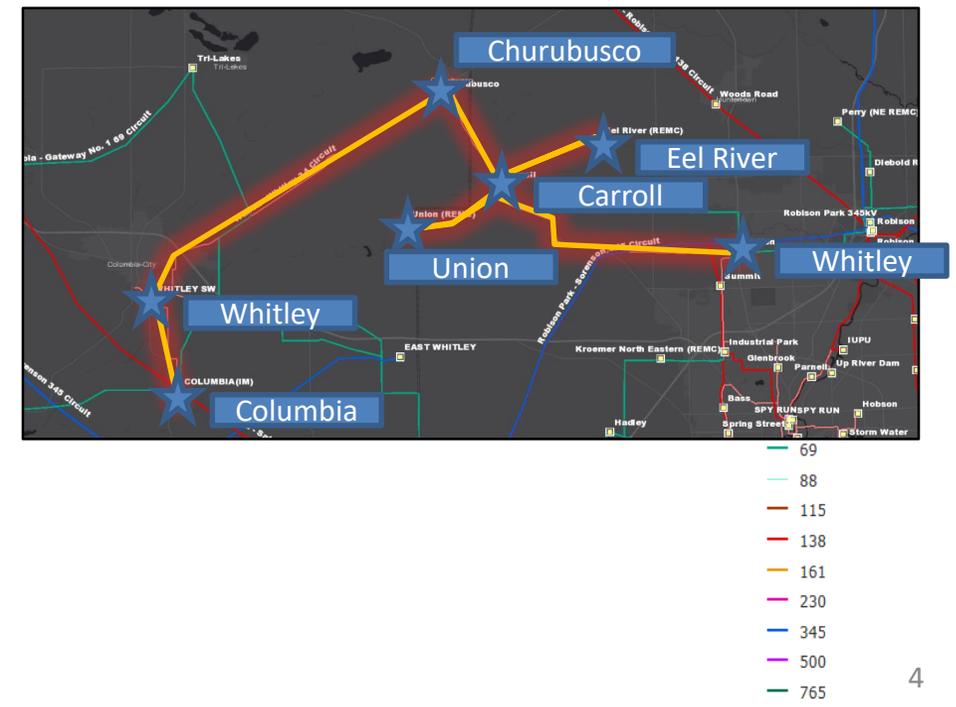
Problem Statement:
Gateway – Columbia 69kV line
 1964 Wood crossarm style line with 13 open conditions across its ~2.5 miles

Richland – Columbia 69kV line
 1959 Wood crossarm style line with 29 open conditions across its ~13 miles.

Churubusco – Whitley 34.5kV line
 1946 Wood crossarm style line with 31 open conditions across its ~10.6 miles

Columbia – Whitley 34.5kV line
 1954 Wood crossarm style line with 2 open conditions across its ~3.4 miles

Churubusco – Wallen 34.5kV line
 1972 Wood crossarm style line with 42 open conditions across its ~11.4 miles

Carroll – Union REMC 34.5kV line
 1968 Wood pole style line with 3 open conditions across its ~3 miles

Carroll – Eel River 34.5kV line
 1964 Wood pole style line with 1 open conditions across its ~3 miles

Gateway – Columbia #1
 Due to the load on this line, it's exposure, and the outages it has sustained in the last 10 years, this line requires additional sectionalization.

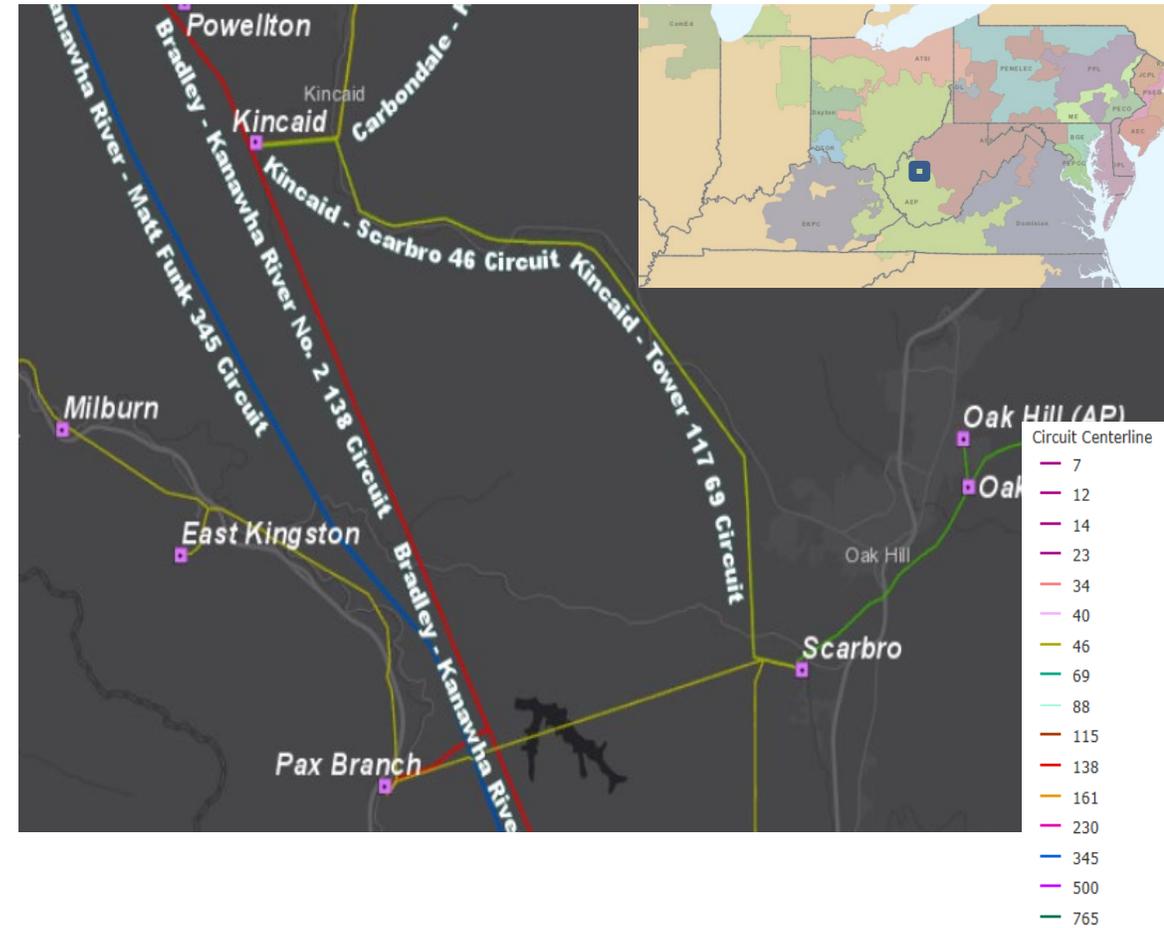
- The double circuit segment from Kincaid to Scarbro is comprised of a combination of lattice steel and wood poles.
 - Lattice structures utilize direct embed grillage foundation

- Line originally installed in 1913, primarily with 3/0 Copper conductor
 - The structures failed to meet 2017 NESC 250B and 250D loading criteria
 - The lattice towers show flaking of the galvanized coating with significant section loss and corrosion above and below grade on the tower legs.

- 4-bell insulators have noticeable wear and tear including rusting
 - The original conductor has visible signs of wear, such as burns and rust.
- Since 2014 there have been 86 momentary and 27 permanent outages on the Kincaid – Tower 117 69 kV and Kincaid – Scarbro 46 kV circuits.

- There are currently 33 structures with at least one open structural condition, which relates to 29% of the structures on the double circuit segment (10.1 miles).

- There are currently 68 open structural conditions mainly related to heavy rust on lattice steel lacing and rot on poles/crossarms.

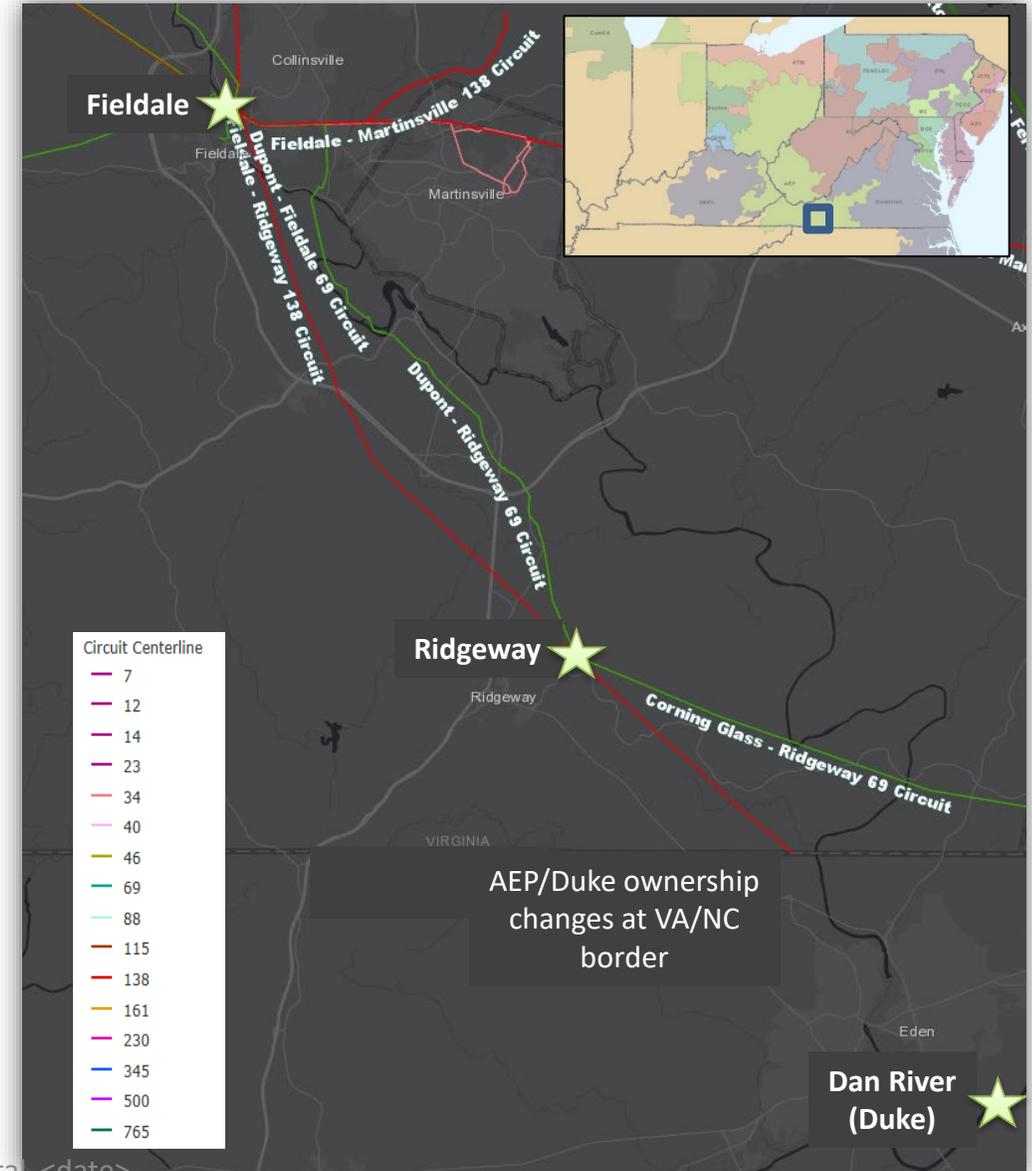
- **Fieldale-Dan River 138 kV Line Asset (14.8 mi.)**
 - **Fieldale-Ridgeway 138 kV Circuit (10.3 mi.)**
 - 1949 wood H-Frame construction
 - 58 Type A open conditions on 35 unique structures (51% of all structures on circuit)
 - From 2015-2018, a total of 4 permanent outages resulting in 241,094 customer minutes of interruption
 - **Ridgeway-Dan River 138 kV Circuit (4.5 mi.)**
 - 1949 wood H-Frame construction
 - 40 Type A open conditions on 23 unique structures (68% of all structures on circuit (owned by AEP))
 - From 2015-2018, a total of 3 permanent outages occurred

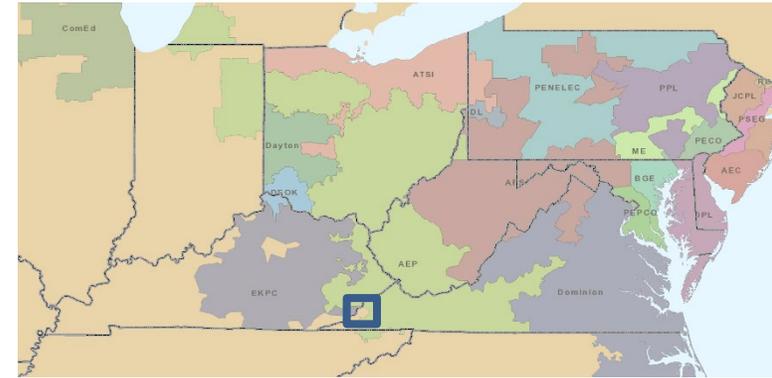
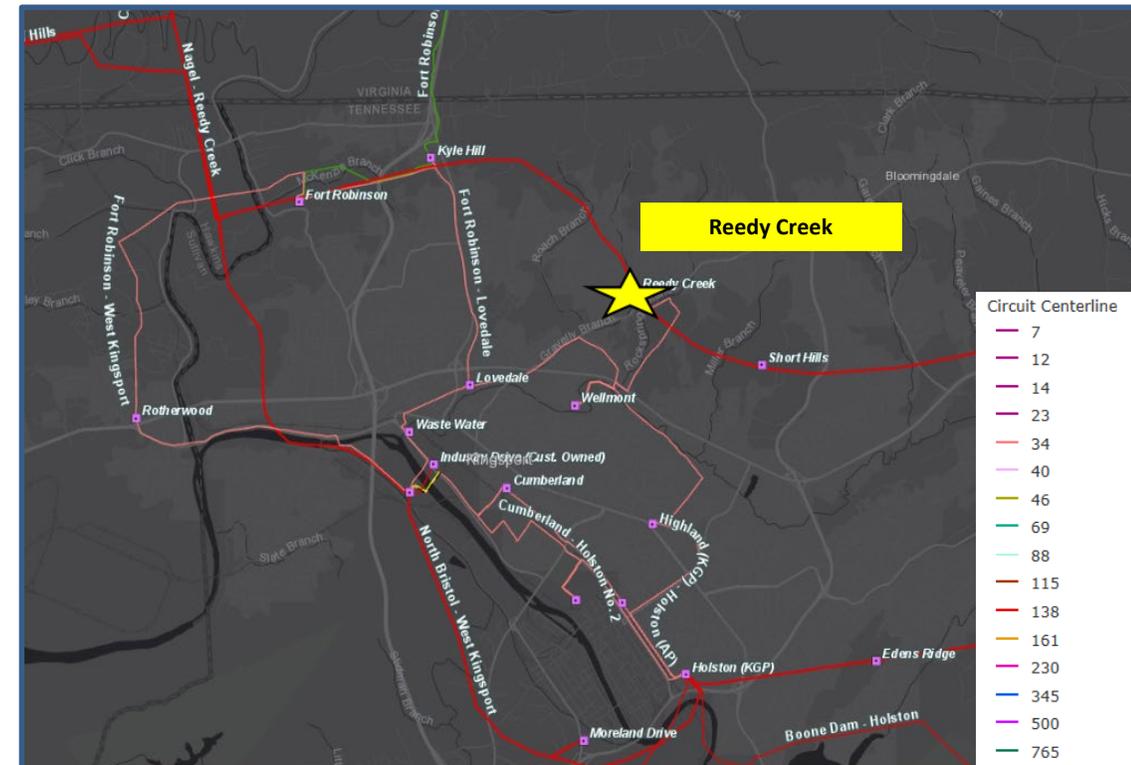
- Reedy Creek CB A is a 32 year old GCB and it's the only breaker of its kind left on AEP system—there are no longer usable, retired breakers to harvest for spare parts.
- It has 16 malfunction records related to SF6 leaks and 13 fault operations, exceeding the 10 operations recommended by manufacturer.
- Units of similar design demonstrated serious issues relating to the accelerated deterioration of the rubber lines that comprise the hydraulic system. Losing pressure in the hydraulic system is an imminent failure mode and once detected, this failure mode can only be resolved by de-energizing the unit.

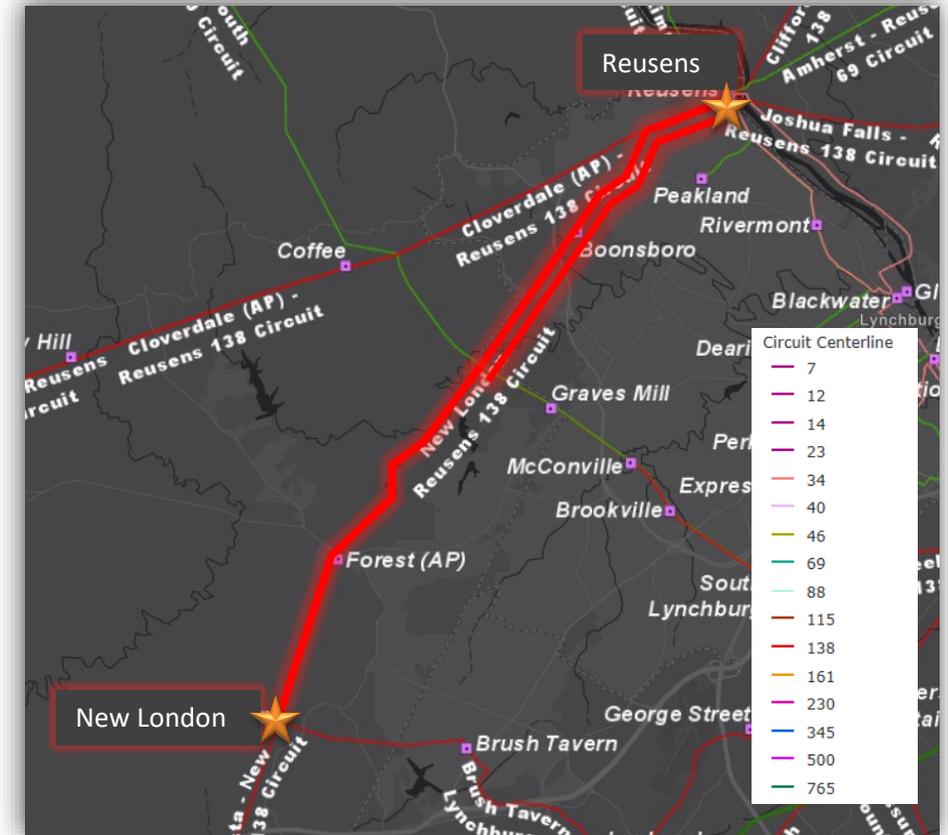
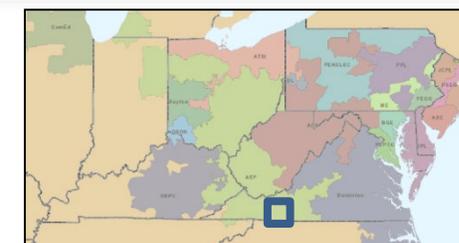
- A total of 16 open conditions on 13 unique structures (comprising 18% of the line asset)
- New London-Reusens 138 kV Circuit: From 2015-2018, a total of 2 permanent and 2 momentary outages occurred

- The current shielding does not comply with the current standards, specifying a maximum of 30 degrees. The current shielding angle is approximately 50 degrees.

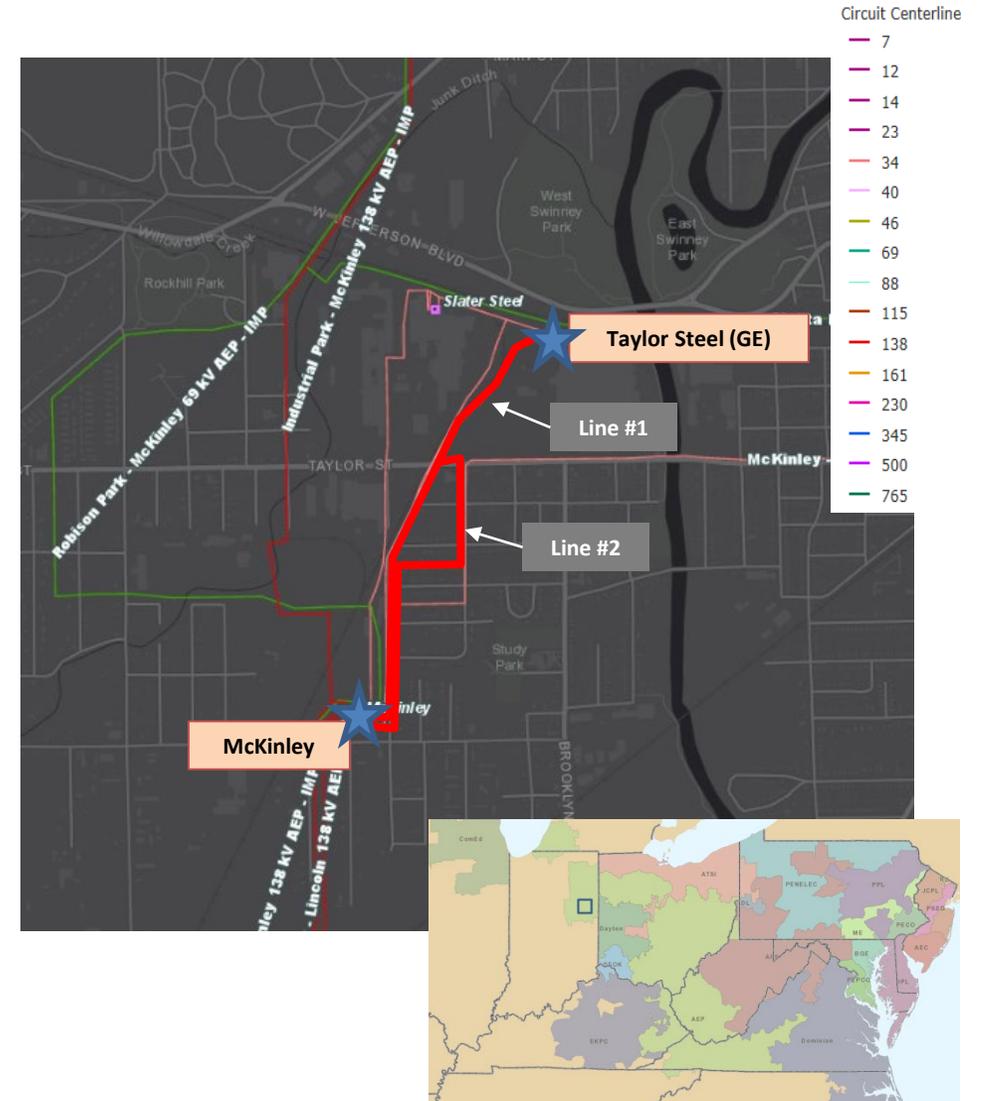
1. McKinley – Taylor General Electric Line 34kV Line (~0.9 Miles)
 - 1956 vintage wood pole, crossarm construction
 - There are currently 3 open conditions on this line.
 - Open conditions include: Split pole and stolen ground lead wires.

2. McKinley – General Electric Taylor East 34kV Line (~0.7 Miles)
 - 1960 vintage wood pole, crossarm construction
 - There are currently 9 open conditions on this line.
 - Open conditions include: Damaged, split or rotted structures.

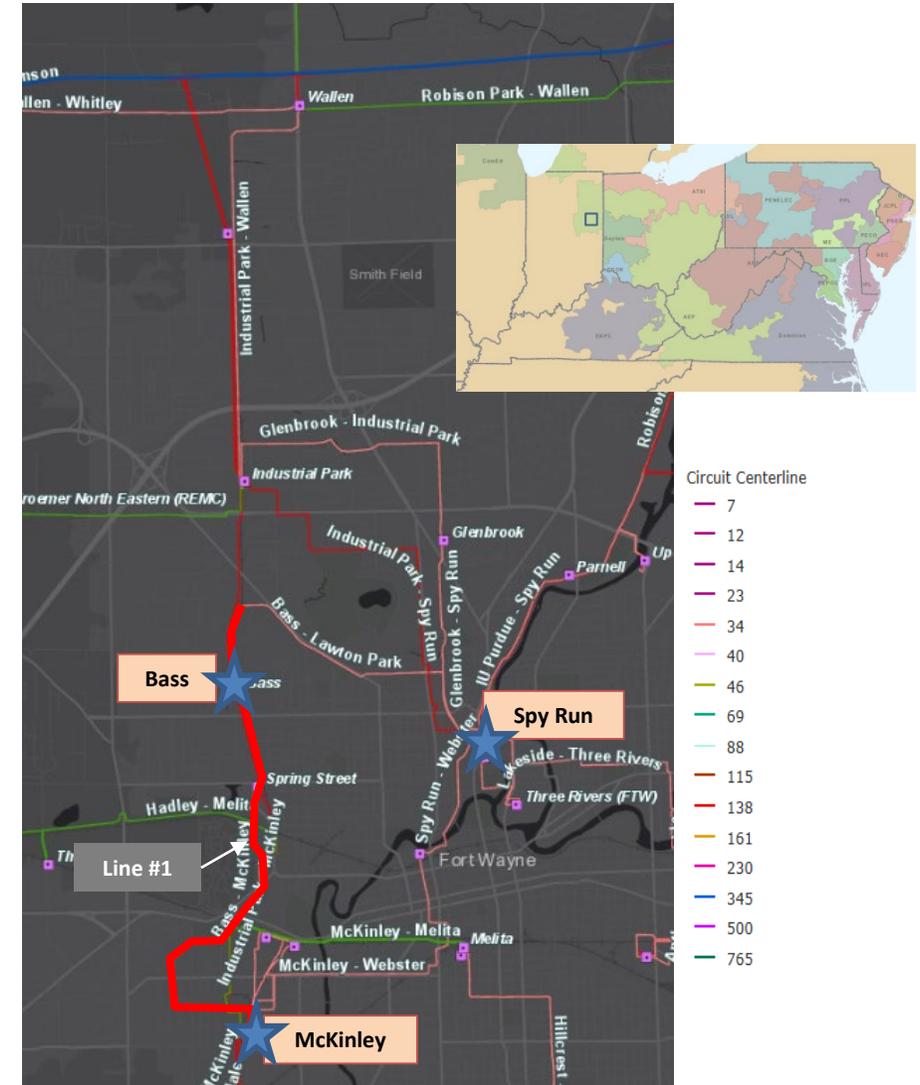
1. Bass – McKinley 34.5kV (~3.5 Miles)

- 1930 vintage steel single circuit lattice construction.
- There are currently 4 open conditions on this line.
- Six wired Copper conductor with copper weld shield wire. Copper conductors become brittle with age and Copper weld conductor has long been obsolete

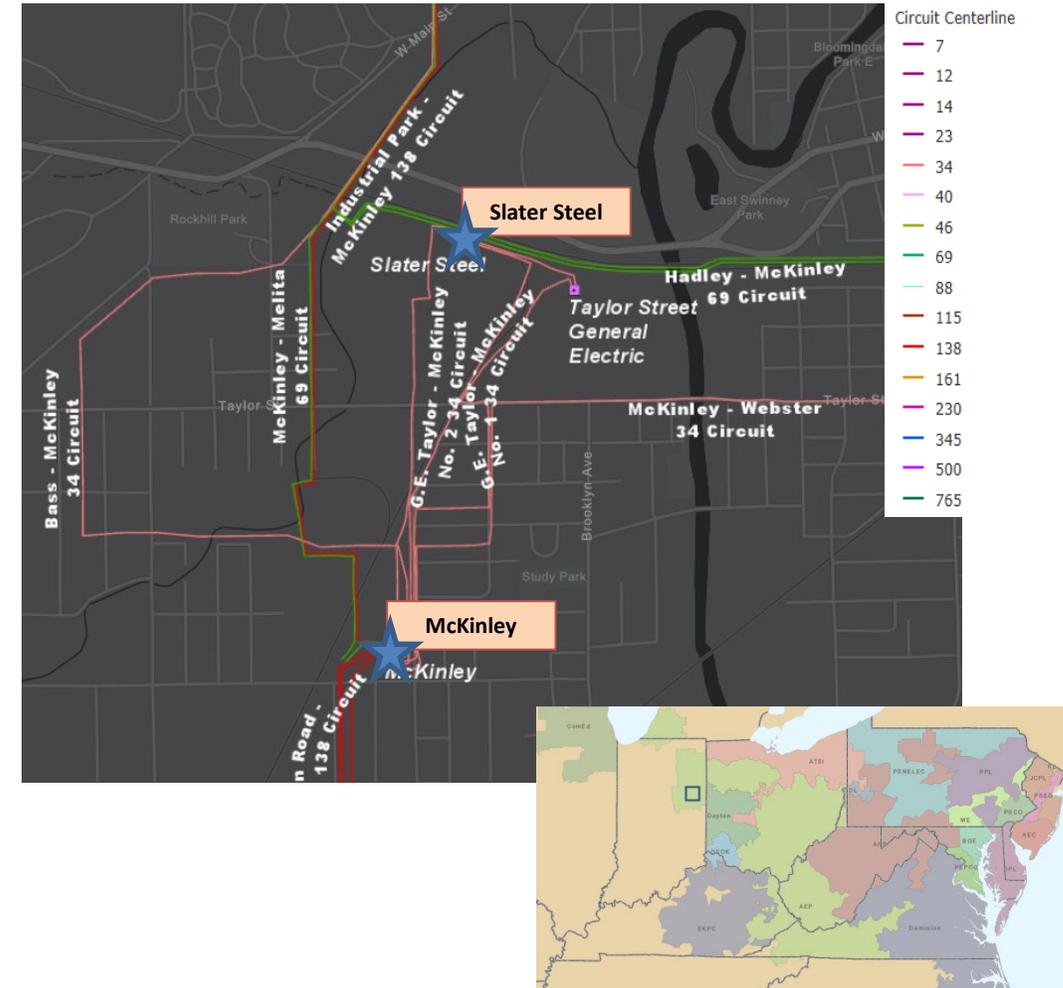
- Breakers F,J,K & M 34kV
 - 1956 vintage FK Oil breakers which have been known to fail violently.
- Breaker DD 34kV
 - 1962 vintage FK Oil breakers which have been known to fail violently.
- Oil filled breakers have much more maintenance required due to oil handling that their modern, vacuum counterparts do not require. Finding spare parts for these units is difficult or impossible, and these models are no longer vendor supported

Slater Steel 34kV station

- Customer-owned 34 kV switching facilities inside Slater Steel Station.
- Concerns about employees safety while switching in the customer station

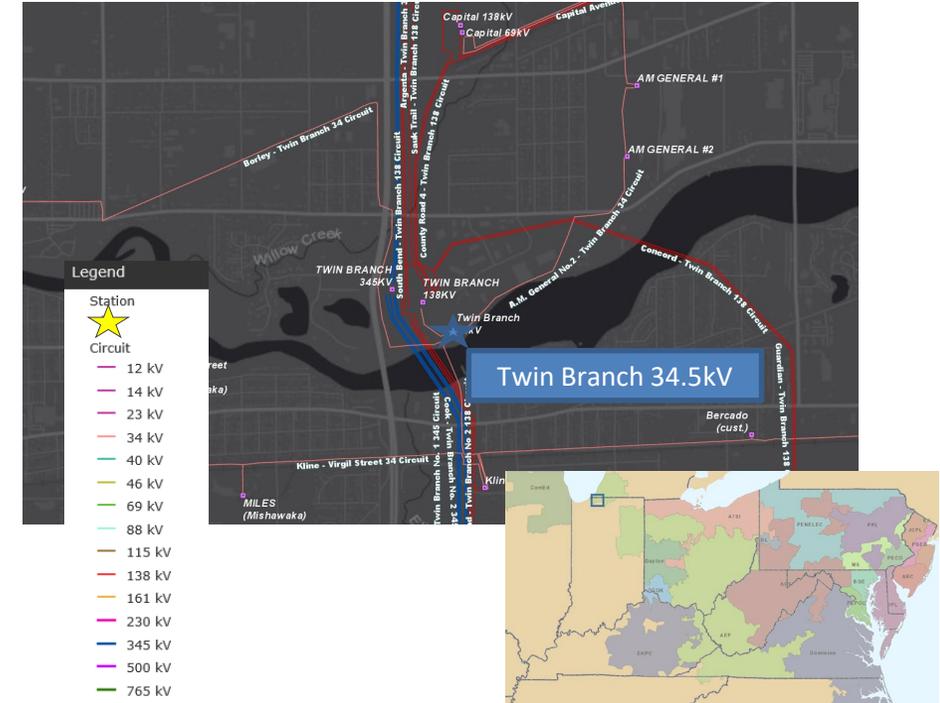
- The 34.5 kV Circuit Breakers CB, BB, DD, HH, and NN at Twin Branch 34.5kV Station are GE 'FK' oil-filled breaker manufactured in the 1950's. Common failure modes documented in AEP malfunction records for these breaker types are:
 - compressor failures and valve defects, which cause low pressure and oil leaks.
 - trip or reclose failures, caused primarily by spring latching and charging motor component failures.
 - the vacuum oil and oil breakers have a lot of oil contamination from aging gaskets allowing moisture and other particle ingress.
- Oil spills are frequent with failures and routine maintenance, which can also present an environmental hazard
- Because these breaker types are no longer manufactured, spare parts are not available.

34.5/4kV Transformer #4:

- The interfacial tension of the oil is below acceptable limits and the moisture content in the oil relates to a level of relative saturation. These indicate that:
 - sludge has formed in the radiators, core and coil.
 - high moisture levels in the oil and paper insulating materials.
 - the transformer oil is in poor quality to withstand dielectric events.
- Due to the age of this transformer, oil processing is not feasible option to extend the life of the unit.

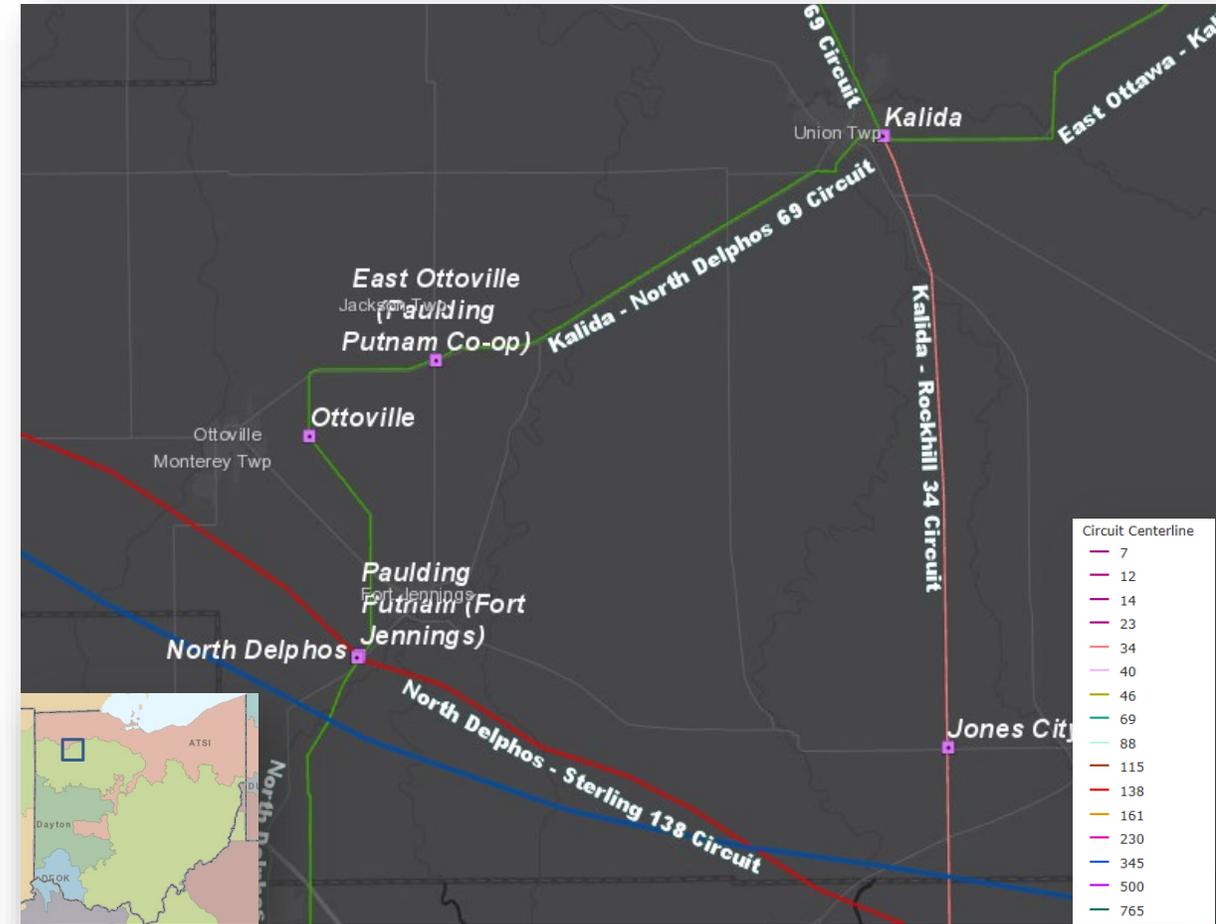
- Length: 11.26
- Original Construction Type: Wood
- Original Conductor Type: 4/0 Copper 7
- Momentary/Permanent Outages: 9 Momentary, 3 Permanent (5 year)
- CMI: 206,131 (5 year)
- Total structure count: 268
- Number of open conditions: 58
 - Open conditions include: rot heart, insect damage, broken/missing ground leads, burnt insulators
- Unique structure count with open conditions: 50

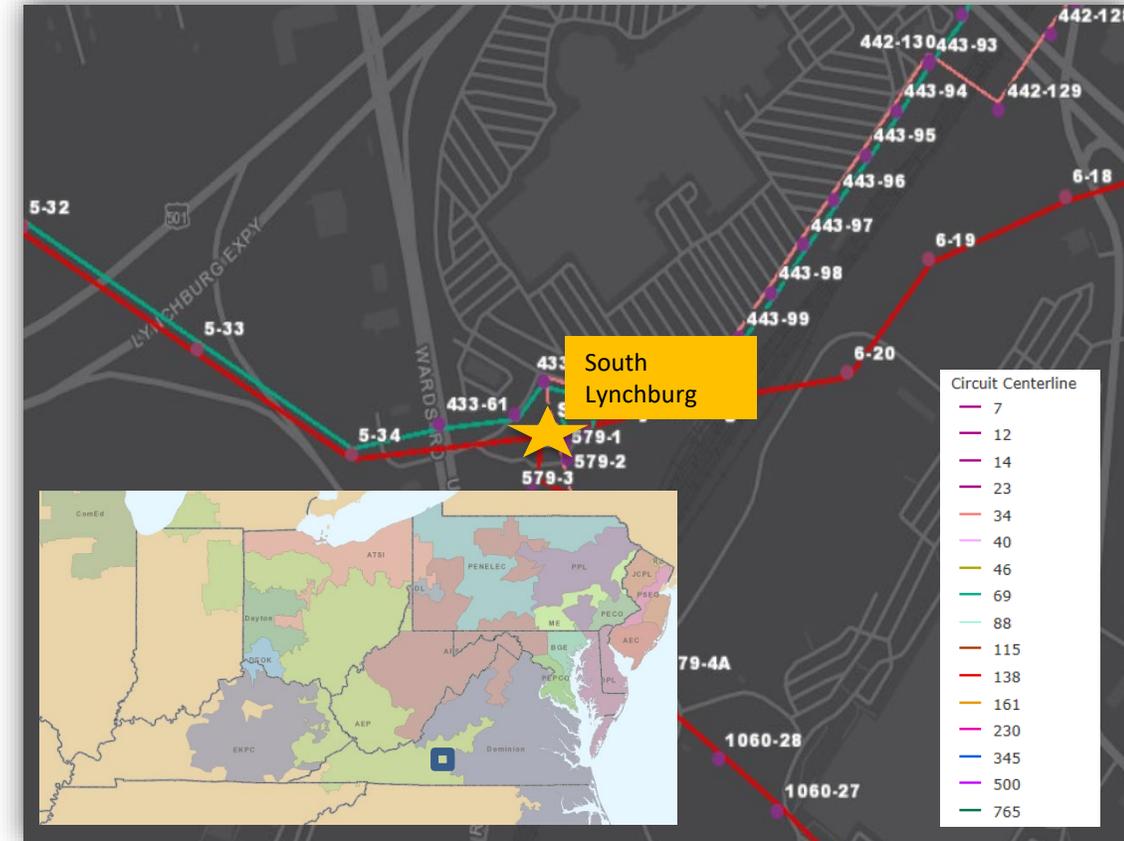
- The 1959 vintage 138/69/34.5 kV transformer #1 at South Lynchburg Substation has elevated levels of carbon dioxide which began increasing in 2004. Additionally, the interfacial tension is steadily decreasing and the oil power factor is steadily increasing indicating that the oil insulation is beginning to degrade as well. This data proves that the transformers insulation is aged and has degraded.

- The 34.5 kV Grounding Bank was manufactured in 1954 and has high concentrations of combustible gases, specifically CO and CH₄, due to various thermal faults and electrical discharges. Short circuit breakdown caused by the amount of through fault events, some greater than 700 degrees Celcius has contributed to the deterioration of the bank.

- 34.5 kV CB G has 63 fault operations

At South Lynchburg station, replace existing 138/69/34.5 kV transformer #1 with a new 138/69/34.5 kV, 130 MVA bank and install associated protection. Replace the grounding bank. Replace 12kV CB's P, L, K, N, M and R with new 1200A 25KA CB's and install associated relays. Replace 34.5kV CB G and F with new 3000A 40kA CB. Install 69 kV CB between T1 secondary and 69 kV bus. Estimated Cost: \$5.7M

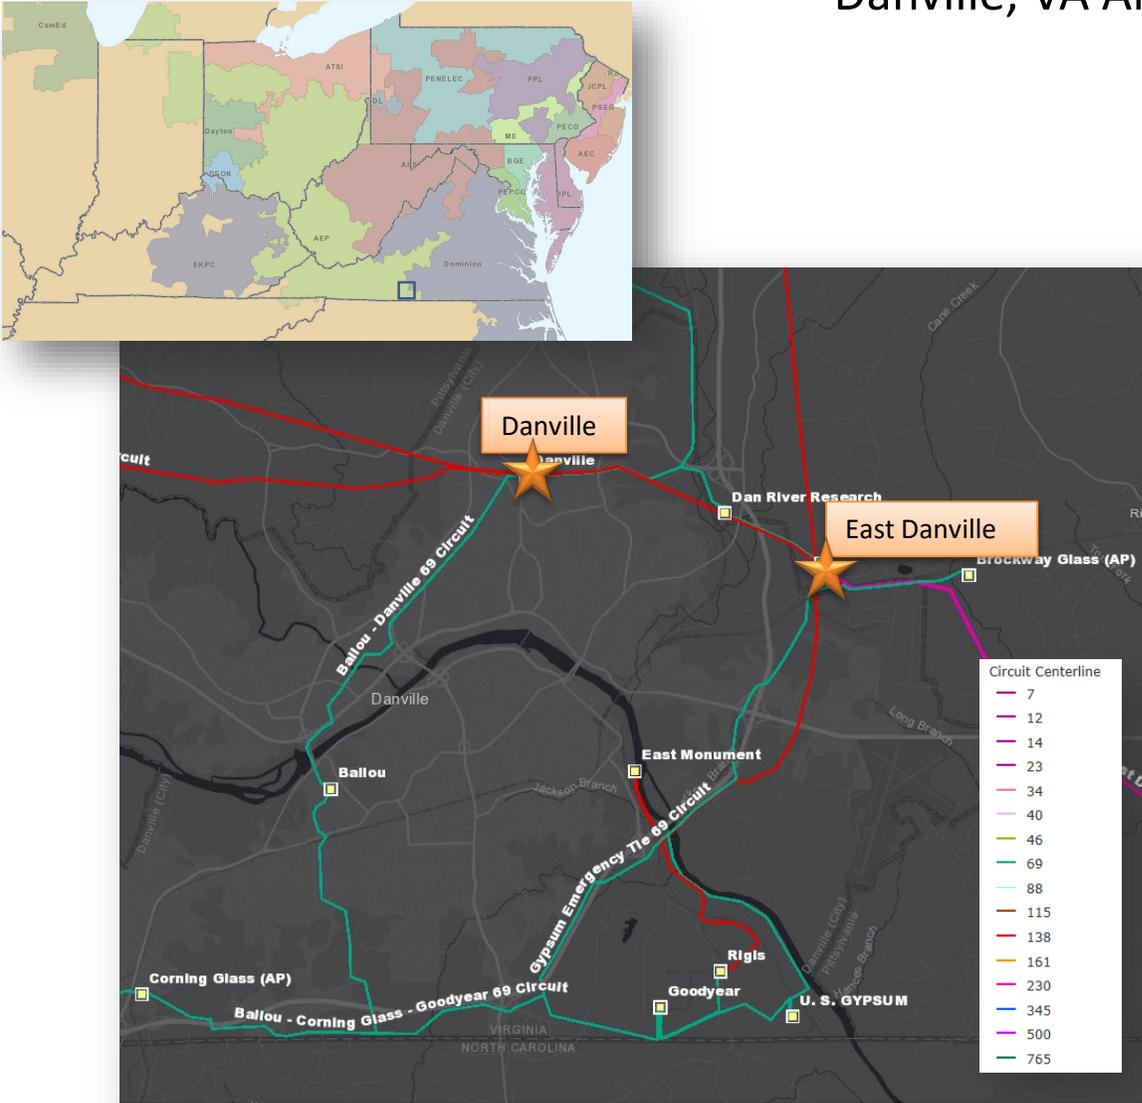
- Several documented mis-operations have occurred related to defective and disabled pilot wire relaying between Danville, East Danville and the local 69 kV network. Pilot wire maintenance is a known safety concern especially during poor weather conditions throughout the Transmission organization. Elimination of pilot wire in the Danville area will address ground splice concerns reported by TFS management, pilot wire cabinet access issues and low hanging pilot wire on poles. Corrective maintenance continues to be a concern due to the lack of spare relay components and it being an obsolete technology. Due to the abnormal conditions and overall age of the pilot wire in the Danville area, mis-operations have continued to impact several large industrial customers exceeding a total of 15 MW.

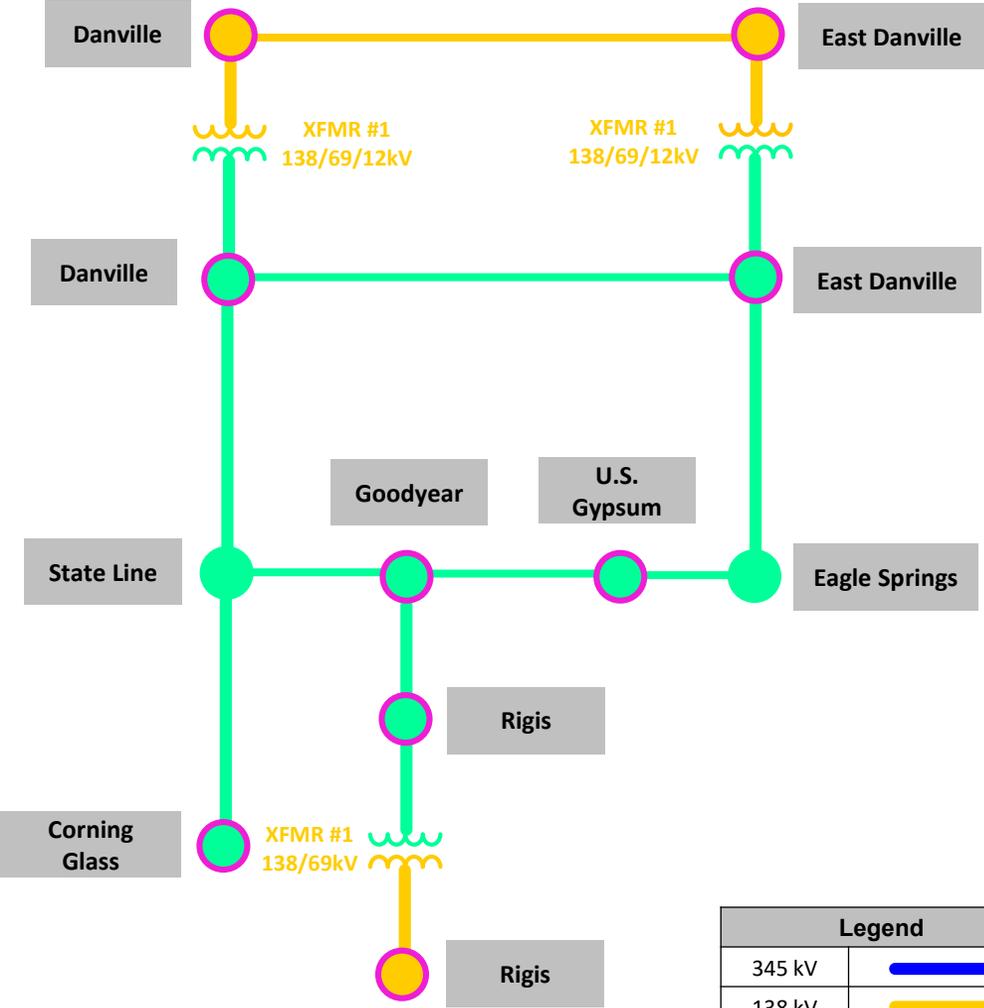
Legend	
345 kV	—
138 kV	—
69 kV	—
46 kV	—
New	—

At Danville station, install new 138 kV line relaying and CCVT's/foundations/stands on the East Danville line. Replace 69 kV Bus CCVT's and install required fiber and retire all pilot wire. Replace 69 kV breaker J with a 3000 A, 40 kA breaker. Estimated Cost: \$2.3M

At East Danville station, replace 138 kV circuit breakers L, M, and P and associated disconnect switches with 3000 A, 40 kA breakers and 3000 A disconnect switches. Install 69 kV circuit breaker on low-side of T1. Replace 69 kV breakers F, H and associated disconnect switches with 3000 A, 40 kA breakers and 2000 A switches. Install new 138 kV line relaying and CCVT's/foundations/stands on the Danville line. Install new 69kV line relaying and CCVT's/foundations/stands on both the Danville line and U.S. Gypsum lines. Replace MOAB ground switch on T#3 with circuit switcher and relocate T#3 connection from US Gypsum line to 69 kV bus. Install required fiber and retire all pilot wire. Estimated Cost: \$7.2M

At Rigis station, install new 69 kV line relaying and CCVT's/foundations/stands on the Goodyear line. Install required fiber and retire all pilot wire. Replace MOAB ground switch with circuit breaker on high-side of T#1. Estimated Cost: \$1.4M

At Goodyear station, install new 69 kV line relaying and CCVT's on the Rigis line, U.S. Gypsum line and Corning Glass line. Install required fiber and retire all pilot wire associated with 69 kV US Gypsum, Rigis and Corning Glass circuits. Replace 69 kV breakers A, C and D and associated disconnect switches with 3000 A, 40 kA breakers and 2000 A disconnect switches. Upgrade existing 2-element customer metering at each of the feeds to the customer (3 total). Estimated Cost: \$4.4M

At Ballou station, retire in-line equipment and retire transformer in-place. Estimated Cost: \$0M (Distribution)

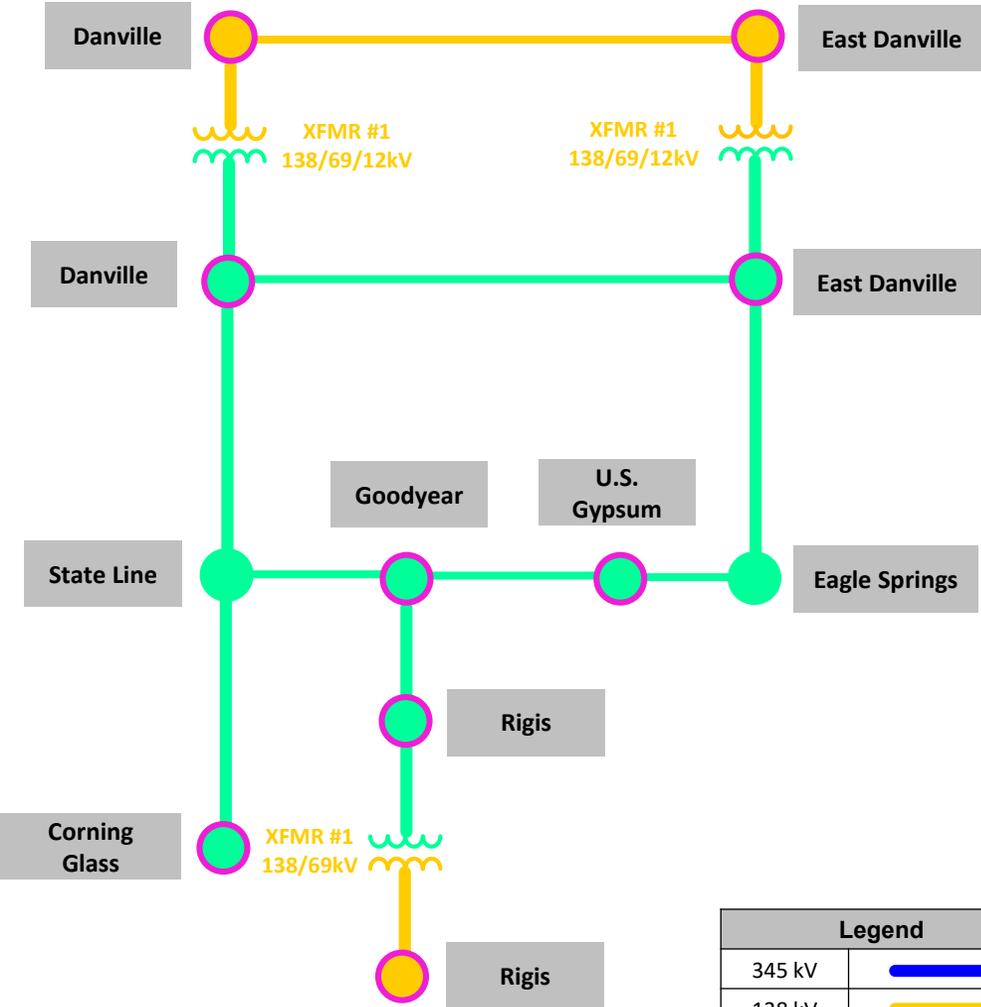
Legend	
345 kV	
138 kV	
69 kV	
46 kV	
New

At US Gypsum station, install 69 kV line relaying and CCVT's on both the East Danville line and Goodyear line. Install required fiber and retire all pilot wire associated with the Goodyear – U.S. Gypsum and East Danville circuits. Replace 69 kV breaker A with 3000 A, 40 kA breaker and 2000 A disconnect switches. Replace 69 kV customer metering with 3 element CT/PT combo. Estimated Cost: \$2.8M

At Corning Glass station, install required fiber and retire all pilot wire. Replace 69 kV breaker B with 3000 A, 40 kA circuit breaker and 2000 A disconnect switches. Replace 69 kV circuit switcher A with 3000 A, 40 kA circuit breaker and 2000 A disconnect switches. Replace 69 kV circuit switcher AA with 600 A, 40 kA capacitor switcher. Estimated Cost: \$0 (Distribution)

At Smith Mountain station, upgrade remote end relaying and replace breaker control cables. Estimated Cost: \$0.9M

On the Danville-East Danville 69 kV line, replace 4 wood structures to accommodate additional loading of new ADSS and install ADSS under-build. Estimated Cost: \$1.1M

On the Corning Glass-Goodyear 69 kV line, replace 13 wood structures to accommodate additional loading of new ADSS and install ADSS under-build. Estimated Cost: \$1.9M

On the Goodyear-Rigis 69 kV line, replace 4 wood structures to accommodate additional loading of new ADSS and install ADSS under-build. Estimated Cost: \$0.9M

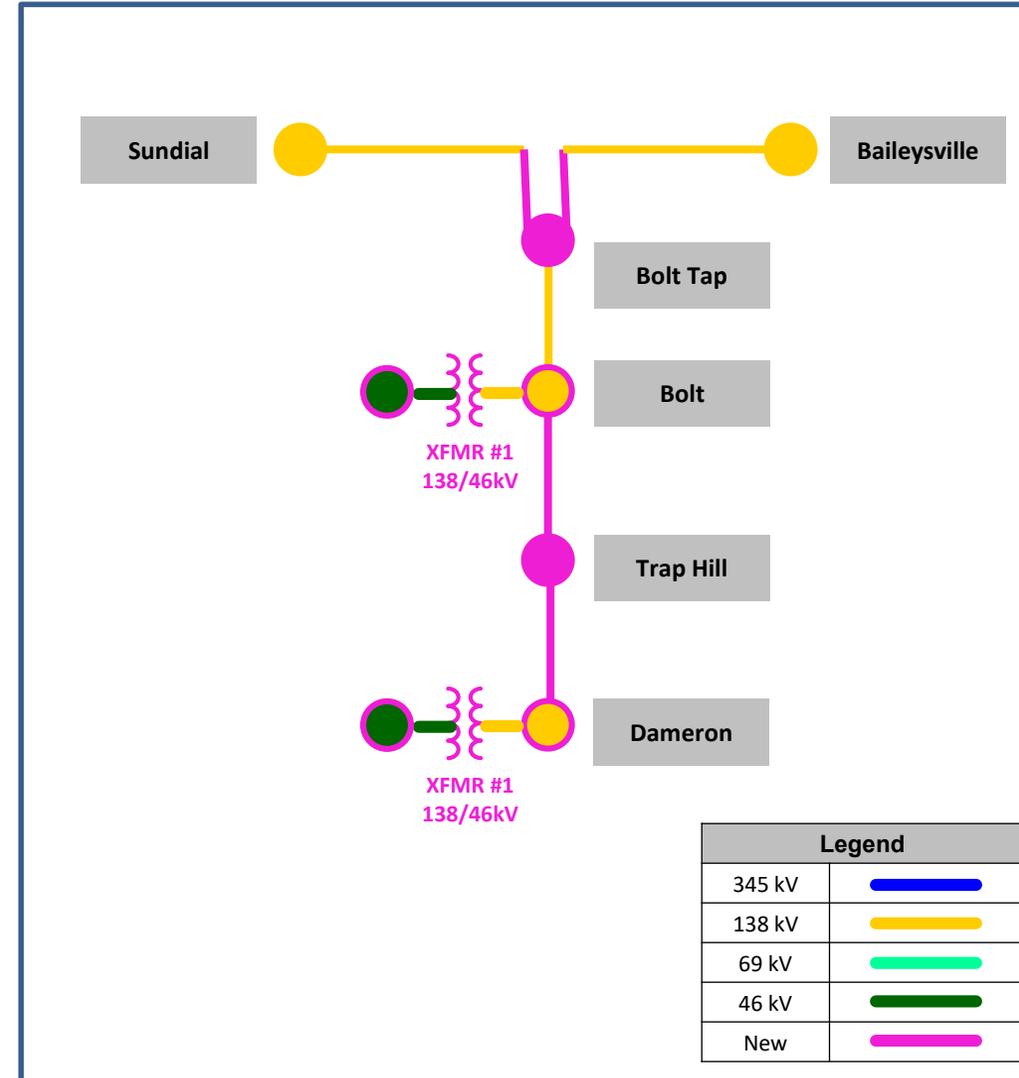
At Bolt Station, install 138 kV bus and configure the 138kV station into a ring configuration with three new 138kV 3000A 40kA breakers. Replace the existing ground transformer with a new ground transformer. Replace existing cap switcher AA with a new 46 kV 420 A (capacitive current) 40 kA cap switcher. Replace the existing 138/46 kV 75 MVA XFR with a new 138/46 kV 90 MVA XFR. **Estimated Cost: 6.4M**

At Dameron Station, Install 138 kV bus and configure the 138kV station into a ring bus layout utilizing four new 138kV 3000A 40kA breakers. Remove the ground switch MOAB scheme from the high side of XF1. Associated line work to accommodate new 138 kV ring configuration. Replace the existing circuit breaker A with a new 46 kV 3000A 40 kA circuit breaker. Replace the existing cap switcher AA with a new 46 kV 450 A (capacitive current) 40 kA cap switcher. Replace the existing 138/46kV 75 MVA XF #1 with a new 138/46kV 75 MVA XF. Replace the existing grounding transformer with a new grounding transformer. Replace existing 46/34.5 kV XFR with a new 138/34.5 kV 30 MVA XFR. Station fence will need expanded to accommodate new 138 kV bus. Retire Beckley Mining 46 kV line out of Dameron and transfer customer to Distribution service. Customer Service is following up with the customer regarding the new service. **Estimated Cost: 10.5M**

At the new Bolt Tap Station install three 138 kV 3000 A 40 kA circuit breakers into a breaker and a half configuration. **Estimated Cost: 8.0M**

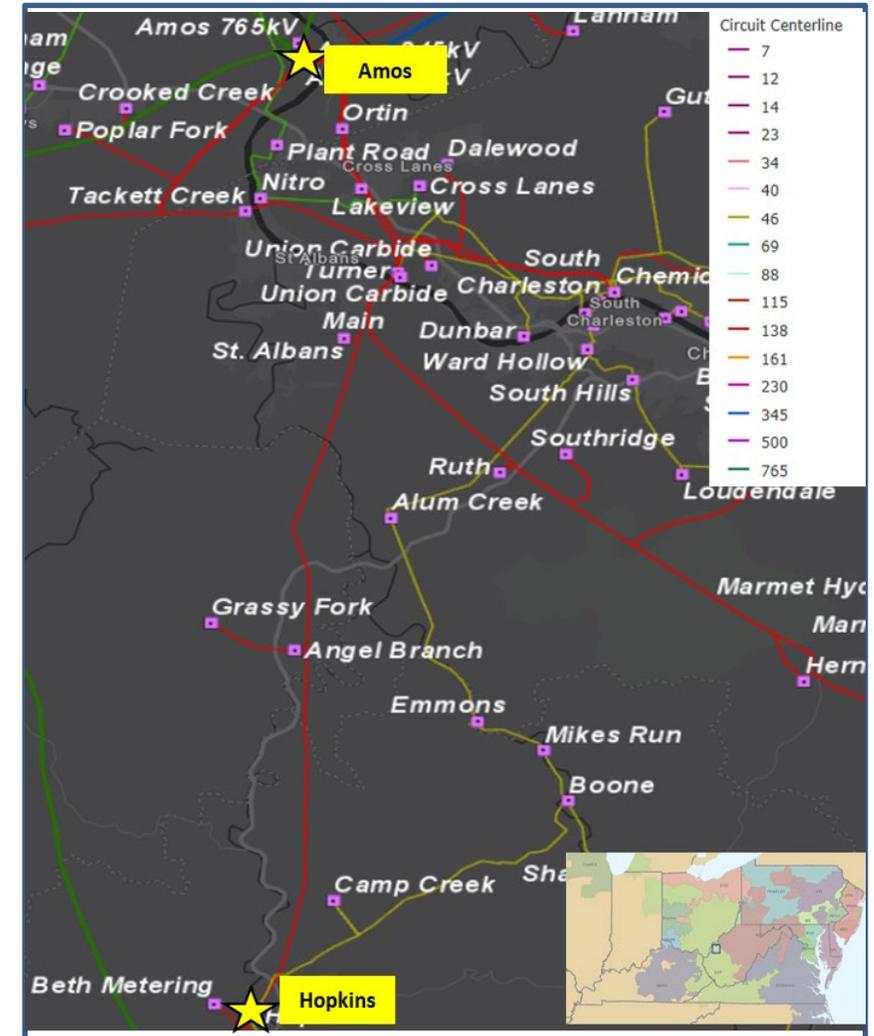
Amos – Hopkins 138 kV (~31.37 miles)

- Majority of the circuit is constructed with 1920s lattice structures
 - The lattice towers used for this line are approximately 94 years old. Structure loading does meet the NESC 250B, 250C and 250D standards for all structures that were analyzed.
 - Steel lattice towers and hardware are currently exhibiting medium to heavy rust
- The shield wire and conductor for this line is 94 years old. Current shielding for the majority of the line does not comply with current standards.

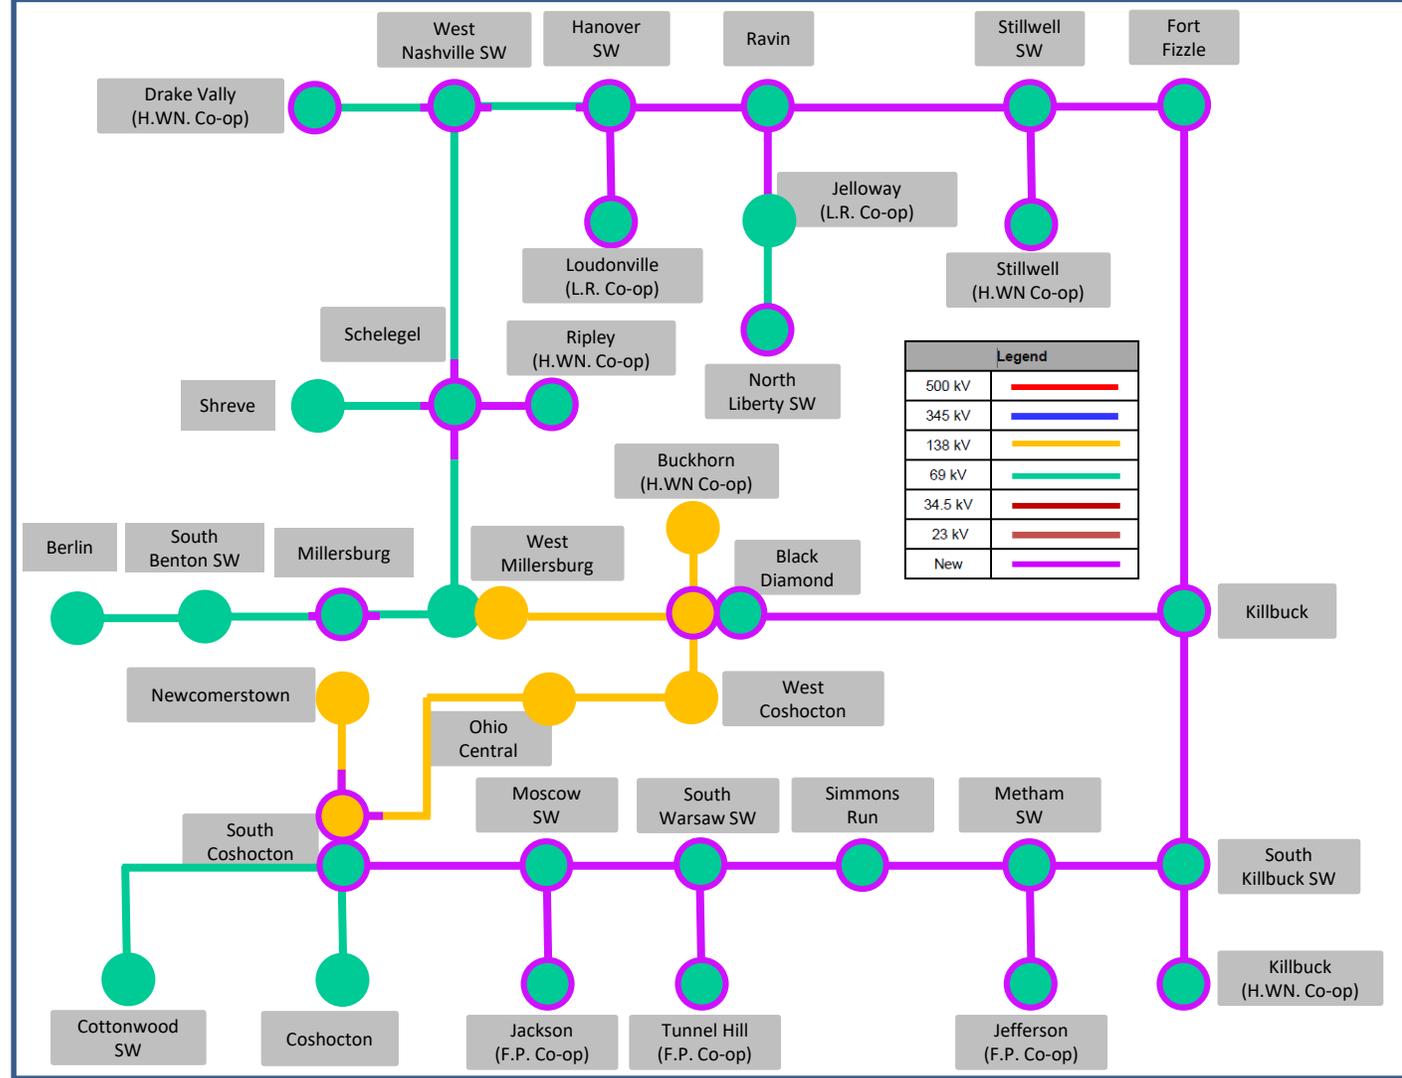
Proposed

- Fort Fizzle – Killbuck 69kV:** Cost \$12.9M
Rebuild ~5.51 miles of the existing Killbuck to Glenmont (Fort Fizzle) 34.5kV line at 69kV.
- Black Diamond (Replaces South Millersburg):** Cost \$10.2M
Build a greenfield station at 138 kV 3000A 40kA in 4-breaker ring configuration. Replace the 138/34.5kV 25MVA transformer with a 138/69kV 90MVA transformer. Remove the 34.5kV circuit breaker “C” and install a new 69kV 2000A 40kA circuit breaker towards Killbuck. Remove the 34.5kV 3000A kVAR Cap bank “AA”. The Buckhorn (H.WN. Co-op) 138 kV delivery point will now connect to Black Diamond station. Remove South Millersburg station and Buckhorn switch.

- Buckhorn (H.WN Co-op) – South Millersburg 138kV line:** Cost \$2.0M
Build a new 138 kV line (~.8 miles) to reconnect the existing Buckhorn (H.WN Coop) into Black Diamond 138 kV station.

- Millersburg:** Cost \$2.8M
Cut the Berlin – West Millersburg 69 kV line into Millersburg station with an in/out configuration with 1200 A line switches.
