SRRTEP Committee Western AEP Supplemental Projects

November 22, 2019

AEP Transmission Zone M-3 Process Western Ft. Wayne, Indiana Area

Need Number: AEP-2019-IM020

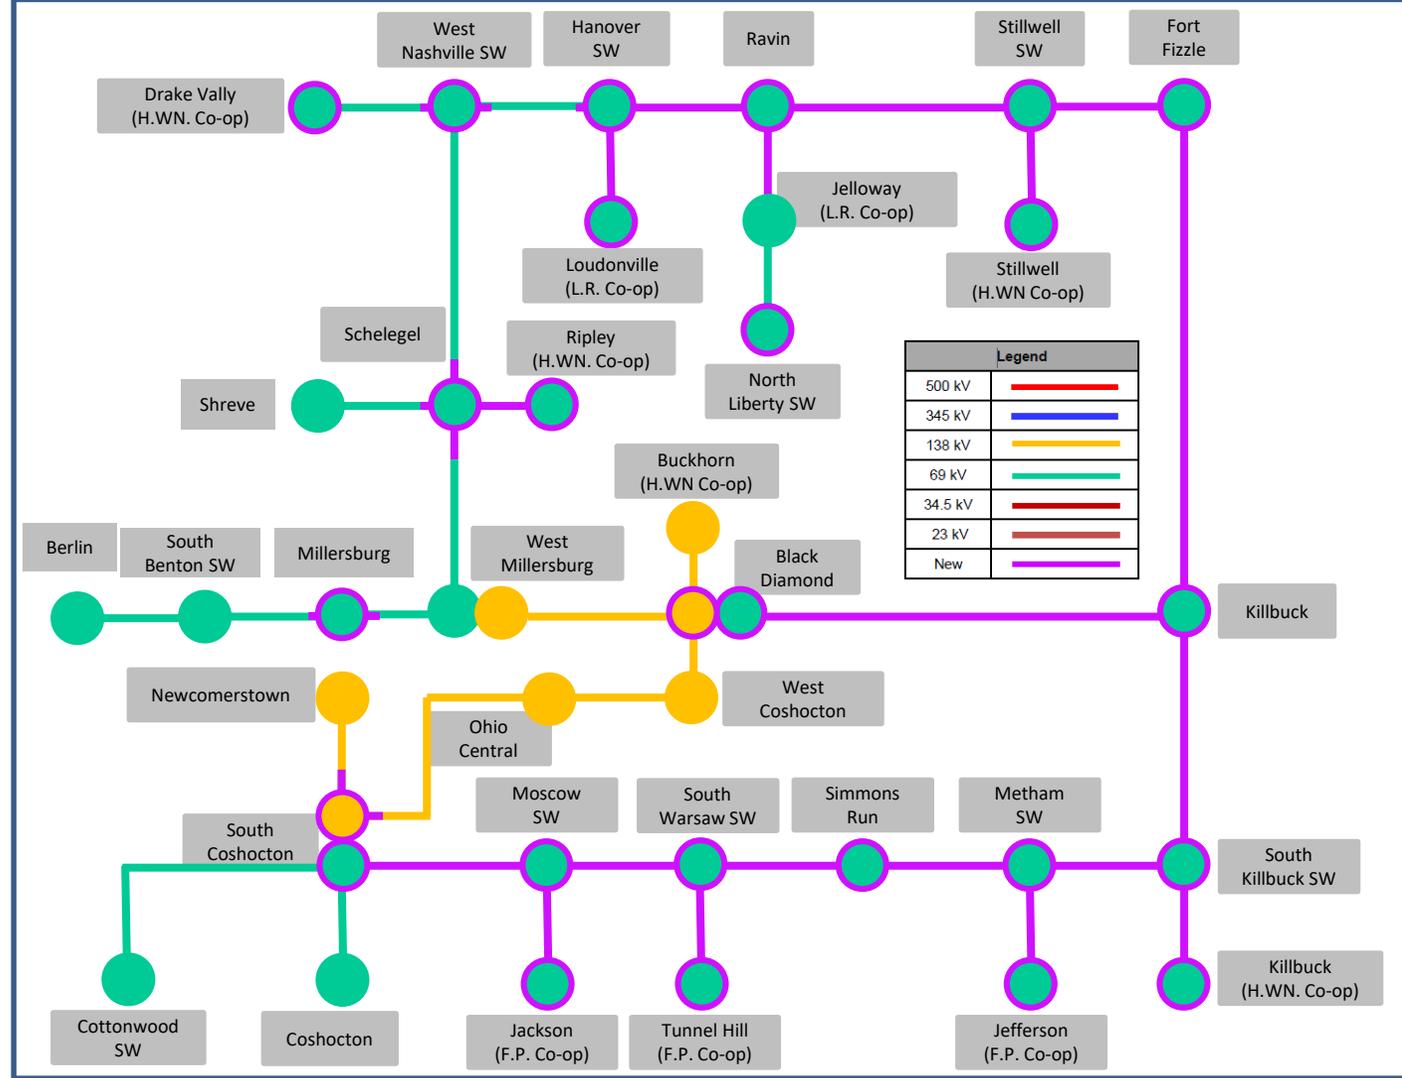
Proposed

- Schlegel (Replaces Ripley Switch):** Cost \$9.5M
Build a greenfield station at 69kV 40kA 2000A in a 4-breaker ring configuration next to Ripley (H.WN. Co-op)'s station. Remove the existing Ripley and Paint Valley switches and reconnect the lines into the new Schlegel station.

- South Killbuck – Killbuck H.WN. Co-op 69kV:** Cost \$0.7M
Rebuild ~0.05 miles of the South Killbuck to Killbuck Holmes Wayne Co-op 34kV line to 69kV.
- Metham Switch:** Cost \$0.6M
Replace 2-way POP with a 3-way 69kV 1200A POP switch.

- Metham – Jefferson (F.P. Co-op) 69kV:** Cost \$1.2M
Rebuild ~0.38 miles of the Metham to Jefferson (F.P. Co-op) 34.5kV line to 69kV.
- Simmons Run – Killbuck 69kV:** Cost \$31.1M
Rebuild ~10.4 miles of the South Coshocton to Killbuck 34.5 kV line to 69kV.

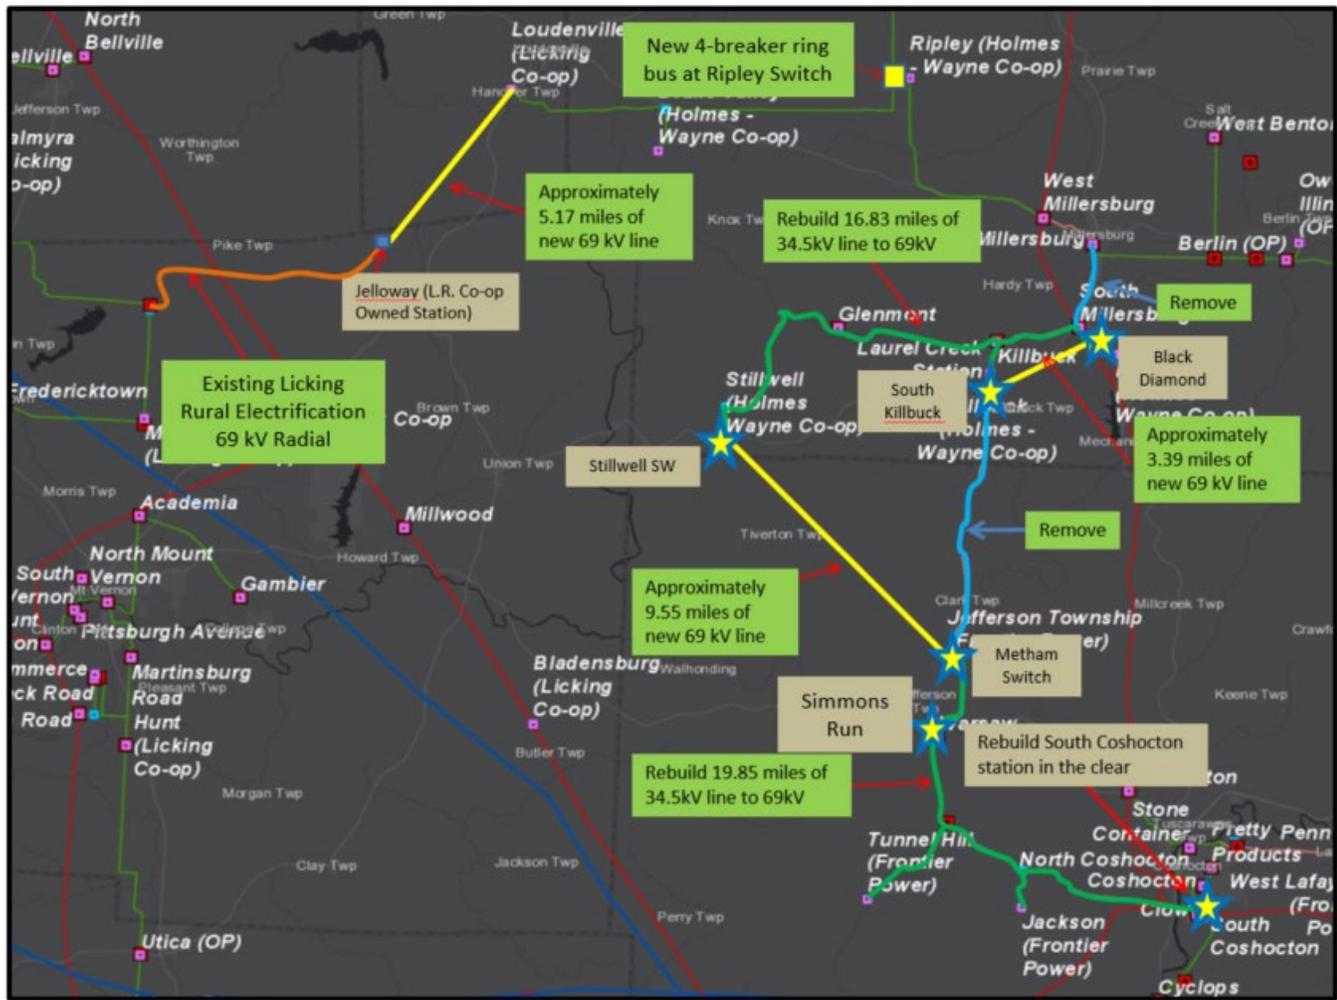
Alternative Considered:

The following items are the differences between the Solution and the Alternative solution. The required rehab remediations are also part of the Alternative solution.

- Retire and remove Metham Switch to South Killbuck Switch ≈ 8.66 miles of line.
- Install ≈ 3.39 miles of 69 kV line from South Killbuck Switch to Black Diamond station.
- Loop Stillwell to Metham Switch ≈ 9.55 miles of 69 kV line.
- Loop Jelloway (which is a 7 mile radial line connected to North Liberty Switch) to Loudonville 69 kV
- Replace North Liberty Switch with a three 69 kV circuit breaker ring bus.
