SRRTEP Committee: Western AEP Supplemental Projects

May22, 2020

AEP Transmission Zone M-3 Process Clifford, VA Area

Need Number: AEP-2020-AP031

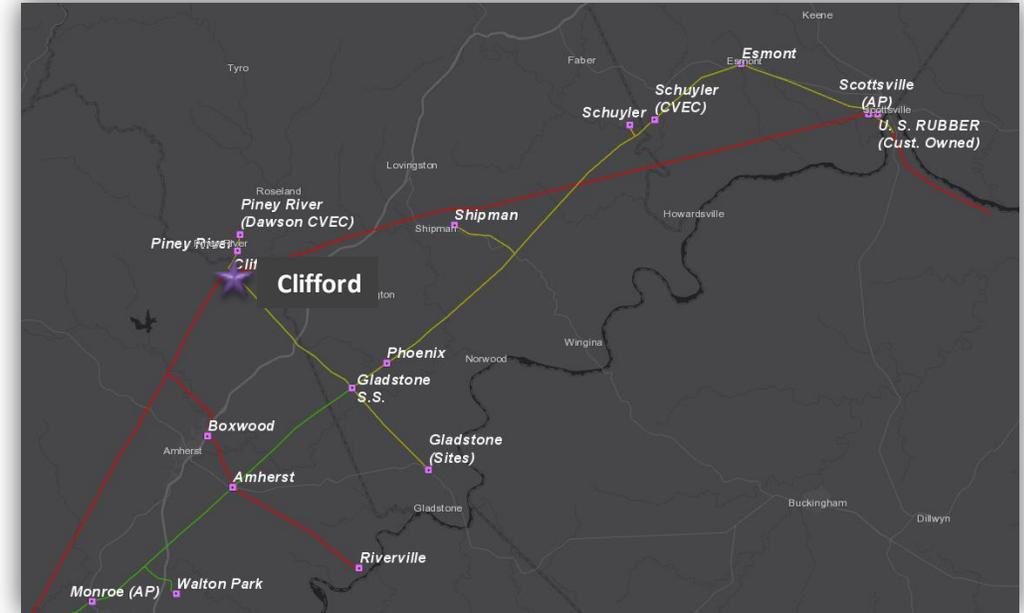
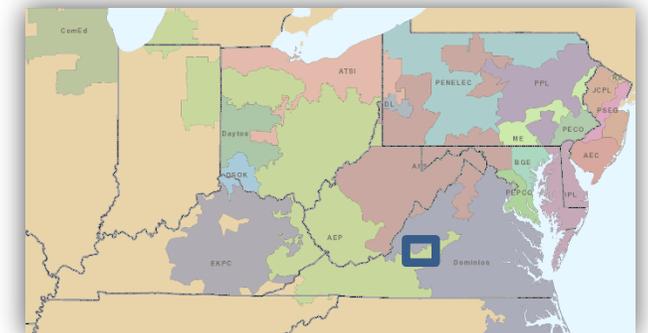
Clifford Station:

- 138/69/46 kV Transformer #1
 - 1963 Vintage Transformer
 - Elevated levels of Acetylene have been documented indicating increased decomposition of the paper insulating materials. The presence of acetylene indicates electrical discharge faults of high energy have occurred within the main tank causing electrical breakdown of the unit.
 - Due to deteriorated gaskets at the radiator headers, this unit is leaking oil.

- 138/46 kV Transformer #3
 - 1950 Vintage Transformer
 - An upward trend in insulation power factor indicates an increase in particles within the oil and the dielectric strength of the insulation system (oil and paper) are in poor condition, impairing the unit's ability to withstand electrical faults.

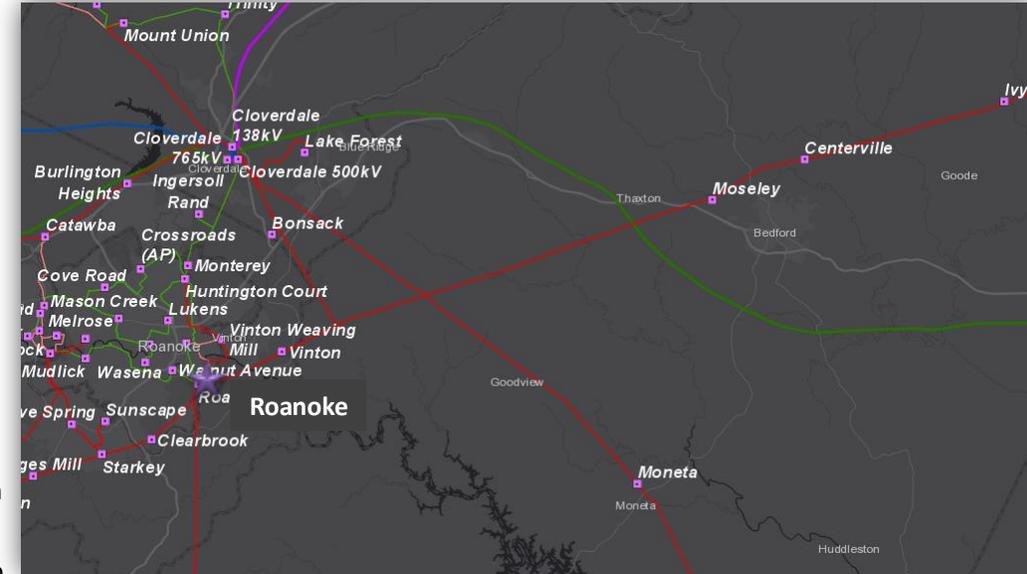
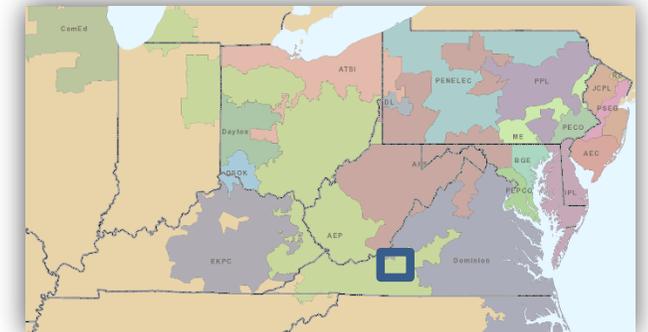
Roanoke Station:

- 138/69/12 kV Transformer #5
 - 1981 Vintage Transformer
 - Elevated levels of carbon monoxide, carbon dioxide and hydrogen indicate excessive levels of decomposition of the paper insulating materials.

- 138 kV Circuit Switchers BB and CC
 - Both are 1990's vintage
 - The Mark V family of circuit switchers have no gas monitor and currently in-service units on the AEP system have experienced 110 malfunctions from May 2000 to August 2019. Failed operational components including high contact resistance, gas loss, and interrupter failure represent half of these malfunctions. Two malfunctions of note were catastrophic equipment failures involving failures to trip.

- 138 kV Capacitor Bank CC and 34.5 kV Capacitor Bank AA
 - Leaking around bushings on both banks
 - 6 cans are failed on bank CC

- 69 kV Circuit Breakers U and V
 - 1970's Vintage Circuit Breakers
 - These breakers are oil filled without oil containment; oil filled breakers have much more maintenance required due to oil handling that their modern, SF6 counterparts do not require
 - Circuit breaker U has each exceeded the manufacturer's designed number of full fault operations (12)

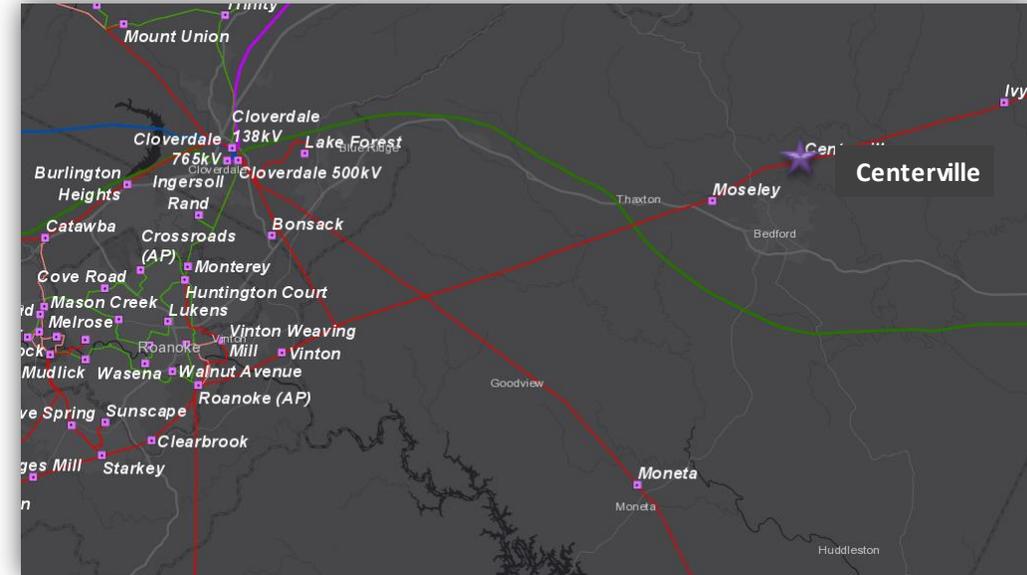
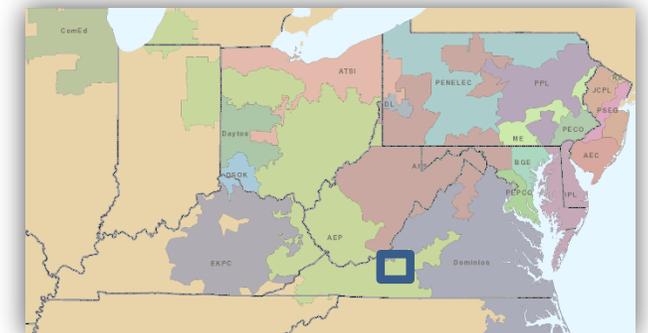
Centerville Station:

- 69 kV Circuit Breaker B
 - 1970’s Vintage Circuit Breaker
 - Oil filled breaker without oil containment. Oil filled breakers have much more maintenance required due to oil handling that their modern, SF6 counterparts do not require.

- This circuit breaker, has exceeded the manufacturer’s designed number of full fault operations (108)
- High-side Transformer MOAB Ground Switch (138/69/12 kV T1) is used for high-side transformer protection

- There is a three terminal line configuration through the Town of Bedford 69 kV loop.
- The flip-flop configuration connection to the double circuit 138 kV line that runs adjacent to the station is a source of operational and protection challenges when faults occur.

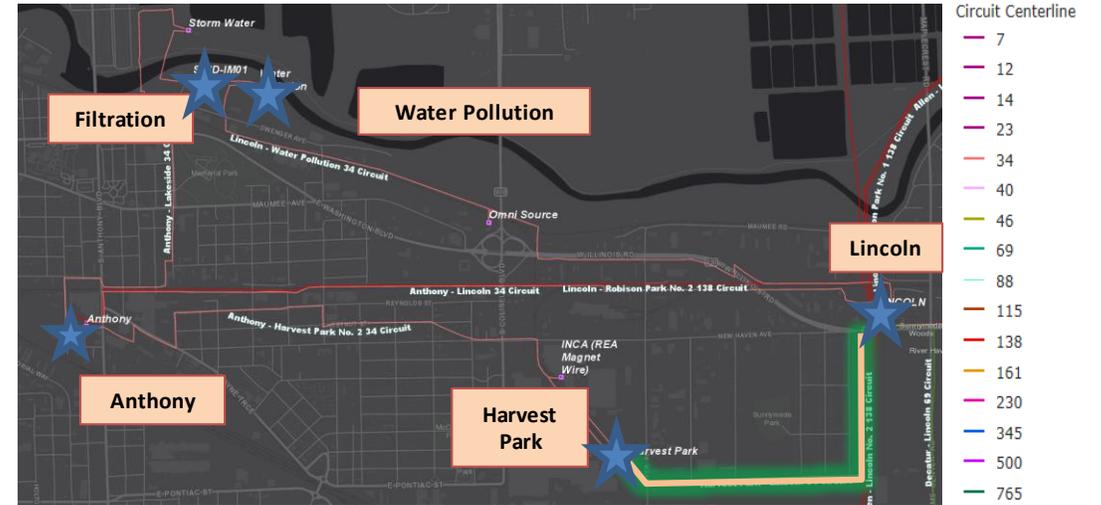
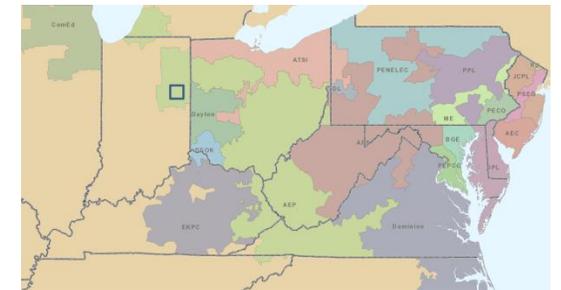
Anthony 138/34.5/12kV Station

- 34.5/12kV Transformer #4 is a 1954 unit
 - Increased CO and CO2 gassing with decreasing interfacial tension and oil deterioration
- 138/34.5kV Transformer #5 currently has a high side MOAB switch protection scheme

Lincoln – Harvest Park 34.5kV line (~1.5 miles)

- 1.5 miles of 1920-1930's steel structures with 300,000 CM copper conductor and 3#8 copperweld shield-wire
- Field inspection found the 10 1920's towers had significant rusting
- Older copper wires like the 300,000 CM copper conductor and the 3#8 copperweld shield wire have a higher rate of failure and become brittle and difficult to splice with age.
- 3 structures had flashover damage and 4 structures had severe rust and corrosion on the insulation.

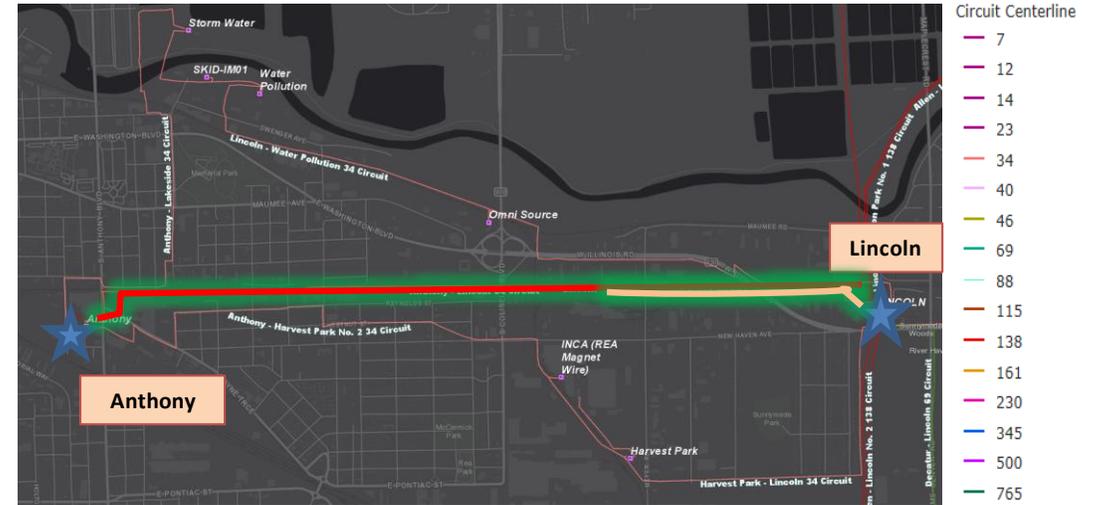
Lincoln – Anthony 34.5kV line (~1.1 miles)

- 1.1 miles of 1971 wood pole line with 300,000 CM copper conductor
- This line segment fails to meet NESC loading criteria.
- This line segment fails to meet AEP loading and leakage distance requirements
- This line segment fails to meet ASCE strength requirements.
- 4 poles have crossarm decay, 2 poles have splitting or decay, 1 broken static lead and 1 knee brace with decay across 21 poles on the line.

Lincoln – Anthony 138/34.5kV line (~3.07 miles)

- 3.07 miles of 1971 wood pole line
- 20 unique structures with open conditions (31% of the line).
 - These conditions include insect damaged poles, twisted crossarms, broken strands and missing grounds.
- This line segment fails to meet AEP strength and leakage distance requirements.
- The line segment fails to meet NESC loading criteria
- The line segment fails to meet ASCE strength requirements
- 4 poles have flashover indication, 1 broken static lead and 1 pole vertically splitting

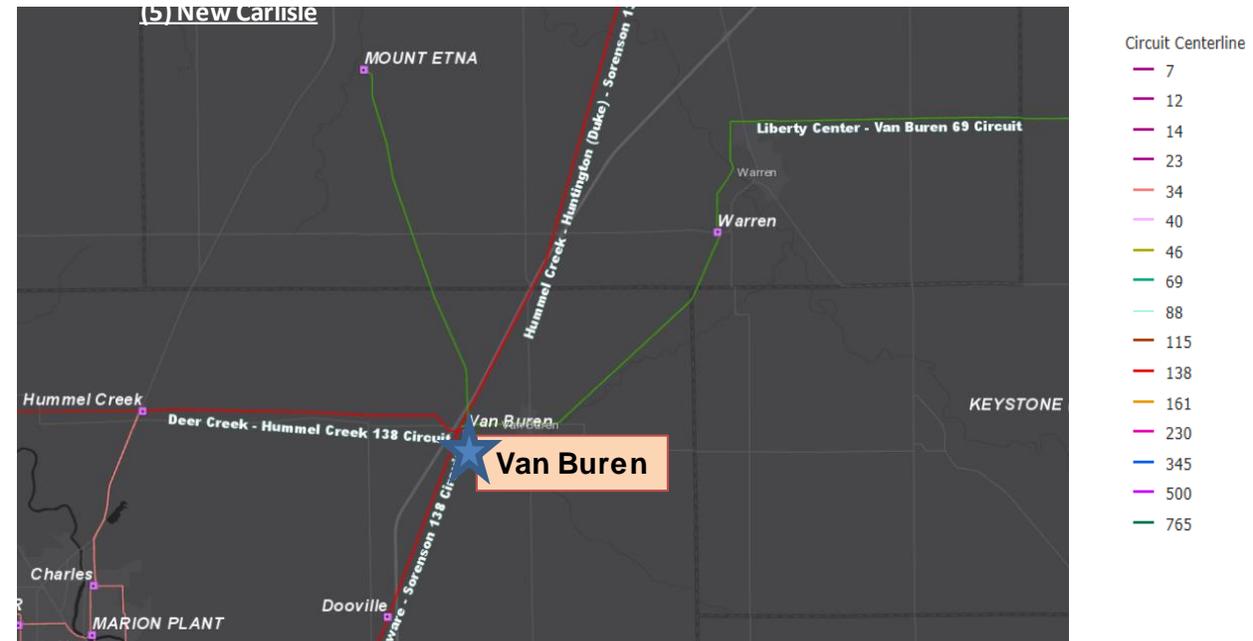
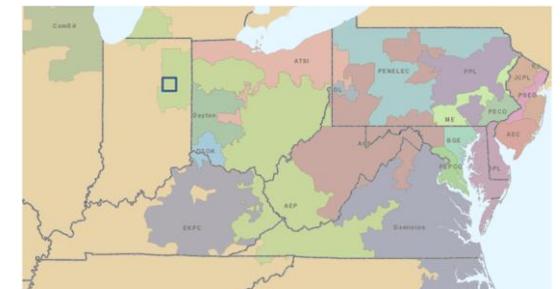
Van Buren 138/69/12kv station

- 138/69/12 kV Transformer #1
 - 1967 vintage
 - Elevated moisture levels
 - Increased cost of maintenance due to leaking
 - Increased levels of decomposition of the paper insulating materials, leading to increased risk of failure
- Breaker B 69kV
 - 1964 vintage oil filled, CF-type breaker.
 - This type is oil filled without oil containment. Oil filled breakers have much more maintenance required due to oil handling that their modern, vacuum counterparts do not require.
 - Finding spare parts for these units is not possible due to these models no longer being vendor supported
- Van Buren is part of a three-terminal line configuration with the Delaware – Sorenson 138kV circuit.

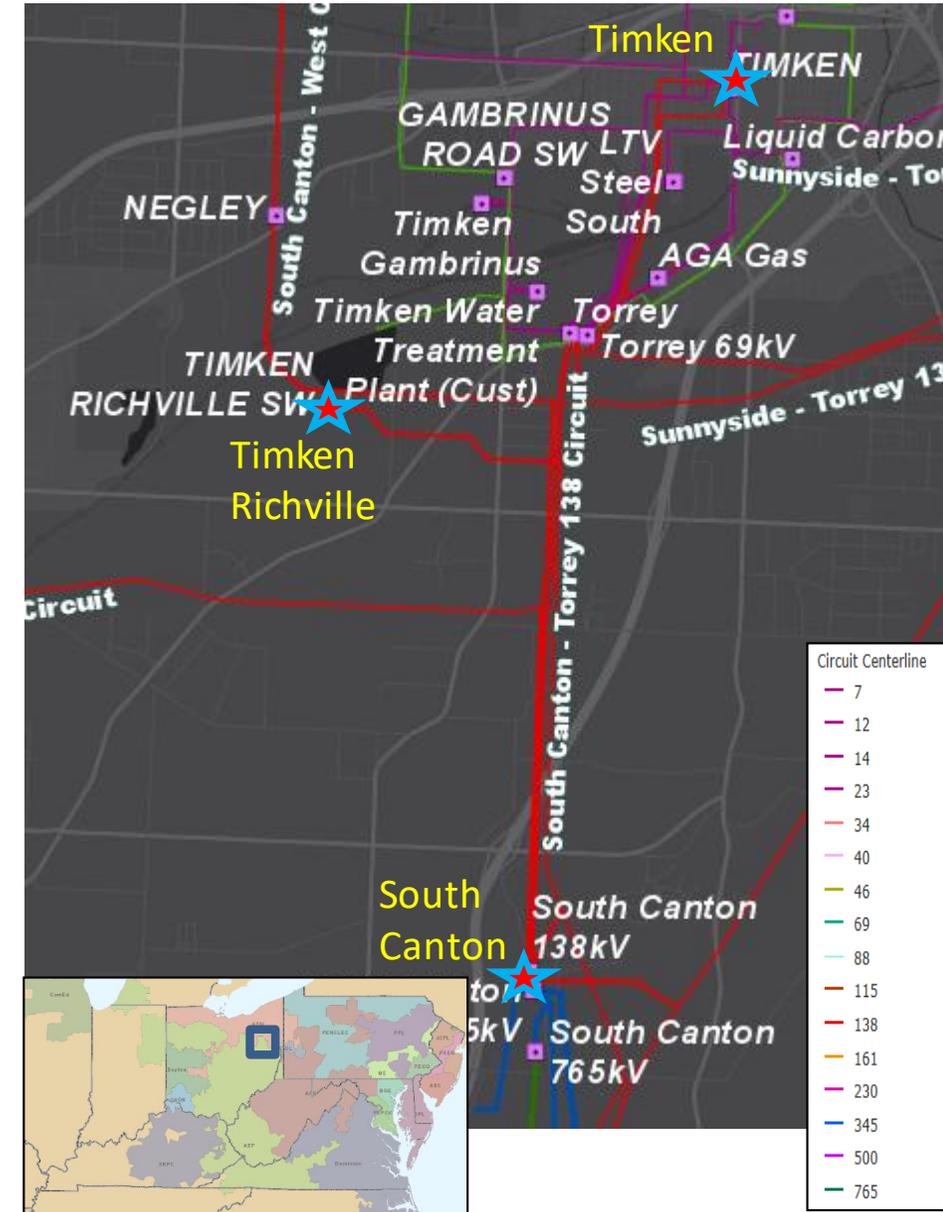
- **Timken Richville 138kV Station**

- The station contains 2- 138kV lines and 2- 138kV customer feeds with only a single 138kV bus-tie breaker. A fault on either of the 138kV lines or bus will take out up to 75 MW of load for a single event (1/2 of peak load).
- A fault on either 138kV circuit requires tripping one of the customer's 138kV breakers to clear the fault. If the customer's equipment were to fail to clear a line fault, a single 138kV circuit fault would expand to take out both 138kV circuits connected to Timken Richville, dropping the customer entirely and requiring additional remote-end clearing (at South Canton or Timken station).

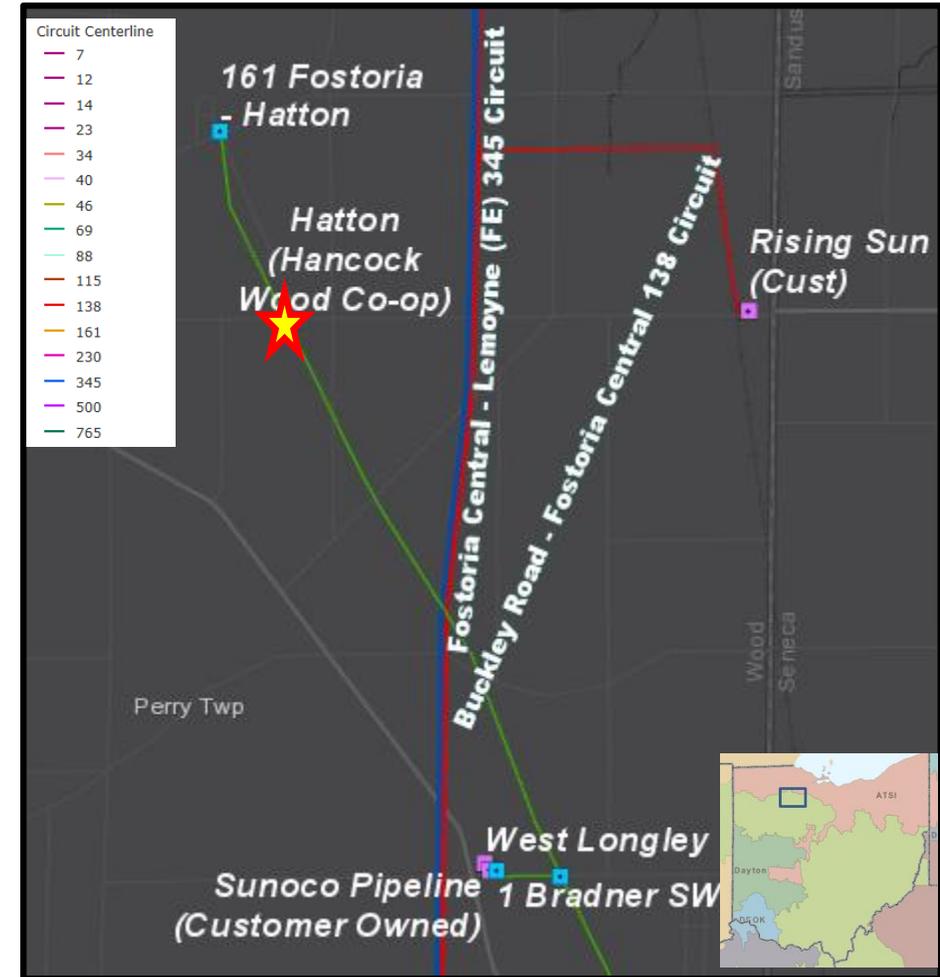
- Hancock-Wood Co-op has requested a new service to replace their existing Hatton Delivery Point. Hatton delivery point is currently served via a hard tap from the Pemberville (FE) – West End Fostoria (AEP) 69kV circuit. The new customer station is being built to adjacent to their existing substation. The hard tap limits operational capabilities for this circuit. It is difficult to coordinate maintenance efforts because any work on the section from Longley Switch to Pemberville (FE) involves outage to the Hatton Delivery Point.
- Load is approximately 2.26 MVA
- CMI: There were no unplanned outages, but there were six scheduled and one monetary outages that affected the customer, in the last 5 years.

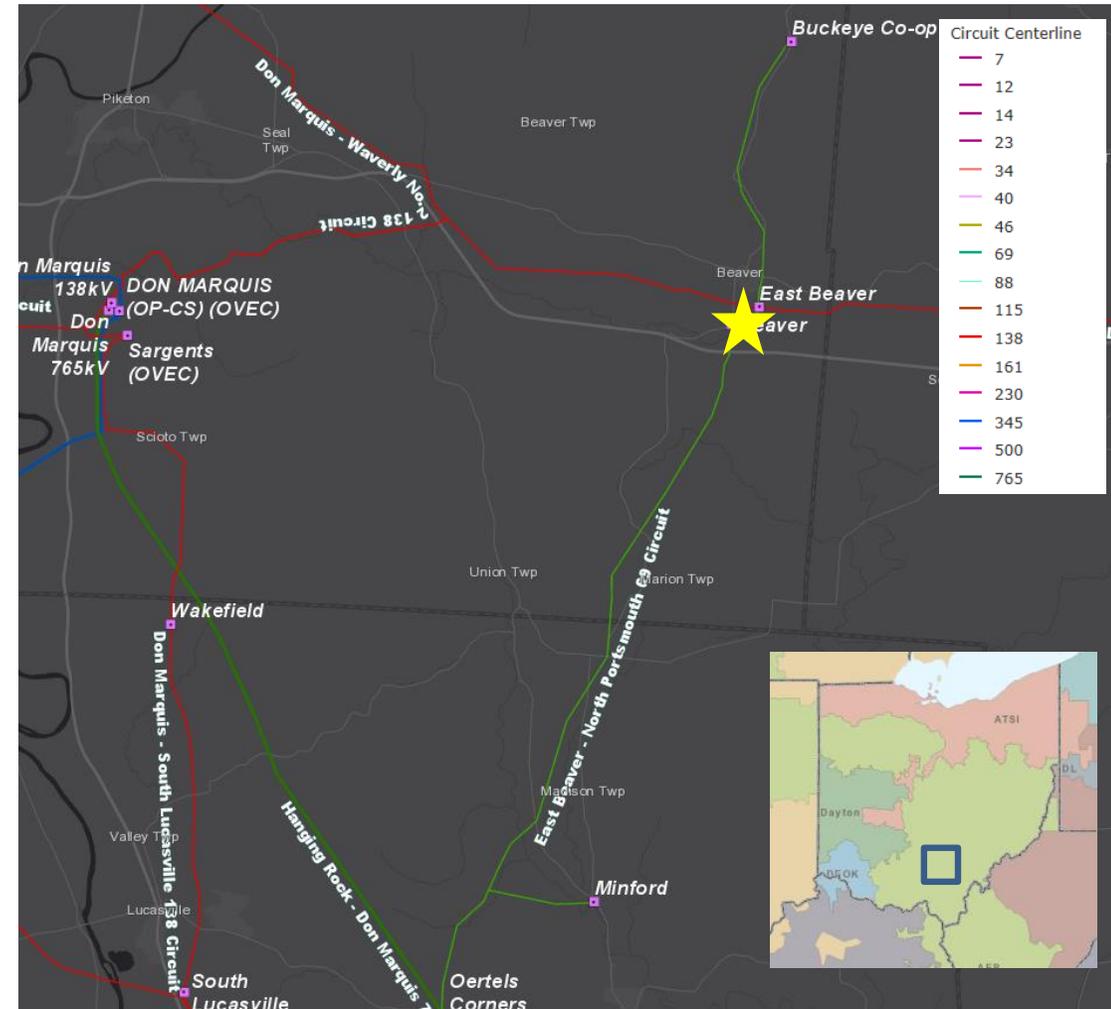
East Beaver 138/69 kV Transformer #1:

- The 138/69 kV 56/72 MVA (vintage 1962) at East Beaver has failed. There is no spare on site to utilize as a replacement.

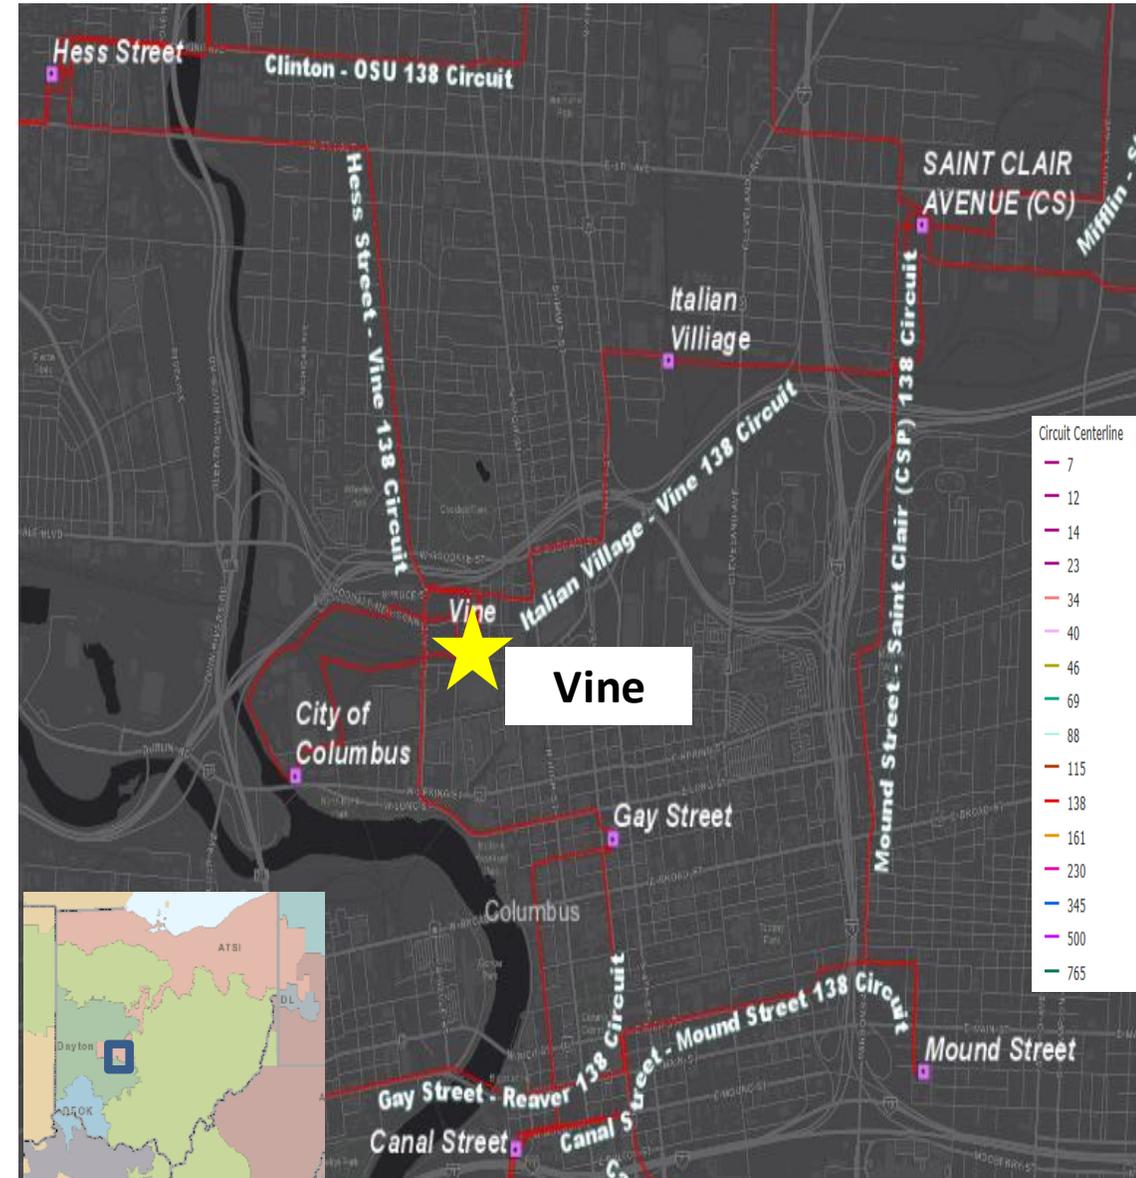
Vine Station

- Circuit Breakers 101, 102, 103, 104, 106, 107
 - 138 kV 2000A 40kA* oil type breakers (*CB 107 is a 50kA)
 - Install date ranging from 1974 -1977 (43-46 years old)

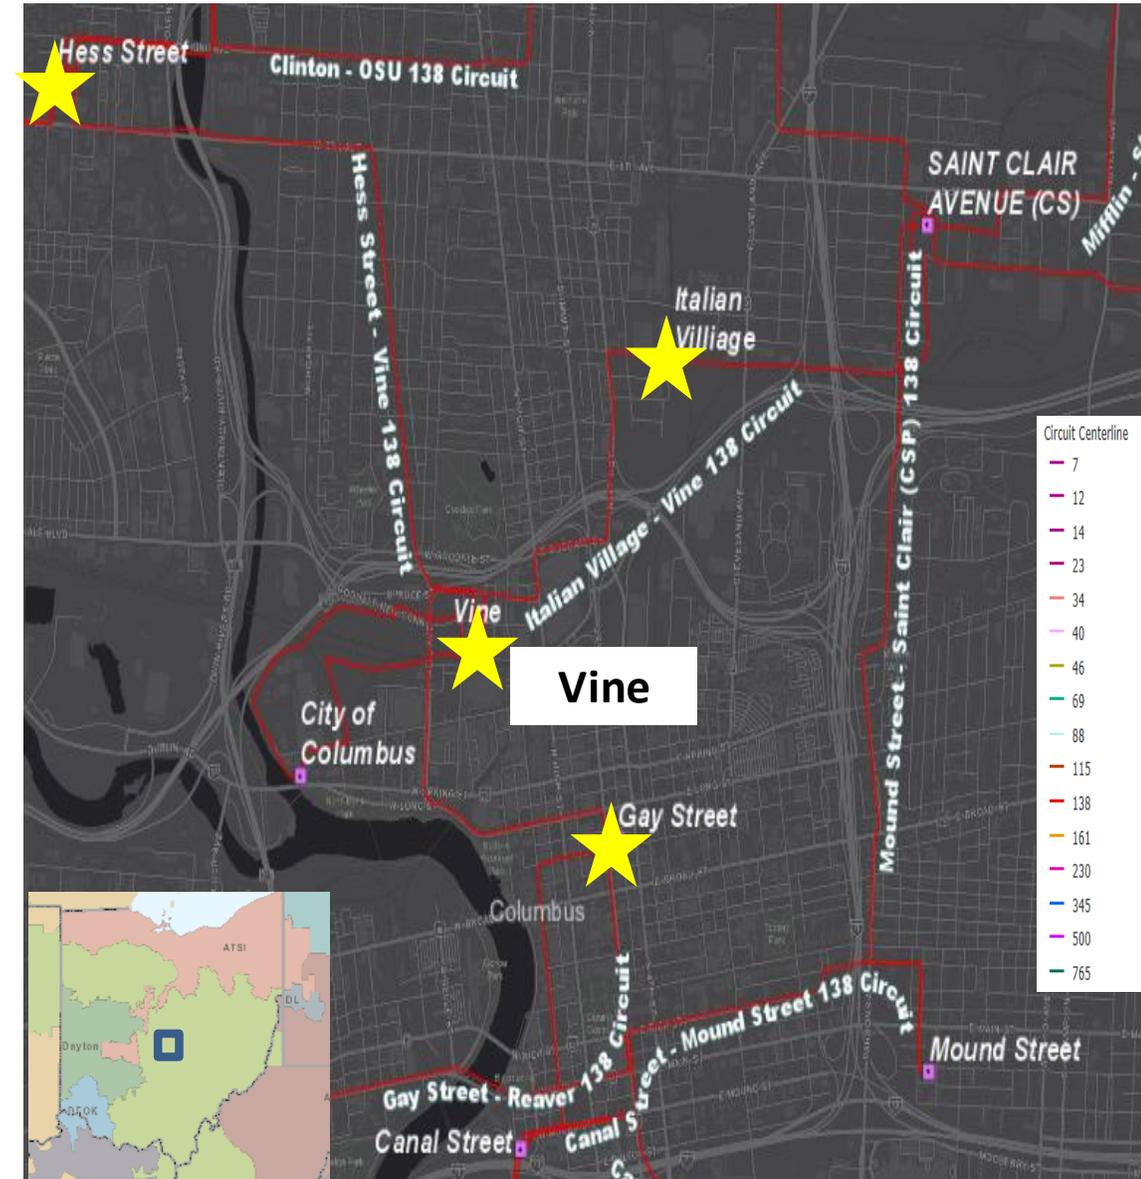
Gay – Vine 138 kV Underground Circuit*

- The existing Gay – Vine 138 kV underground circuit is approximately 1.4 miles long and was originally installed in the 1960's.

Hess – Vine 138 kV Underground Circuit*

- The existing Hess – Vine 138 kV underground circuit is approximately 2.5 miles long and was originally installed in the 1980's.

Italian Village – Vine 138 kV Underground Circuit*

- The existing Italian Village – Vine 138 kV underground circuit is approximately 1.3 miles long and was originally installed in the 1990's.

*All of these circuits utilize an underground oil-filled pipe type cable design. Oil-filled pipe type underground cables come with several challenges/risks in densely populated urban areas. There is a single manufacturer of oil-filled cables which has informed AEP of its desire to discontinue this product due to lack of demand and cheaper available alternates such as XLPE. A failure of any section may result in weeks of outage to customers in downtown Columbus.

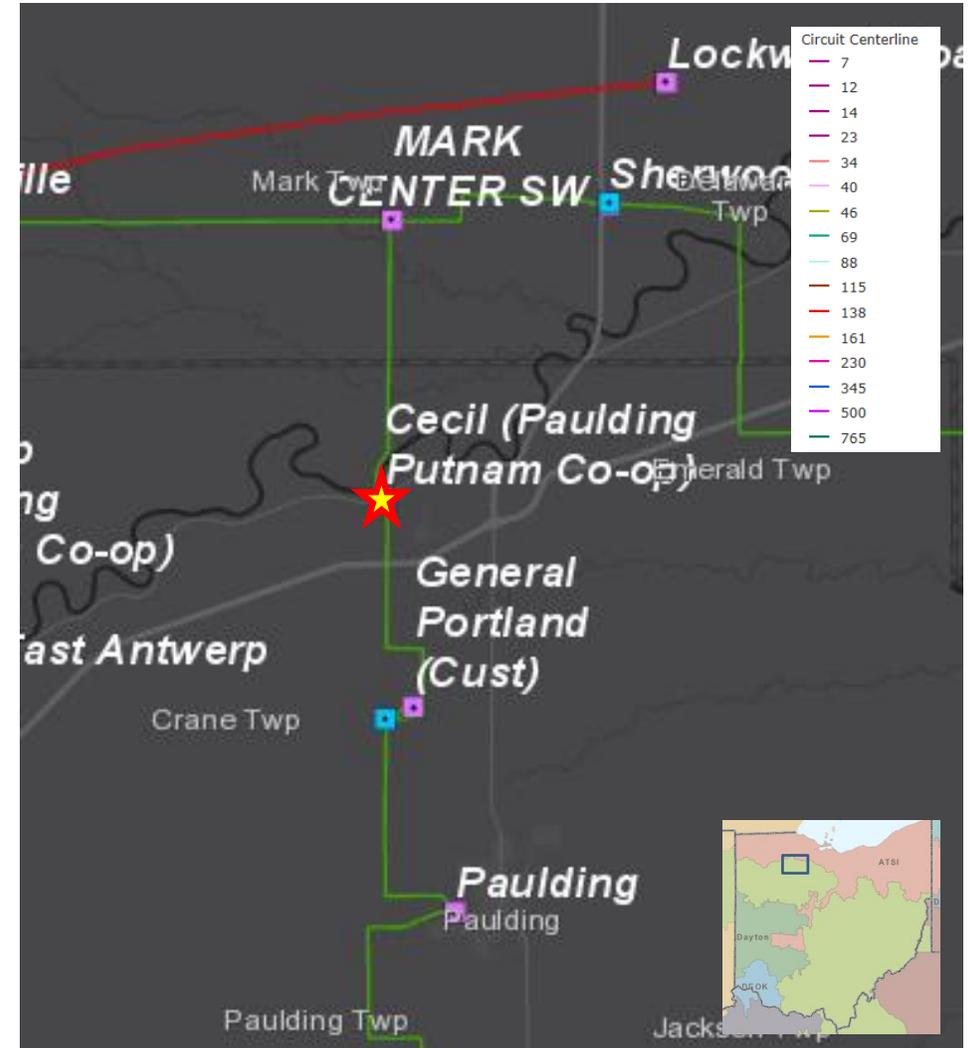
- Paulding – Putnam Electric Co-op is replacing their 3.75 MVA transformer with a 12/16/20 MVA transformer, which requires some changes to their delivery point. This delivery point is served by the North Cecil switch on the Mark Center – Paulding 69 kV circuit. North Cecil has no auto-sectionalizing capability.
- Load: The Co-op delivery point serves approximately 4.9 MW
- CMI: In the last 5 years, there were 6 unscheduled outages affecting the customer, 3 of which were momentary and 3 were permanent outages. The 5-year CMI experienced by this customer is 170,520.
- **Model:** 2024 RTEP

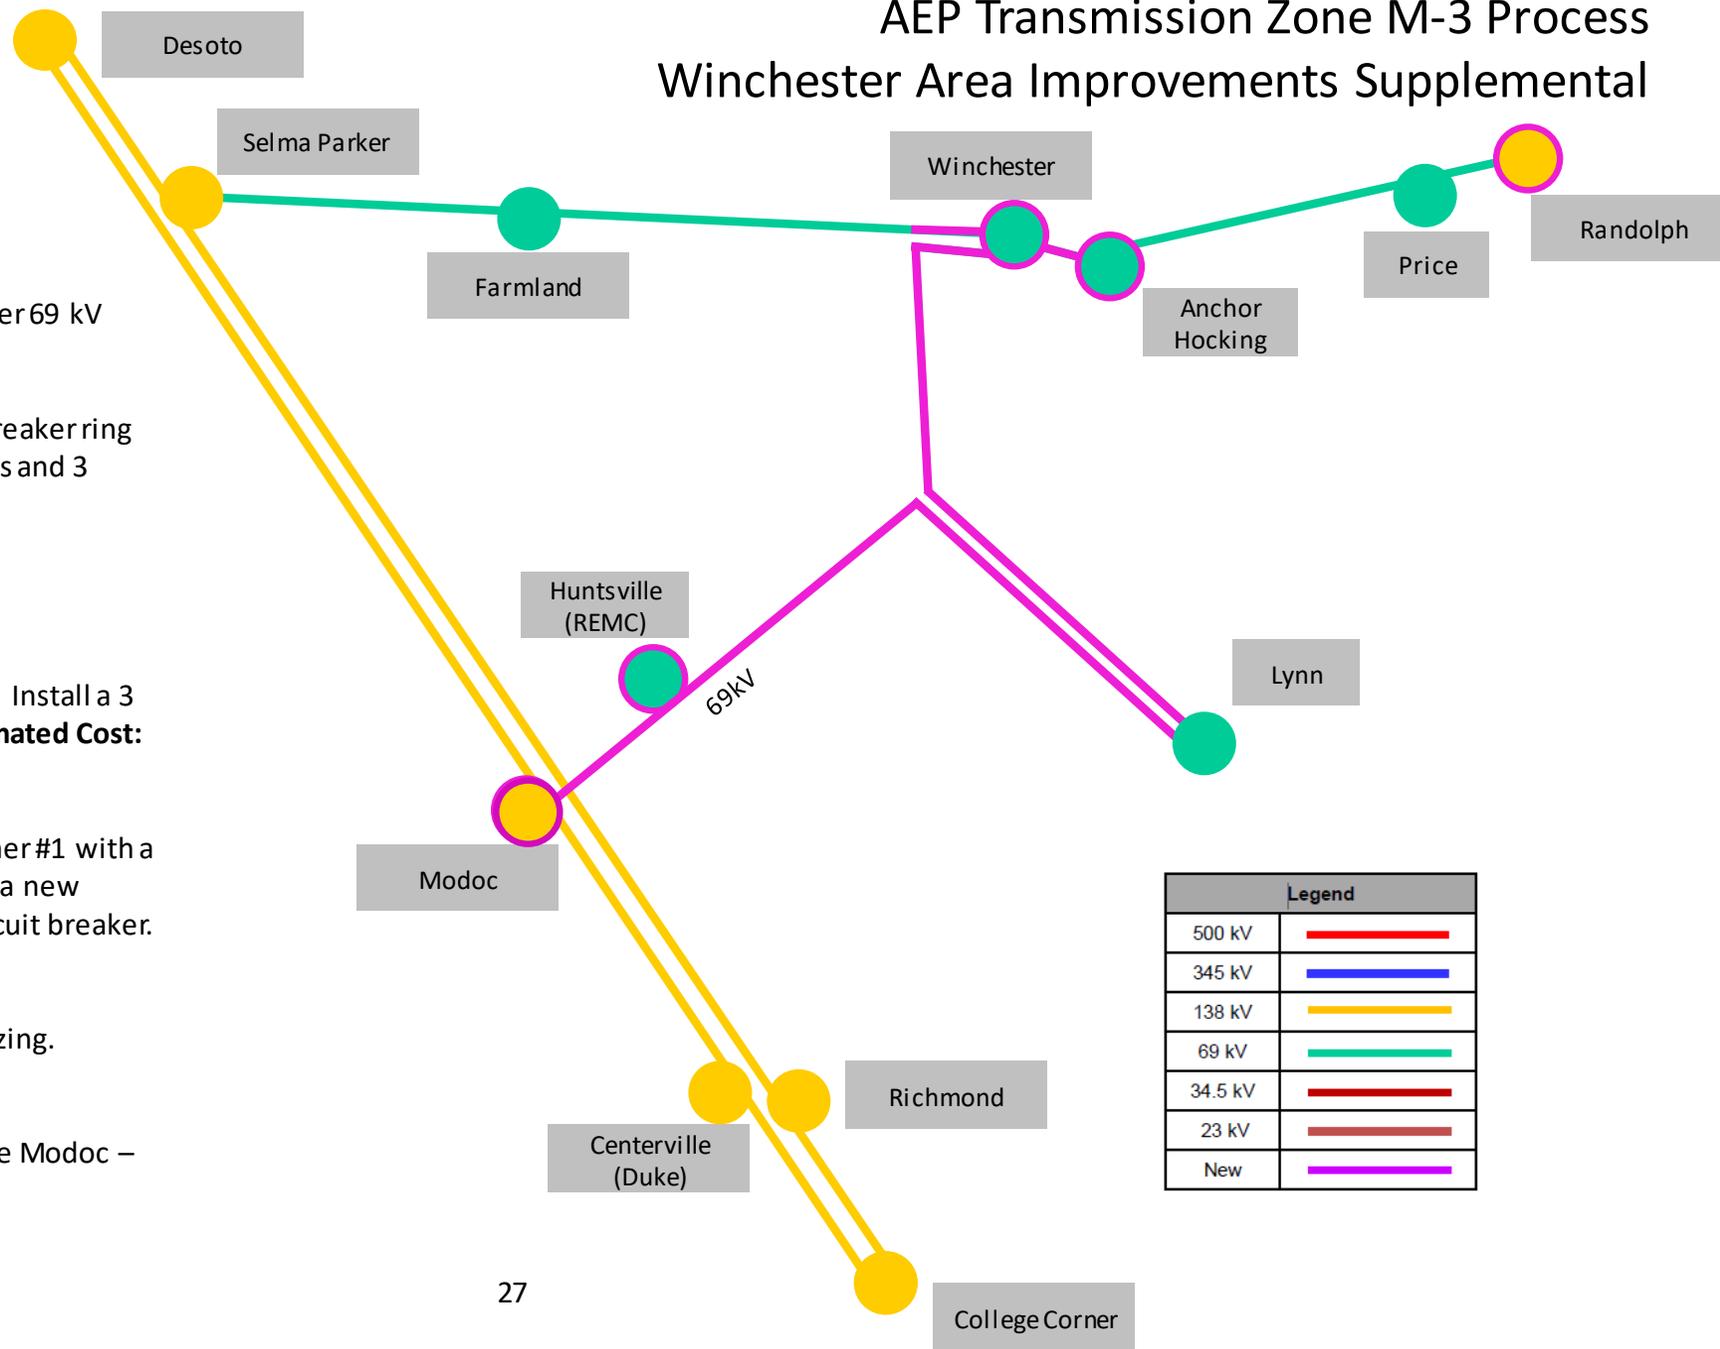
Replace circuit breakers A & B at Winchester station. **Estimated Cost: \$3.0M**

At Modoc station, replace 138/69kV Transformer #1. Install a 3 breaker ring bus eliminating the 3 terminal line. **Estimated Cost: \$11.8M**

At Randolph station, replace 138/69/12 kV Transformer #1 with a 138/69kV 90MVA unit, move the distribution load to a new 138/12kV transformer, and install a 138kV bus tie circuit breaker. Replace cap switcher AA. **Estimated Cost: \$6.8M**

At Lynn station, install 2 69kV switches for sectionalizing. **Estimated Cost: \$0.8M**

Replace the Huntsville (REMC) switch structure on the Modoc – Winchester 69kv line. **Estimated Cost: \$0.6M**
