# SRRTEP Committee: Western EKPC Supplemental Projects

March 19, 2021

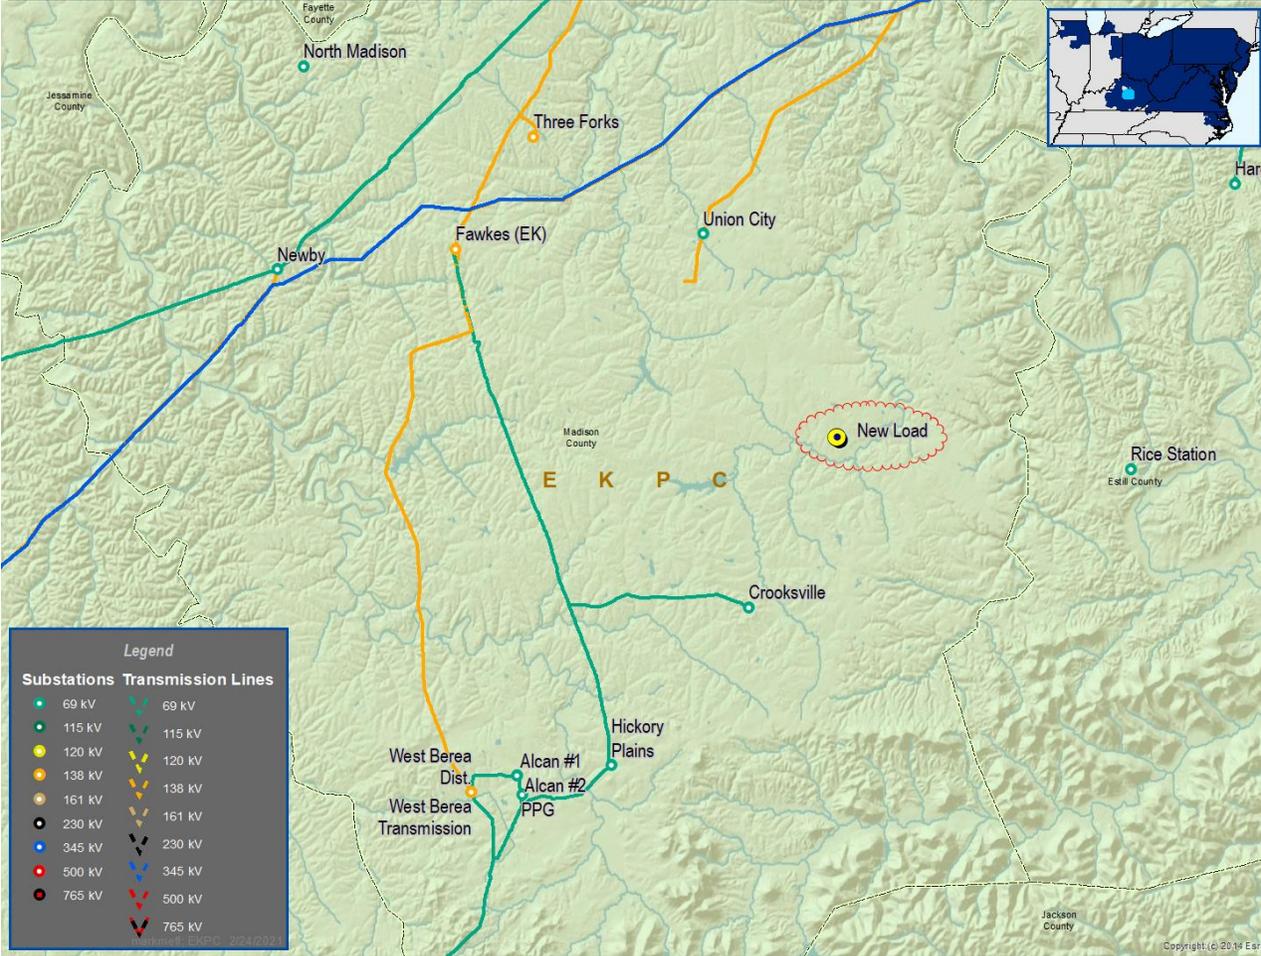
# EKPC Transmission Zone M-3 Process Speedwell Road New Customer Load

A new customer has requested a new delivery point for a winter peak demand of 28.5 MW and 1.5 MW summer peak by 7/1/2022. The new delivery point is located in Madison Co, KY approximately 5.5 miles northeast from EKPC’s Crooksville distribution substation. The existing distribution infrastructure is not capable of serving this request.

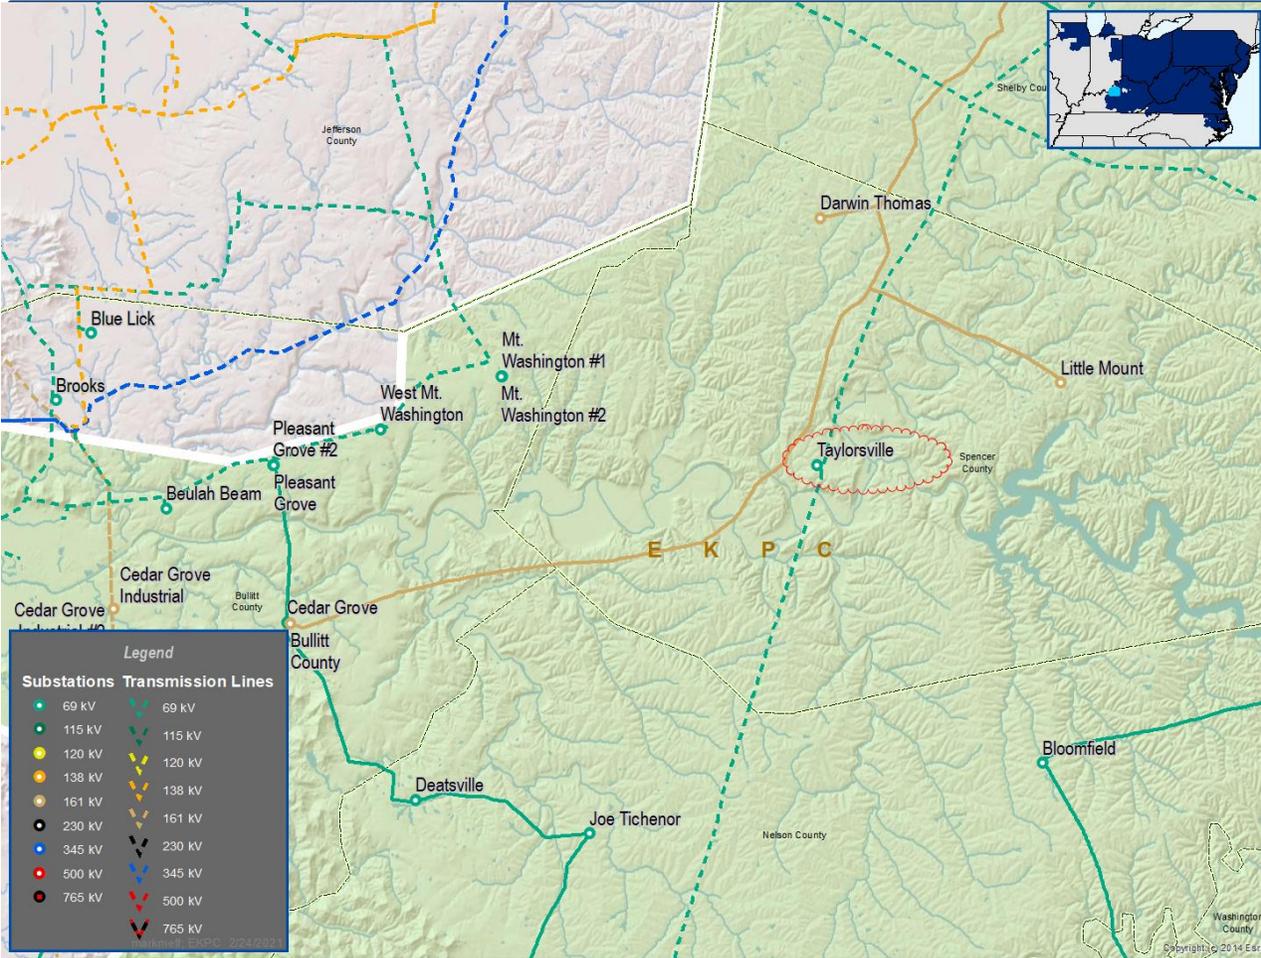
# EKPC Transmission Zone M-3 Process Taylorsville Distribution Substation

The Taylorsville distribution substation was built in 1946. This station is currently served from LG&E/KU’s Bardstown-Finchville 69 KV transmission circuit.

This station has numerous issues associated with aging/condition, site location, and accessibility. The station has a narrow driveway with a 90 degree turn. Extremely small station footprint with minimal space to maneuver around the equipment. High side switch and porcelain lightning arrestors are at end of life. There is no metering bypass, or bypass buss in the low bay, which prolongs restoration. The distribution transformer is inconveniently located under the high side bus which creates prolonged maintenance outage time.

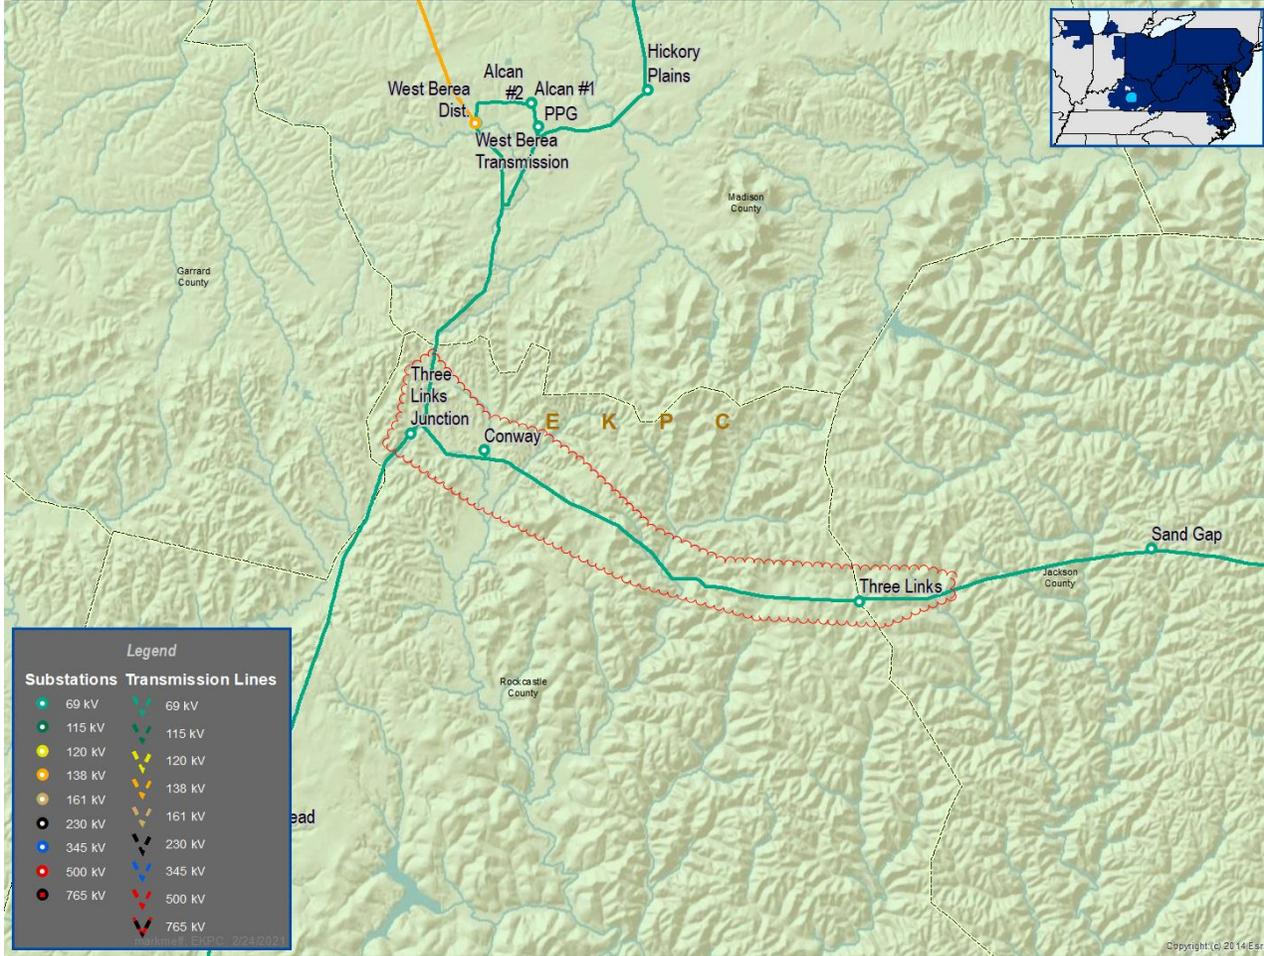
## Three Links Jct. – Three Links 69kV

The 9.61 mile, Three Links Jct.-Three Links 69 KV transmission line is 63 years old.

This line has condition issues such as conductor steel core and static wire deterioration, rusting, pitting and broken strands. Based on this information, the EKPC Reliability team has concluded that this line is at or near end of life and should be addressed due to the condition.

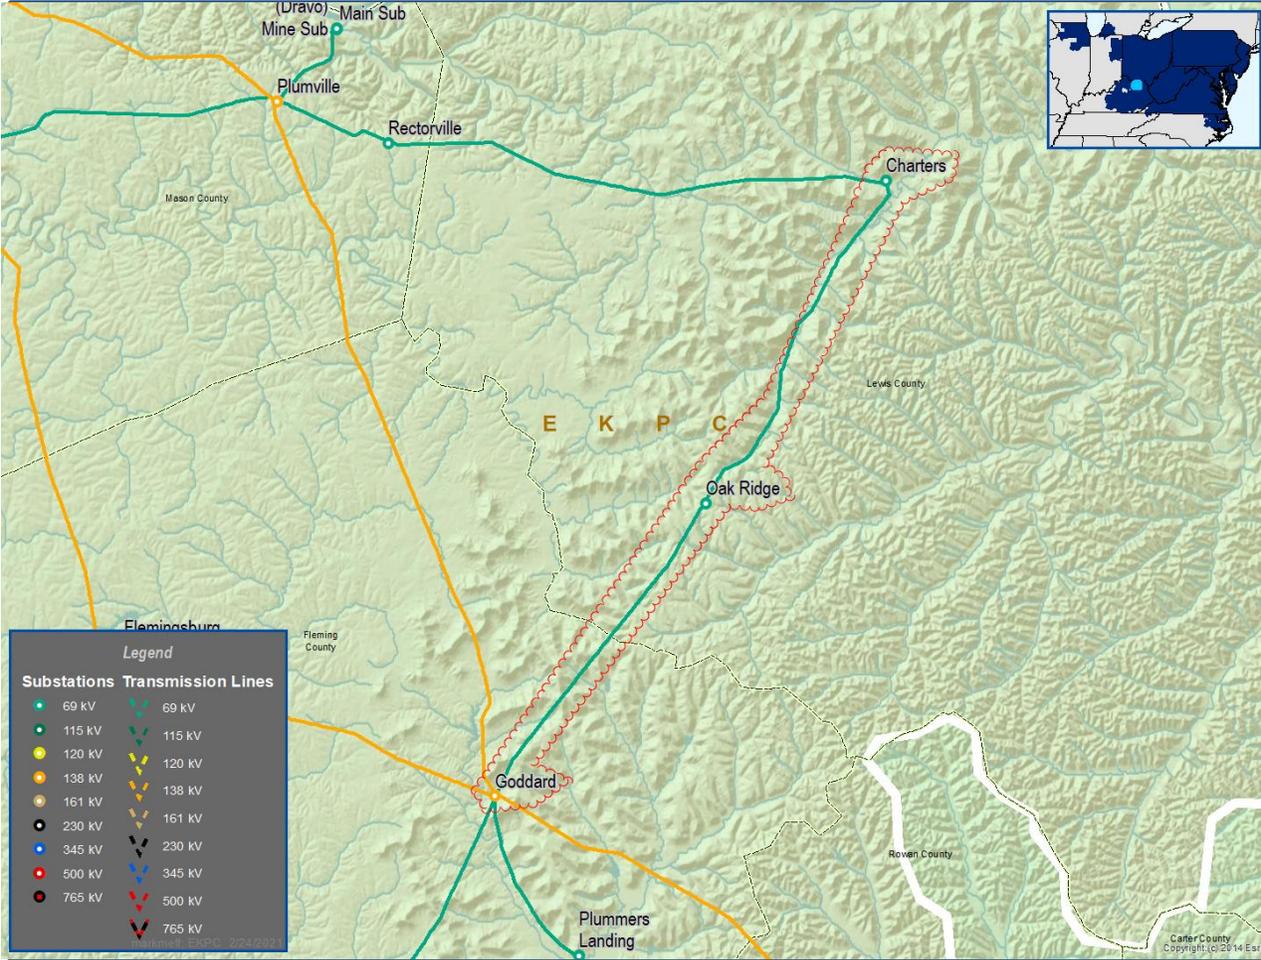
# EKPC Transmission Zone M-3 Process Goddard - Charters 69 KV

The 17 mile, Goddard - Charters transmission line is 69 years old.

Testing from the LineVue robot from Kinectrics Corporation deemed the phase and static wire condition as marginal. The testing identified instances of rusting, pitting, and broken strands. Based on this testing information, the EKPC Reliability team has concluded that this line should be addressed due to the condition assessment.

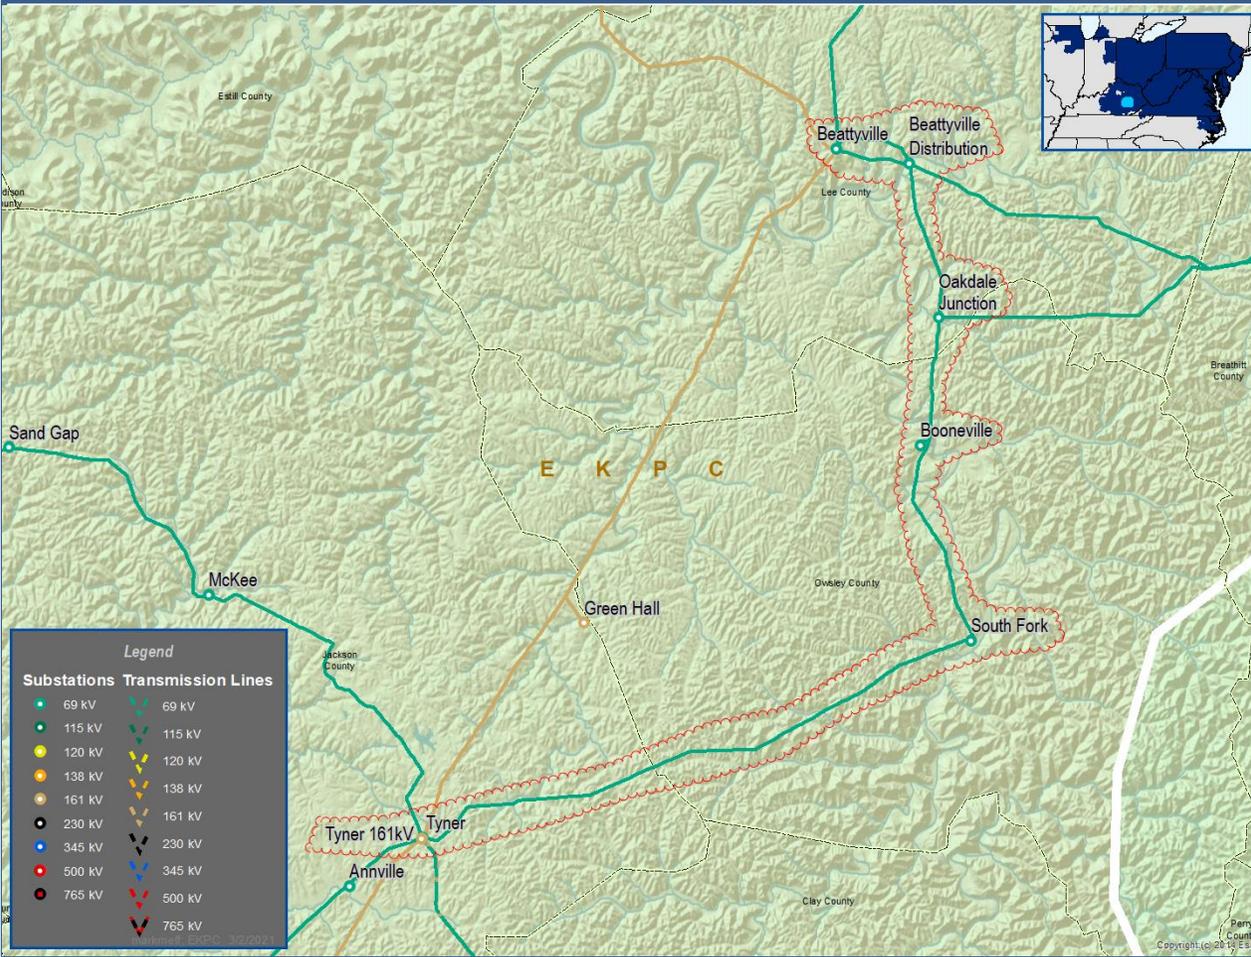
# EKPC Transmission Zone M-3 Process Beattyville - Tyner 69 KV

The 29.29 mile, Beattyville-Tyner transmission line is 65 to 66 years old.

Testing from the LineVue robot from Kinectrics Corporation deemed the phase and static wire condition as poor. The testing identified instances of rusting, pitting, and broken strands. Based on this testing information, the EKPC Reliability team has concluded that this line should be addressed due to the condition assessment.

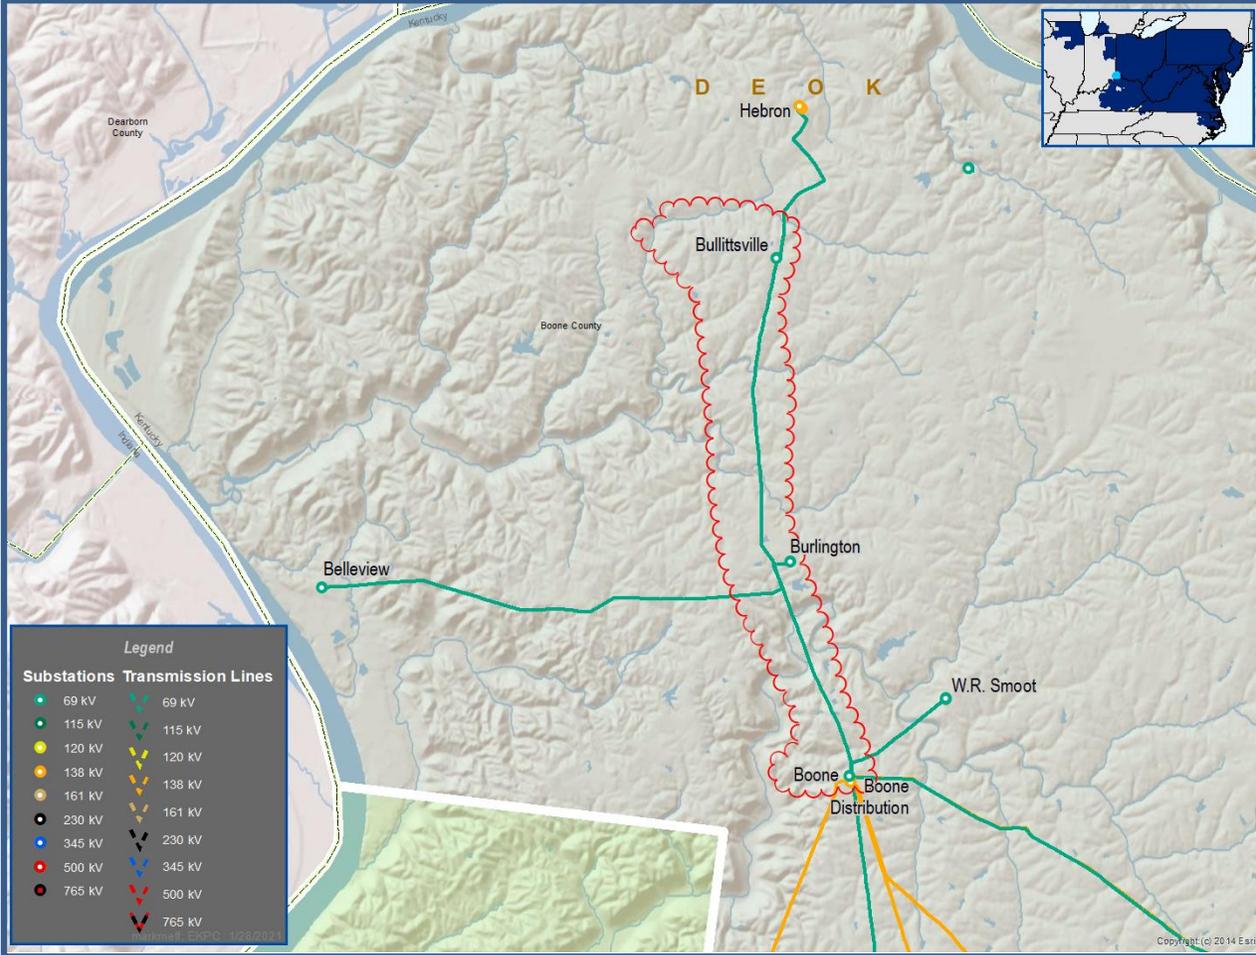
# EKPC Transmission Zone M-3 Process Boone-Bullittsville 69 KV

The 6.4 mile, Boone-Bullittsville 69 KV transmission line is 60 years old. Testing from the LineVue robot from Kinectrics Corporation deemed the phase and static wire condition as unacceptable. The testing identified instances of rusting, pitting, and broken strands. Based on this testing information, the EKPC Reliability team has concluded that this line should be addressed due to the condition assessment.

Also, the current configuration of the transmission lines routed into the Boone County transmission station has created lines crossing at undesirable angles. This produces safety issues and possible longer outage times during maintenance activities.

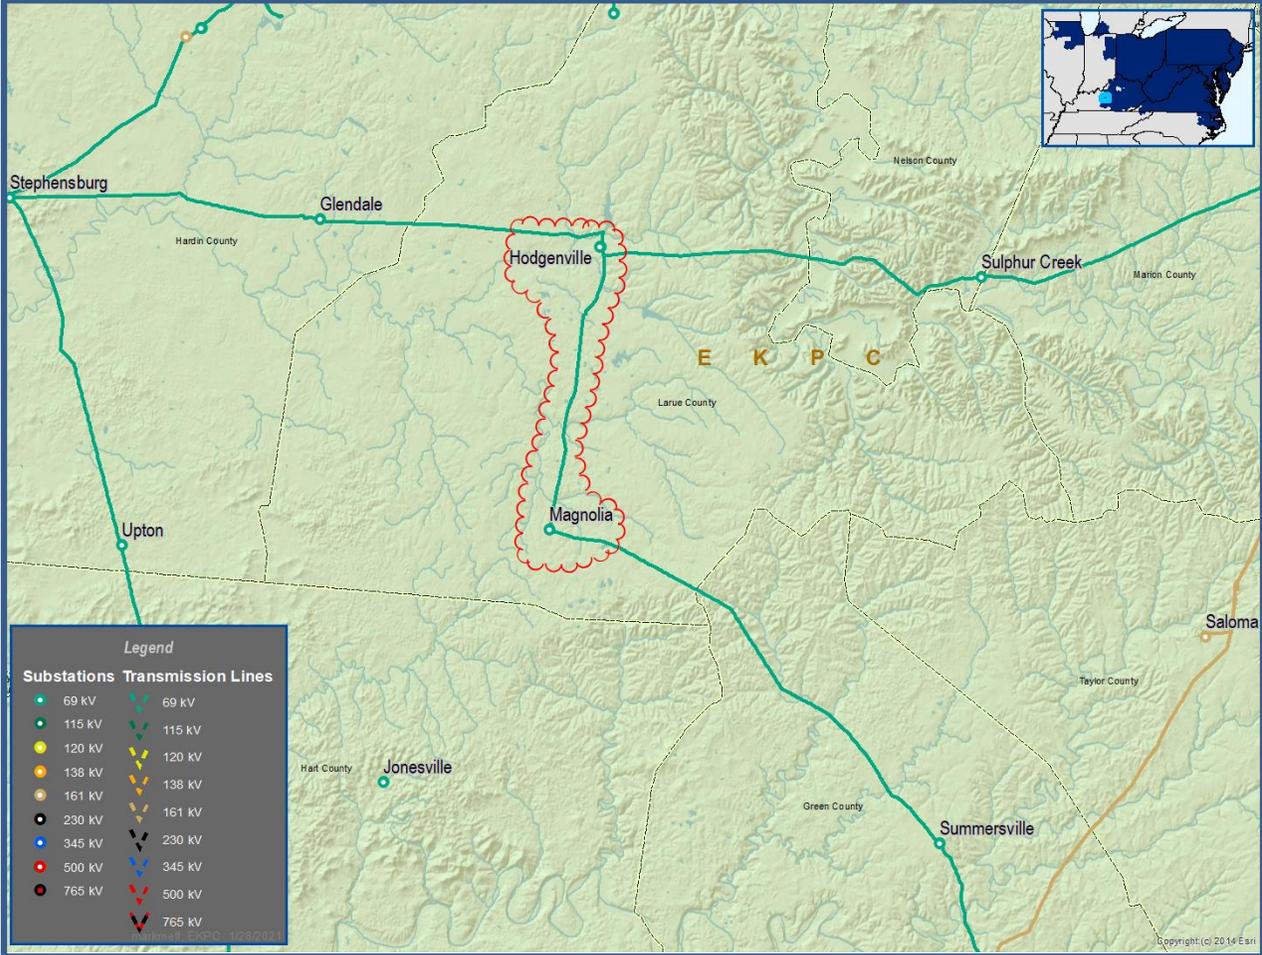
# EKPC Transmission Zone M-3 Process Hodgenville - Magnolia 69kV

The 8.49 mile, Hodgenville-Magnolia 69 KV transmission line is 64 years old. Testing from the LineVue robot from Kinectrics Corporation deemed the phase and static wire condition as unacceptable. The testing identified instances of rusting, pitting, and broken strands. Based on this testing information, the EKPC Reliability team has concluded that this line should be addressed due to the condition assessment.

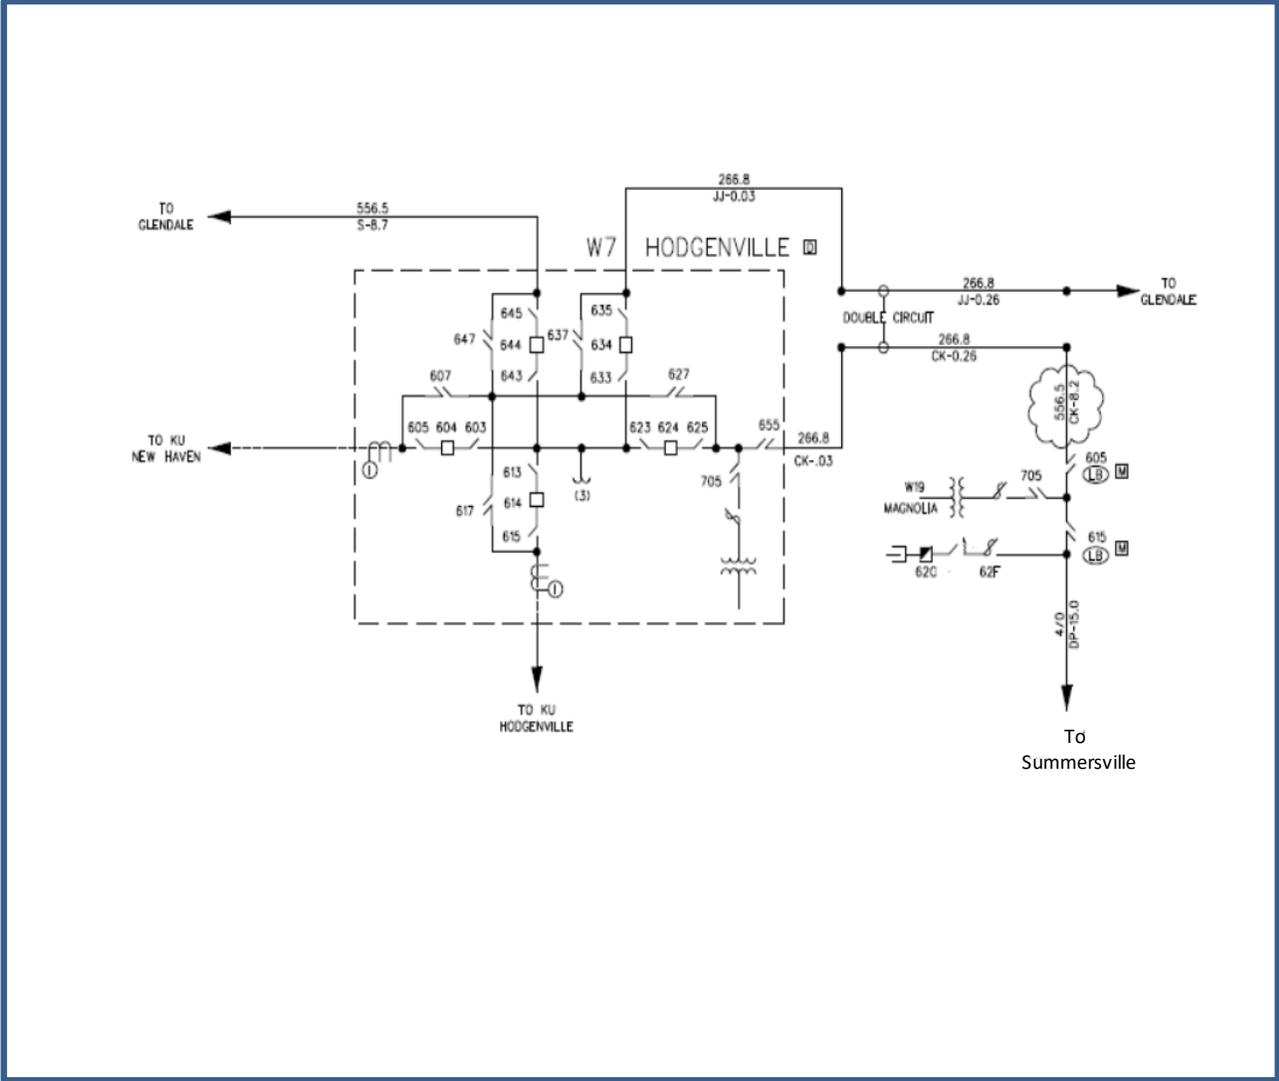
# EKPC Transmission Zone M-3 Process Hodgenville - Magnolia 69kV

Rebuild the 8.49 mile, Hodgenville-Magnolia 69 KV transmission line using 556.5 ACSR/TW conductor.

8.49 mile of single structures will be replaced.

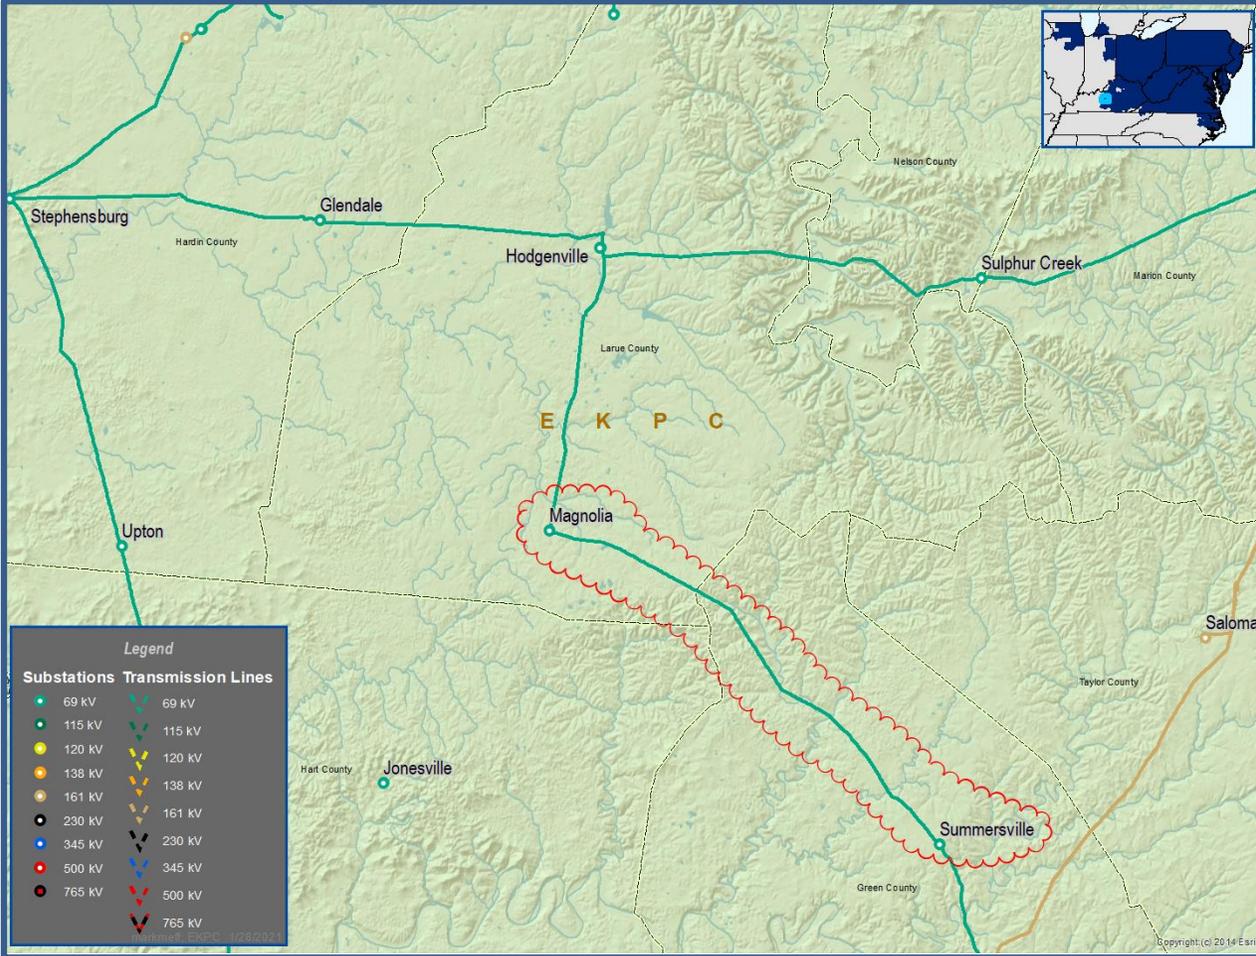
# EKPC Transmission Zone M-3 Process Summersville - Magnolia 69kV

The 15 mile, Summersville-Magnolia 69 KV transmission line is 59 years old. Testing from the LineVue robot from Kinectrics Corporation deemed the phase and static wire condition as unacceptable. The testing identified instances of rusting, pitting, and broken strands. Based on this testing information, the EKPC Reliability team has concluded that this line should be addressed due to the condition assessment.

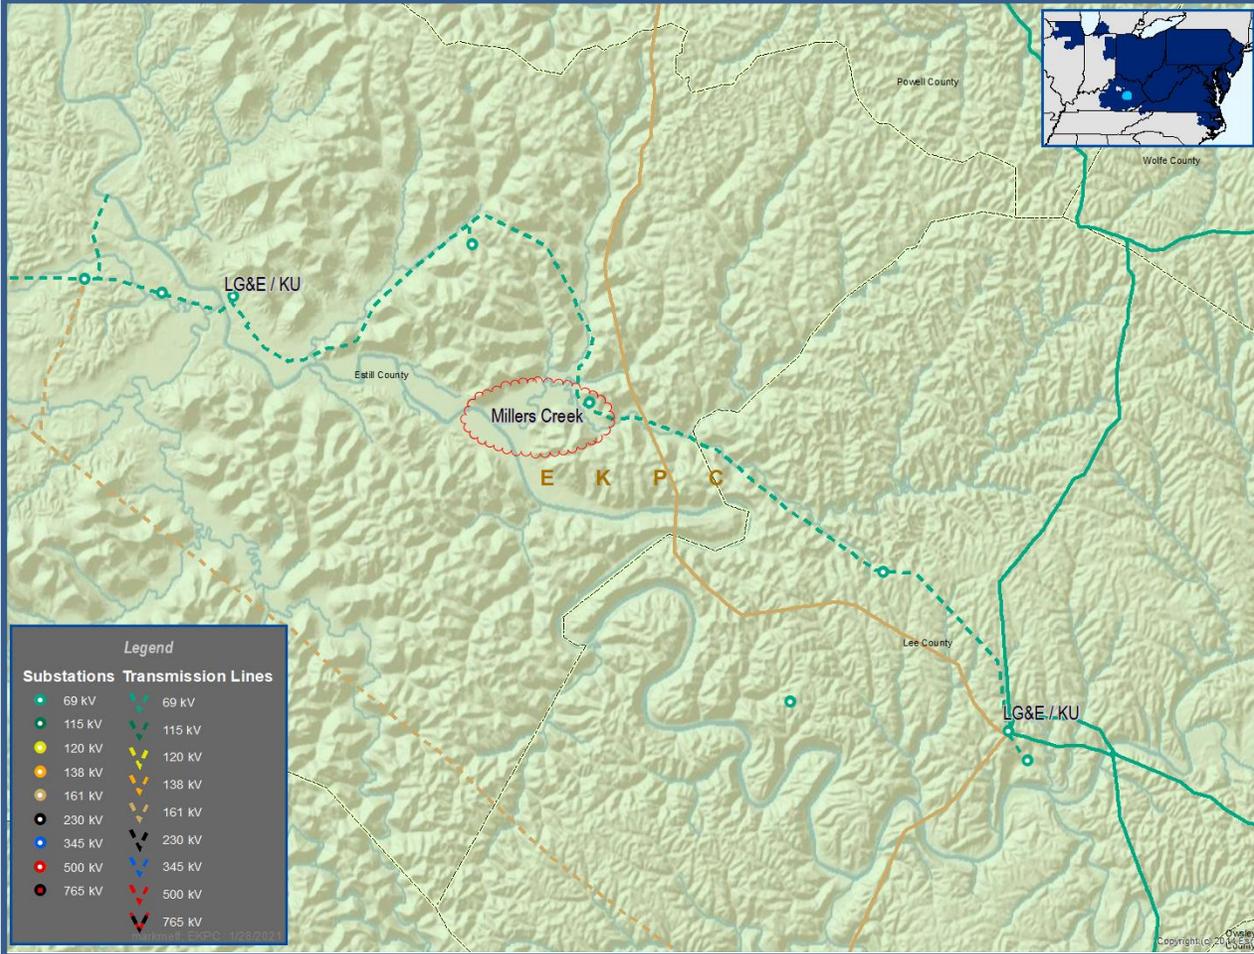
# EKPC Transmission Zone M-3 Process Millers Creek

The Millers Creek substation was built in 1965. It has continued to show up on EKPC’s list of Worst Performing areas for several years, and it is currently the #2 worst performing location. It is served on the LG&E/KU 69 KV transmission line between Beattyville and West Irvine. This substation had 12 transmission related outages for the 2015-2019 period.

The substation has multiple issues related to poor site access, degraded condition, safety, and obsolete design. Degradation issues include failing fence and erosion around the perimeter of the substation. There is an atypical metering structure with no bypass capability making maintenance more difficult. Regulators are under the low bay structure and are difficult to remove in the event of a failure. Regulator bypass switches and energized feeders have spacing and clearance issues and there is no bypass bus.

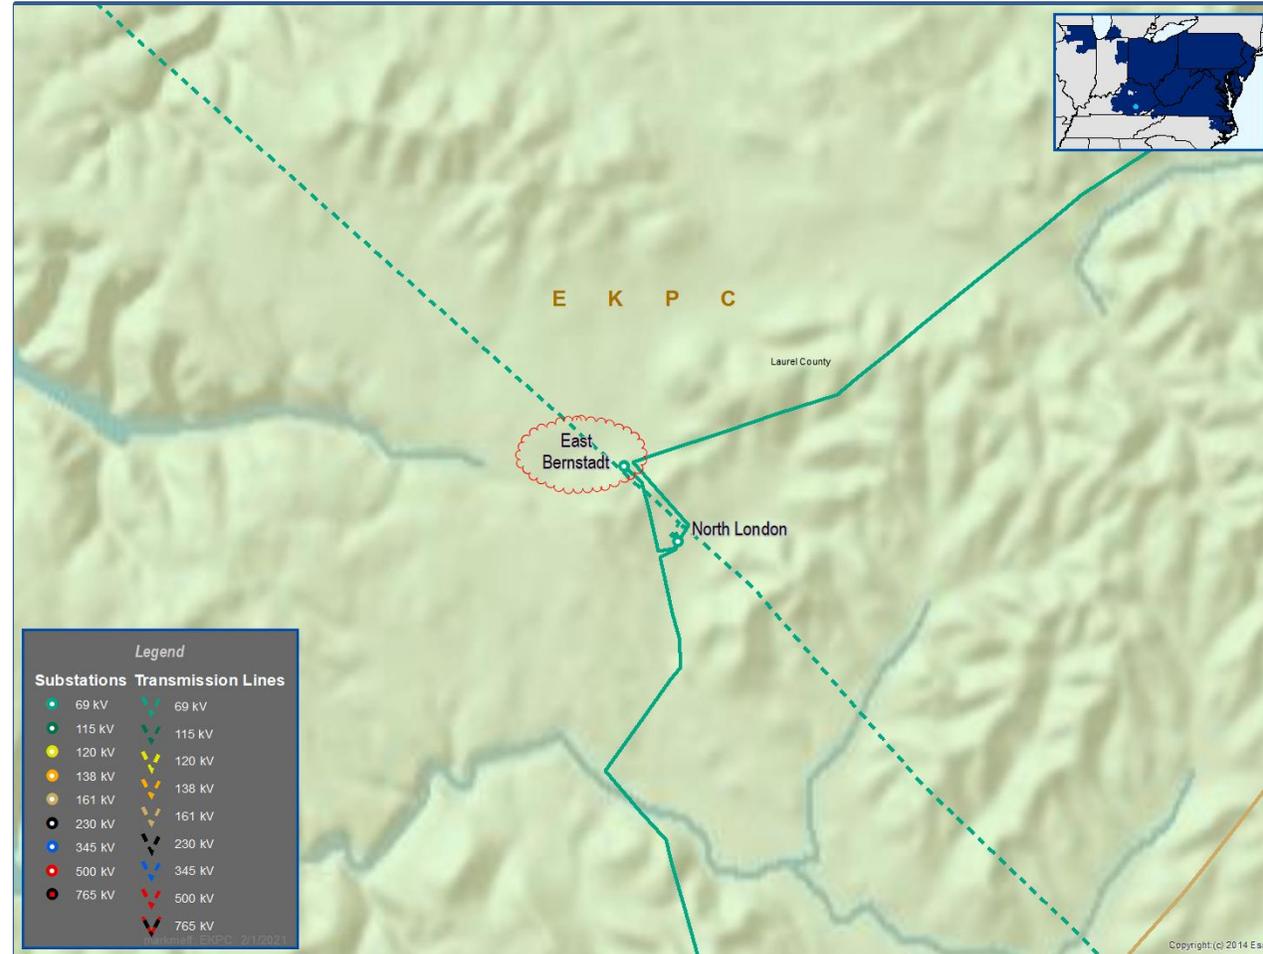
# EKPC Transmission Zone M-3 Process East Bernstadt

Options are being evaluated to address aging condition issues of the East Bernstadt distribution substation. It has been determined that more space is needed to achieve EKPC's standard substation design requirements. EKPC's planning department has been asked to evaluate the ongoing need of the East Bernstadt 16.2 MVAR capacitor bank due to space limitations at the site.

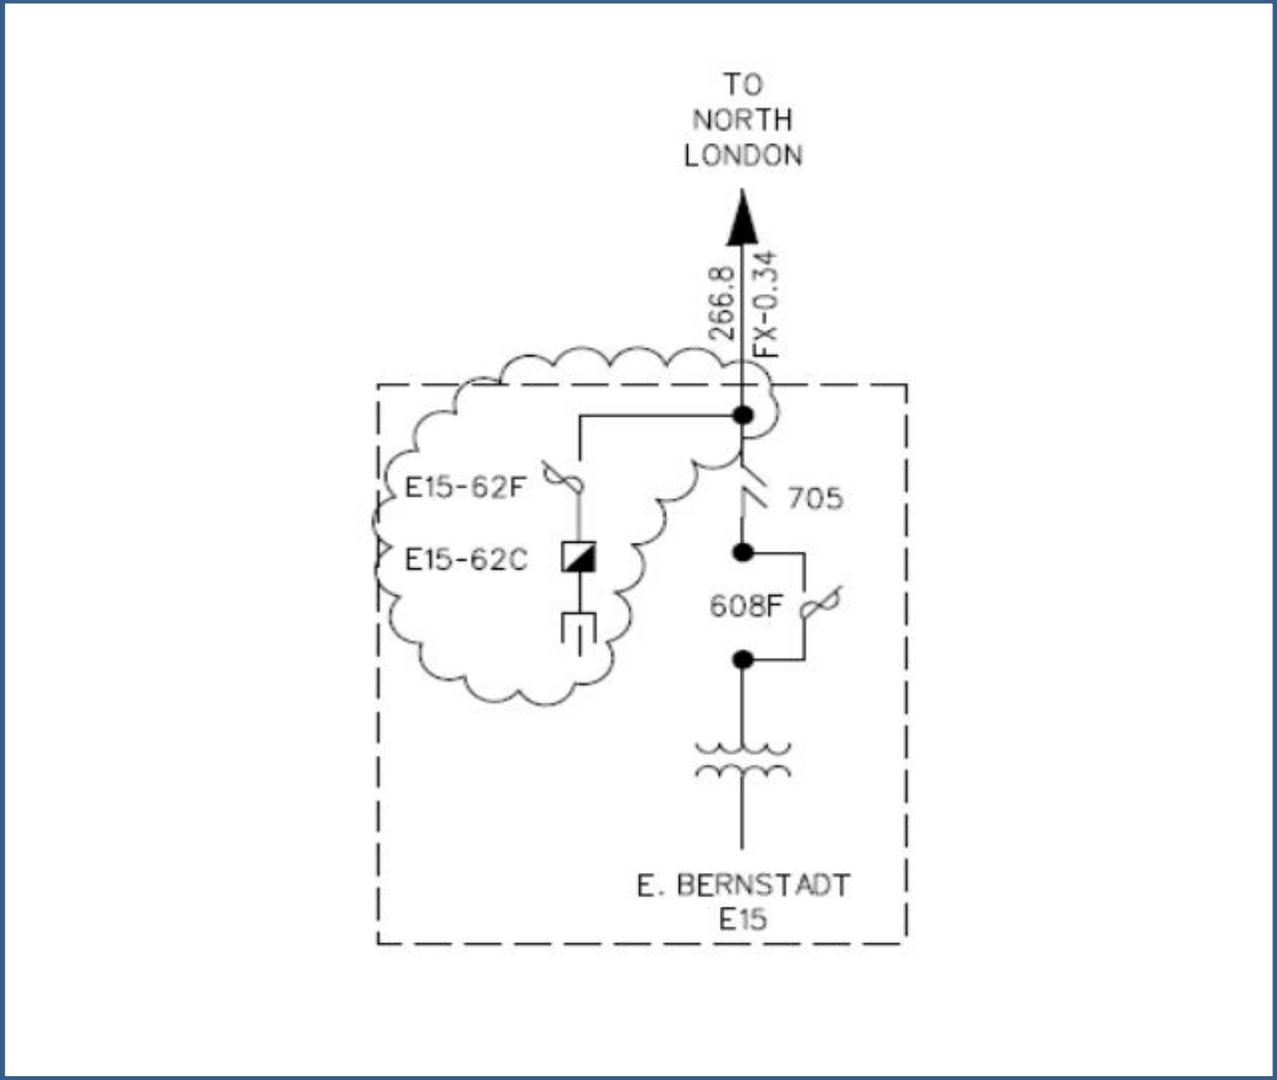
# EKPC Transmission Zone M-3 Process East Bernstadt

It has been determined that the East Bernstadt capacitor bank is no longer needed for voltage support in the area. This will enable the substation to be rebuilt on the existing property where the capacitor bank currently sits. The 16.2 MVAR capacitor bank will be removed during construction.

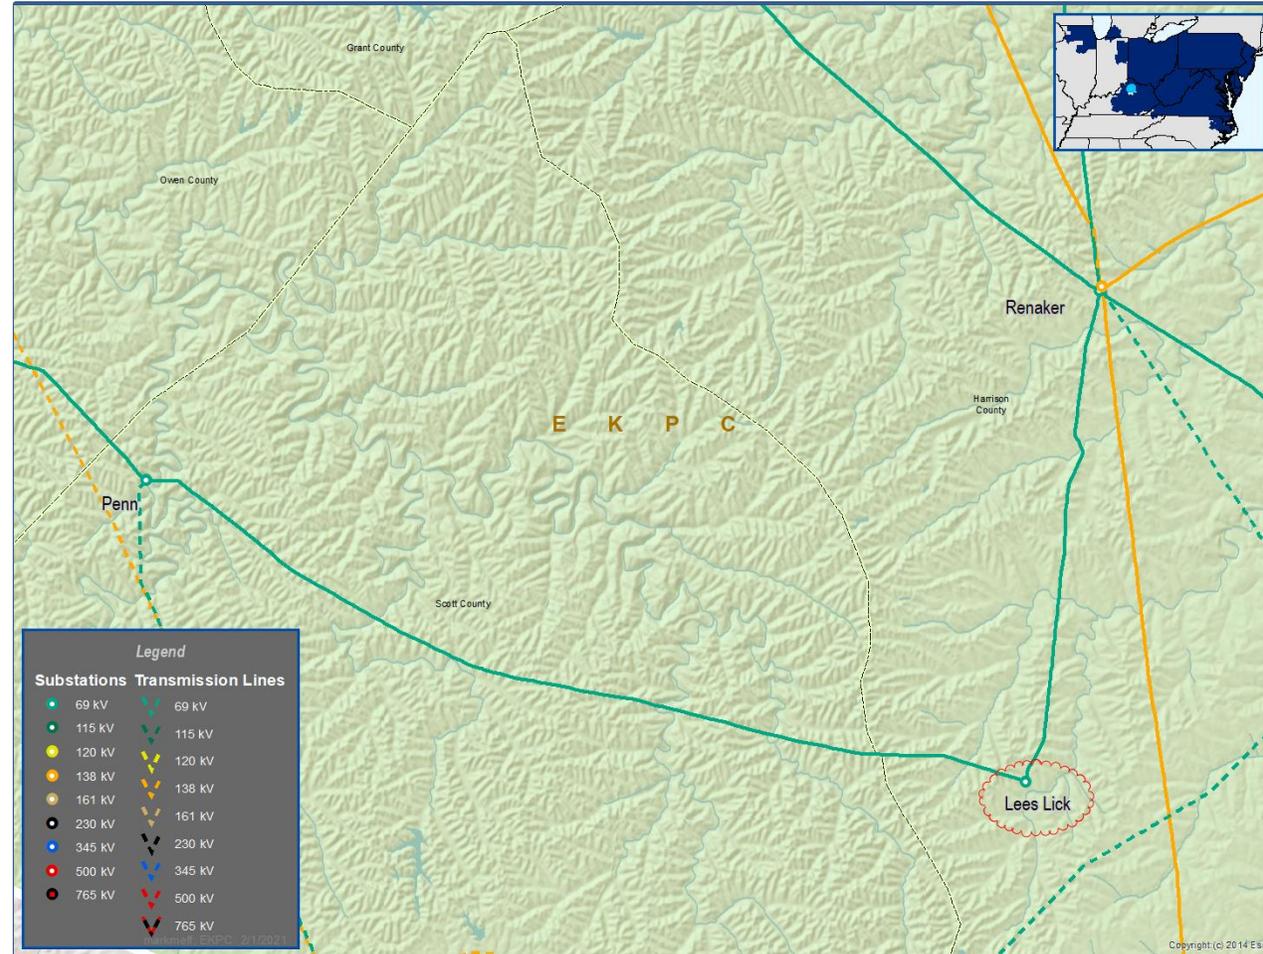
# EKPC Transmission Zone M-3 Process Lees Lick

Options are being evaluated to address aging condition issues of the Lees Lick distribution substation. It has been determined that more space is needed to achieve EKPC's standard substation design requirements. EKPC's planning department has been asked to evaluate the ongoing need of the Lees Lick 10.72 MVAR capacitor bank due to space limitations at the site.

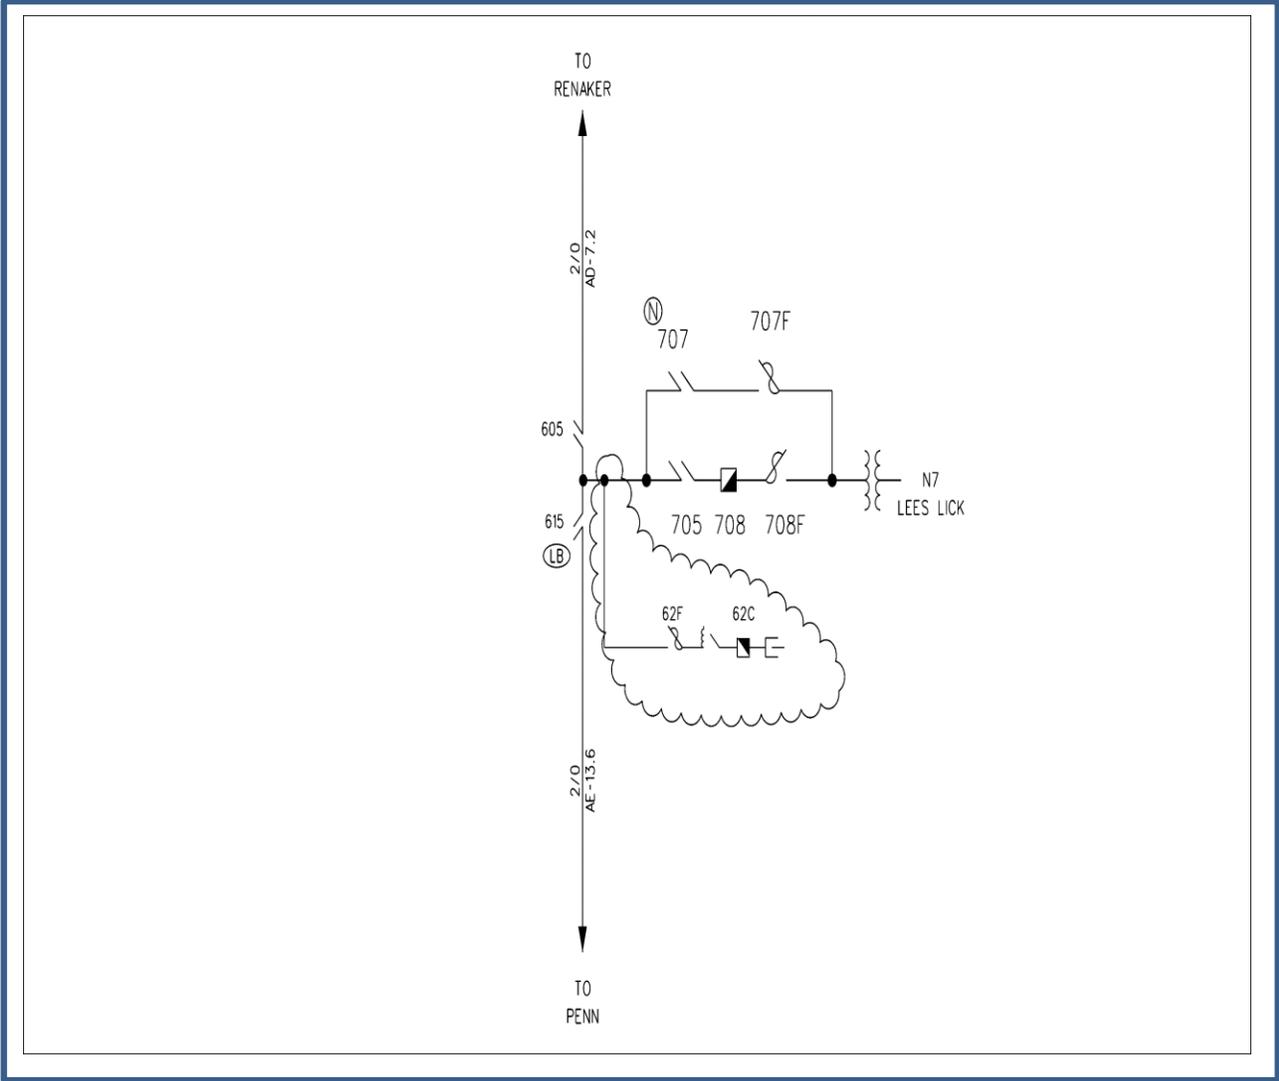
# EKPC Transmission Zone M-3 Process Lees Lick

It has been determined that the Lees Lick capacitor bank is no longer needed for voltage support in the area. This will enable the substation to be rebuilt on the existing property where the capacitor bank currently sits. The 10.72 MVAR capacitor bank will be removed during construction.
