Sub Regional RTEP Committee: Western AEP Supplemental Projects

Sept 16, 2022

AEP Transmission Zone: Supplemental S0350 Cancellation

AEP Transmission Zone: Supplemental New Carlisle, IN

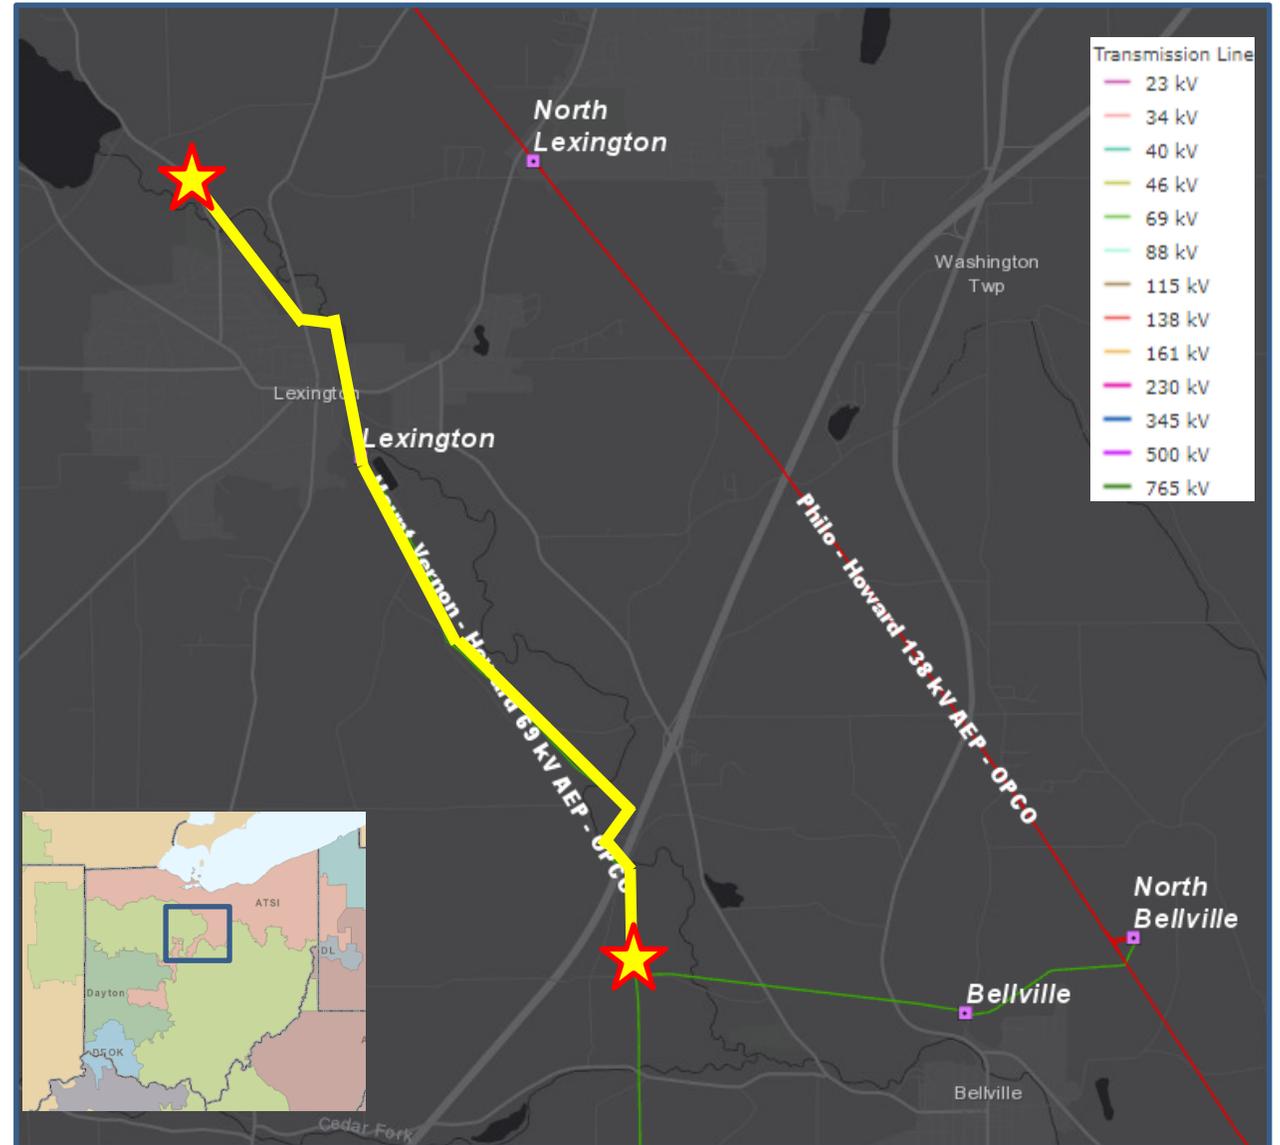
Mount Vernon – Howard 69kV (Structure 487 – 615):

- Length of Line: 5.6 Miles
- Wooden monopole structures with vertical and horizontal insulators, originally installed in 1935
- Conductor Type: #1 COPPER 3 (#1COP)

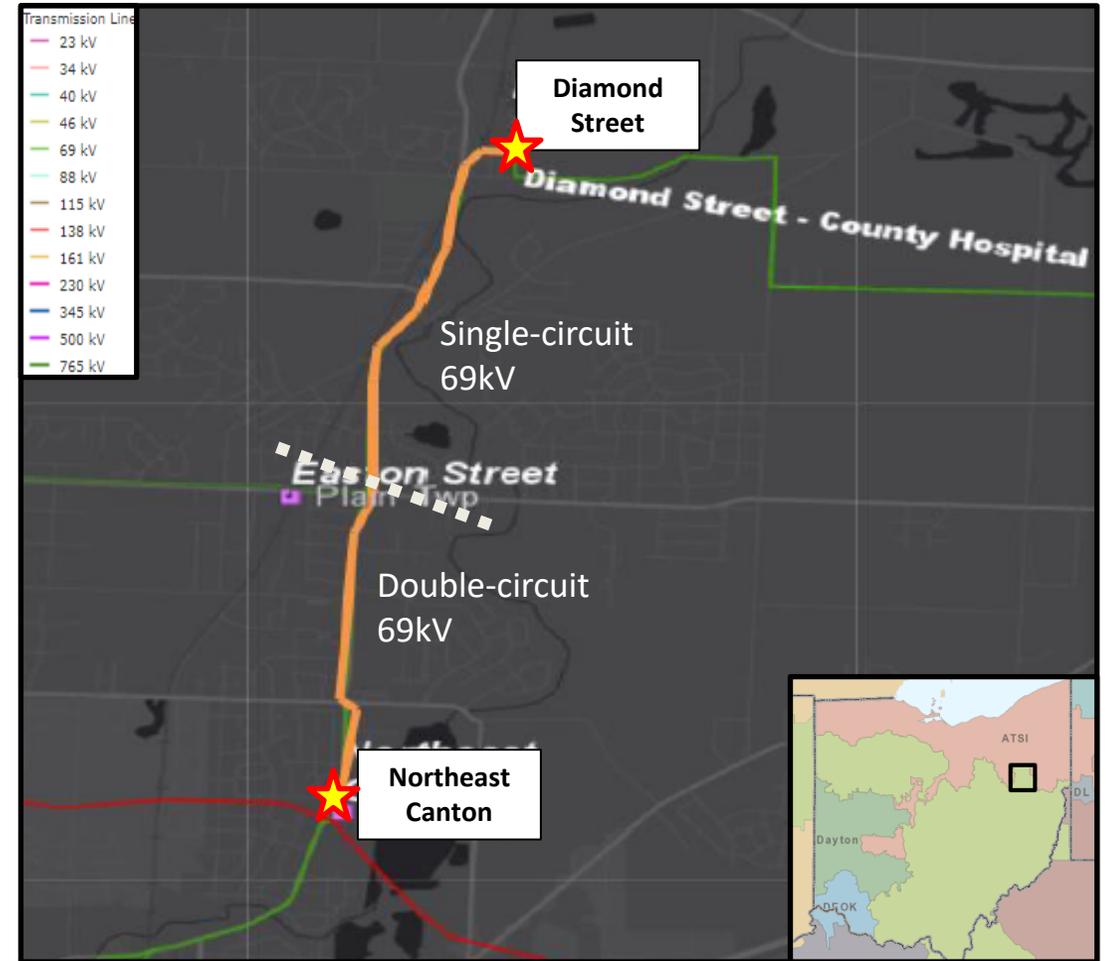
Northeast Canton – Diamond Street 69kV (1954):

- Length of Line: 3.5 Miles (1.6 miles of which is double-circuit with Northeast Canton-Easton Street)
- Total Structure Count: 125
 - Wood: 123
 - 2 from 1940, 53 from 1950s, 37 from 1960s, 17 from 1970s, 11 from 1980's, 1 from 1992

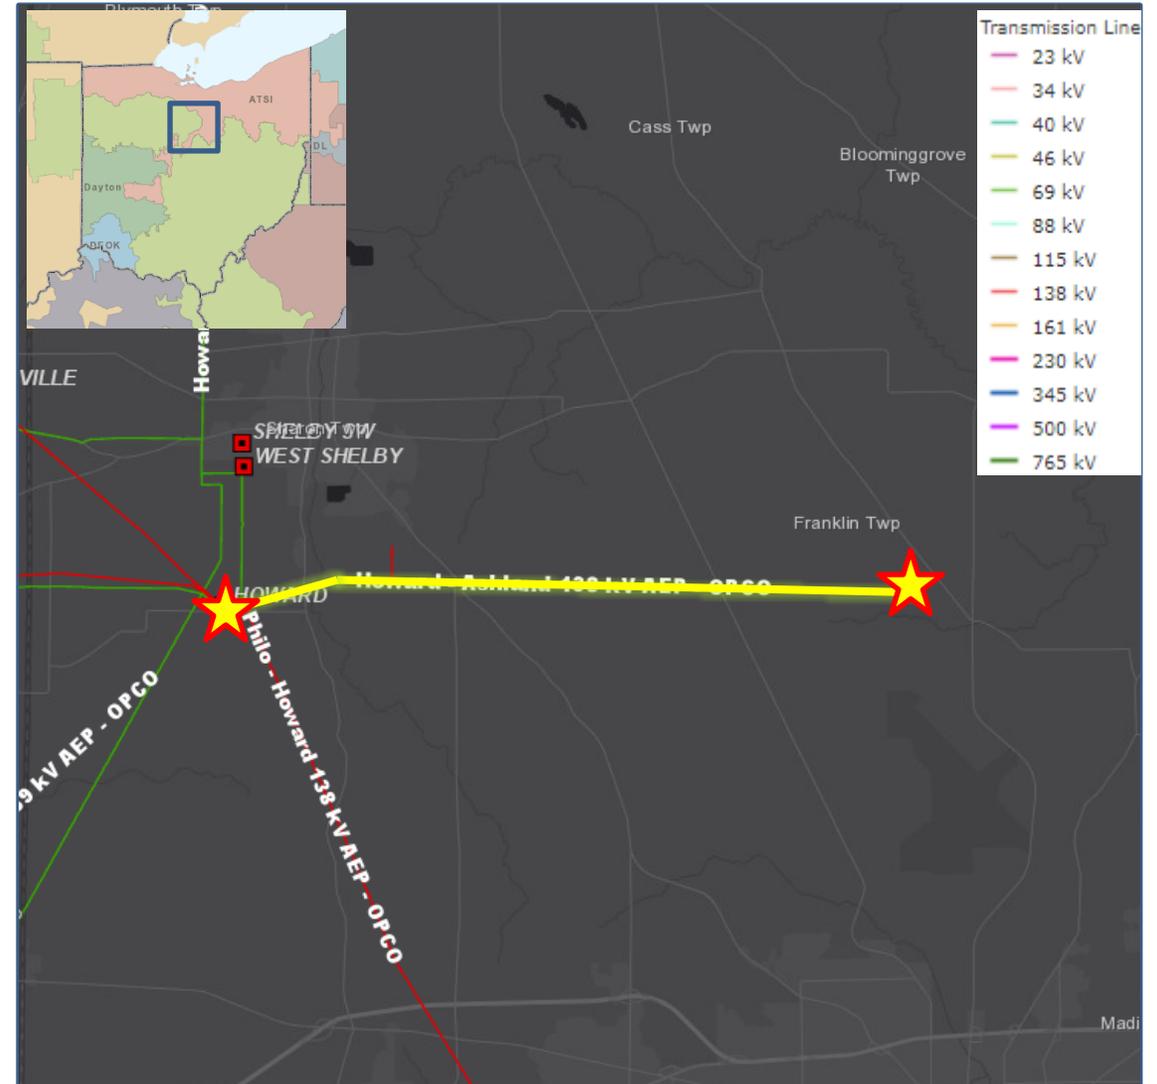
Howard Ashland 138kV (1930):

- Length of Line: 8.09 Miles
- Total Structure Count: 47
- Steel lattice structures with vertical insulators
- Conductor Types: 397,500 CM ACSR 30/7 (Lark)

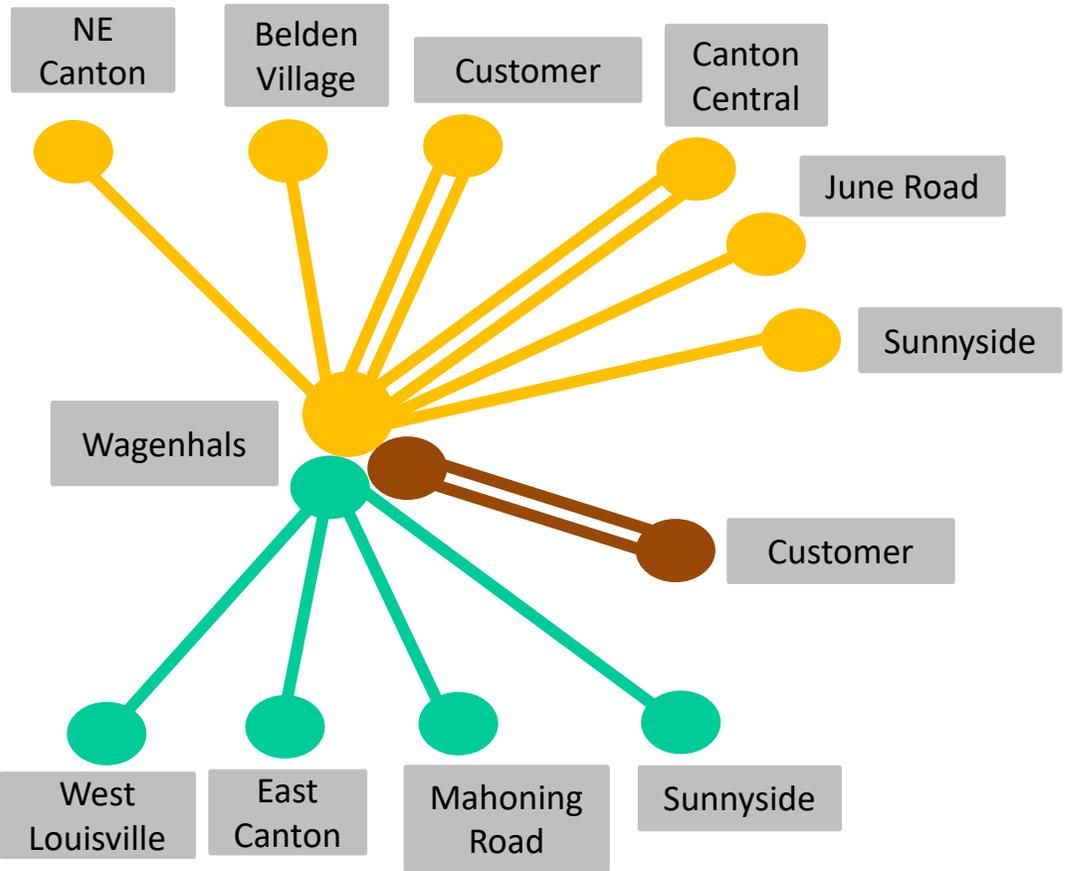
Existing:

Need Number: AEP-2021-OH001
Process Stage: Solution Meeting 10/14/2022

Wagenhals Station: Construct a new Wagenhals 138-69kV station on greenfield property owned by AEP to the south of the existing station. The 138kV portion will be a breaker-and-a-half design, with a total of 17 breakers. The 69kV will be a 5-breaker ring bus. The existing 138-69kV transformer #3 and 138kV cap bank will be transferred, while the 138-69-23kV transformer #2 will be retired. **Estimated Cost: \$27.45 Million**

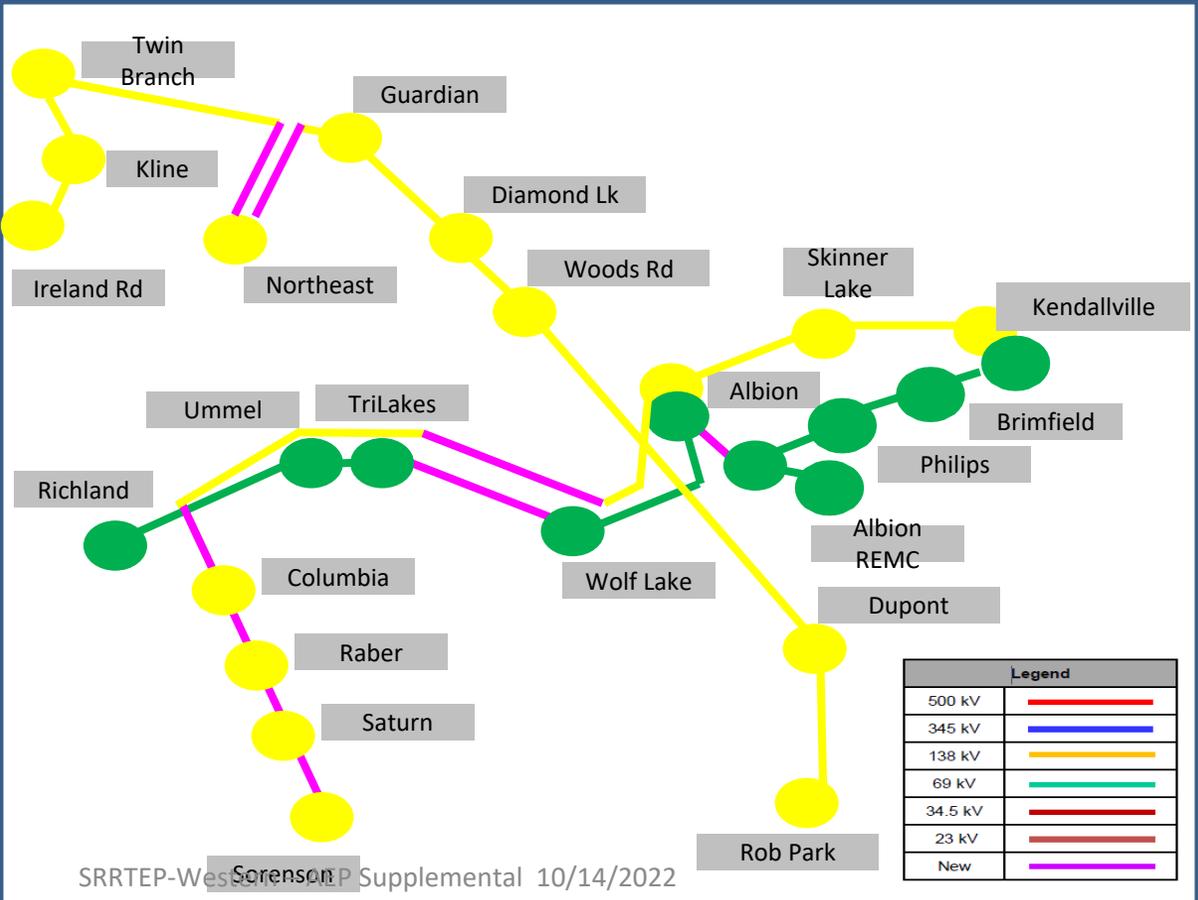
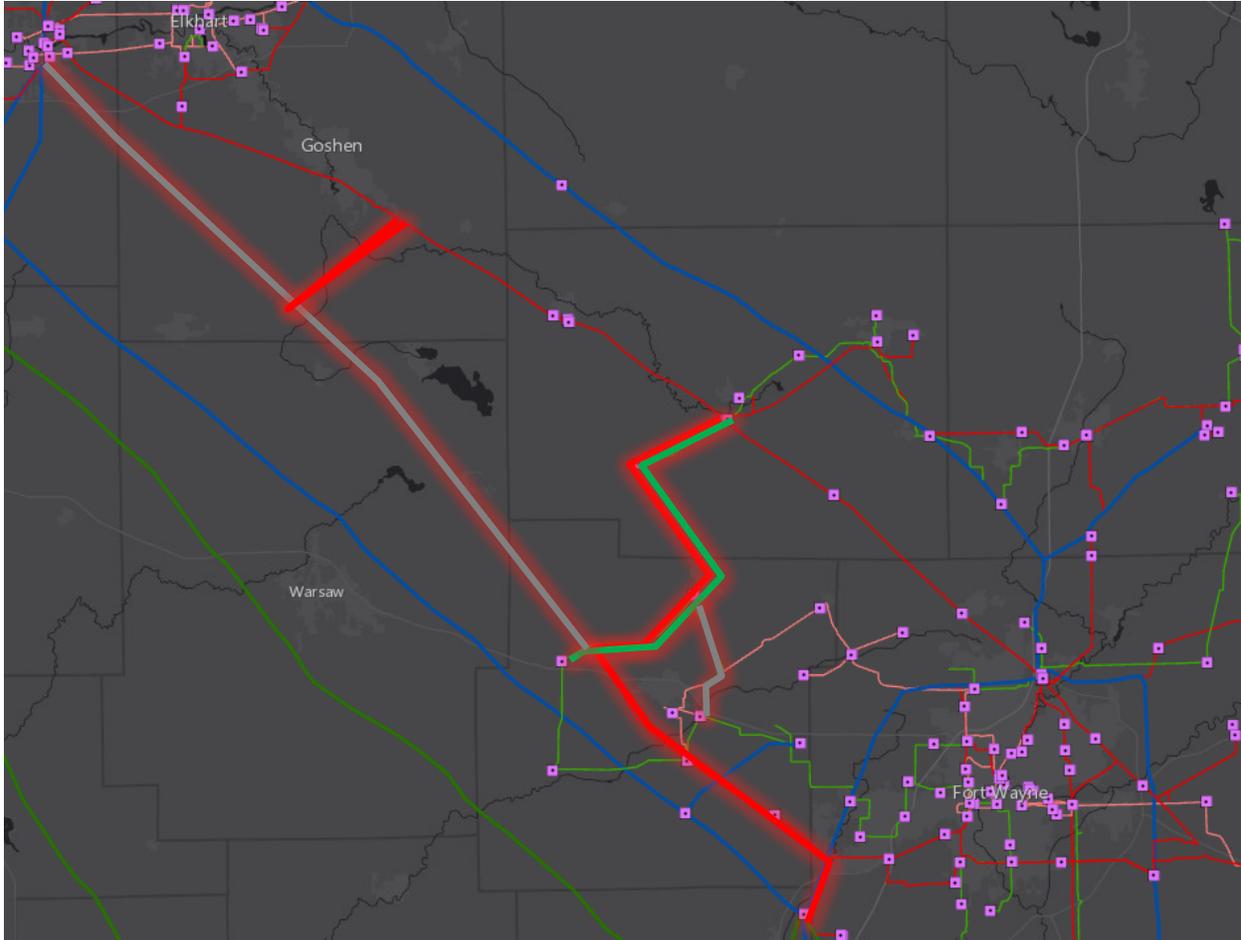
138kV Plan summary

Twin Branch – Sorenson is a 65.1 mile 1940’s line that AEP can retire due to other improvements made in the area and multiple paths on both 138 kV and 345 kV lines. By building Richland – Tri Lakes and Wolf Lake tap to 138kV double circuit standards in phase 1, the network is set up so that in phase 2, AEP will not need to rebuild the full 65.1 miles that exist currently and can instead retire a good portion of it.
