Submission of Supplemental Projects for Inclusion in the Local Plan

AEP Transmission Zone M-3 Process Anguin Station

Need Number: AEP-2018-OH002

Process Stage: Submission of Supplemental Project for inclusion in the Local Plan

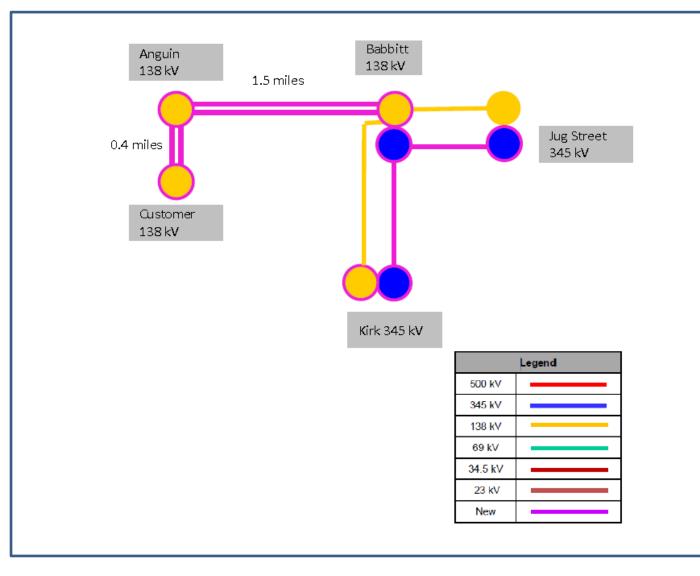
- Construct 2-138 kV circuits (~1.5 miles) from Babbitt Station to a new Anguin Station using 2 bundled 1033 ACSS conductor per circuit. (\$2139.1) Estimated Cost: \$15.2M

- Construct 2-138 kV circuits (~.4 miles) from Anguin Station to a new customer station using 795 ACSS conductor. (S2139.2) Estimated Cost: \$2.5M
- At the existing 138 kV Babbitt Station, install 4-138 kV 4,000A 63kA breakers to accommodate
 the new 138 kV double circuit to Anguin Station, 2-138kV 4,000A 63kA bus tie breakers, a

- Cut into existing Jug Street-Kirk 345kV circuit into a new 345 kV yard at Babbitt Station.
 Relocate Babbitt-Kirk 138kV circuit exit at Babbitt Station. (\$2139.5) Estimated Cost: \$3.3M

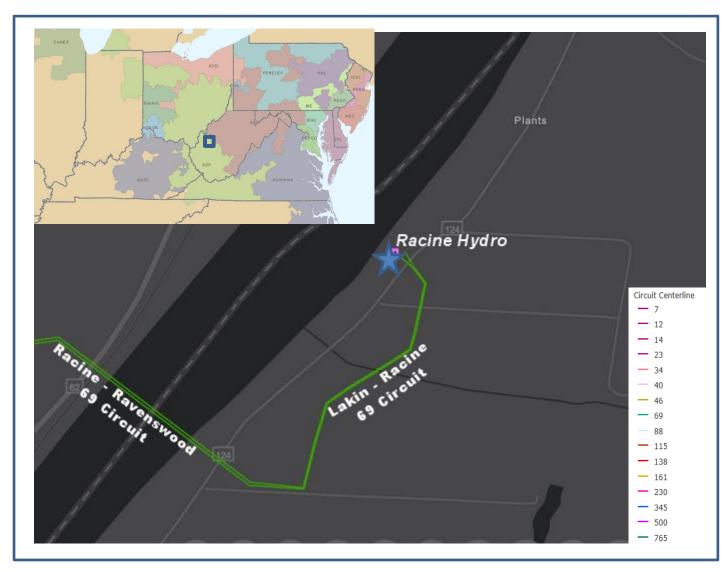
Racine 69 kV circuit breaker B

- CG-48 oil type breakers that was manufactured in 1980.
- Oil breakers are more difficult to maintain as oil spills have the potential to occur during maintenance which can be an environmental and safety hazard.
- Experienced 43 fault operations, exceeding the manufacturer's designed number of fault operations of 10.

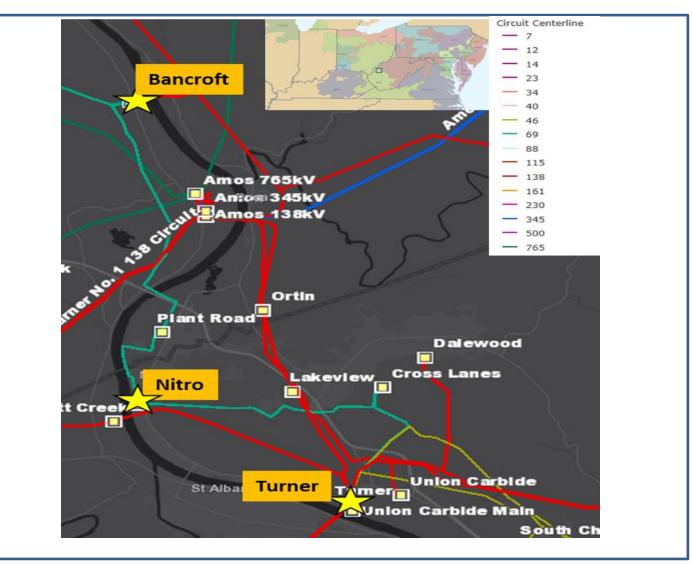
- Turner 46kV CB-O
 - One of only six remaining of the 72EPB-20-12 model on the AEP system.
 - These model types have historically exhibited bad gas leaks, bushing failures, and CT cores getting wet.

- Since 2015, there have been 25 documented malfunction records on this unit in regards to low SF6 gas levels.
- Turner 138/69 kV Bank #5
 - Recently de-rated due to the loss of a cooling pump that cannot be replaced.

- This unit could experience an increasing number of overheating events with the potential to cause damage to internal components
 - Moisture content has been rising for a number of years but more severely over the past 11.

- The rise in moisture content correlates to a significant drop in dielectric strength and rising power factor level for the oil.
 - All three high side bushings are of the Type U design that have extensive manufacturer alerts related to catastrophic failures

Turner Station: Replace 138/69 kV 50 MVA XFR #5 with a new 138/69 kV 90 MVA XFR. Install a new 138 kV 3000 Å 40 kA circuit breaker in the F string. Terminate the new 138/69 kV XFR in the F string. Install a new 138 kV 3000 A 40 kA circuit breaker in the E string and terminate XFR #6 in the E string. Replace grounding bank #7. Replace existing 46 kV 1200 A 20 kA CB-O with a new 69 kV 3000 A 40 kA CB (operated at 46 kV). 138/46 kV XFR #6 will be relocated to accommodate the work at the station. Install DICM and upgrade relaying at the station. (S2165.6) Estimated Cost: \$6.9M

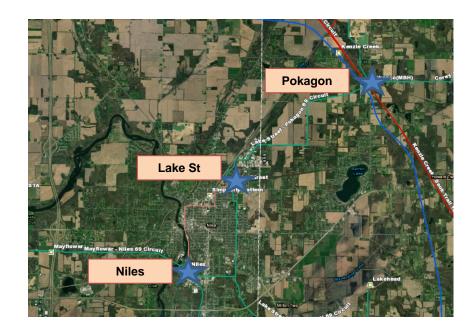
- 1960's wood cross arm construction
- Poor shielding condition
- Lakehead Pumping Tap has open conditions on 30% of structures
- Total open conditions 54

Lake Street - Niles 34.5kV circuit

- 1965 wood pole construction
- Total open conditions 51
- 40% of structures with open conditions
- 97% of line original wood poles
- Wooden cross arm with cap and pin insulator construction
- · No shield wire

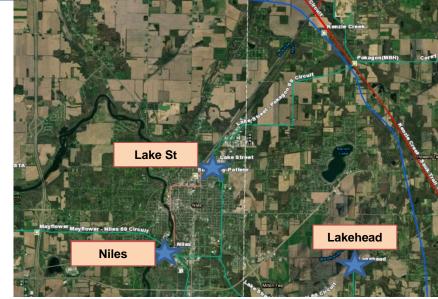
South Bend – Niles 69kV Line (~11.47 Miles)

- 1968 vintage wood pole construction
- Forced Momentary outages: 5
- Forced Permanent outages: 3
- Total structure related open conditions 47
- Unique structure count with open conditions 44
- Insect Damage, Rotten Poles, Broken/Burnt cross-arm, Woodpecker holes, broken/burnt insulators, stolen/broken ground wires, broken guy strain insulators and cracked stub pole.
- More than three in-line sectionalizing MOABS

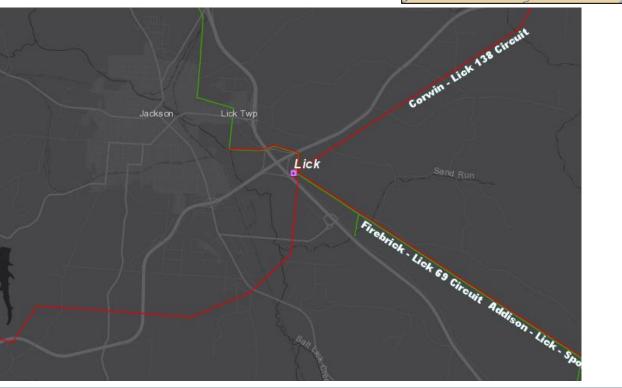
At Lick substation there are six 69 kV circuit breakers with condition issues. CB's 61,62, 65, 66, 67, and 69 are oil type breakers that were manufactured between 1956 - 1967. There is a potential for oil spills during routine maintenance and fault operations. In addition, spare parts are difficult to obtain. The breakers' fault operation counts are as follows: {61-126, 62-11, 65-26, 66-8, 67-19 and 69-4}. For most of these breakers, the number of fault operations exceed the manufacturers recommended number of 10.

There are three 138/69 kV, 18 MVA transformers at Lick. T#1 is a Westinghouse transformer manufactured in 1956. Transformers #2 and #3 are both GE transformers manufactured in 1950. All three transformers have maintenance issues with their LTCs and have significant oil leaks. In addition, loss of two of the transformers can load the remaining transformers tertiary winding above it's rating.

- At Lick station, replace the three existing 138/69-12kV transformers with two 138/12 kV transformers and one 138/69 kV transformer. The 69 kV bus will be rebuilt in the clear within the station due to constructability concerns. Three 69kV 40kA, 3000A CBs will be installed on the low side of transformer and 69 kV line exits. An additional 138kV 40kA, 3000A CB will be added at the station to separate the 138 kV circuits towards the City of Jackson and Don Marquis. (S2154.1) Estimated Cost: \$8.3M
- Relocate the Don Marquis Lick 138 kV circuit associated with the station work at Lick. (S2154.2) Estimated Cost: \$0.7M
- Relocate the Firebrick Lick 69 kV circuit associated with station work at Lick. (S2154.3) Estimated Cost: \$0.8M
- Relocate the Ironman Lick 69 kV circuit associated with station work at Lick. (S2154.4) Estimated Cost: \$0.5M

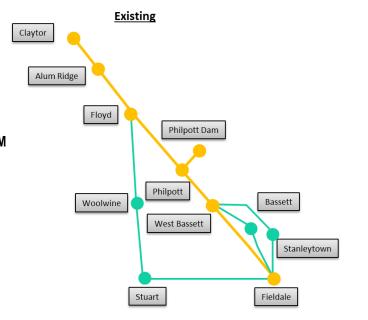
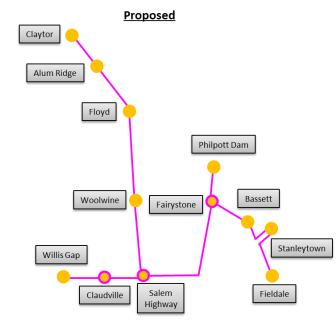
- Remove ~0.34 miles of 138 kV line from Philpott SS-Philpott. (\$2179.17) Estimated Cost: \$0.1M
- Remove ~19 miles of 69 kV line from Fieldale to Stuart. (\$2179.18) Estimated Cost: \$8.3M

- Remove ~7.1 miles of 69 kV line from Fieldale to West Bassett. (S2179.19) Estimated Cost: \$10.1M
- Remove ~6.8 miles of 69 kV line from Fieldale to West Bassett. (\$2179.20) Estimated Cost: \$9.5M

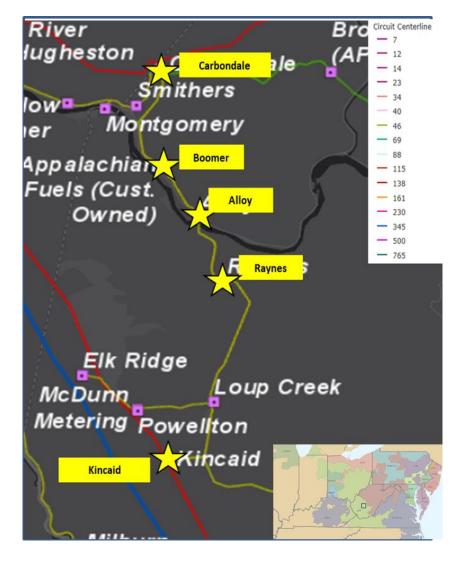
Carbondale 138/69/46 kV Station

- Carbondale 138/69/46 kV TR-1, manufactured in 1972, has experienced a sharp increase in combustible gas concentrations in January 2016.
 - Numerous gasses have remained at elevated levels, including acetylene at IEEE Condition 4 and ethylene at IEEE Condition 2.

- The concentrations present are strongly correlated to electrical discharges of high energy and thermal faults in excess of 700°C.
 - Despite declining moisture levels and improving interfacial tension, oil power factor levels are on the rise, and dielectric strength is declining. This supports contamination in the oil from the high energy discharges and thermal faults.

- The current MOAB/Ground SW configuration on TR-1 creates a fault in the station to signal the remote end breakers to open; this is a known safety hazard in legacy station designs.

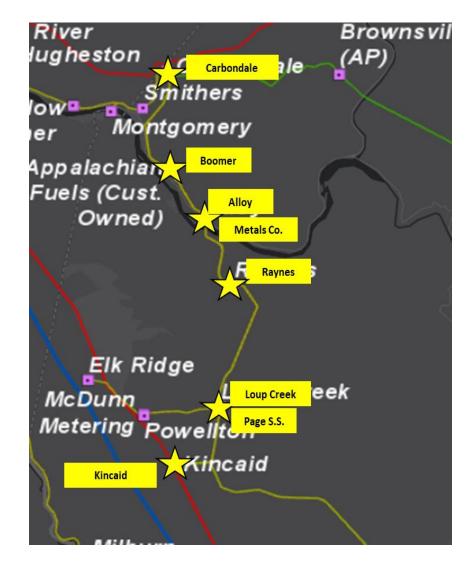
Kincaid 138/69/46 kV Station

- GND TR PH 1-3
 - All three single phase units of GND TR are experiencing similar health deterioration.
 - There are elevated levels of Acetylene at IEEE condition 2 and Carbon Dioxide at IEEE Condition 2 or 3.

- In addition, significantly diminished oil interfacial tension corroborates the frequent overheating events. Sludge has likely developed in the oil from particulate formation during arcing and other fault events. This sludge impairs the natural circulation of oil.

- Moisture levels are on the rise which can lead to diminished dielectric strength over time.
- The current 138 kV MOAB/Ground SW configuration on TR-1 creates a fault in the station to signal the remote end breakers to open; this is a known safety hazard in legacy station designs.

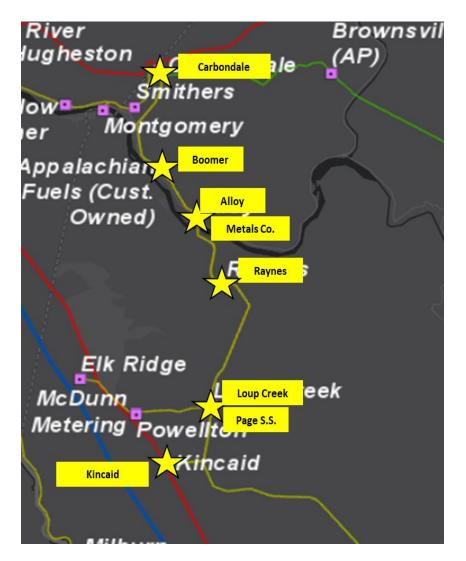
Carbondale Station: Replace existing circuit breakers A and G with two new 69 kV circuit breakers. Replace existing 46 kV circuit breakers B, C and F. Retire 46 kV circuit breaker D. Install two new 138 kV circuit breakers and a high side circuit switcher. Replace existing 138/69/46 kV 115 MVA transformer with a new 138/69/46 kV 130 MVA transformer. 138 kV line work needed to accommodate the station work. (S2177.7) Estimated Trans. Cost: \$11.4M

Kincaid Station: Replace existing circuit breakers A and B with two new 46 kV circuit breakers. Retire circuit breaker J. Replace existing ground transformer bank with a new ground transformer bank. Install a new high side circuit switcher to replace the existing ground sw. MOAB on the high side of the transformer. (S2177.8) Estimated Trans. Cost: \$3.7M

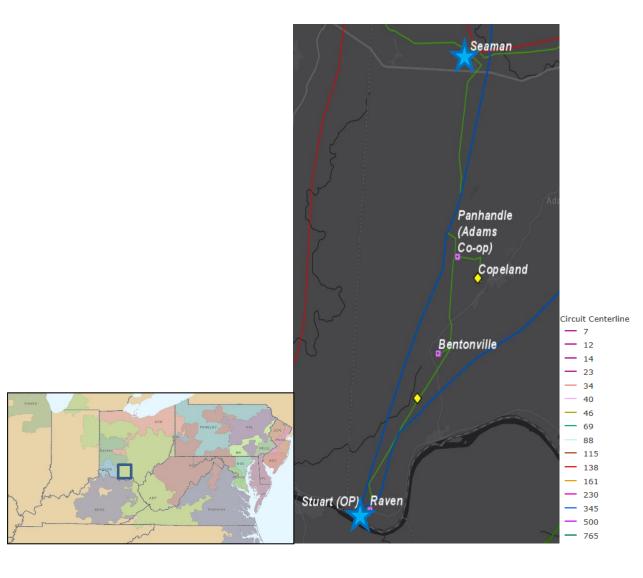
- The existing 28.5 mile, 69 kV line section between Stuart (DP&L/Duke) and Seaman(AEP) was constructed in 1974 using wood pole structures with 636 ACSR conductor. There are 260 open conditions distributed across the 170 structures on this line.
- The Stuart-Seaman 69 kV circuit has experienced over 2.2 million customer minutes of interruption in the past three years: 753,716 for AEP and 1,517,618 for Adams Coop.

Rebuild 22.0 miles of the existing 28.5 mile Stuart-Seaman 69kV circuit with 795 ACSR. Retire approximately 3 miles of the line between West Union and structure 86. 32 of the line's 170 structure were replaced since 2012 and will not be replaced as part of the rebuild (\$2184.1)

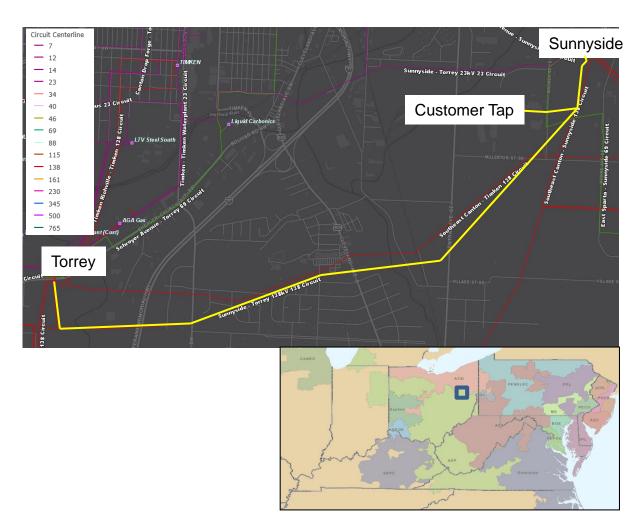
- The majority (94%) of the Sunnyside-Torrey 138 kV line (4.3 miles) is comprised of steel lattice towers built in 1918, with the remaining 6%, dating back to 1954.
- The conductor is original vintage (1918), consisting of 6-wired 200 MCM copper & 250 MCM copper.
- Note that the 0.3-mile customer tap was built in 2007 and is in adequate condition.

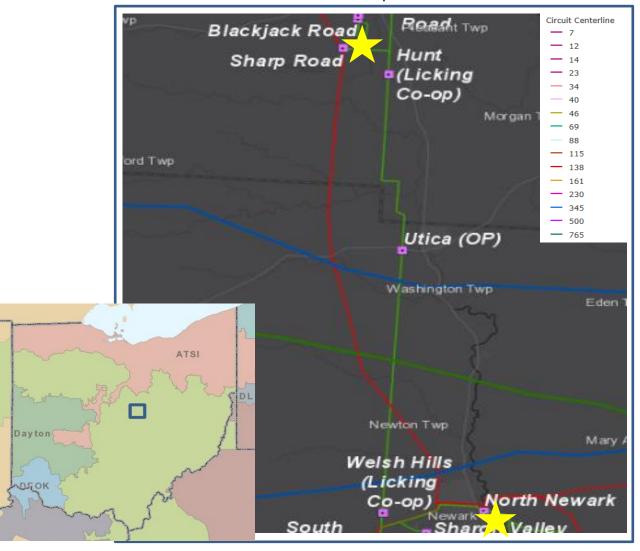
North Newark – Sharp Road 138kV (vintage 1951)

- Length: 19.38 Miles
- Original Construction Type: Wood Pole
- Original Conductor Type: 477 KCM Hawk
- Number of open conditions: 68
 - Open conditions include: Burnt insulators, insect damage, pole rot, woodpecker damage

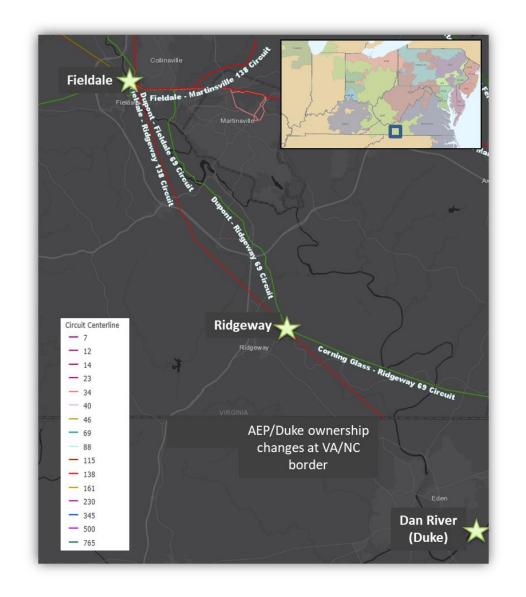
- Fieldale-Ridgeway 138 kV Circuit (10.3 mi.)
- 1949 wood H-Frame construction
- 58 Type A open conditions on 35 unique structures (51% of all structures on circuit)
- From 2015-2018, a total of 4 permanent outages resulting in 241,094 customer minutes of interruption
- Ridgeway-Dan River 138 kV Circuit (4.5 mi.)
- 1949 wood H-Frame construction
- 40 Type A open conditions on 23 unique structures (68% of all structures on circuit (owned by AEP))
- From 2015-2018, a total of 3 permanent outages occurred

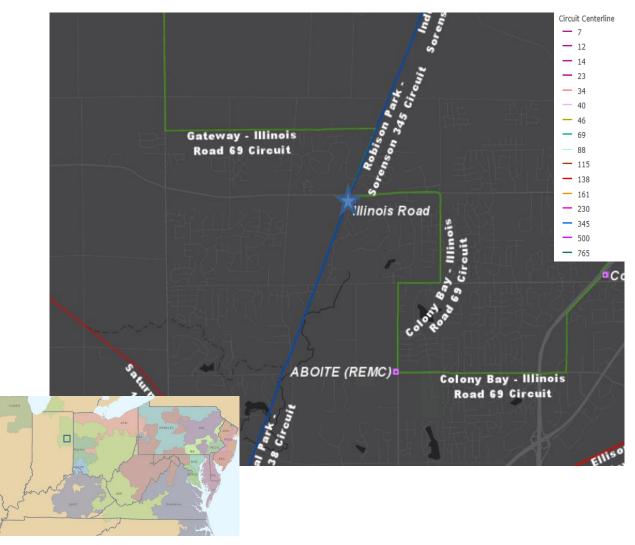
Illinois Road 138kV station

- Breakers A & B 69kV
 - 1969 and 1970 vintage Oil breakers
 - Fault Operations: A(23) & B(67) Recommended(10)
 - Oil filled breakers have much more maintenance required due to oil handling that their modern, vacuum counterparts do not require. Finding spare parts for these units is difficult or impossible, and these models are no longer vendor supported

Replace 69kV CB's A and B and add a low side 69kV CB. Add 2 138kV CB's on the line exits.

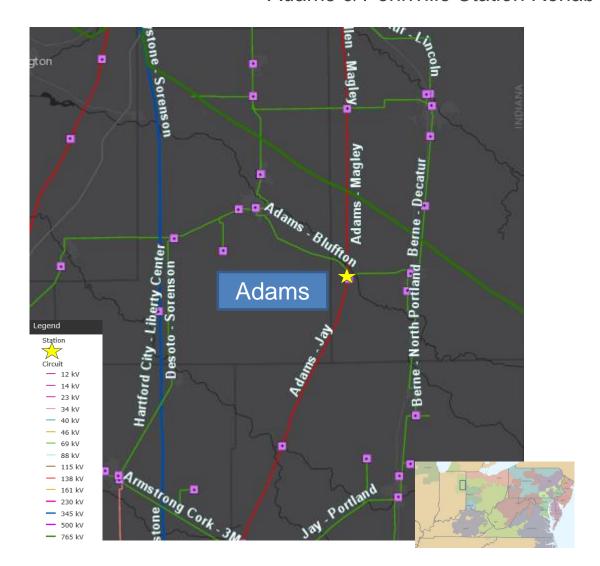
69kV Circuit Breaker D

- Vintage 1966 Oil filled McGraw Edison CF type breaker
- Last oil breaker at Adams station
- Oil filled breakers have much more maintenance required due to oil handling that their modern, vacuum counterparts do not require
- Spare parts are not available and these models are no longer vendor supported
- Fault operations (10) Manufacturers recommended maximum (10)

Rebuild the high side of Adams 138/69kV station as a 3 breaker ring bus, re-using the existing breaker "C," and replace 69kV Breaker "D"

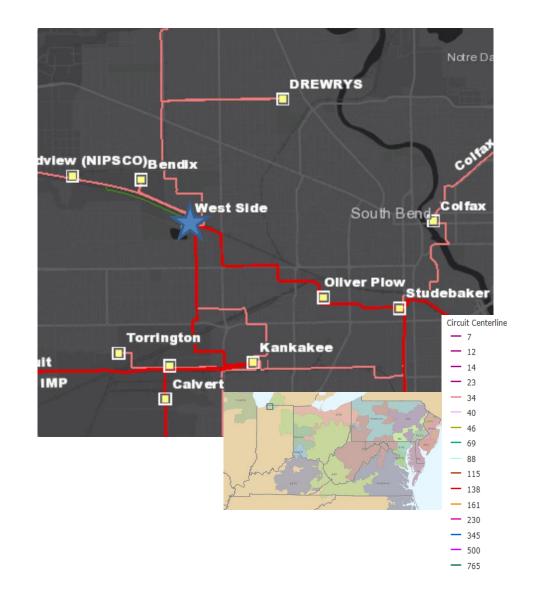
West Side 138kV Station

- Three terminal line
 - Three-terminal lines are very challenging to protect/coordinate and misoperation or switching error become much more significant.
- Bus Tie Switch between the distribution transformers
 - Bus Tie Switch when operated without de-energizing the whole bus jeopardizes the Bus Differential Protection.
 - With no Bus Differential Protection the correct interrupting device wouldn't operate during fault scenarios, this can be dangerous for people working in the station.

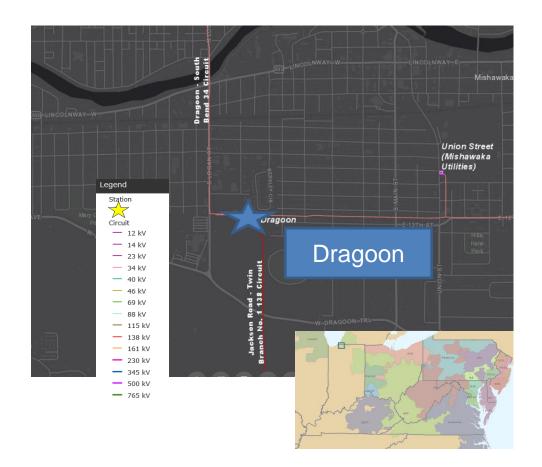
Dragoon Station:

- The 34.5 kV Circuit Breakers A, C and D at Dragoon Station are GE 'FK' oil-filled breaker manufactured in 1968
- 17, 51 and 9 fault operations (manufacturer recommendation of 10)
- Oil filled Breakers without oil containment
- The breakers have the following documented conditions:
 - Bushing problems
 - · Unavailability of spare parts
 - · Fault operations count
 - · High moisture readings
- · Oil spills are frequent with failures and routine maintenance which is also an environmental hazard

At Dragoon Station, replace 3-69kV breakers A, C & D.

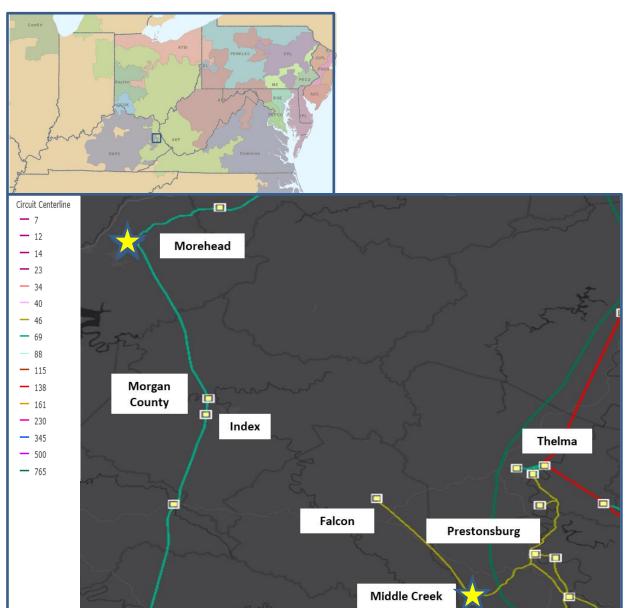
From 2013-2018 the Falcon –Prestonsburg 46 kV circuit (~ 23 miles) has experienced 19 momentary and permanent outages. Over the last three years the circuit has experienced 1.77 million customer minutes of interruption. The ~14.5 mile 46 kV line section between Falcon and Middle Creek has 84 category A open conditions associated with the structures that make up the line. These conditions include damaged/rotted poles and damaged guy wires, cross arms. The majority of this line utilizes 1950s wood structures and 3/0 ACSR conductor. The ~8.5 mile 46 kV line section between Middle Creek and Prestonsburg has 27 category A open conditions associated with the structures that make up the line. These conditions include damaged/rotted poles and damaged guy wires, cross arms. About half the structures that make up the line are 1940s wood structures with the majority of the line utilizing 1/0 Cu. conductor.

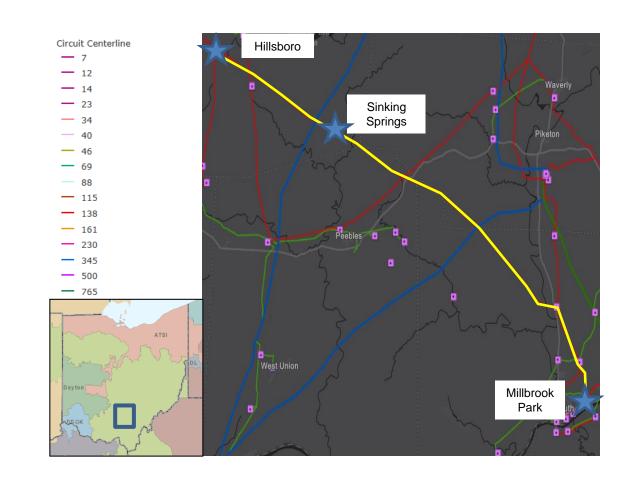
- The 1943 Hillsboro Millbrook Park 138 kV circuit (~52 miles) is wood pole construction and has 1,342 open conditions.
- The majority (93%) of the original conductor (vintage 1944 & 1948) is 477 MCM (26/7) ACSR and is still in-service.
- Half of the wood pole structures from the 1940's are still in-service; the remaining are a mixture from 1960's 1980's.
- There are additional concerns with the shielding, grounding, and hardware along this 52 mile long line.
- Sinking Springs is in a remote part of AEP's service territory making manual switching difficult.
- Originally installed in 1942-1943 timeframe. 98% of the line is on wood structures.
- Age Profile: 53% from 1940's; 4.4% from 1960's; 13% from 1970's; 27% from 1980's; 2.6% from 2000's

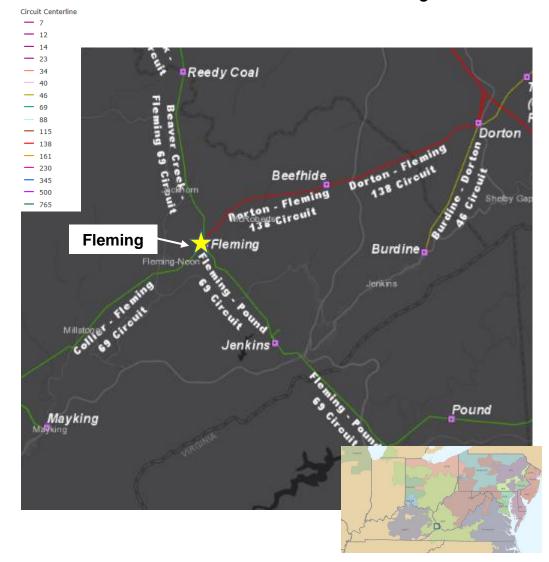
AEP Transmission Zone M-3 Process Fleming Station

- 138/69 kV Transformer #1
 - 1984 vintage transformer.
 - Shows signs of dielectric breakdown (insulation), accessory damage (bushings), and short circuit breakdown (due to through faults).

- Reports from the field show active oil leaks from the gaskets and slight leaks from the unit's welds.
 - Utilizes a ground switch MOAB scheme as part of the high side transformer protection.

- 69/12 kV Transformer #3
 - 1979 vintage transformer.
 - Shows signs of dielectric breakdown (insulation), accessory damage (bushings), and short circuit breakdown (due to through faults).

- 69 kV Circuit Breakers B. E. and F.
 - CF-48 type oil breakers. (1965, 1968, and 1967 vintage)
 - These are oil breakers that are difficult to maintain due to the required oil handling. There is an increased potential
 for oil spills during routine maintenance and failures with these types of breakers.

- Other drivers include damage to bushings and an excessive number of fault operations exceeding the manufacturers recommendations.
 - Have experienced 114, 26, and 68 fault operations respectively. The manufacturer's recommendation for this type of breaker is 10.

- This circuit breaker model family has experienced numerous documented mechanism bearing issues and failures
 within the AEP population. CBs B & F have had malfunction records indicating a failure to properly latch during
 operation.

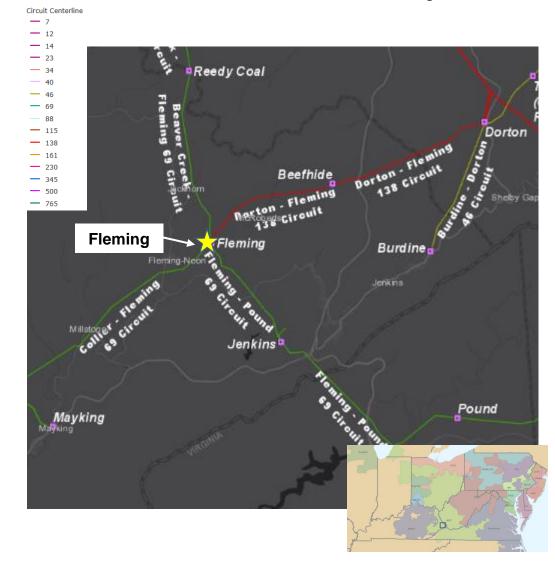
AEP Transmission Zone M-3 Process Fleming Station

- Rebuild Fleming station in the clear
- Replace 138/69kV Fleming Transformer #1 with 138/69kV 130 MVA transformer with high side 138 kV CB
- Install a 5 breaker 69 kV ring bus on the low side of the transformer, replace 69 kV circuit switcher AA, replace 69/12kV transformer #3 with 69/12kV 30 MVA transformer, Replace 12 kV CB A and D. Retire existing Fleming substation.

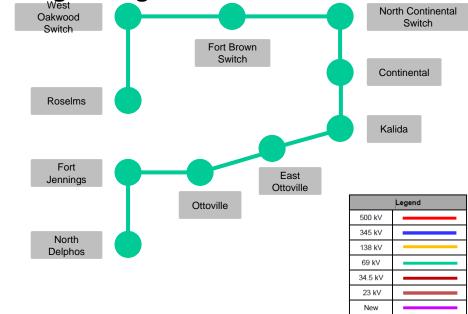
Existing Configuration:

Continental – Roselms 69 kV is a 18 mi radial circuit serving ~10.6 MVA load. The customers served from this radial line have experienced 2.1 million customer minutes of interruptions over last 5 years. These radial loads are not automatically transferable. Any maintenance on this line results in outages to multiple stations.

Majority of the line has 4/0 ACSR conductor with a 2 mi section with 795 ACSR. This circuit has 89 open conditions. Most of the 258 structures on this circuit are 1960s and 1970s wood pole vintage with rotting issues.

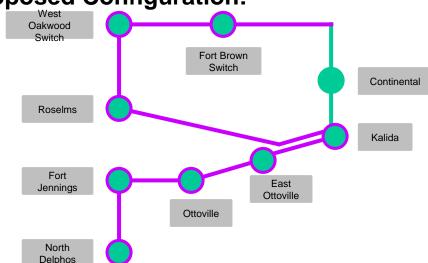
Proposed Configuration:

- At Fort Jennings, replace hard tap with a three way 69kV, 1200 A phase-over-phase switch, with sectionalizing capability. (S2215.13) Estimated Cost: \$0.6M

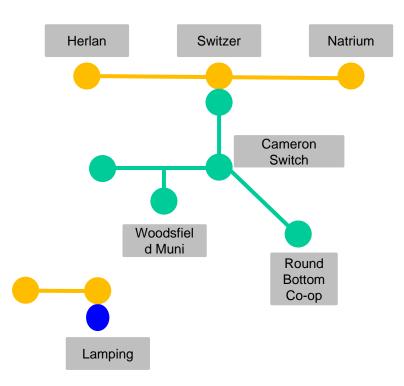
Existing:

Ancillary Benefits: Improved reliability for the 3 wholesale customer stations served from the 69kV circuit; increased ability for AEP to maintain the existing 69kV transmission line and Switzer station equipment (without dropping customers).

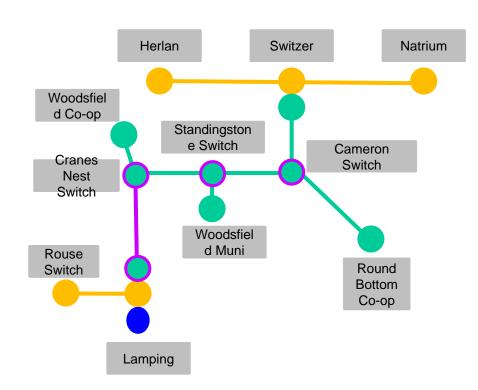
Proposed:

At the 138kV remote-end of Natrium, replace the line protection relays to coordinate with the upgrade at Switzer. (**\$2216.7**) **Estimated Cost: \$0.6M**

Modify the existing Switzer-Woodsfield 69kV transmission line on each side of the switches due to the switch installation. (S2216.8) Estimated Cost: \$1.9M

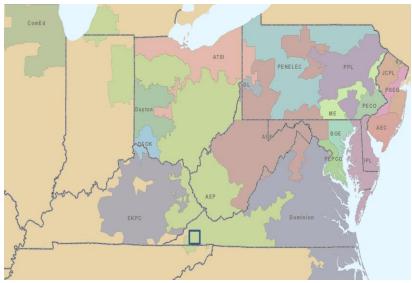
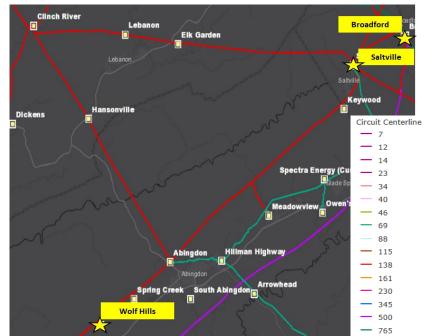
AEP Transmission Zone M-3 Process Saltville – Kingsport Rebuild

- Additional Info: Insulator & Hardware Corrosion:
 - Section Loss: The connecting elements including the tower attachment hole and the insulator hook have experienced serious section loss due to corrosion and wear. This loss of metal cross-section significantly reduces the capacity of the connection

- Corrosion: The insulator caps and connecting hardware have experienced heavy to complete loss of galvanizing.
 When the protective galvanized coating is gone or significantly compromised the bare steel corrodes at an accelerated rate

- Tower members with corrosion and damage. Lattice tower structures have little structural redundancy. A failure of
 one member of the structure will impact the integrity of the structure and may cause the entire tower to collapse.

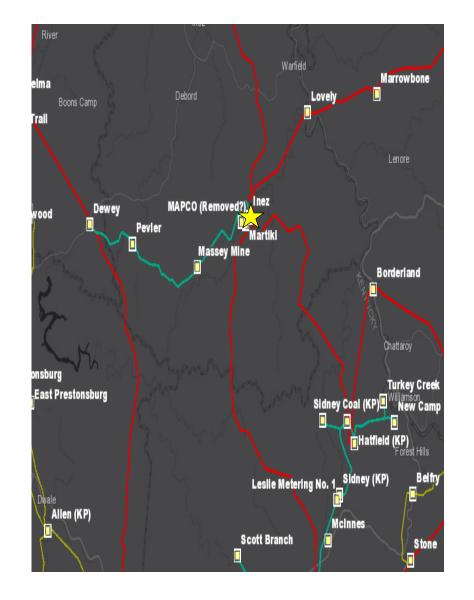
Capacitor switchers 'BB' and 'CC' at Inez station are Mark V model which no longer support modern relaying packages. Mark V's have been historically prone to mechanism failures and are being replaced system wide where possible. S&C circuit switcher 'AA' at Inez station is an S&C 2030 type with no gas monitor.

The Inez 138 kV yard was designed as a breaker and a half station, but the 'B' string was never completed leaving dissimilar zones of protection between the #1 bus and 20+ mile Inez to Johns Creek 138 kV circuit. Dissimilar zones of protection also exist between the 138 kV bus #2, 138/69 kV transformer #1, and the 138 kV circuit to the Martiki coal service point.

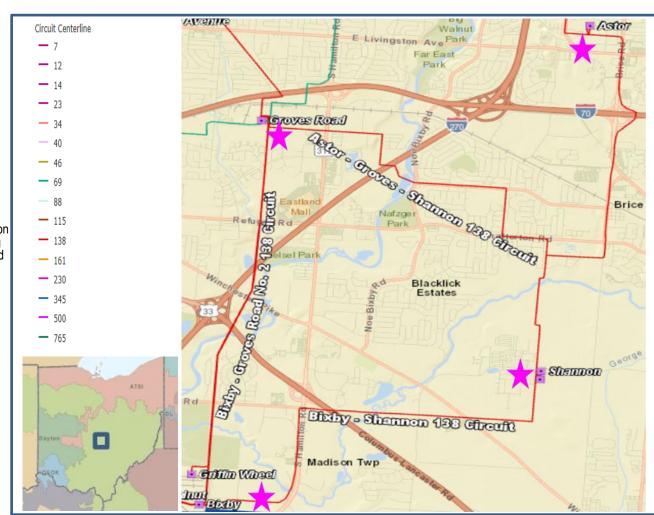
A study of the current physical loading capability of the structures along the Astor-Shannon-Groves & Shannon
 - Bixby 138 kV circuits revealed that many of the poles are currently overloaded under NESC Heavy Loading Conditions. Additionally, the line structures are unable to handle the addition of telecom fiber, which is needed to improve communications in this area.

- 36% of poles on the Astor-Bixby 138 kV circuit show overloading.
- 29% of poles on the Bixby Shannon 138 kV circuit show overloading.
- 20% of the poles on the Shannon Refugee 138 kV circuit show overloading.
- 58% of poles on the Refugee (Future) Brice 138 kV circuit show overloading.
- 35% of poles on the (Future) Brice Astor 138kV circuit show overloading.
- Primarily 1952 wood poles (57% of total line)
- Conductor is all from 1952
- 43 (out of 155) structures on the circuit have at least 1 open condition (28%), with a total count of 63 open conditions

- No outage history (0 CMI/CI)
- The Astor-Groves-Shannon 138 kV circuit is a three-terminal line, which limits sectionalizing and can cause mis-operations and over tripping.
- Astor 138 kV Station has ground switch MOAB's on both 138/13 kV transformers. Ground switch MOABs
 cause intentional high side faults, which can damage nearby equipment.

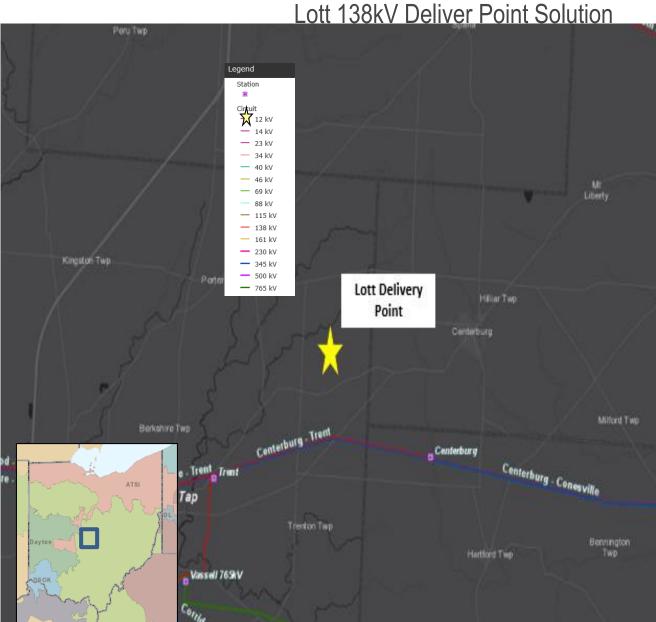
- Buckeye Power, on behalf of Consolidated Electric Cooperative, has requested transmission service in Delaware County west of Centerburg, Ohio.
- Consolidated Electric Cooperative customers are currently connected to a radial 34.5 kV distribution line from AEP Ohio's Trent station.
- The delivery point has consistently been identified as having poor reliability by Buckeye.
- Consolidated Electric Cooperative has reported approximately 700 thousand customer-outage minutes (CMI) over a three year period (2015-2017).

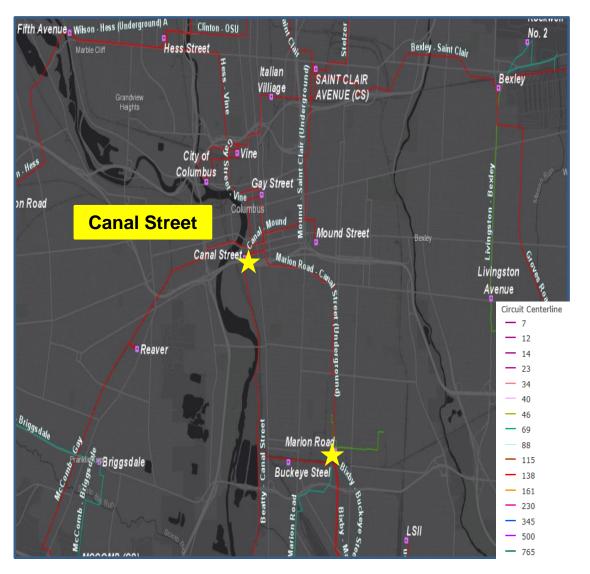
Canal Street - Marion Road 138 kV Underground Circuit

- Ohio Department of Transportation (ODOT) has requested that approximately 1500 feet of the existing Canal – Marion 138 kV underground circuit be relocated as part of a planned Interstate improvement project.
- The existing Canal Marion 138 kV underground circuit is approximately 3.8 miles long and was originally installed in the 1950's.
- The circuit utilizes an underground oil-filled pipe type cable design. Oil-filled pipe type underground cables come with several challenges/risks in densely populated urban areas. Lead times for replacement/repairs from the remaining single vendor can be 6 months to a year. Even minor issues with the cable could result in costly outages over an extended period of time due to this single remaining vendor.

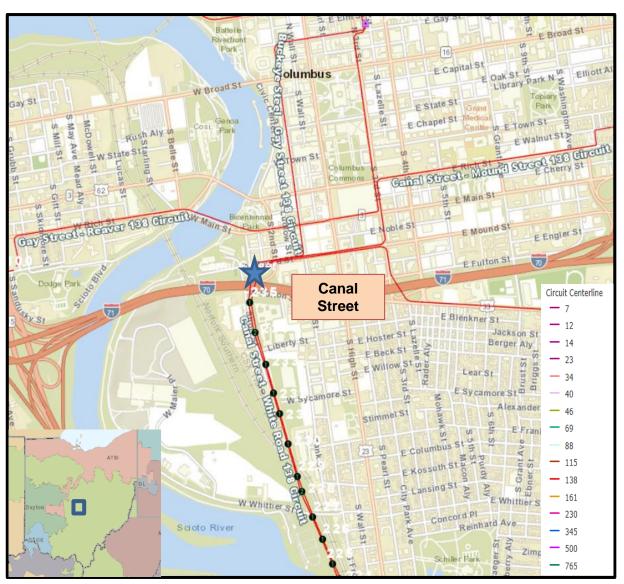
- Additional Information:
 - Interrupting Capability: 37kA
 - Fault Operations:
 - Number of Fault Operations: 15
 - Manufacturer recommended Number of Operations: 10
 - Oil breaker maintenance has become more difficult due to the oil handling required to maintain them. Oil spills are frequent with breaker failures and routine maintenance and can become an environmental hazard. This is the last remaining oil breaker at Canal Street station.

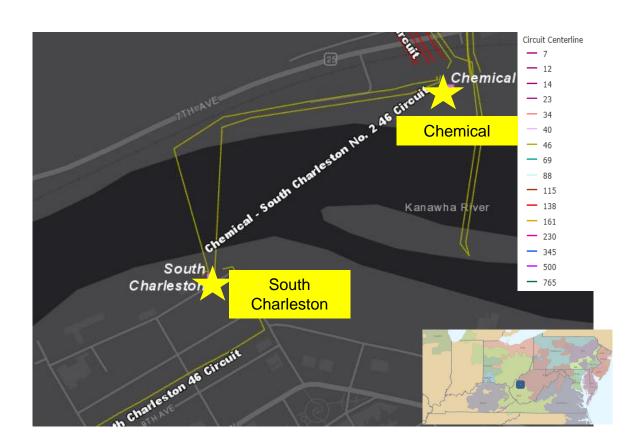
Chemical 138/46 kV XF #1 has been declared a failure. Operations has noted that Chemical 138/46 kV XF #1 fans and cooling system are not working properly and winding temperature was documented at an extremely hot level of 109°C prior to taking the unit offline in 2017. There are no parts attainable to repair the obsolete cooling system. In addition, interfacial tension has been diminished since 2002. This is an early indication of the development of sludge which can impede oil circulation, further hampering the ability of the unit to cool. Based on dissolved gas analysis, the observed gas concentrations, specifically of ethylene and acetylene, are likely the result of a mixture of thermal and electrical faults along with the carbonization of the insulating paper. The signal of insulation paper carbonization, which generates particles in the oil, highly correlates to the generation of sludge indicated by the interfacial tension.

Chemical 138/46 kV XF #2 moisture levels have recently been increasing, resulting in downward trending dielectric strength. In addition, interfacial tension has been on the decline. This is an early indication of the development of sludge which can impede oil circulation and cooling. Operations has noted numerous conditions with this unit, most critical of which is that the bank was derated to 33.75MVA because only one pump of three is operational for the cooling system. There are no parts attainable to repair the obsolete cooling system.

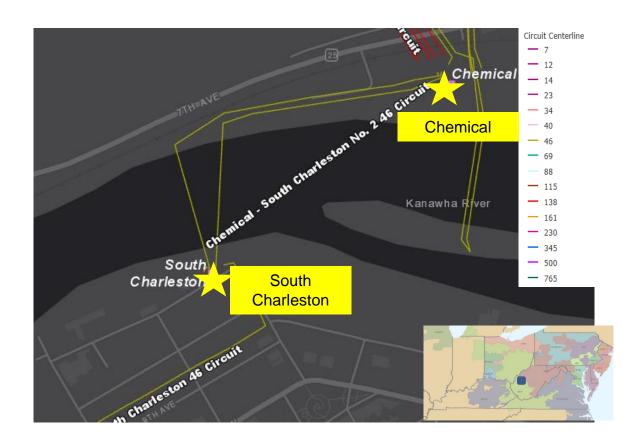
The 46kV CBs C, G, H, Q, R, and S are oil filled breakers without secondary oil containment. Oil filled breakers have much more maintenance required due to oil handling that their modern, SF6 equivalents do not require. CBs G and H are 2 of 40 in the FK-72.5-27000-10 model family remaining on the AEP system. CB A is the last FK-339-46-1500-Y model on the entire AEP system. CBs B, Q, R, and S are the last 4 in the FK-339-46-1500-5 model family remaining on the entire AEP system. CB C is the last FK-46-1500 model on the entire AEP system. This scarcity of sister units makes finding spare parts for these units difficult to impossible, and these models are no longer vendor supported.

The 46kV CS CC is an S&C 2030-69 model. The S&C 2030 circuit switcher model family has no gas monitor and sister units on the AEP System have experienced malfunctions; the major ones include gas loss, interrupter failures, and operating mechanism failures.

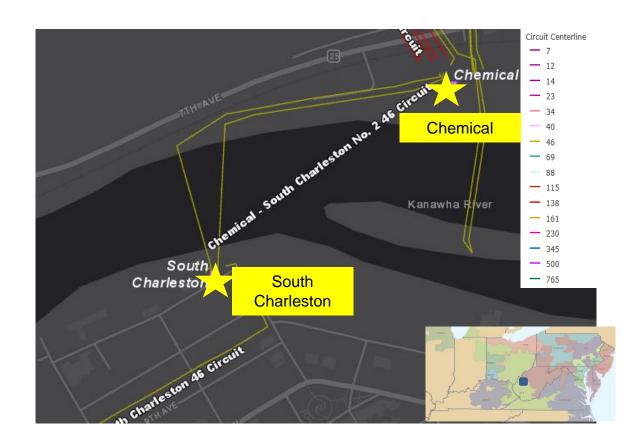
- South Charleston 46kV CBs A and B are 460G-3000 oil filled breakers.
 - Oil breakers are more difficult to maintain as oil spills have the potential to occur during maintenance which can be an environmental and safety hazard.
 - These are the last 2 circuit breakers in the 460G-3000 CB model family on the AEP system, making spare parts difficult or impossible to obtain.
- Chemical South Charleston 46 kV #1 (~0.5mi) currently has 9 open conditions on 8/8 structures.
 - The majority of the circuit is constructed with 1950s wood structures and lattice structures.
 - · The conditions include rot shell, insect damage and heavy rust.
- Chemical South Charleston 46 kV #2 (~0.5mi) currently has 16 open conditions on 9/9 structures.
 - The majority of the circuit is constructed with 1950s lattice and wood structures.
 - · The conditions include rot and heavy rust and rot shell.

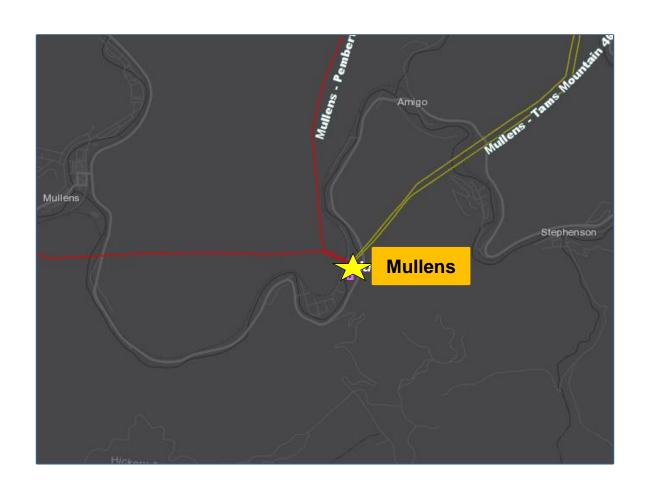
- Transformer Bank #4 138/46 kV
 - · Short circuit strength breakdown caused by the amount of high energy electrical through fault events
 - Numerous gases are at the IEEE level 2 condition level with acetylene and ethylene being at the highest condition level 4, which negatively impacts the oil dielectric

- There is a bad fan on transformer #4, on the bottom of cooling group 2
- Grounding Bank #3
 - · Upward trending of oil moisture content resulting in downward trending to the oil dielectric strength

- Increasing moisture content is a resultant of water ingress and/or break down of paper insulation of TF windings
 - · Short circuit strength breakdown caused by the amount of thermal through fault events

- Existing Gr. SW. MOAB configuration on the 138/46 kV and 138/34.5 kV transformers create faults in the station; known safety hazard in legacy station designs

- 63 of the 74 relays in the station (85% of all station relays) are of the electromechanical type which have significant limitations with regards to fault data collection and retention

- 13.2kV CBs R & S at are oil filled breakers without oil containment

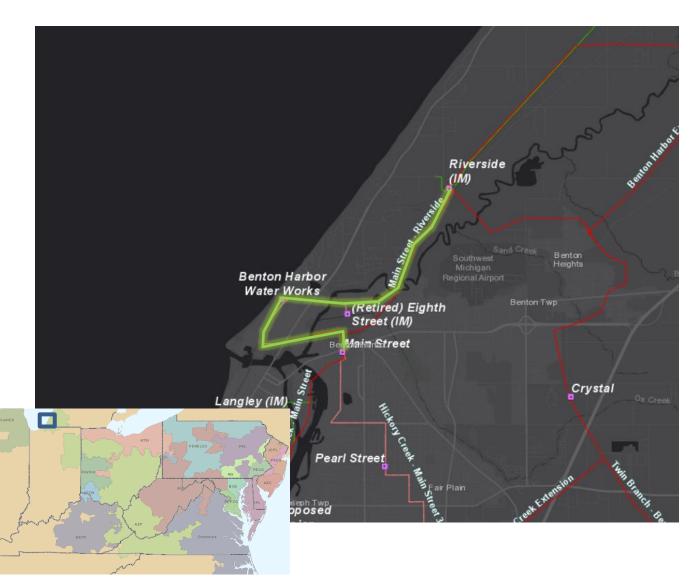
- 4.1 miles of the 4.6 mile 34.5kV line from Main St. –Riverside 34.5kV:
 - 1930's double circuit steal lattice towers and 1950's wood pole line with cross arm construction
 - 15 structures with at least one open condition (21% of the line)
 - Open conditions include pole leaning, rot, woodpecker or insect damage

- There are (2) 34.5kV oil filled breakers of FK-type 1960's vintage
 - Circuit breaker G has exceeded it's manufacturer designed number of fault operations
 - The common failure mode documented by AEP are compressor failures and valve defects which cause low pressure and oil leaks
 - The manufacturer no longer provides support for this fleet of circuit breakers. Spare parts are not available.

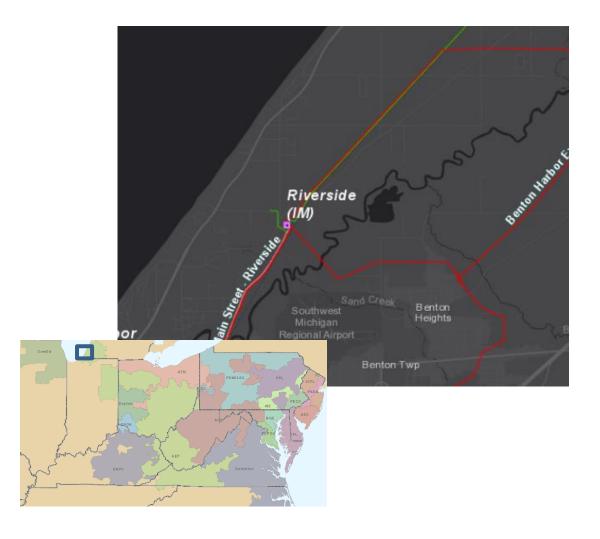
- (2) 138kV Breakers "O" & "A"
 - 1988 vintage SF-6 filled breakers
 - The breaker type has hydraulic leak issues on internal mechanisms which are caused by porous cylinder blocks and chips in the seal groove on the spring connecting rods.
 - Breaker A has operated for a fault 17 times exceeding its manufacturer recommendation of fault operations (10)

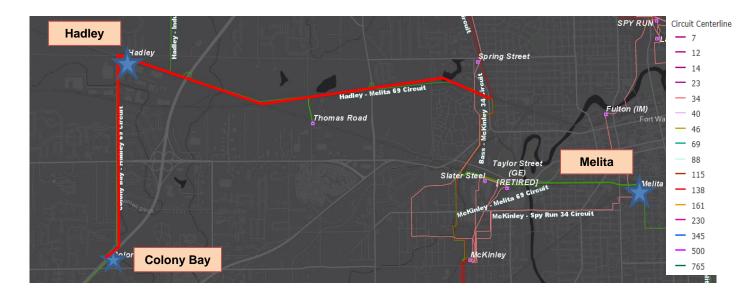
- The Colony Bay Melita circuit has ~5.8 miles of primarily 1960 wood pole structures
- This section has 34 open conditions across 26 unique poles (~17% of line). These
 conditions include, but aren't limited to Stolen/broken ground leads, broken insulators,
 damaged and rotting poles.
- An additional 23 poles on this section (~15%) were found to be decayed to the point of failure. These poles had steel reinforcers installed to allow them to last until a more permanent fix was available.
- The 2014-2019 5 year period this line was subject to 3 momentary outages and 3 permanent outages.

Hadley 69kV station

Station has a bus tie switch that breakers the bus differential. AEP has been addressing these as we have the opportunity

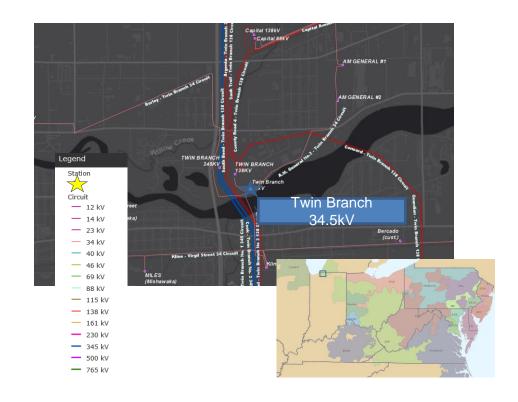
- The 34.5 kV Circuit Breakers CB, BB, DD, HH, and NN at Twin Branch 34.5kV Station are GE 'FK'
 oil-filled breaker manufactured in the 1950's. Common failure modes documented in AEP malfunction
 records for these breaker types are:
 - compressor failures and valve defects, which cause low pressure and oil leaks.
 - trip or reclose failures, caused primarily by spring latching and charging motor component failures.
 - the vacuum oil and oil breakers have a lot of oil contamination from aging gaskets allowing moisture and other particle ingress.
- Oil spills are frequent with failures and routine maintenance, which can also present an
 environmental hazard
- Because these breaker types are no longer manufactured, spare parts are not available.

- The interfacial tension of the oil is below acceptable limits and the moisture content in the oil relates to a level of relative saturation. These indicate that:
 - · sludge has formed in the radiators, core and coil.
 - high moisture levels in the oil and paper insulating materials.
 - the transformer oil is in poor quality to withstand dielectric events.
- Due to the age of this transformer, oil processing is not feasible option to extend the life of the unit.

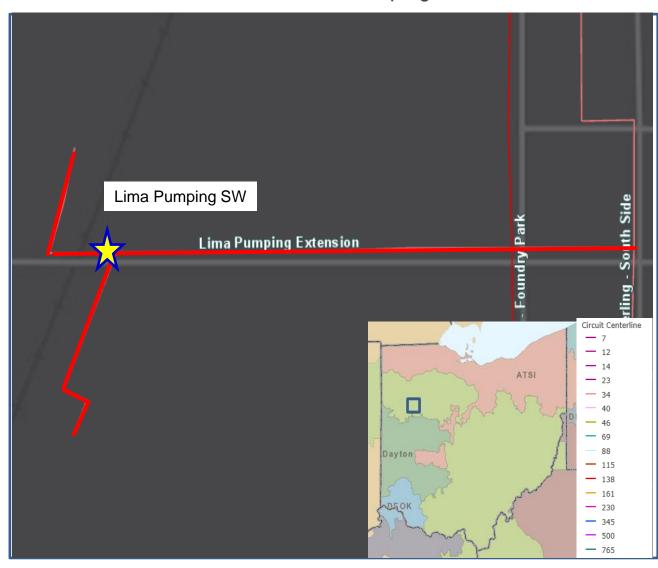
The line has experienced four (4) conductor failures since August 1, 2018. The first 8 spans of
the line have 35 total splices. In most cases the burned down 34.5 kV conductors end up
falling into and faulting the AEP Ohio 3-phase distribution underbuild, interrupting several
hundred additional distribution customers.

Marathon Pipe Line has experienced multiple outages to their facilities due to geese contact
with AEP's 34.5 kV transmission line serving them and another customer. Additionally these
two customers are connected off of a hard tap at the end of the radial 34.5 kV line forcing both
of them to be out when one of them request and outage.
