Reliability Analysis Update

Transmission Expansion Advisory
Committee

October 11, 2018

2018 RTEP Analysis Update

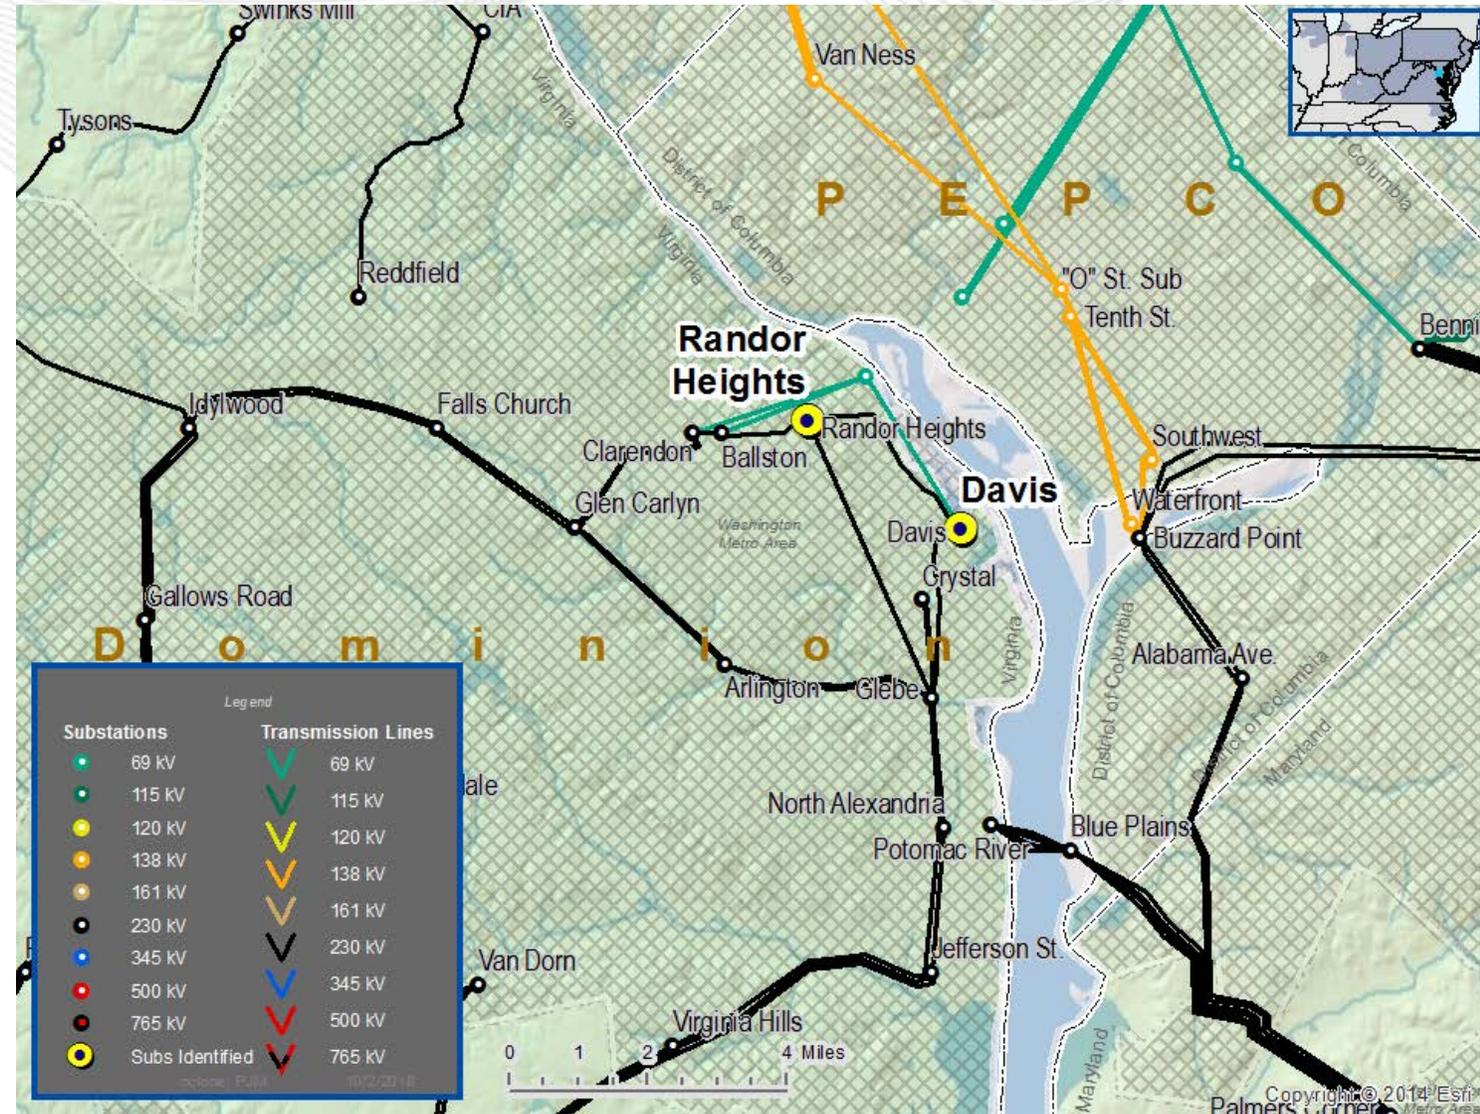
PJM Criteria Violation – N-1 High Voltage (Summer), (N1-SVH1 & N1-SVH2)

- N-1 high voltage conditions exist at 230kV Radnor Heights bus and 230kV Davis bus following a breaker-failure event (2036T2142).

Projected IS date: 6/1/2023

Status: Conceptual

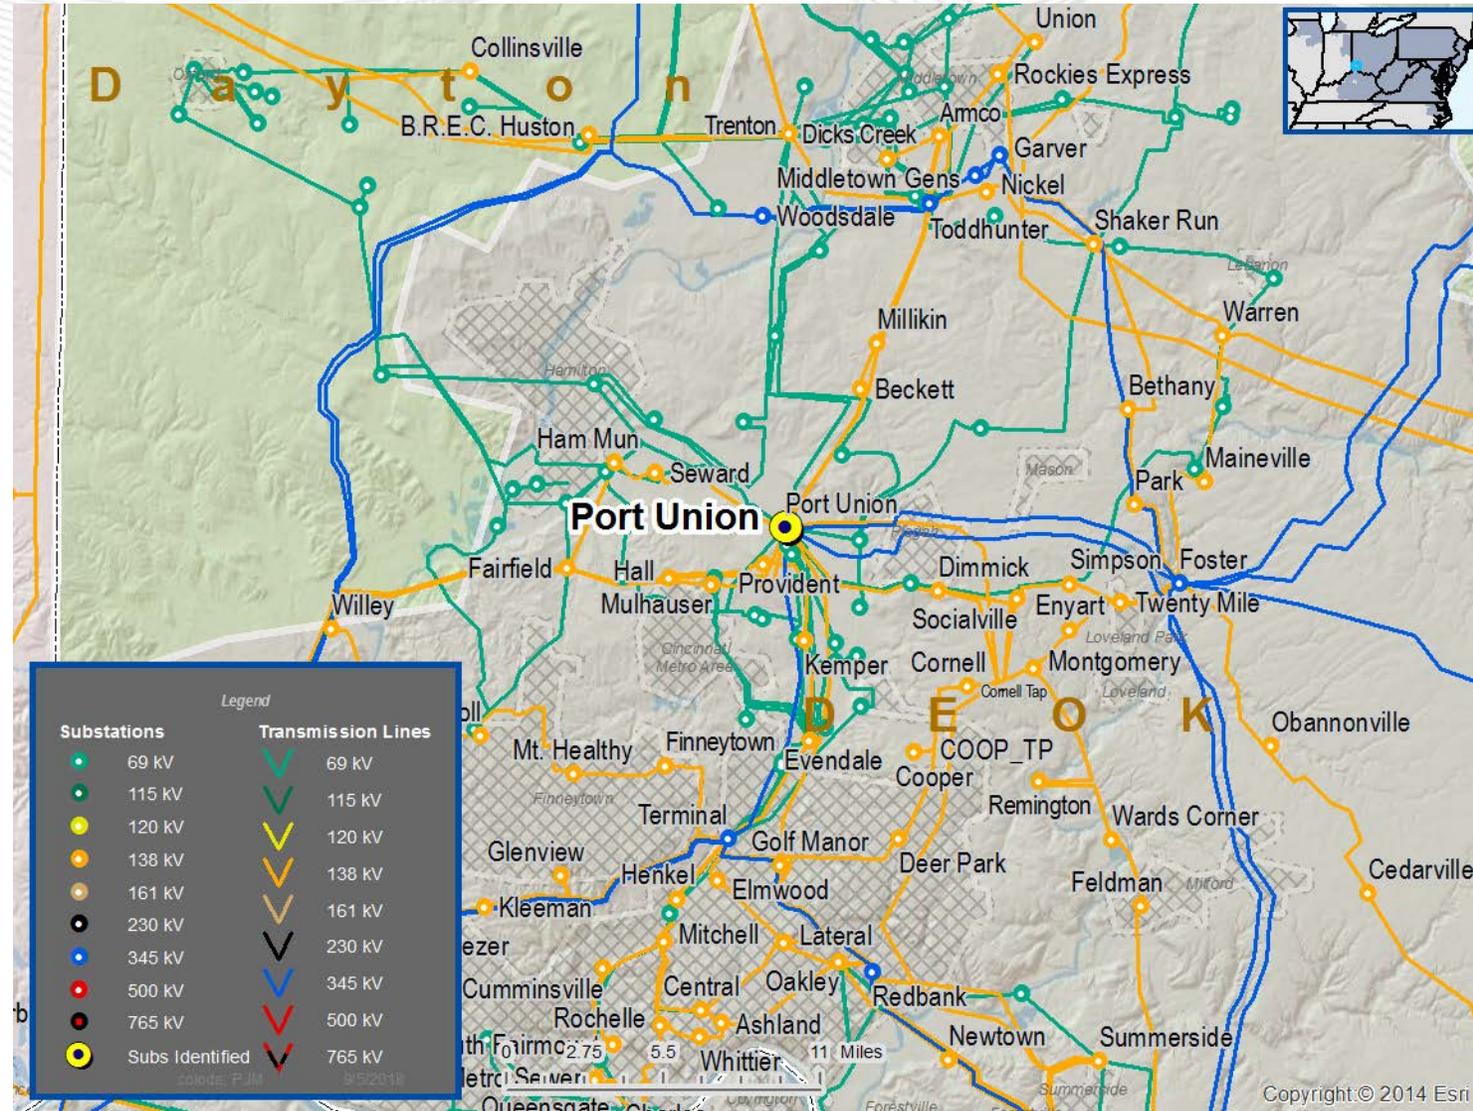
PJM Criteria Violation – Load Loss limit (Summer), (N1-SLD1)

- Consequential Load Loss is greater than 300MW for the loss of the Port Union 138kV Bus #2 with relay failure.

- Add redundant relay to Port Union 138kV Bus #2 (2018_1-1A). (B3050)

Estimated Project Cost : \$0.367M

Required IS Date: 6/1/2023

Projected IS date: 11/30/2022

Status: Planning

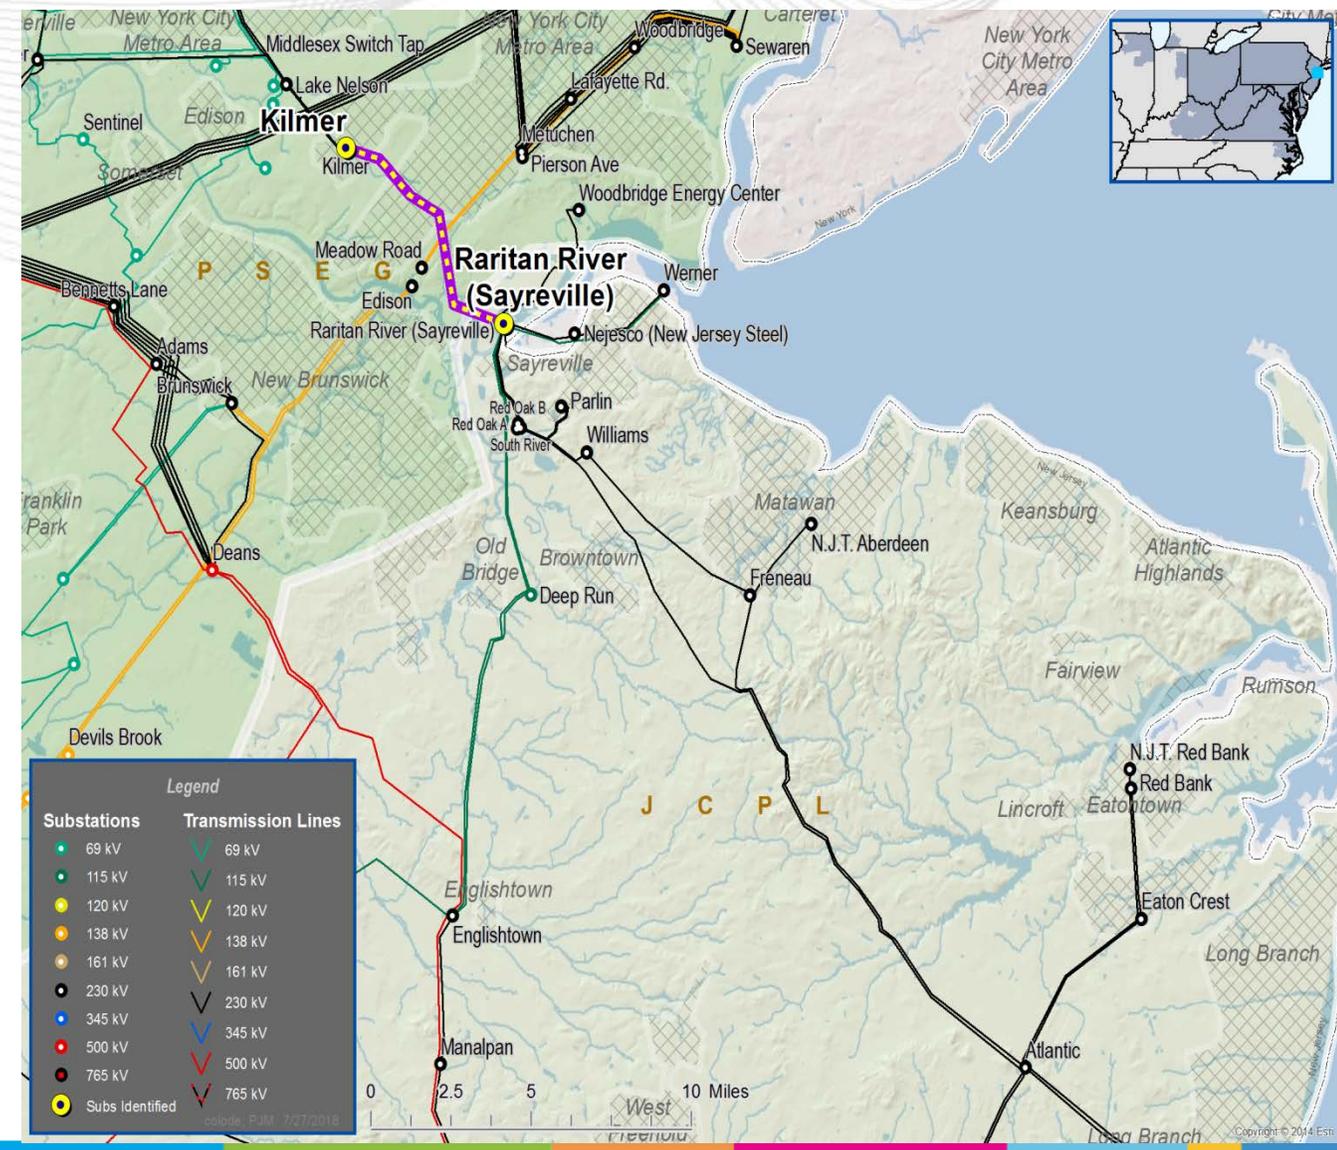
JCPL Transmission Zone: Baseline Project

- The Raritan River – Kilmer 230 kV circuit is overloaded for a tower line outage loss of Atlantic – R11 230 kV (P1030) and Freneau – Parlin 230 kV (K1025) circuits. (FG# GD-S466)

- Replace substation conductor at Raritan River 230 kV substation on the Kilmer line terminal to achieve 709N/869E MVA summer rating. (B3042)

Projected IS Date: 6/1/2023

Status: Conceptual

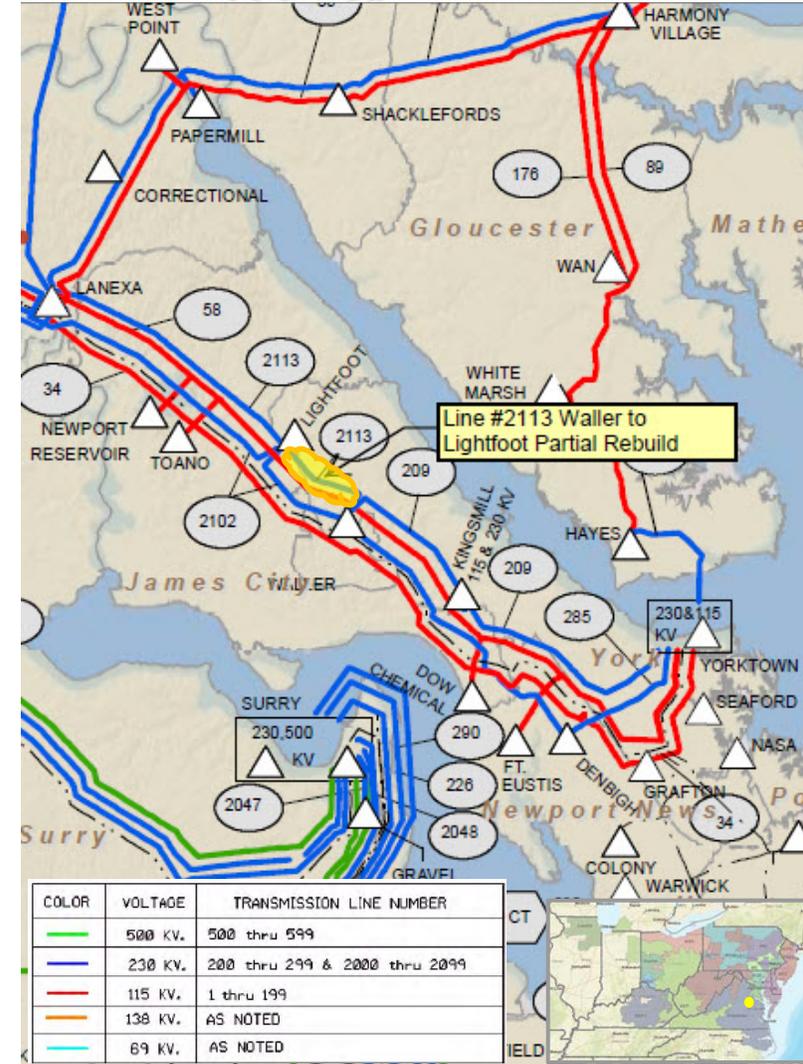
Dominion Transmission Zone: Baseline Line #2113 Waller to Lightfoot Partial Rebuild

Waller to Lightfoot section of 230kV Line #2113 and 115kV Line #58 were constructed on double circuit 3 pole wood H-frame structures in 1966 and 1952. Industry guidelines indicate equipment life for wood structures is 35-55 years, conductor and connectors are 40-60 years, and porcelain insulators are 50 years. This section of the Line #2113 have been identified for rebuild based on the company’s End of Life criteria.

The Line #2113 runs between Lanexa Substation and Waller Substation. It provides service to Lightfoot Substation with a total of 16,881 customers. Permanent load loss is 83 MW. Waller to Lightfoot section of this line is approximately 4 miles long and has a current summer emergency rating of 470 MVA.

End-of-Life reliability assessment, with Waller to Lightfoot section removed from service, creates a radial line from Skiffes Creek to Waller with 118 MW. This is a violation of Dominion’s 100 MW planning criteria. N-1-1 study also indicates multiple thermal overload conditions.

Rebuild 4 miles of Line #2113 between Waller and Lightfoot Substation to current standards with a minimum summer emergency rating of 1047 MVA at 230 kV utilizing single circuit steel structures. Remove this section of Line #58.

Projected In-service Date: 12/30/2024

Project Status: Conceptual

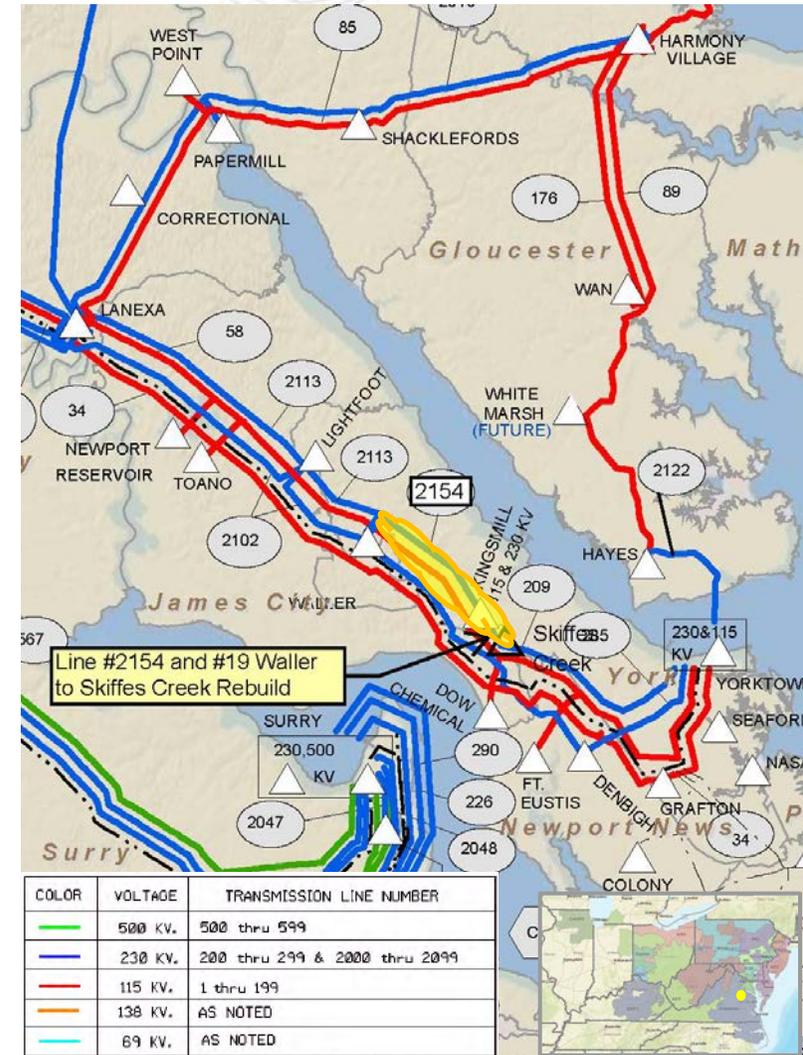
230kV Line #2154 from Waller to Skiffes Creek was constructed on double circuit 3 pole wood H-frame structures with 115kV Line #58 (from Waller to Kings Mill) and #19 (from Kings Mill to Skiffes Creek) in 1966 and 1952. Industry guidelines indicate equipment life for wood structures is 35-55 years, conductor and connectors are 40-60 years, and porcelain insulators are 50 years. Line #2154 and #19 have been identified for rebuild based on the company’s End of Life criteria. Line #2154 has a current summer emergency rating of 470 MVA. Line #19 has a current summer emergency rating of 147 MVA.

End-of-Life reliability assessment, with the line #2154 removed from service, creates a radial line from Lenexa to Waller with 113.5 MW. This is a violation of Dominion’s 100 MW planning criteria. N-1-1 study also indicates multiple thermal overload conditions.

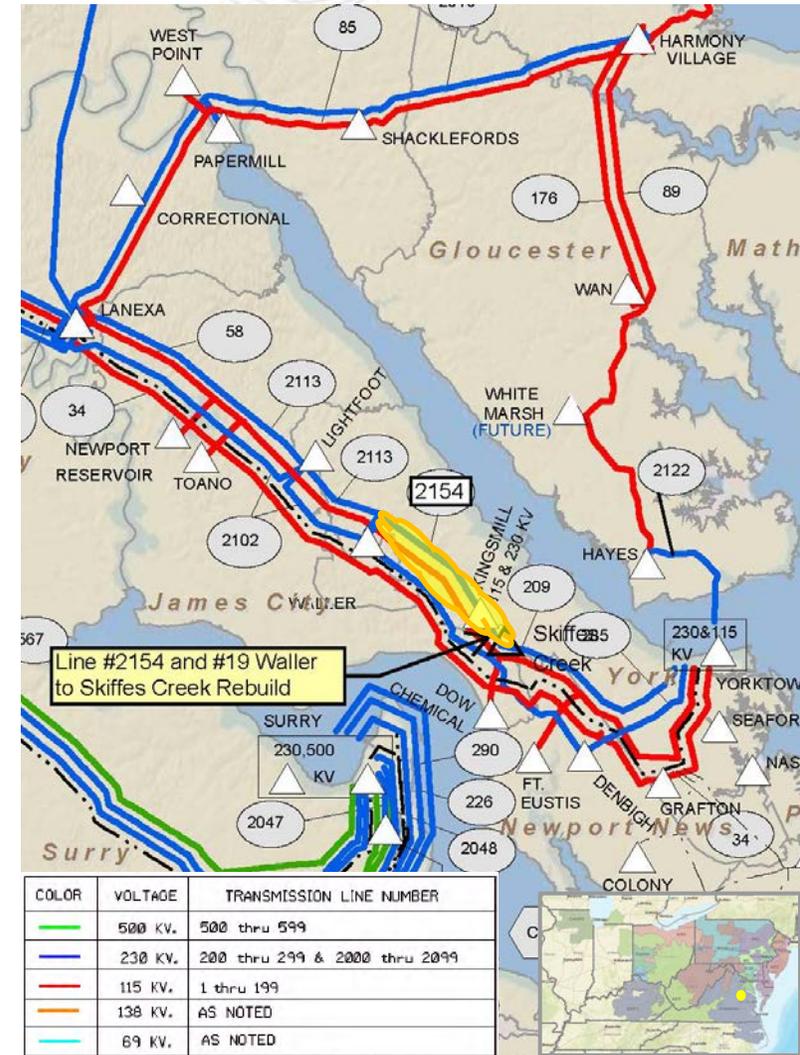
Continued from previous slide...

Potential Solution:

Alternative: No feasible alternatives.

Projected In-service Date: 12/30/2024

Project Status: Conceptual

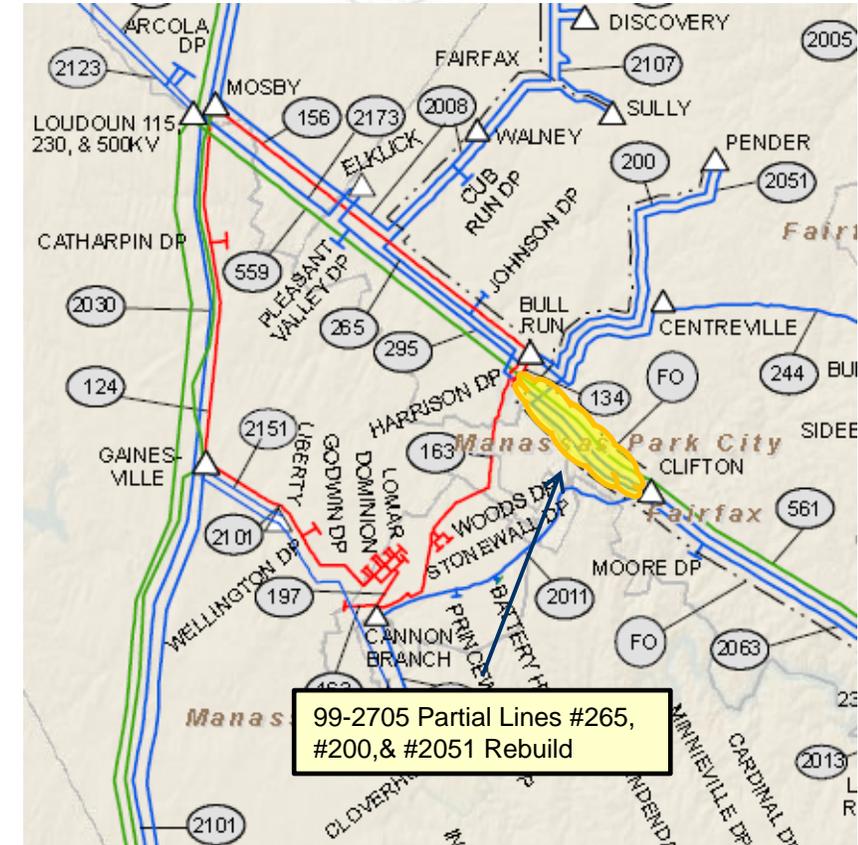
Dominion Transmission Zone: Baseline Partial Lines #265, #200 and #2051 Rebuild

A 3.61 mile long section of 230 kV Line #265 between Clifton to Johnson D.P. was constructed on Cor-ten lattice-type double circuit towers. A 2.94 mile long section of 230kV Line #2051 between Clifton to Pender is on the same structures as Line #265. A 0.65 mile long section of 230kV Line #200 between Bull Run to Pender is also on the same structures as Line #265. These towers have been shown to have inherent corrosion problems that continuously deteriorate the steel members. These lines have been identified to be rebuilt as part of Dominion’s End of Life criteria.

Additionally, removing partial Lines #265, #200, and #2051 from service permanently creates numerous N-1-1 thermal violations on the transmission system.

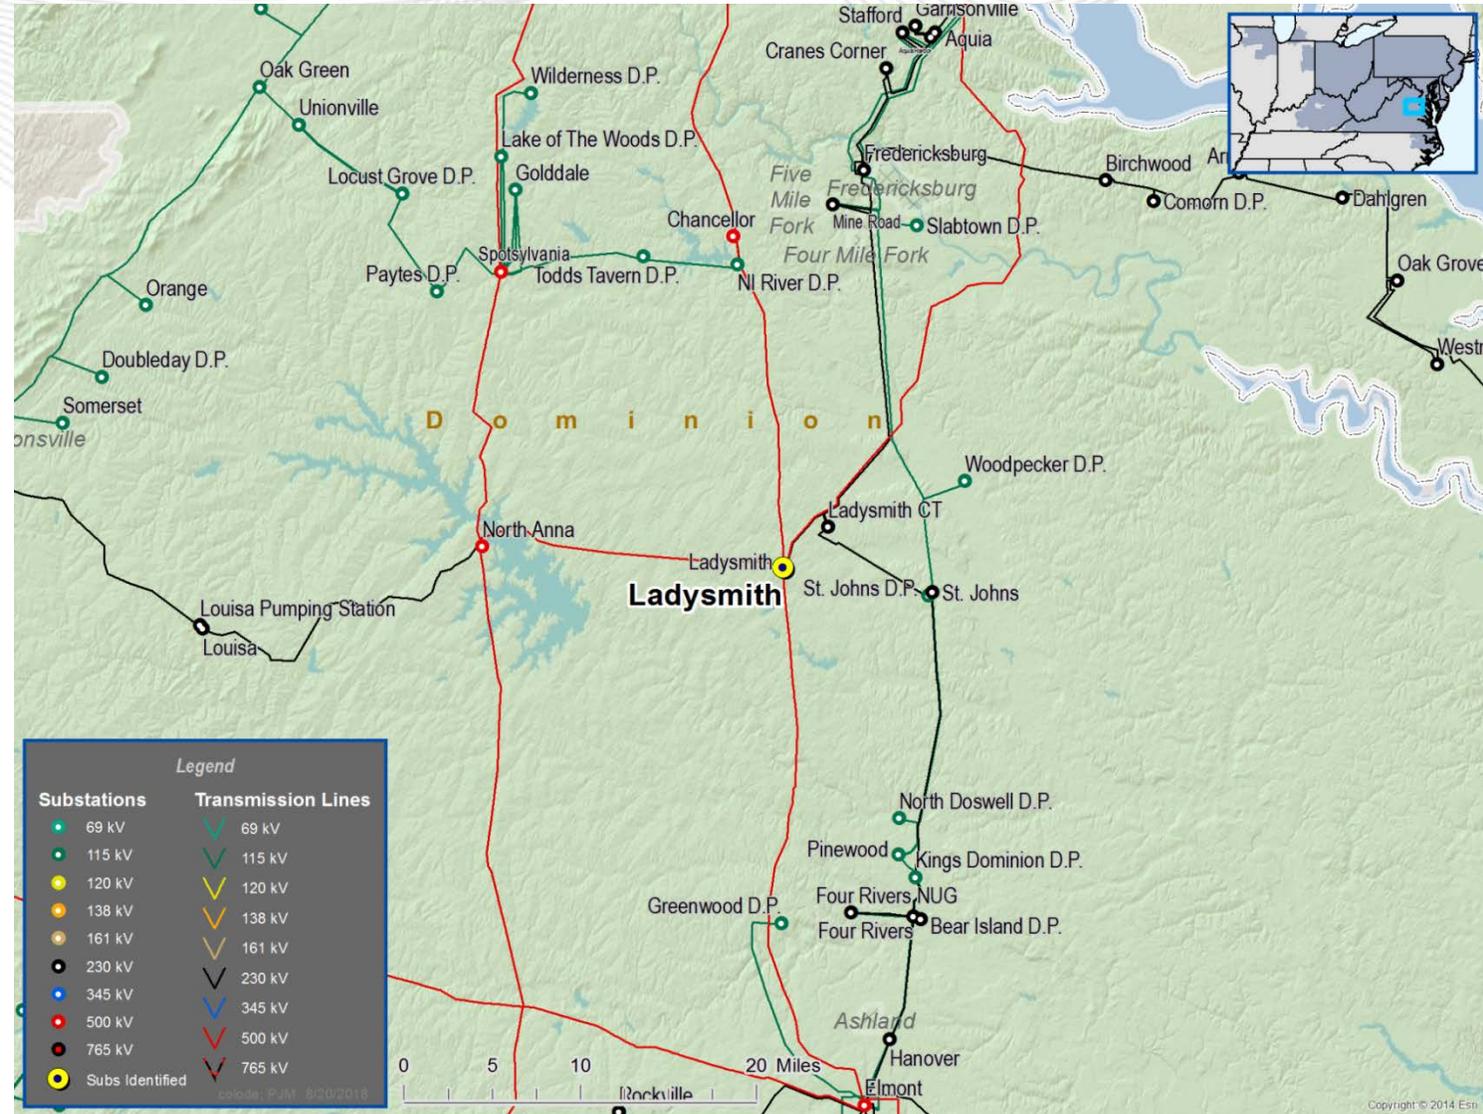
- Replace the Ladysmith 500kV breaker "H1T581" with 50kA breaker (B3027.3)
- Update the nameplate for Ladysmith 500kV breaker "H1T575" to be 50kA breaker (B3027.4)
- Update the nameplate for Ladysmith 500kV breaker "568T574" (will be renumbered as "H2T568") to be 50kA breaker (B3027.5)

Replace breaker	\$1.030 M
New nameplate ratings	<u>\$0.004 M</u>
	\$1.034 M

Required IS Date: June 1, 2021

Projected IS Date: June 1, 2021

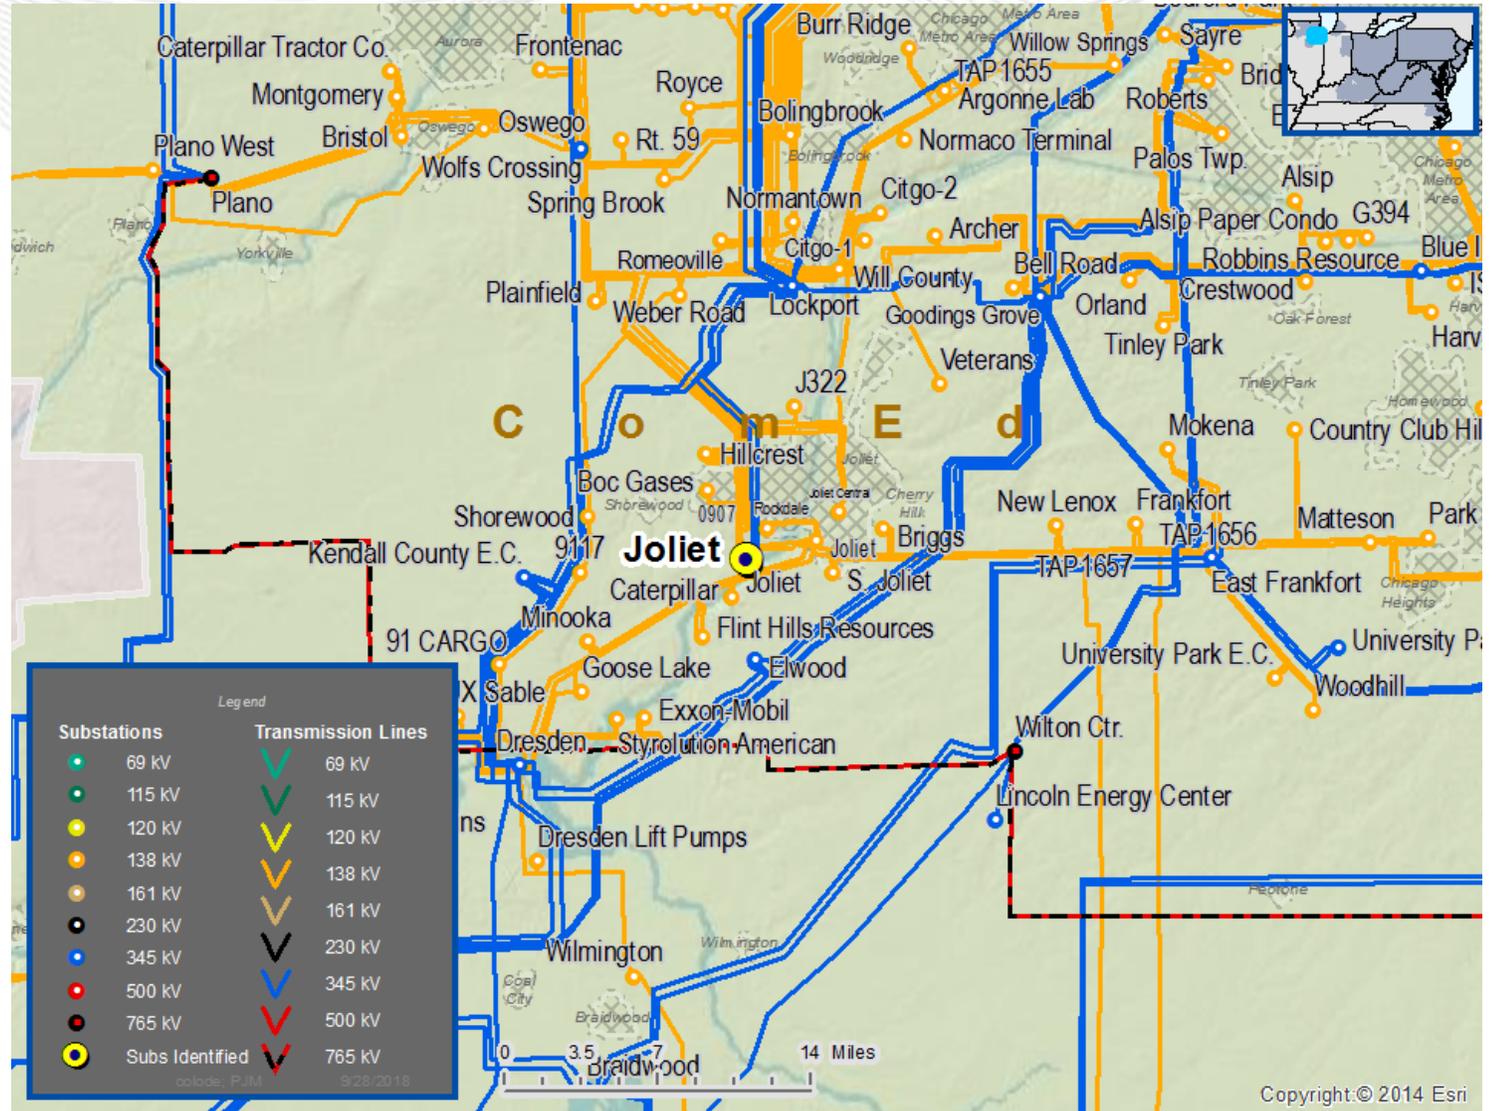
Stability Projects

- Replacement of gang-operated 345kV line breakers on 345kV lines 2912 and 2913 with IPO breakers (b3049)

Projected IS date: 06/01/2021

Status: Conceptual
