# First Energy (MetEd) Local Plan Submission for the 2020 RTEP

**Need Number:** ME-2019-039

**Process Stage:** Submission of Supplemental Project for inclusion in the Local Plan 3/20/2020

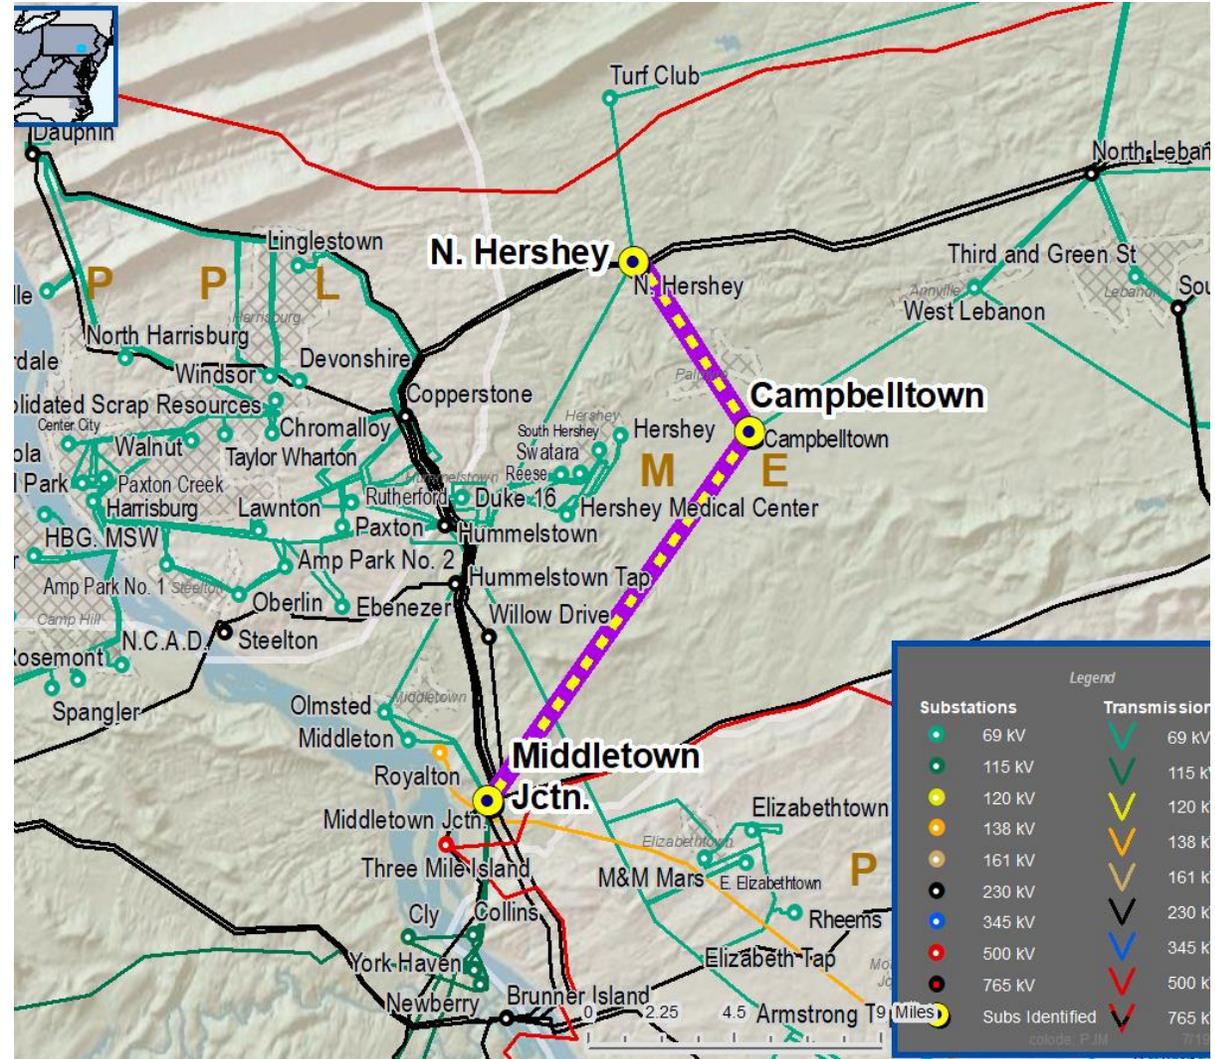
Campbelltown – Middletown – North Hershey 69 kV line sections are exhibiting deterioration.

- Total line distance is approximately 19.7 miles.
- 260 out of 407 structures failed inspection (64% failure rate).
- Failure reasons include age, decay, woodpecker holes.

Transmission line ratings are limited by terminal equipment

Campbelltown – Campbelltown Tap 69 kV line (substation conductor, disconnect switches, relaying)

- Existing line rating: 71/91 MVA (SN/SE)
- Existing conductor rating: 139/169 MVA (SN/SE)

Middletown – Wood St Tap 69 kV line (disconnect switches, line relaying, substation conductor)

- Existing line rating: 82/103 MVA (SN/SE)
- Existing conductor rating: 139/169 MVA (SN/SE)

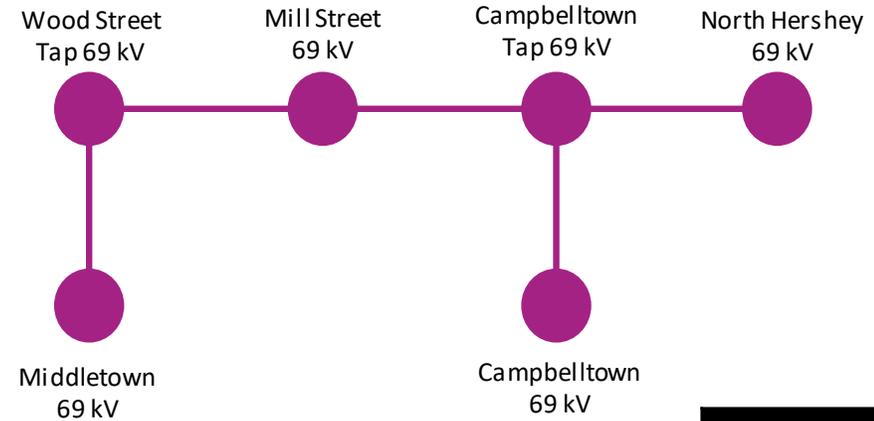
Rebuild and reconductor approximately 15.1 miles of the 19.7 mile line (s2170.1)

Replace line relaying, substation conductor, and disconnect switches (s2170.2-5)

- Middletown – Wood St Tap 69 kV Line:
  - Before Proposed Solution: 82/103 MVA (SN/SE)
  - After Proposed Solution: 139/169 MVA (SN/SE)
- Wood St Tap – Mill Street 69 kV Line:
  - Before Proposed Solution: 80/96 MVA (SN/SE)
  - After Proposed Solution: 139/169 MVA (SN/SE)
- Mill Street – Campbelltown Tap 69 kV Line:
  - Before Proposed Solution: 74/90 MVA (SN/SE)
  - After Proposed Solution: 139/169 MVA (SN/SE)
- Campbelltown Tap – North Hershey 69 kV Line:
  - Before Proposed Solution: 74/90 MVA (SN/SE)
  - After Proposed Solution: 136/169 MVA (SN/SE)
- Campbelltown – Campbelltown Tap 69 kV Line:
  - Before Proposed Solution: 71/91 MVA (SN/SE)
  - After Proposed Solution: 82/103 MVA (SN/SE)

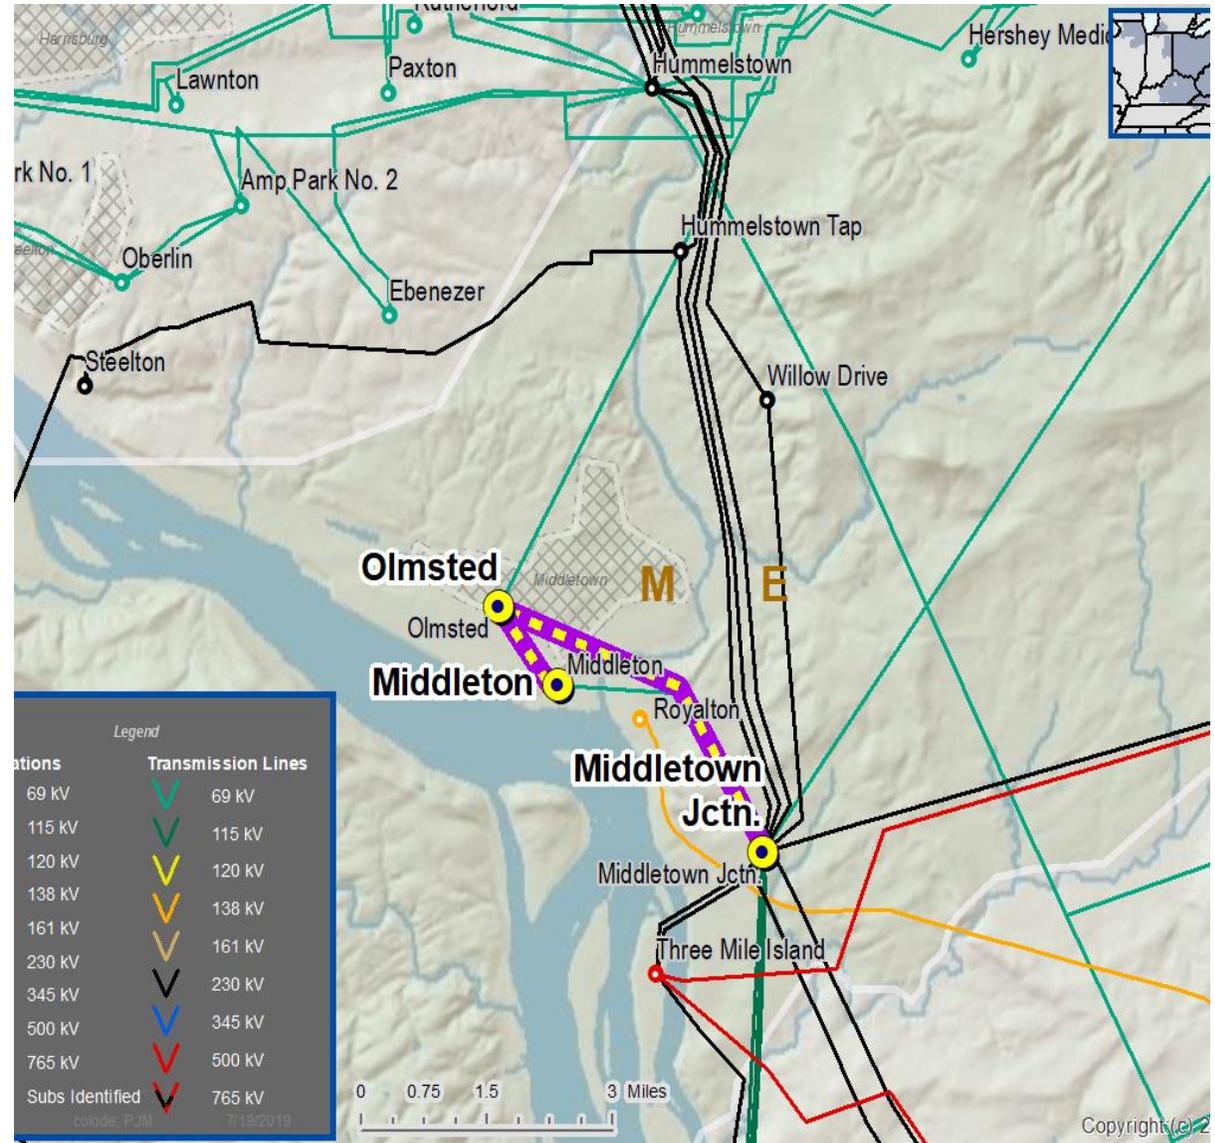
Middletown Junction – Olmsted - Middletown 69 kV line – Terminal equipment has an increased risk of failure (circuit breaker, disconnect switches, line relaying) due to obsolescence of equipment. Limited spare parts are available.

- Circuit breakers are 50+ years old with Type U bushings
- Circuit breakers have a history of failed compressor belt
- Circuit breaker has failing dielectric strength

Wood Street Tap – Middletown 69 kV line (substation conductor, disconnect switches, relaying)

- Existing line rating: 51/66 MVA (SN/SE)
- Existing conductor rating: 139/169 MVA (SN/SE)

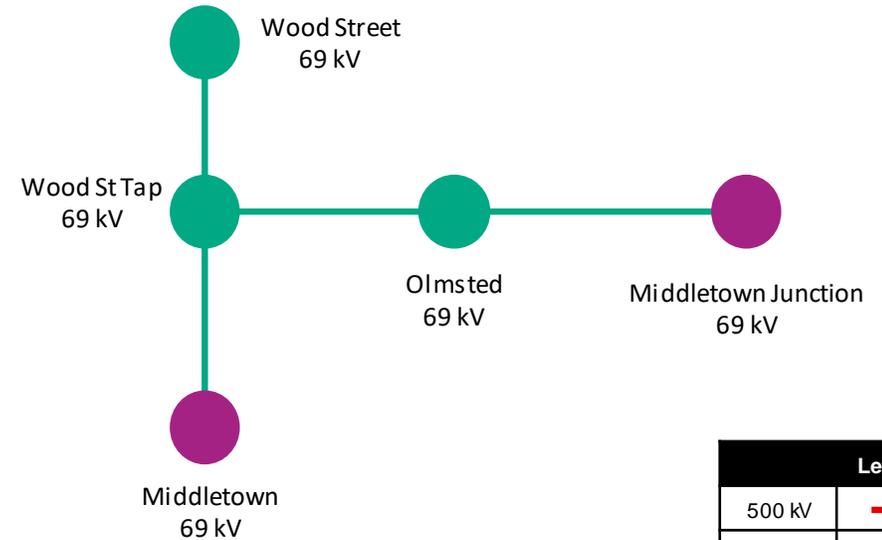
- Replace circuit breaker, disconnect switches, line relaying (s2171.1)

- Replace circuit breaker, disconnect switches, line relaying, substation conductor (s2171.2)

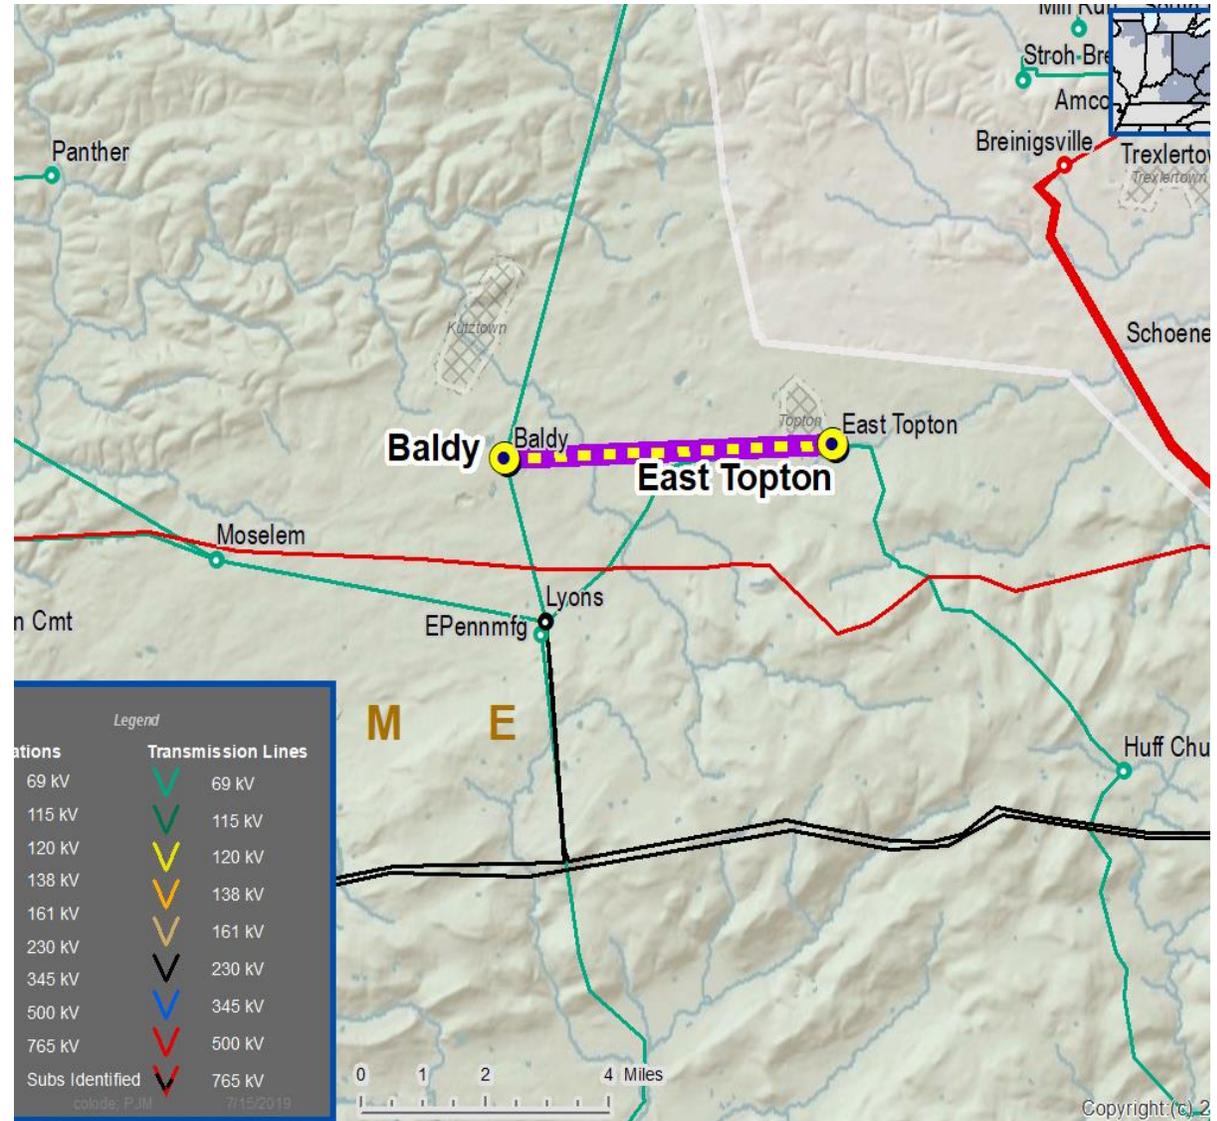
Baldy – East Tipton 69 kV line – Terminal equipment has an increased risk of failure (circuit breaker and line relaying) due to obsolescence of equipment. Limited spare parts are available.

- East Tipton circuit breaker is 40+ years old with Type U bushings and has a history of failed oil dielectric strength

Kutztown – East Tipton 69 kV line (substation conductor, line relaying)

- Existing line rating: 62/62 MVA (SN/SE)
- Existing conductor rating: 80/96 MVA (SN/SE)

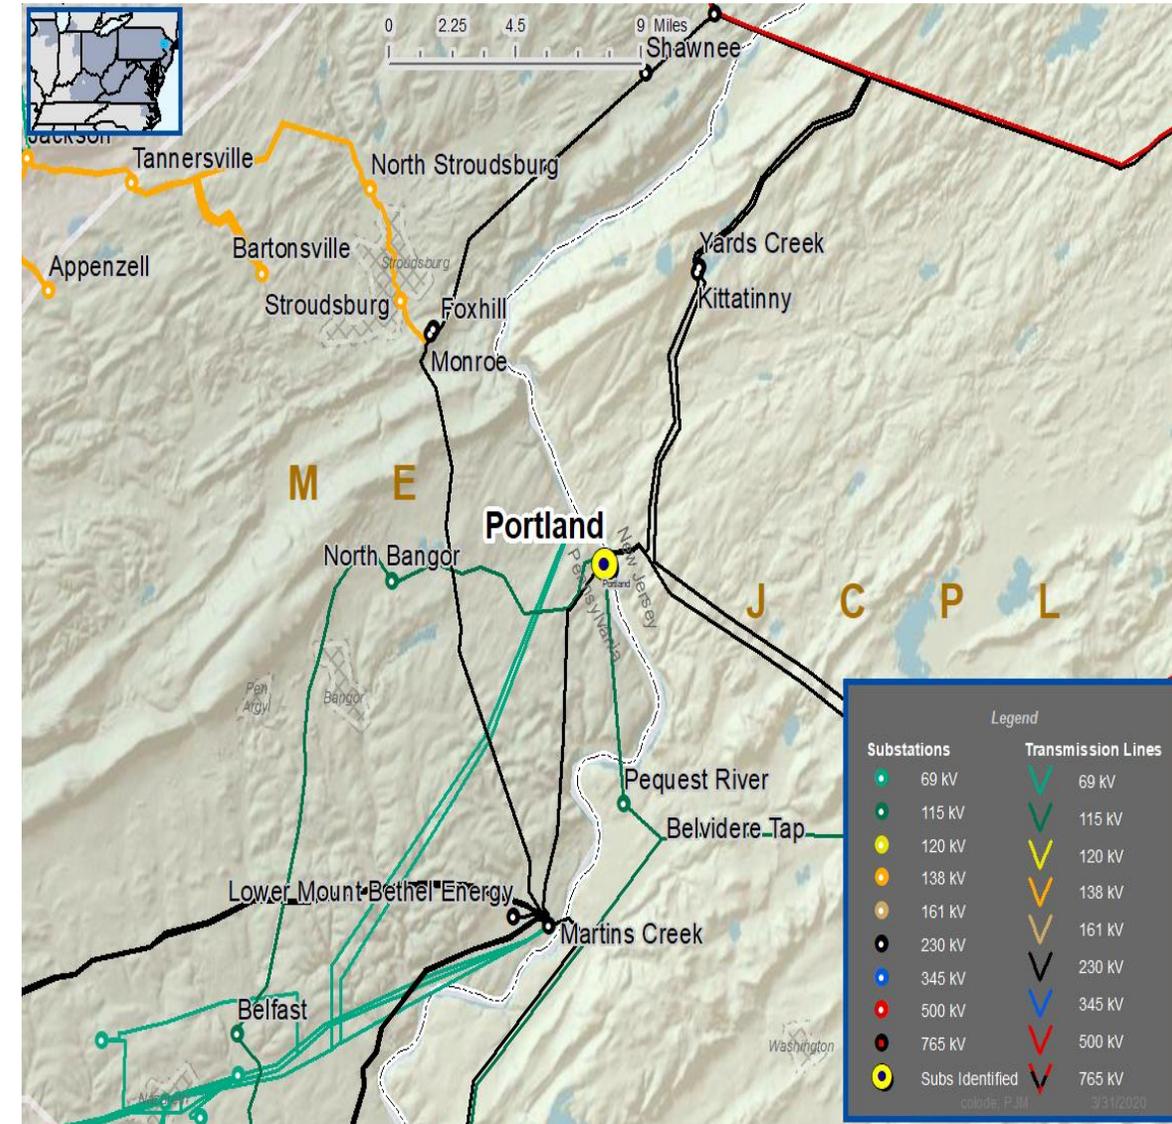
Portland 230/115 kV #3 Transformer was replaced with a spare transformer as a result of a failure in 2017. The transformer was installed on a temporary pad with temporary oil containment.

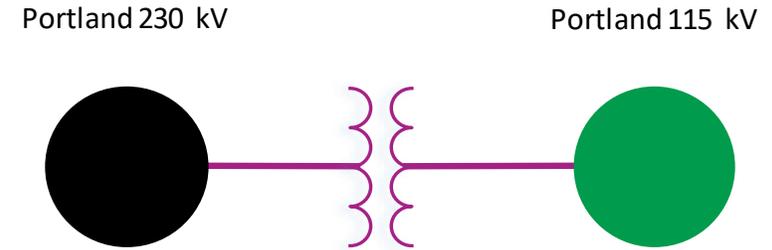
- Replace the #3 230/115 kV transformer and associated equipment with a 180/240/300 MVA transformer

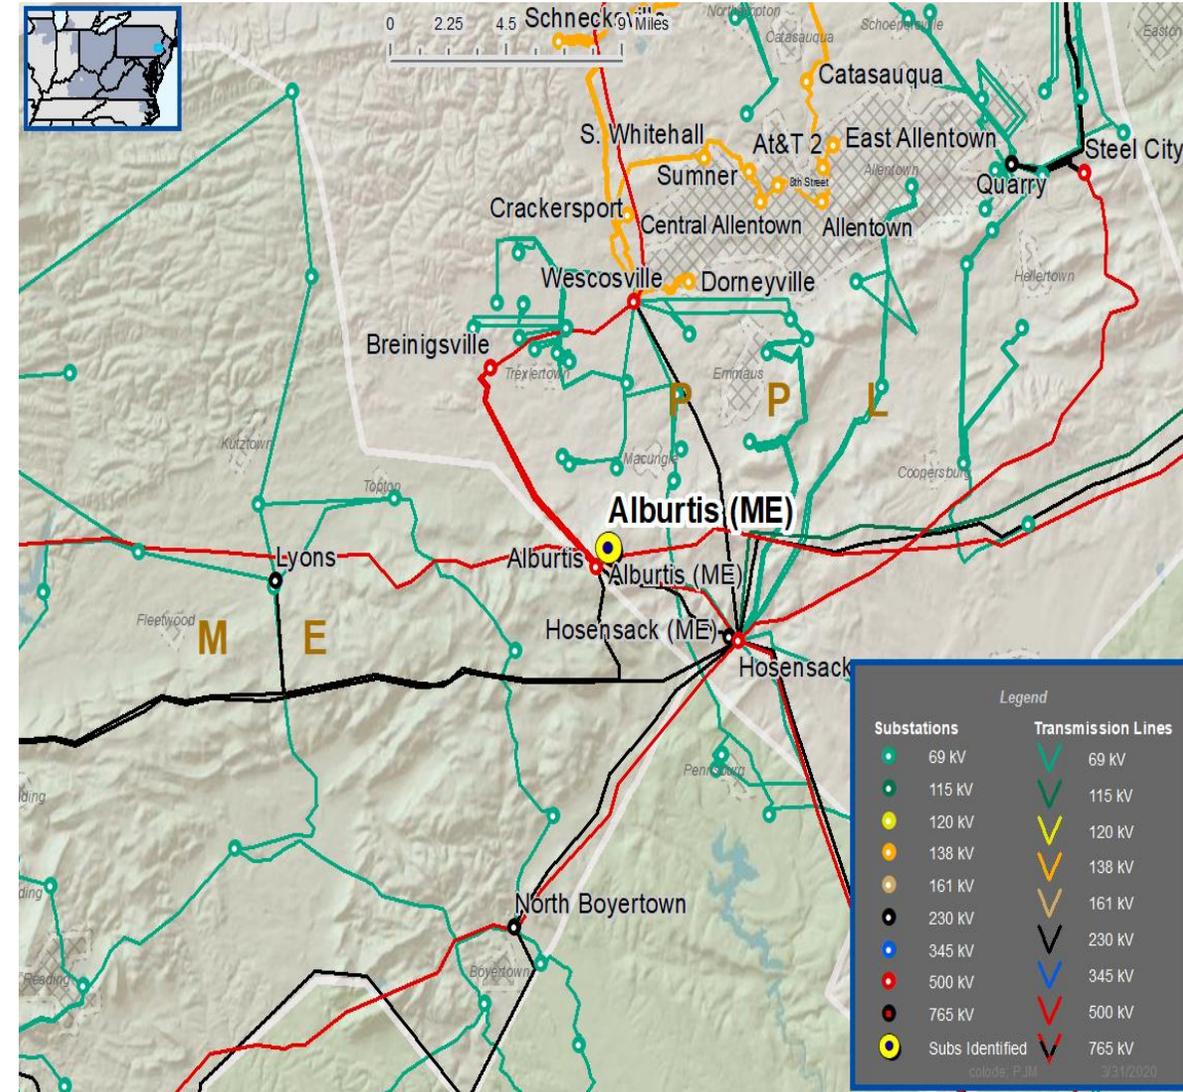
Current Alburtis configuration has two 230 kV lines and one 500/230 kV transformers connected to a straight bus. A bus outage or breaker failure would result in the loss of these three elements.

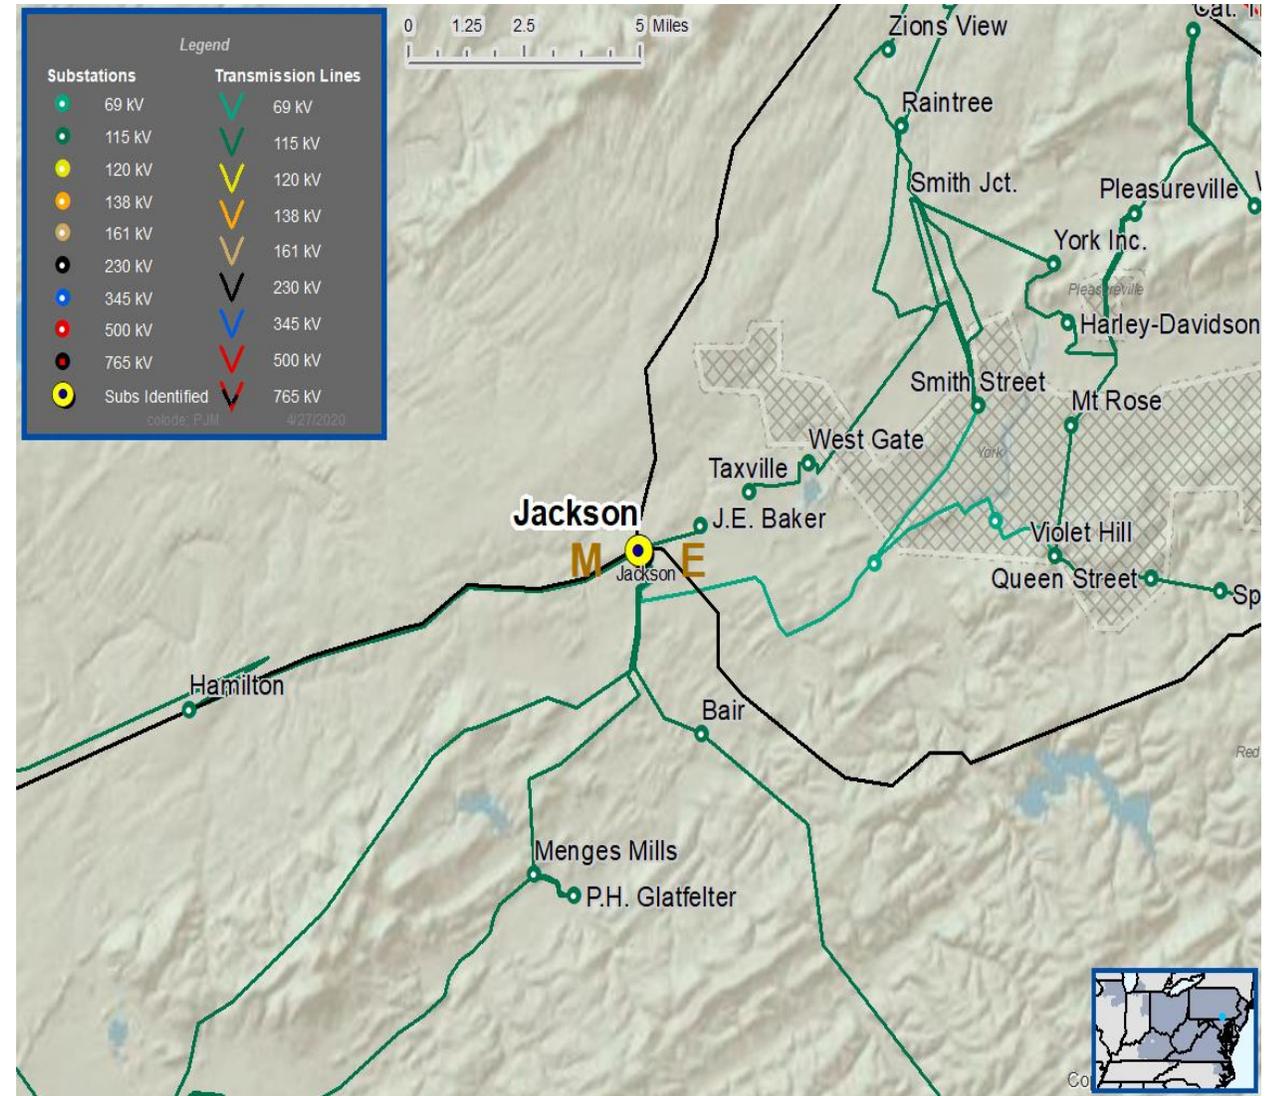
The Jackson 230/115 kV #4 transformer

- Transformer is 55 years old
- Experiencing nitrogen gas leaks
- Deteriorated bushings
- Obsolete parts
- Deteriorated gaskets and seals

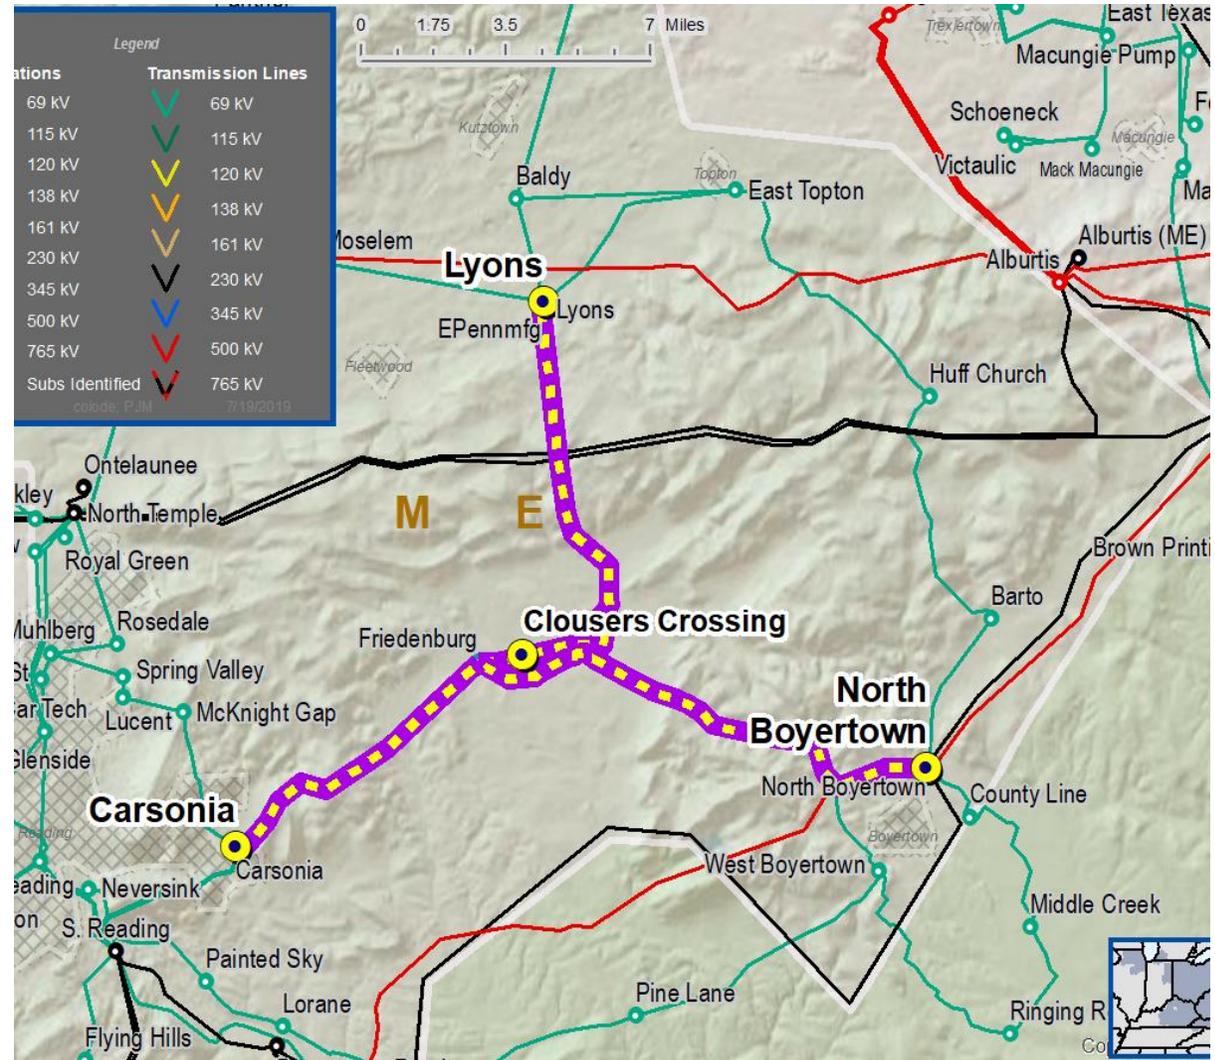
Carsonia – Lyons – North Boyertown 69 kV line is exhibiting deterioration.

- Total line distance is approximately 22.8 miles.
- 339 out of 447 structures failed inspection (76% failure rate).
- Failure reasons include age, woodpecker holes, bayonet pole, top rot.

Lyons – Lyons tap 69 kV line (line relaying)

- Existing line rating: 167/167 MVA (SN/SE)
- Existing conductor rating: 218/251 MVA (SN/SE)

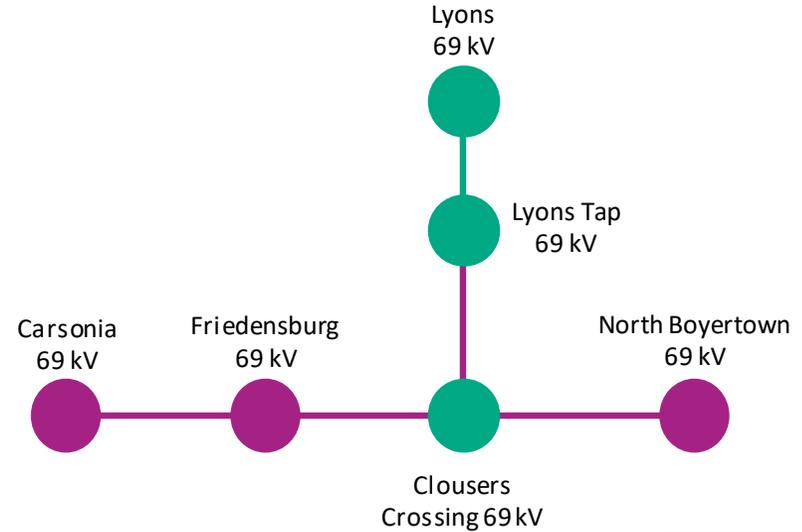
- Replace disconnect switches, substation conductor, and line relaying

- Replace disconnect switches and substation conductor

- Replace circuit breaker and disconnect switches

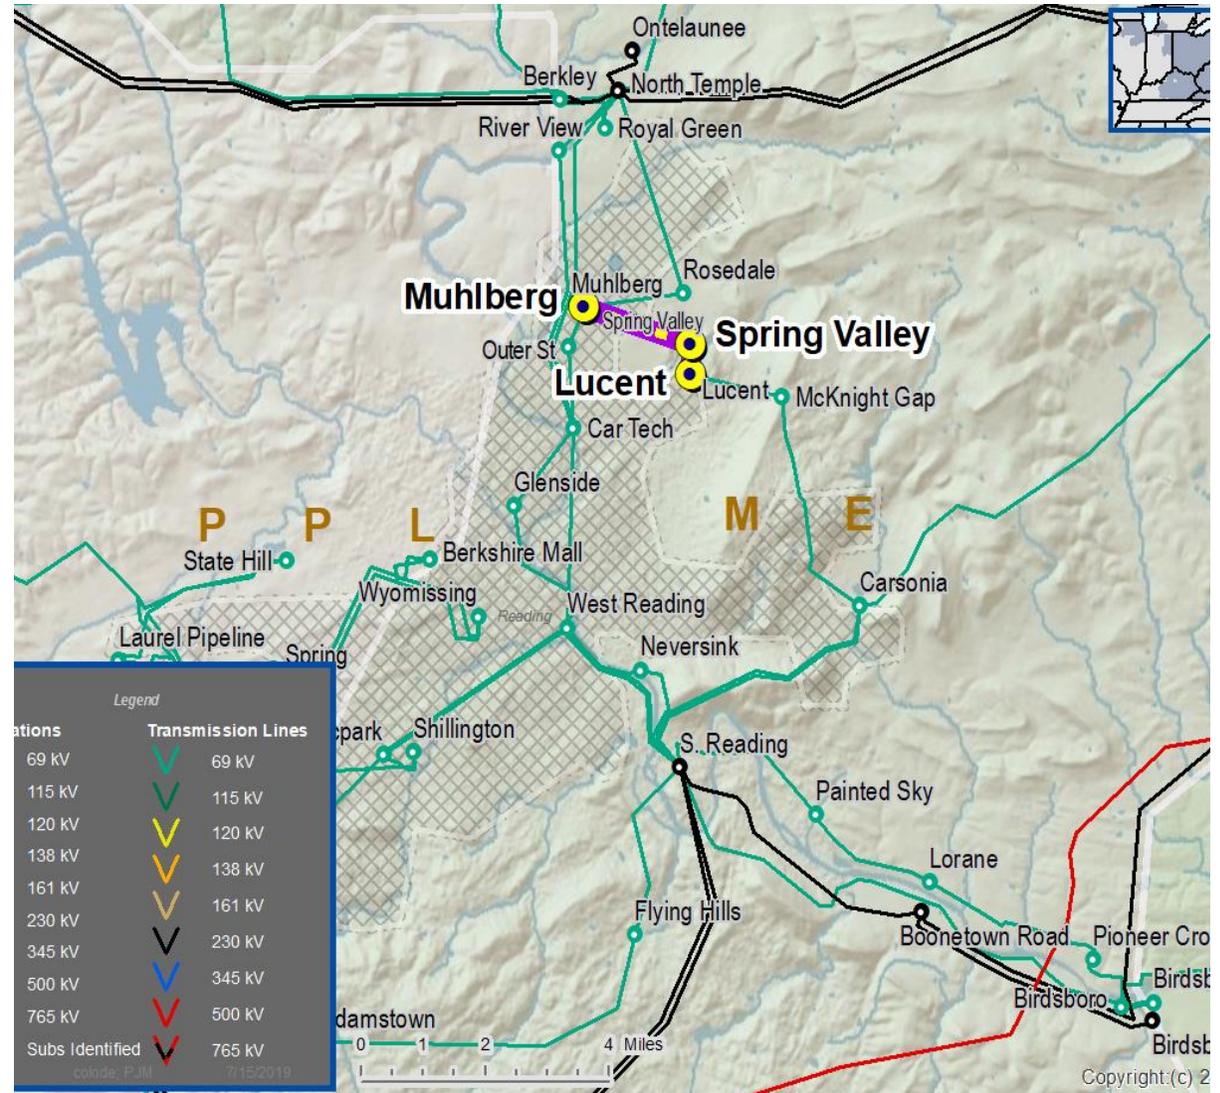
Lucent– Muhlenberg 69 kV line – Terminal equipment has an increased risk of failure (circuit breaker, disconnect switches, line relaying) due to obsolescence of equipment. Limited spare parts are available.

- Circuit breakers are 50+ years old with Type U bushings and have a history of oil leaks
- Lucent disconnect switch has bad contacts
- Line relays have a history of overtripping

MG Tap – Muhlenberg 69 kV line (substation conductor, disconnect switches)

- Existing line rating: 71/91 MVA (SN/SE)
- Existing conductor rating: 111/134 MVA (SN/SE)
