# Sub Regional RTEP Committee Western Region ATSI - Solutions

October 26, 2018

# ATSI Transmission Zone

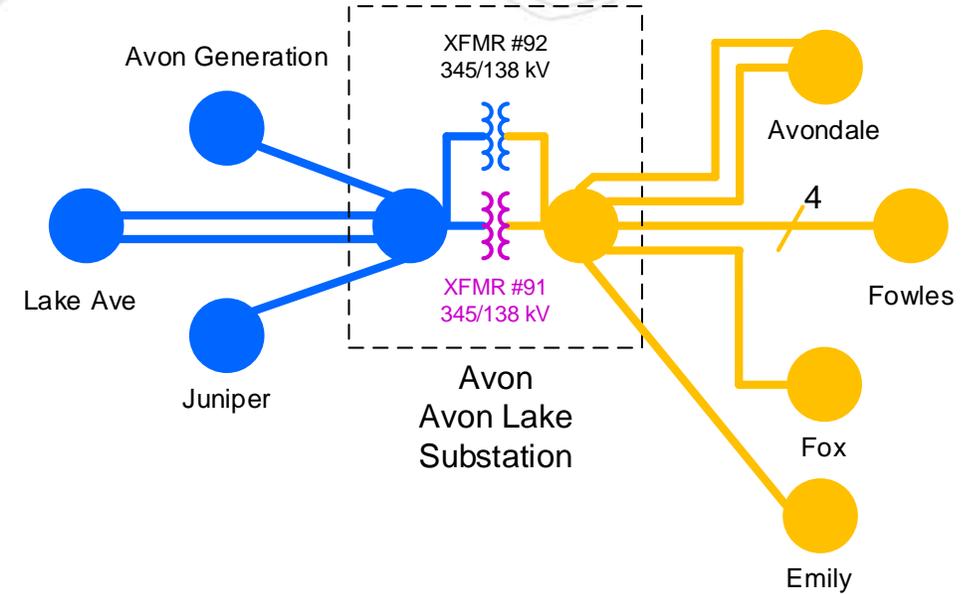
**Avon 345/138 kV #91 Transformer Replacement**

- Replace existing Avon #91 345/138 kV transformer (448 MVA) with a new 345/138 kV transformer (560 MVA)

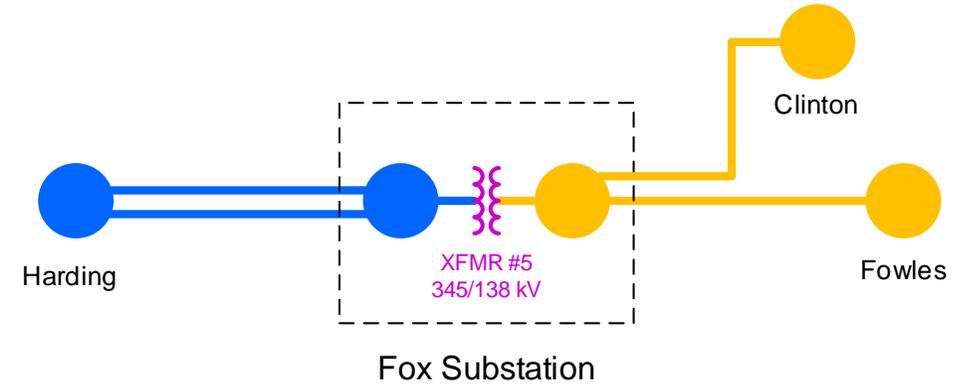
**Fox 345/138 kV #5 Transformer Replacement**

- Replace existing Fox #5 345/138 kV transformer (224 MVA) with a new 345/138 kV transformer (280 MVA).

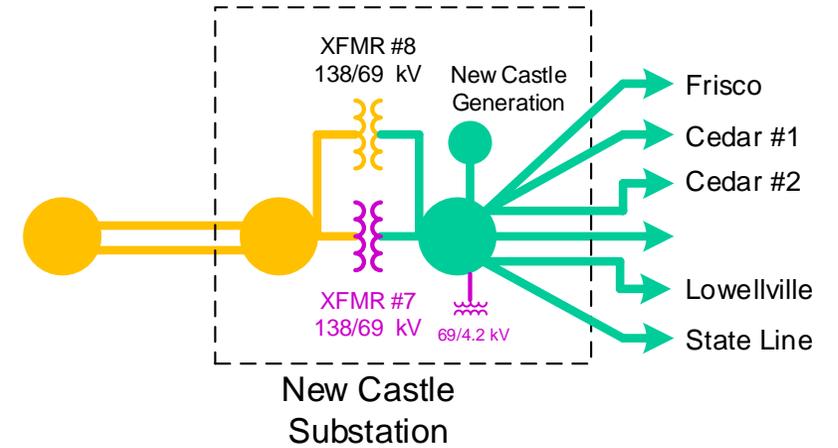
**New Castle #7 138/69 kV Transformer Replacement**

- Replace existing New Castle #7 138/69/4.2 kV transformer (125 MVA) with new 138/69 kV transformer (134 MVA).
- Replace existing 69 kV breaker (B32).
- Install new 69/4.2 kV transformer (15 MVA) and a 69 kV circuit breaker in existing 69 kV transformer position for generation station service.

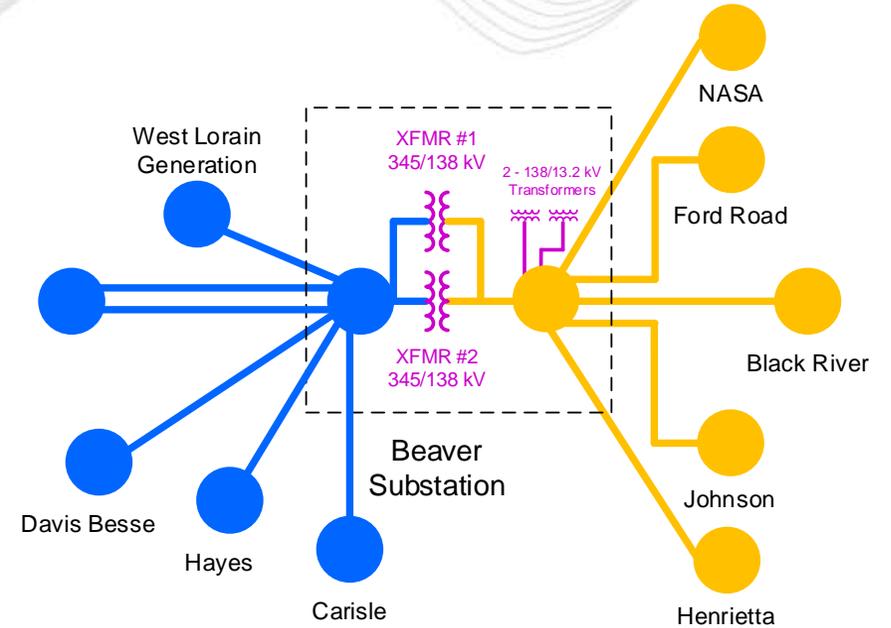
**Beaver #1 and Beaver #2 345/138 kV Transformer Replacement**

- Replace existing Beaver #1 345/138/13.2 kV transformer (350 MVA) with new 345/138 kV transformer (448 MVA)
- Replace existing Beaver #2 345/138/13.2 kV transformer (350 MVA) with new 345/138 kV transformer (448 MVA)
- Install new 138/13.2 kV transformer (14MVA) and breaker for power to station service at Beaver
- Install new 138/13.2 kV transformer (14MVA) and breaker for power to station service at West Lorain Generation

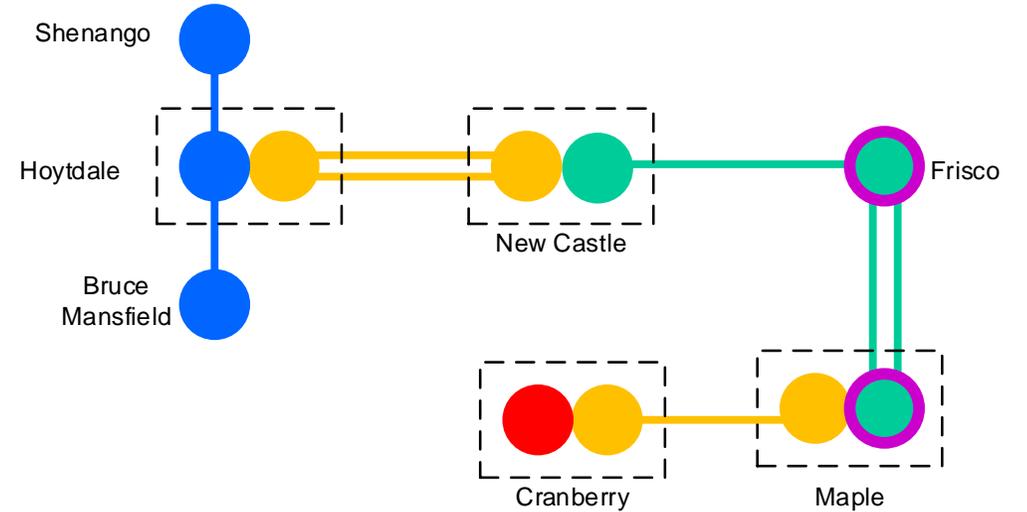
- Install new relay panels on B4 breaker and line exit.
- Upgrade 336.4 ACSR substation conductor
- Replace disconnect switches

- Install new relay panels on B118 breaker and line exit.
- Upgrade 336.4 ACSR substation conductor at Maple
- Replace disconnect switches
- Replace Breaker B118 (due to age and condition)

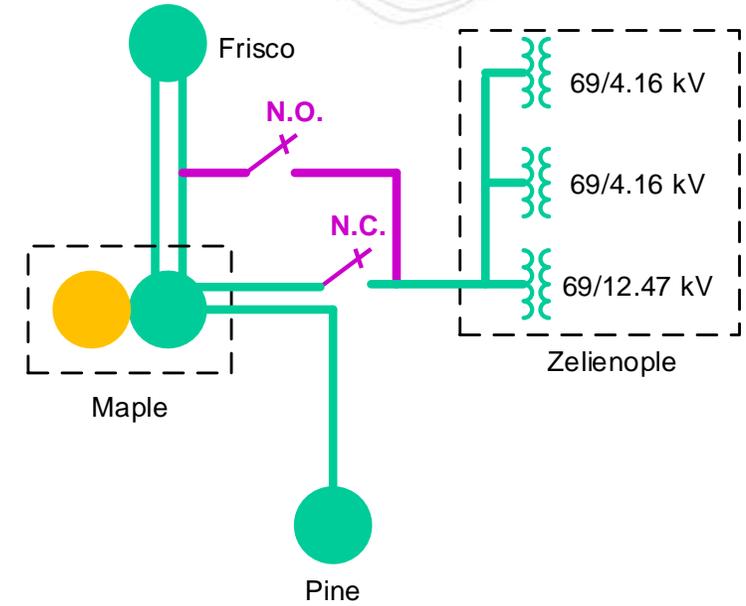
- Install one normally closed SCADA controlled switch on the Maple-Zelienople 69 kV Line
- Install one normally open SCADA controlled switch to connect the Zelienople 69 kV load to the Maple-Frisco 69 kV Line under emergency or maintenance conditions.

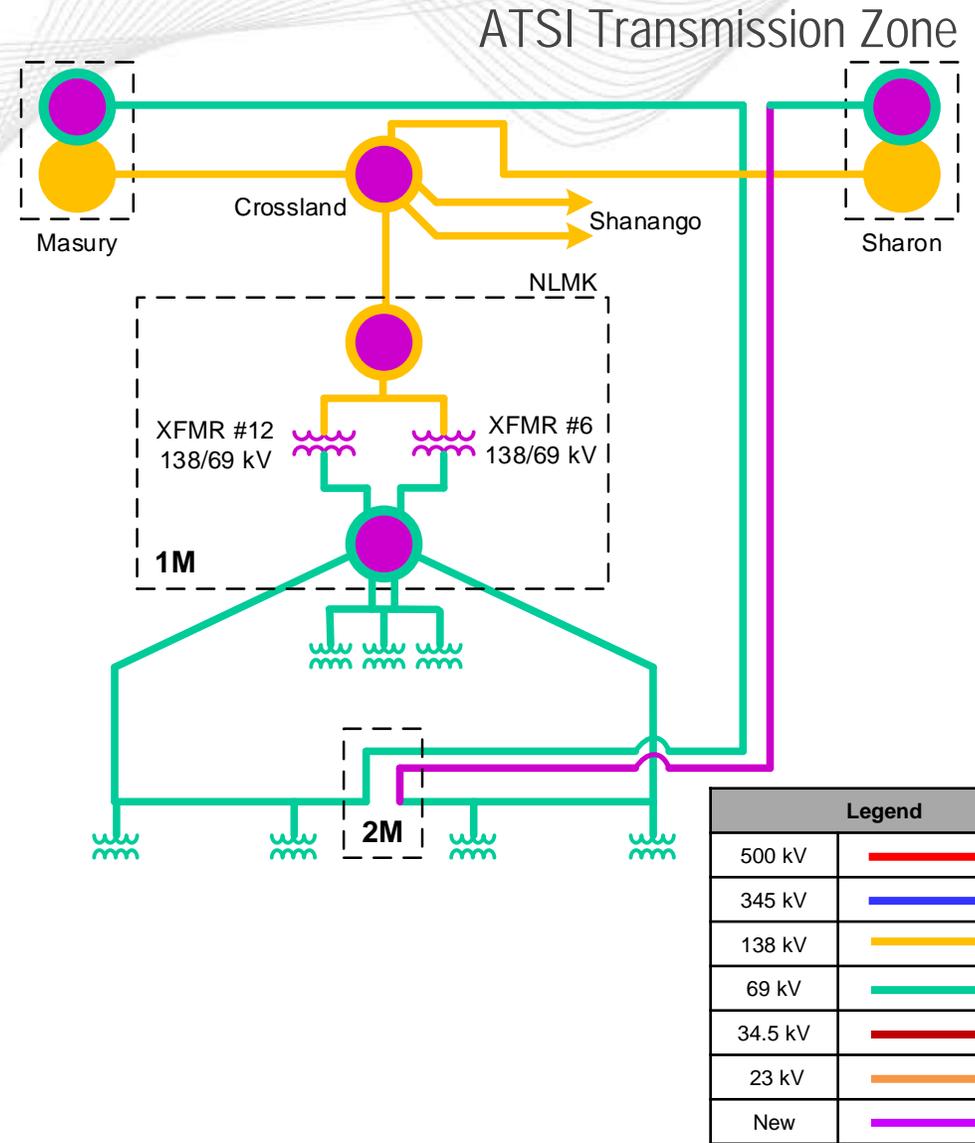
**NLMK 138/69 kV Substation Rebuild Project**

- Retire existing NLMK 1M and 2M substations and network the existing NLMK 69 kV system with the Masury-Sharon 69 kV line
- Install a loop structure at the Masury tap and rebuild the segment of line from the tap to the 2M substation as double circuit 336 ACSR (0.8 miles)
- Replace existing NLMK 138/69 kV 1M substation with new a 138/69 kV substation
  - 3-138 kV breakers in a straight bus configuration (1-Line and 2-transformer breakers)
  - 2-138/69 kV transformers (134 MVA)
  - Six (6) breaker 69 kV ring bus
  - New control building
- Re-configure existing 69 kV lines around NLMK
  - Masury-NLMK 69 kV Line: 57 MVA SN / 73 MVA SE
  - Sharon-NLMK 69 kV Line: 57 MVA SN / 73 MVA SE
- Install revenue metering
- Add a 138 kV breaker at Crossland for the Crossland-NLMK 138 kV Line
- Upgrade 69 kV relays at Masury and Sharon substations

Convert Masury 69 kV into breaker-and-a-half configuration and replace two (2) 138/69 kV transformers, seven (7) 69 kV breakers at NLMK 1M substation, and all substation control cable at NLMK 1M substation

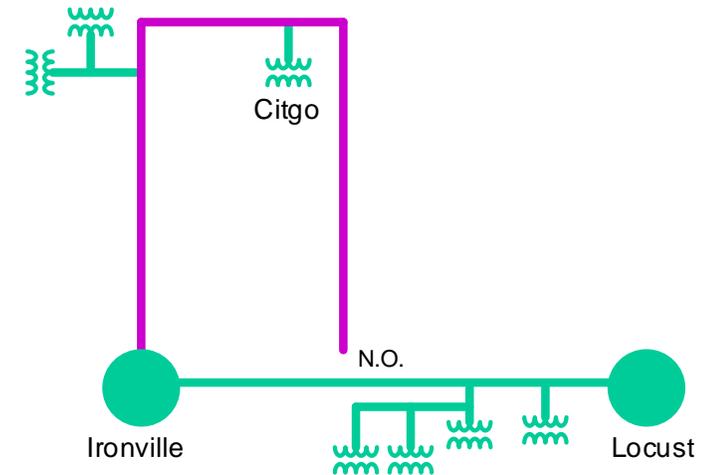
- Rebuild/reconductor existing radial Ironville – Citgo 69 kV Line with 477 ACSR and replace line switches A6648, A6791, A6792, A6793, and A6647.
- Existing conductor is 336 ACSR.

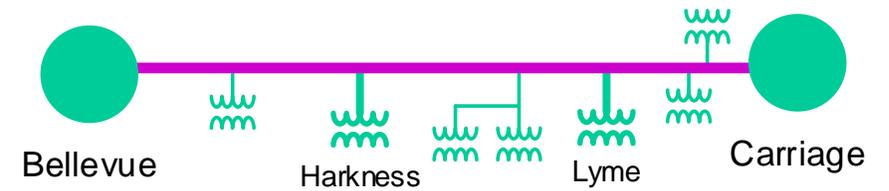
**Bellevue-Carriage 69 kV Line**

- Rebuild/reconductor ~9.7 miles of the existing Bellevue-Carriage 69 kV Line with 336 ACSR (existing conductor 3/0 ACSR, 336 ACSR and 4/0 CU); replace existing line switches at Harkness (A50 & A51) and Lyme (A1 & A2) substations.
- Existing line rating: 45 MVA SN / 54 MVA SE
- New line rating: 76 MVA SN / 92 MVA SE
