PJM Western SRRTEP Committee AEP Supplemental Projects

April 23, 2019

Changes to Existing Supplemental Projects Before M-3 Process

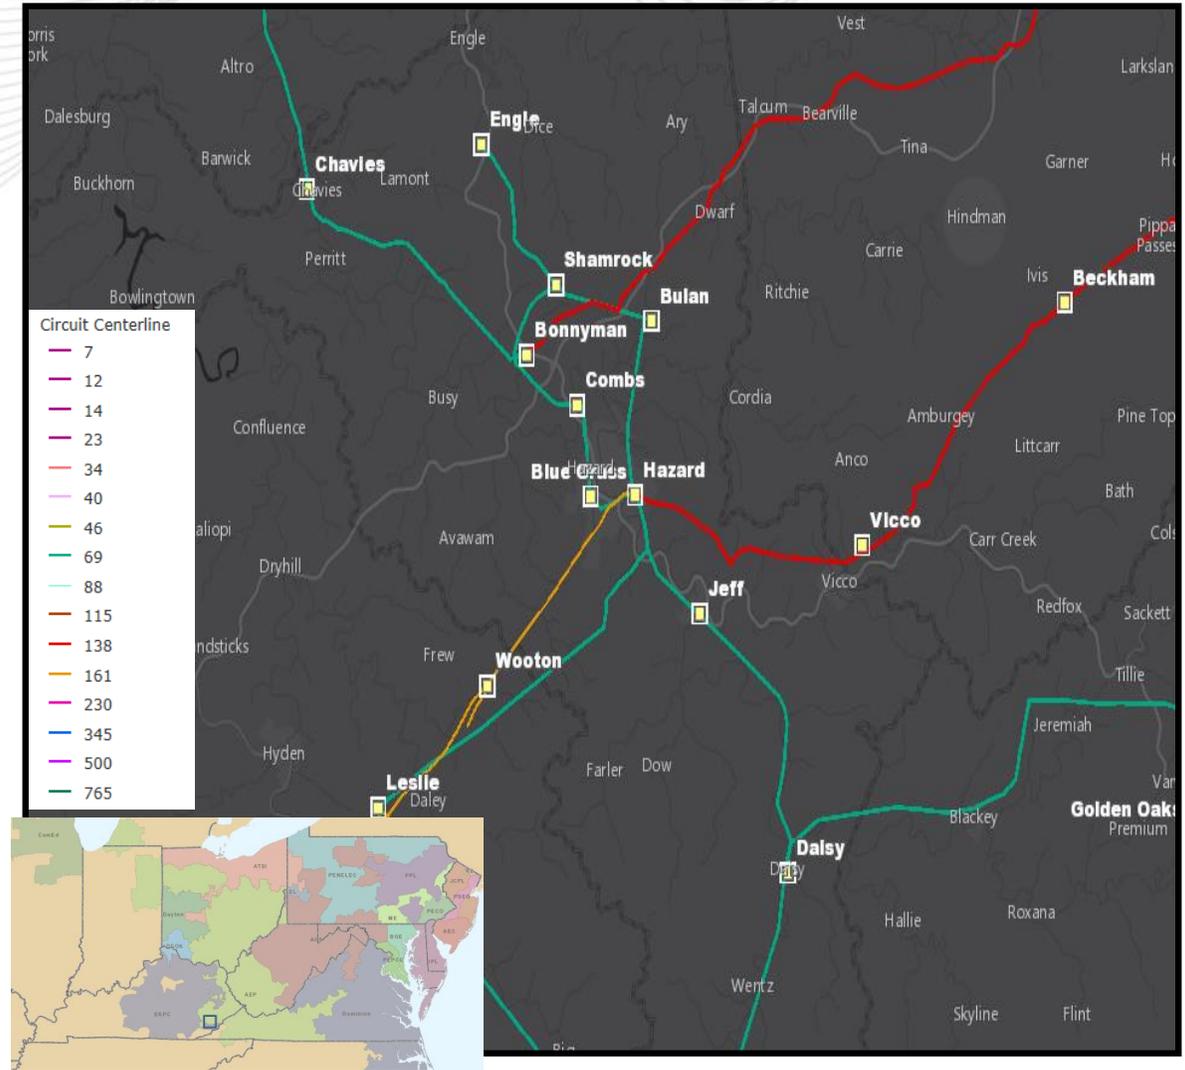
Circuit breakers S (1100 A, 11.3 kA) and E (1800 A, 27 kA) at Hazard station are FK type breakers all over 40 years old. Circuit breaker F at Hazard is a 1200 A, 31.5 kA CG type breaker. These are oil breakers that have come more difficult to maintain due to the required oil handling. In general, oil spills occur often during routine maintenance and failures with these types of breakers. Other drivers include PCB content, damage to bushings and number of fault operations exceeding the recommendations of the manufacturer. Breakers S, E, and F have experienced 82, 184, and 193 fault operations respectively, well above the manufacturer's recommendation of 10.

Circuit breaker M (2000 A, 40 kA) will need to be relocated in association with the baseline project to replace the existing 161/138 kV transformer at Hazard station (b2761) in order to limit outage times. The breaker is an SF6-gas breaker, 29 years old and has experienced 21 fault operations, which exceeds the manufacturer's recommendation of 10.

Transformer #1 (1974 vintage, 50 MVA) and #2 (1973 vintage, 130 MVA) show dielectric breakdown (insulation), accessory damage (bushings/windings) and short circuit breakdown (due to amount of through faults). Transformer #1 also shows signs of corrosion on radiators as well as oil leaks.

Circuit Switcher BB a MARK V unit which have presented AEP with a large amount of failures and mis-operations. AEP has determined that all MARK V's will be replaced and upgraded with the latest AEP cap-switcher design standard. **Capacitor bank BB will need to be relocated in association with the baseline project to replace the existing 161/138 kV transformer at Hazard station (b2761).** Additional engineering design has indicated that Capacitor bank BB would not need to be relocated to accommodate the baseline 161/138 kV transformer replacement/relocation.

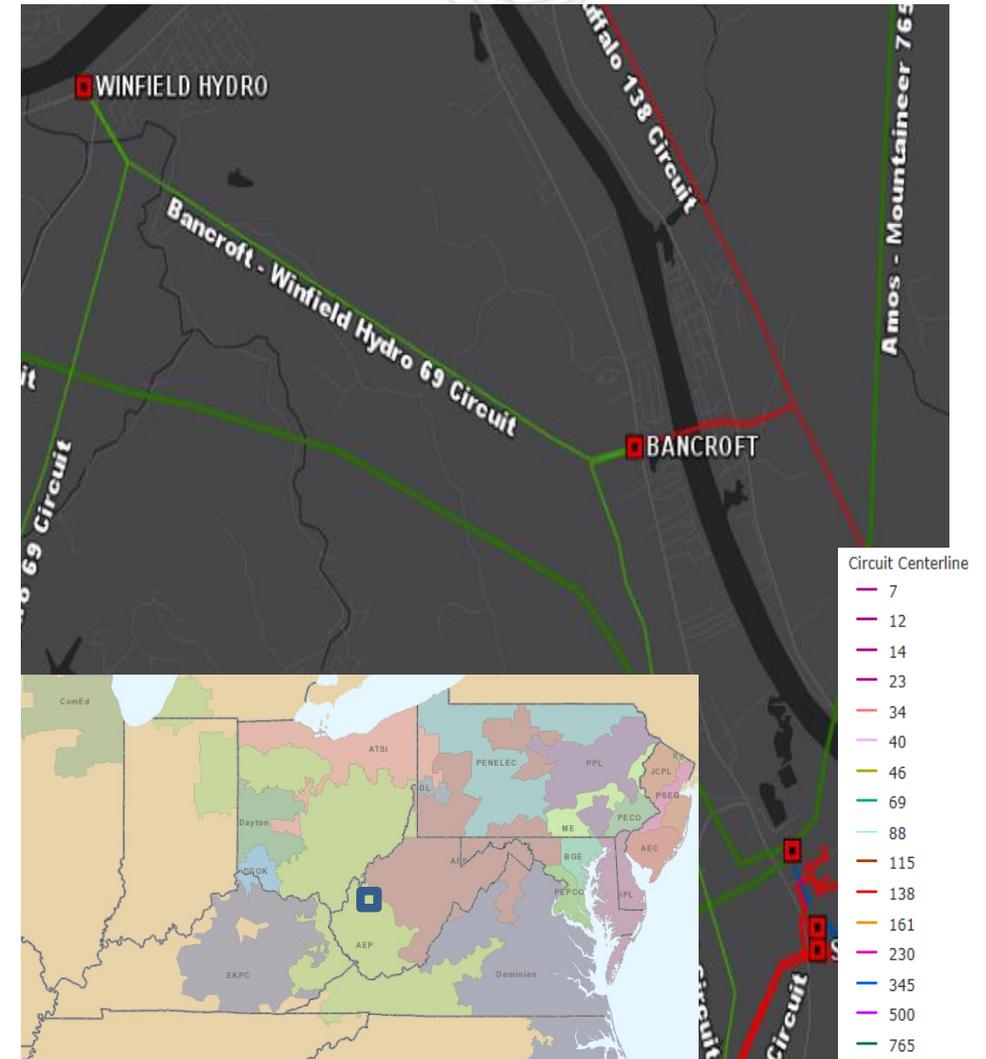
69 kV circuit breakers F and G at Bancroft station are CF-48 oil type breakers that were manufactured in 1965.

- Oil breakers are more difficult to maintain as oil spills have the potential to occur during maintenance which can be an environmental and safety hazard.
- Breakers F and G have experienced 55 and 70 fault operations, exceeding the manufacturer's designed number of fault operations of 10.

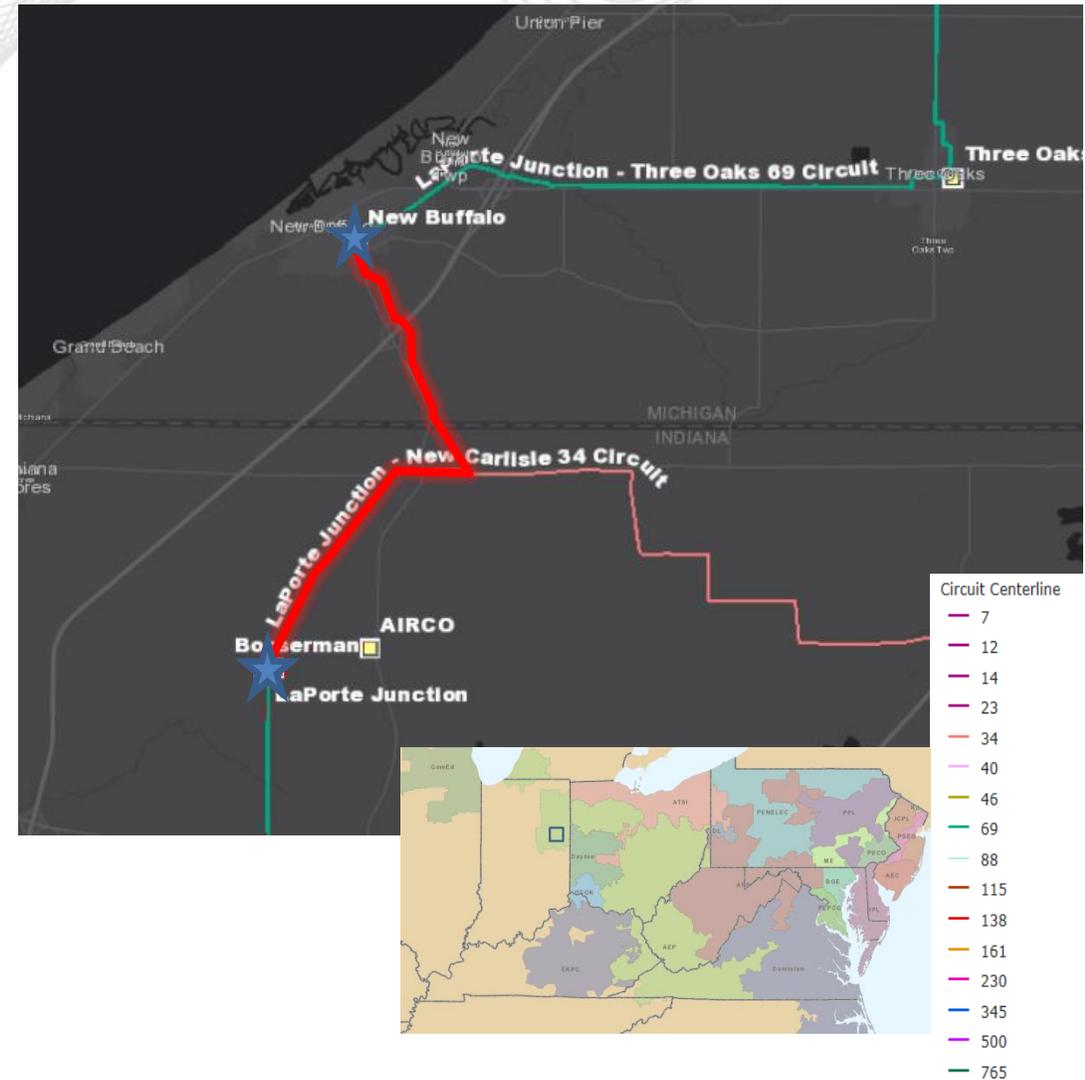
Laporte Junction – New Buffalo (IN) 69 kV Line (~4 Miles)

- 1960's vintage wood crossarm construction
- Approximately 78% of the structures have Insect Damage
- There are currently 132 open conditions on this line with majority being structure issues. The O&M cost of the line is expected to increase as the age of the line increases.

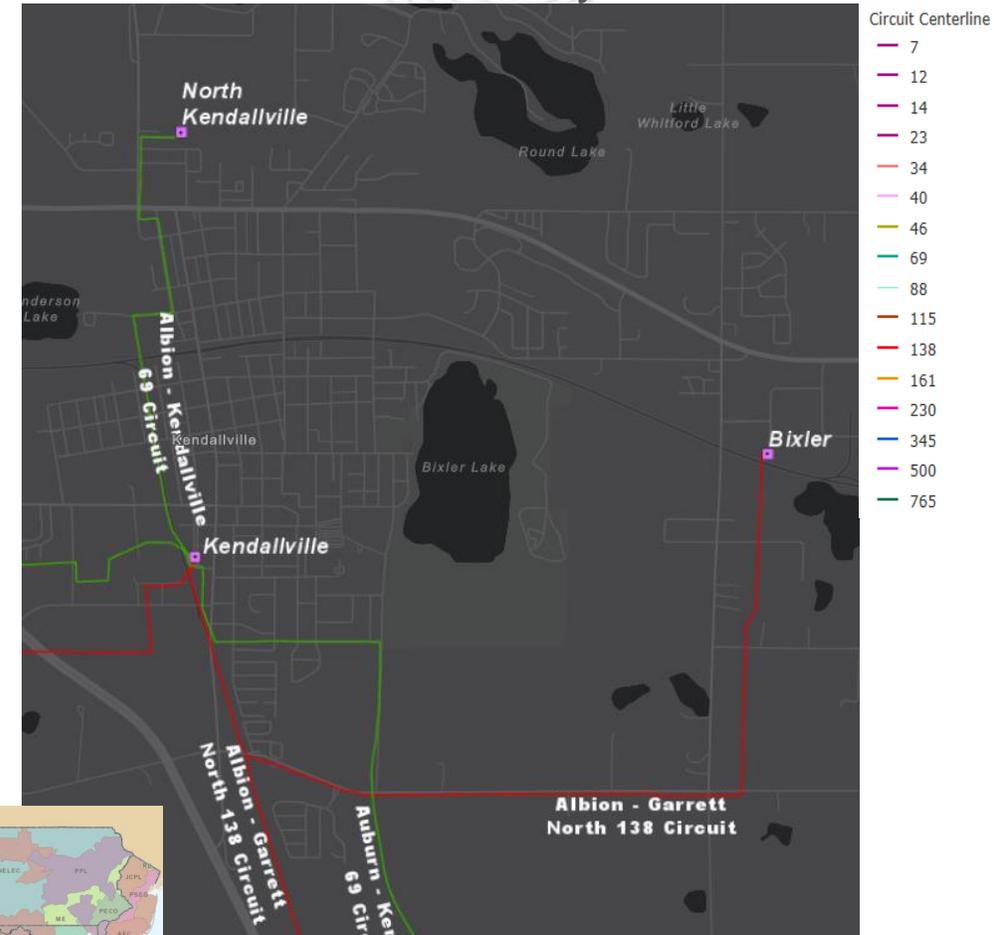
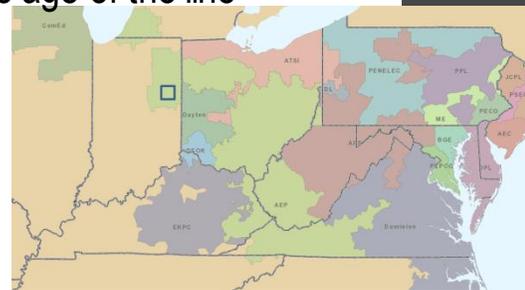
Kendallville – North Kendallville 69 kV Line (~1.7 Miles)

- 1960's vintage wood pole construction
- There are currently 5 open conditions on this line with majority being structure issues. The O&M cost of the line is expected to increase as the age of the line increases.
- CMI: 1,541,297
- Forced Momentary Outages: 1
- Forced Permanent Outages: 9

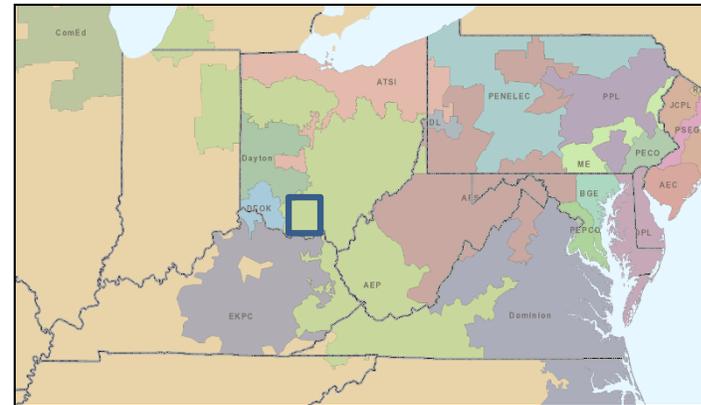
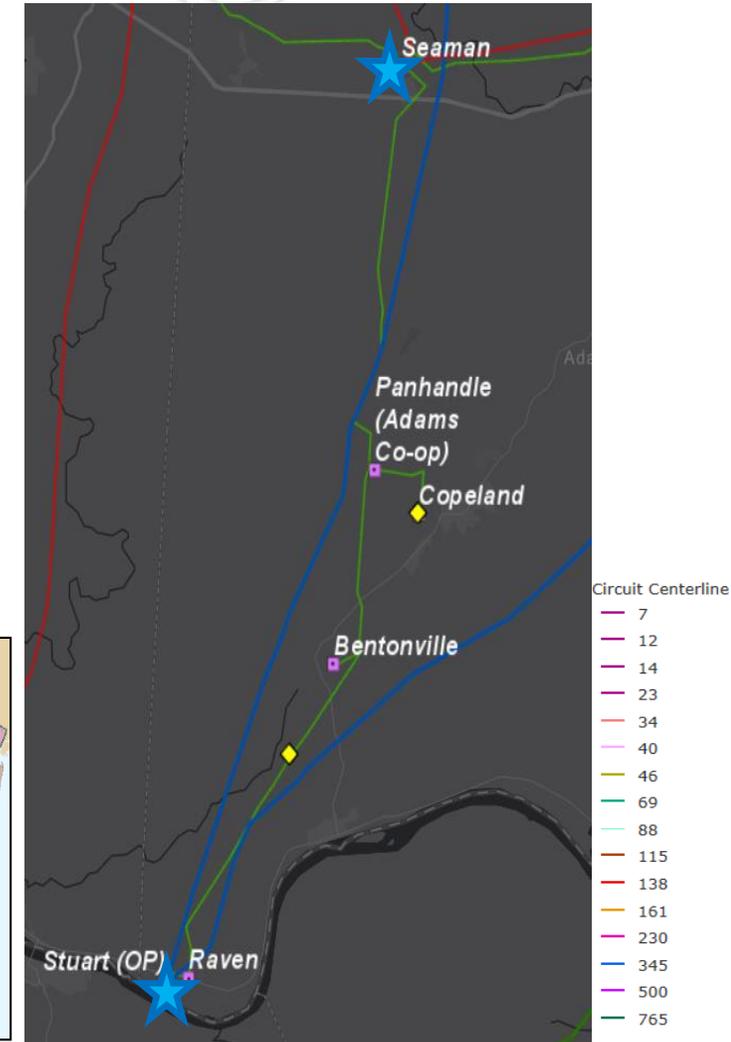
- The existing 28.5 mile, 69 kV line section between Stuart (DP&L/Duke) and Seaman(AEP) was constructed in 1974 using wood pole structures with 636 ACSR conductor. There are 260 open A conditions distributed across the 170 structures on this line.
- The Stuart-Seaman 69 kV circuit has experienced over 2.2 million customer minutes of interruption in the past three years: 753,716 for AEP and 1,517,618 for Adams Coop.

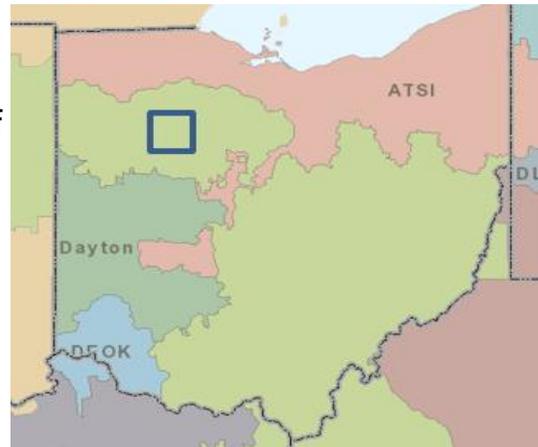
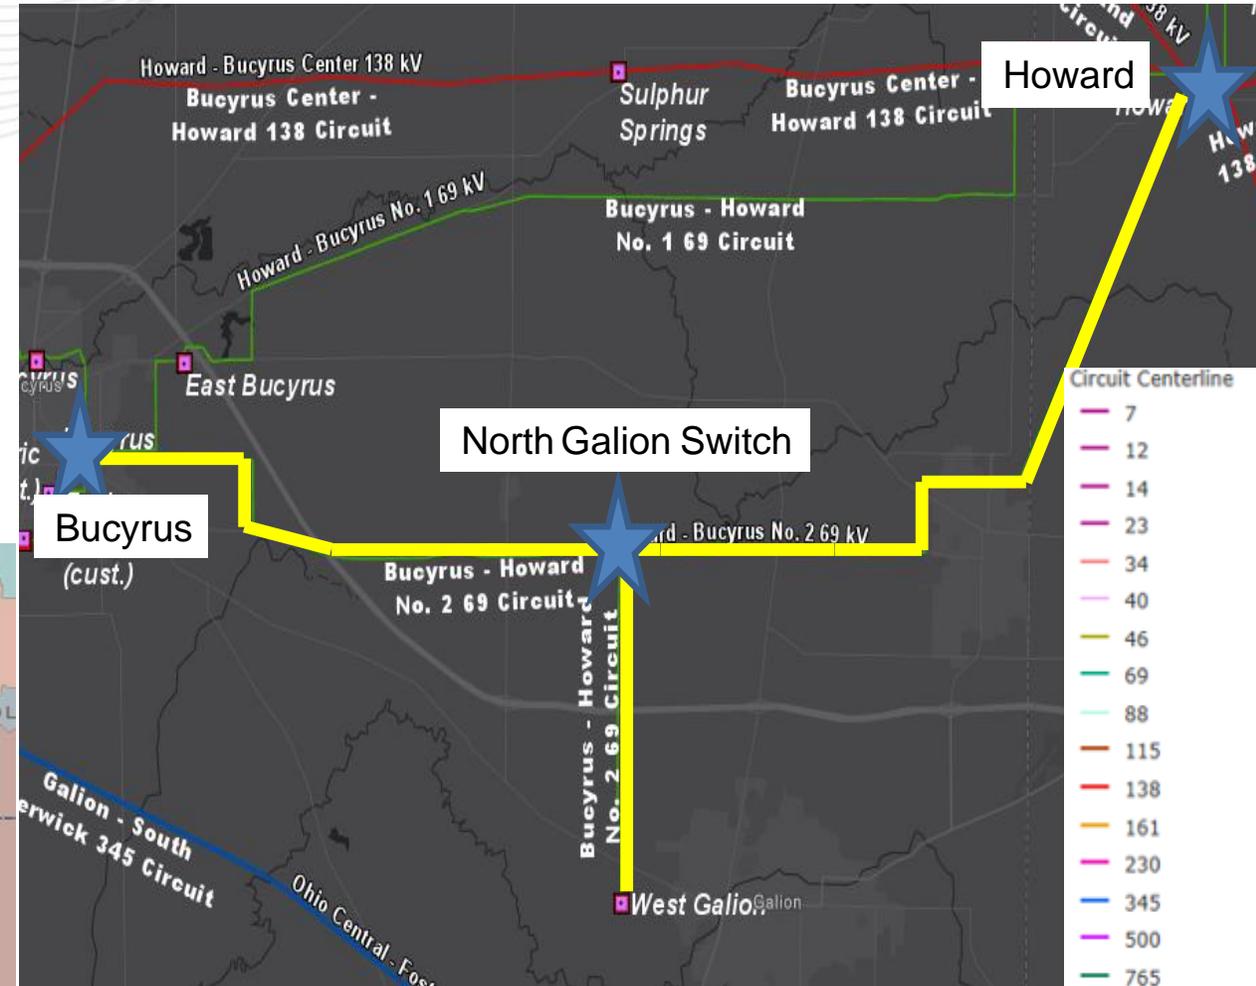
- The Bucyrus-Howard No.2 69 kV circuit was originally constructed in 1919 with wood structures and copper conductor (#1 CU and 3/0 CU). 84% of the line still utilizes the original 1919 copper conductor.
- Some structures have been replaced over the years; however, they have been like for like wood pole replacements.
- The circuit has had 38 forced operations in the last 11 years of which 7 have been permanent and resulted in 54 hours of down time. 2 out of the 7 outages have been caused by conductor failures, the most recent of which resulted in 188,000 CMI.
- There are currently 144 open conditions along the 23 mile long line.

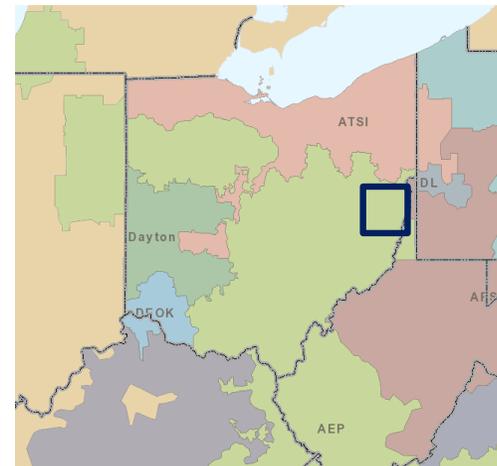
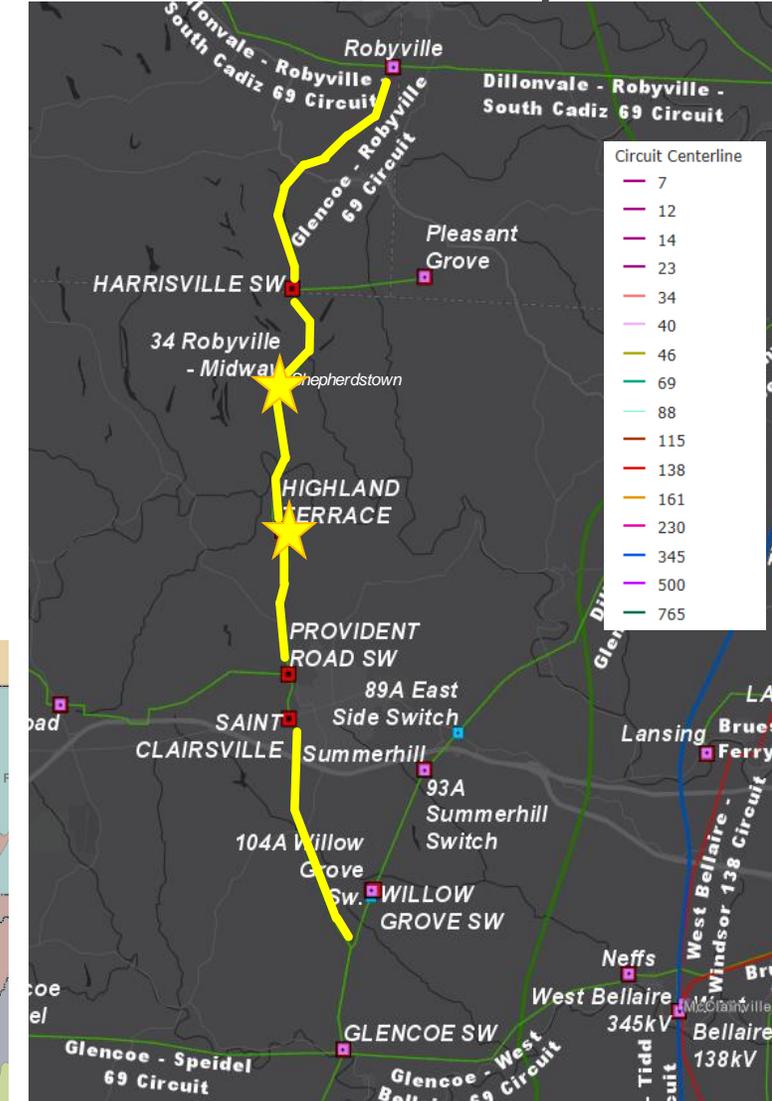
- The Glencoe – Robyville 69 kV circuit is 13.3 miles long and originally constructed in 1915-1925 using wood pole structures. This circuit currently has 556 ACSR 18/1 (Osprey) conductor rated for 126 MVA WE.
- The Glencoe – Robyville 69 kV circuit has 136 open A conditions which includes broken shield/ground wires, heavy structure rot, woodpecker damage, broken insulators, and split cross arms/knee braces.
- This circuit has experienced 789,612 CMI between 2013 – 2018.
- The existing switch at Highland Terrace two-way GOAB that restricts our ability to perform routine maintenance and restoration activities in this remote area of our system.
- The Shepherdstown delivery point is connected via a hard tap which limits operational flexibility, can cause over tripping and relay mis-operations, and restricts restoration activities.

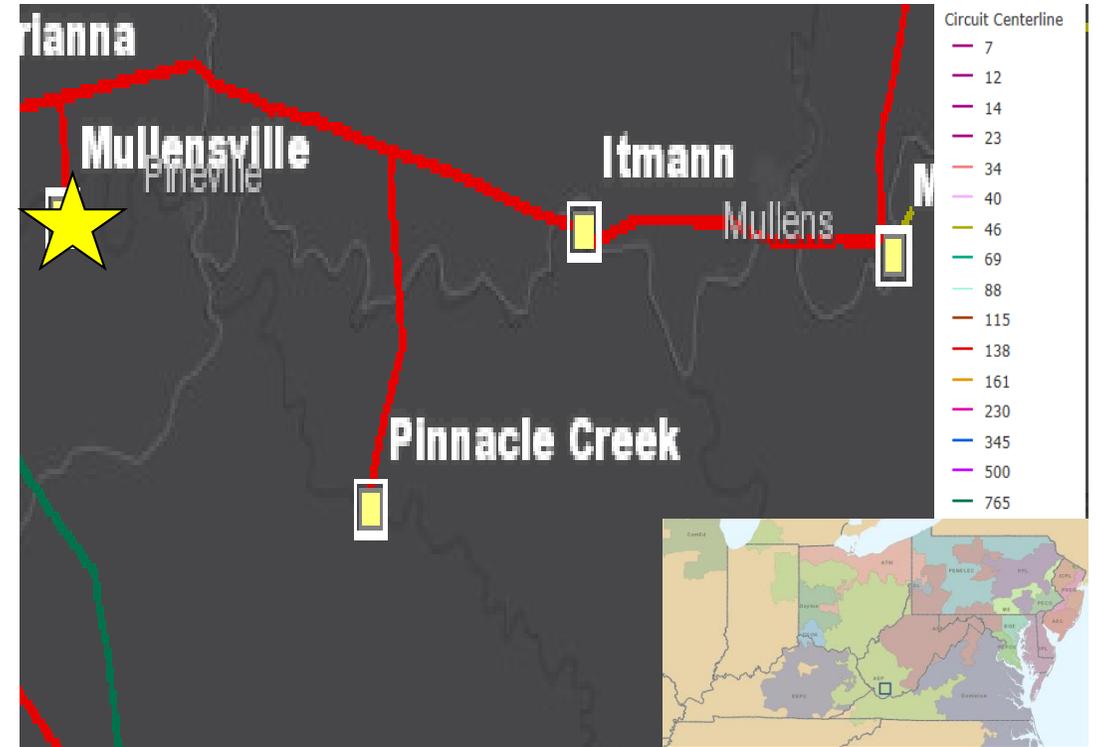
The need to address Mullensville transformer #1 is driven by the short circuit strength breakdown caused by the amount of electrical discharges of high energy has led to rising gas levels in the tank oil and carbonization of the insulating paper. Acetylene is at IEEE Condition 3 and Ethylene is at IEEE Condition 2 per the latest DGA readings in 2018 which contributes to poor dielectric strength. The rising presence of these hot metal gasses can be caused by poor connections, shorted turns, broken winding strands, or inadvertent core grounding from damage to the core ground insulation during through faults events; all of these are indicative of circulating currents in the core resulting in hotspots of the core and surrounding internal components. High energy discharges can be caused by flashovers, tracking or arcing, or short circuits between a number of internal components.

In addition to the 2018 compressor failure on CB A, IPS malfunction records indicate that the compressor motor burnt up in 2008 and failed again in 2009. There are only 13 of these FK-69-1500-3 types on the AEP system, making replacement parts difficult or impossible to obtain. This oil filled breaker has no oil containment and requires O&M costs to maintain the unit's oil that similar SF6 type breakers do not require.

The Ground-Switch MOAB on the high side of the 138/46 kV transformer at Mullensville are obsolete and create an overlap in the zones of protection.

Replace Gr. Sw. MOAB with a new 138 kV circuit switcher. Replace existing 138 kV/46 kV 30 MVA XFR #1 with a new 138/46 kV 30 MVA XFR. Replace 46 kV circuit breaker A with a new 46 kV 3000 A 40 kA circuit breaker.

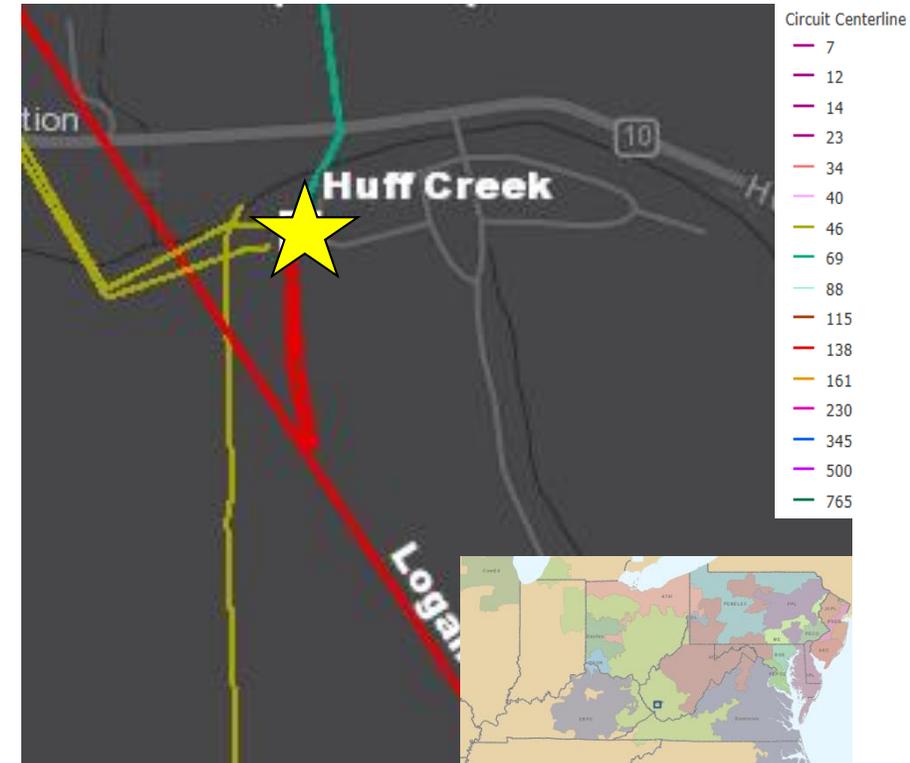
The need to address Huff Creek transformer #1 is driven by the oil's interfacial tension, which has been consistently below 30 mN/m (the acceptable limit for this voltage class). This is an indication of sludge beginning to form from oil contaminants, which will lead to accelerated aging of the unit, the sludge will impair oil circulation and lead to more frequent overheating. In addition, the moisture content and CO levels have begun a rapid increase over the past four years. CO is now at IEEE Condition 2 and dielectric strength is trending down. The presence of increased CO and moisture levels occurring over the same span of time is indicative of the cellulose breakdown from the insulating paper; this increases the risk of future shorts in the windings due to decreased insulating material.

The need to address Huff Creek ground transformer #2 is driven by Thermal through fault events, mostly in excess of 700°C, have led to, steady increases in gasses including the now IEEE Condition 3 levels of ethylene in PH A, IEEE Condition 2 levels of carbon monoxide in PH A, methane in PH B, and ethylene and methane in PH C. These faults have also generated carbonization of the insulating paper. In addition, all phases have seen sustained and elevated moisture levels which has resulted in low and decreasing dielectric strength.

The 69 kV circuit breaker D is an FK type oil filled circuit breaker with no oil containment. Oil filled breakers have much more maintenance required due to oil handling that their modern, SF6 counterparts do not require. Circuit breaker D is 1 of the 13 remaining FK-69-1500-3 model family remaining on the AEP system. This circuit breaker family is no longer supported by their original vendor and spare parts are scarce to non-existent. In addition, CB D has seen at least 148 faults; based on the maximum fault current levels available for this circuit breaker location, it has likely exceeded the manufactured life expectancy of cumulative fault current, 113 kA.

Huff Creek Substation currently deploys 74 relays, implemented to ensure the adequate protection and operation of the substation. Currently, all 74 (100% of all station relays) are in need of replacement. There are 60 of the electromechanical and 4 of the static type which have significant limitations with regards to spare part availability and fault data collection and retention in addition to a lack of vendor support. The remaining 10 microprocessor relays were commissioned in 1997 and 2007; the warranties are now expired and the firmware is no longer supported by the vendor. There appears to be little available panel space in the existing control house.

Replace existing 69 kV CB 'D' with a new 3000 A 40 kA 69 kV CB. Replace the existing 90 MVA 138/69/46 kV transformer #1 with a new 90 MVA 138/69/46 kV transformer. Replace the existing 3000 A GR. TRF Bank with a new 3000 A GR. TRF Bank. Replace the relaying at the station.

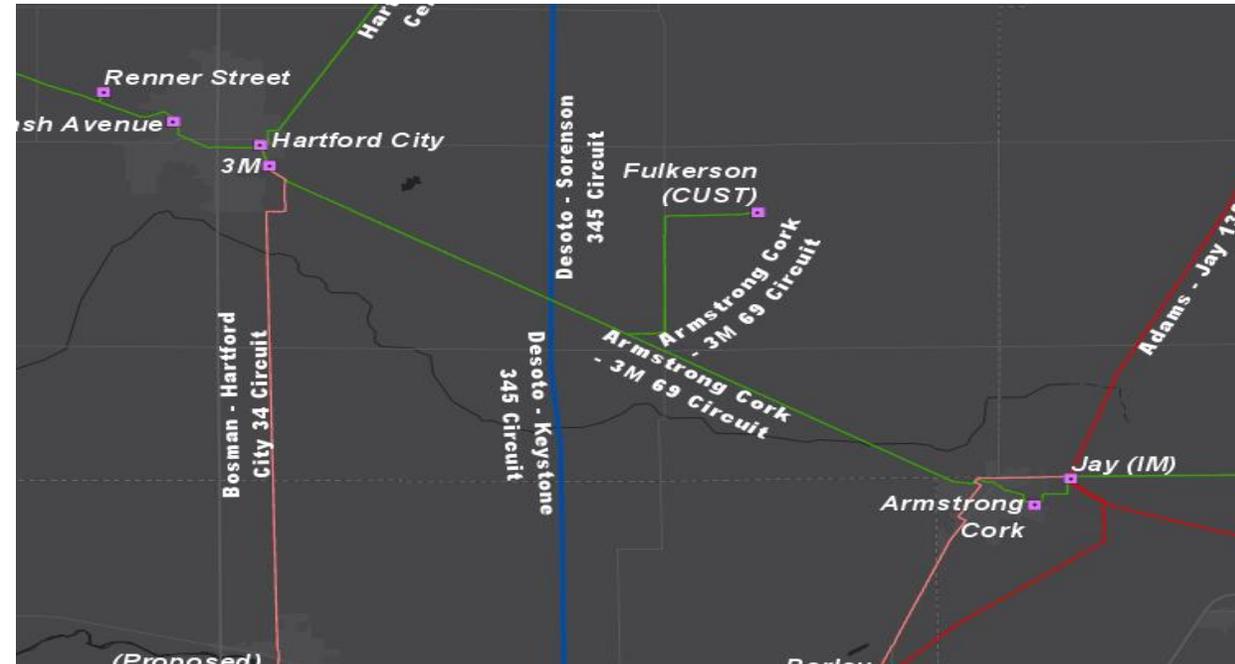
3M Station 69 kV Station

- Breaker A
 - 1967 FK oil filled breakers without oil containment.
 - Fault Operations: CB A(23) – Recommended (10)

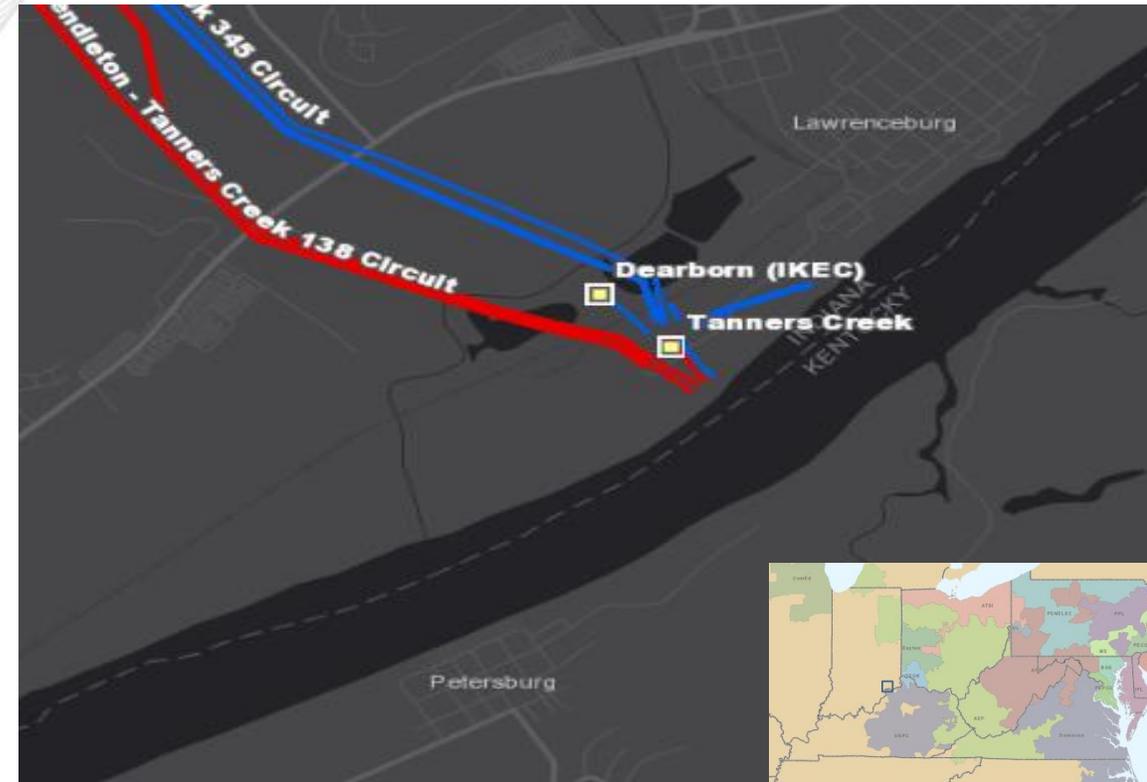
Tanners Creek 345 kV

- Currently a line fault on the Dearborn circuit causes 5 EHV breakers to open. This is above the AEP max of 4 and must be addressed.
- According to the DEDSTFMRS PJM document, 200 kV+ facilities with 7+ elements are required to be in a complete breaker and a half setup at a minimum. This facility has 9 elements and is currently in an incomplete breaker and a half setup.

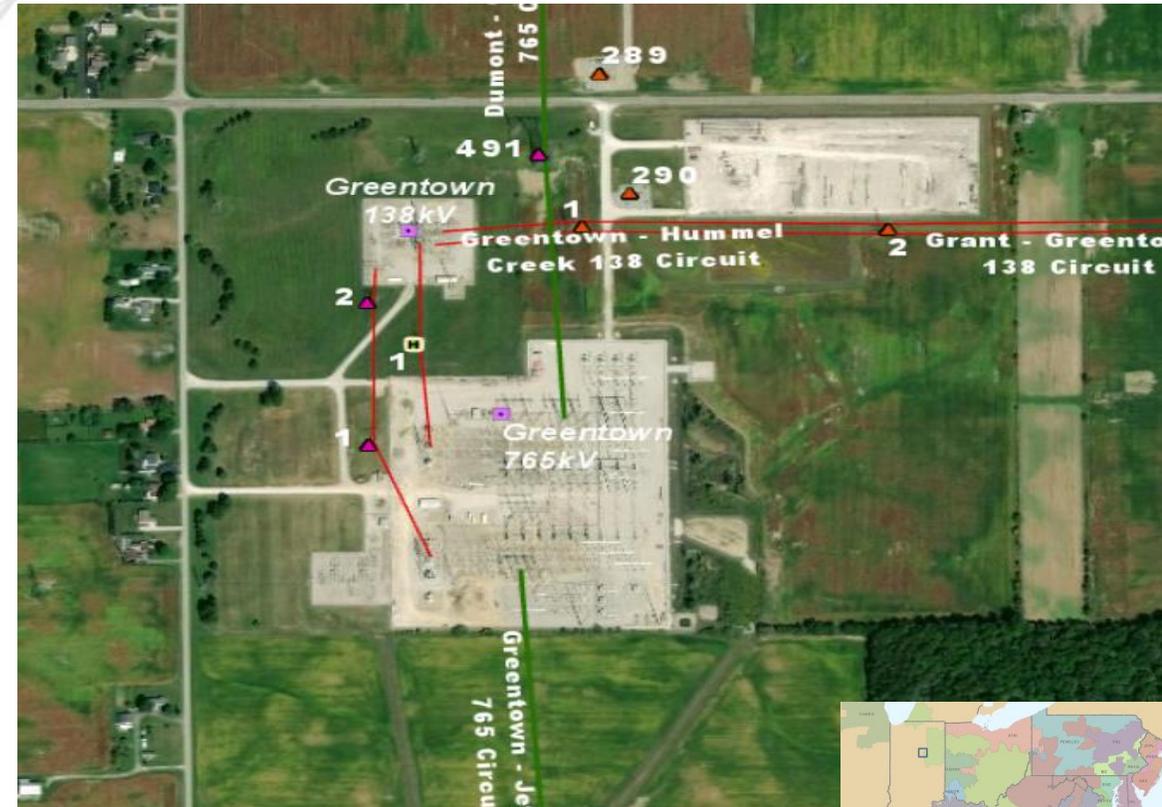
- Greentown
 - According to the DEDSTFMRS PJM document, BES facilities with 7+ elements are recommended to be in a complete breaker and a half setup at a minimum. This facility has 7 elements and is currently in an incomplete breaker and a half setup.

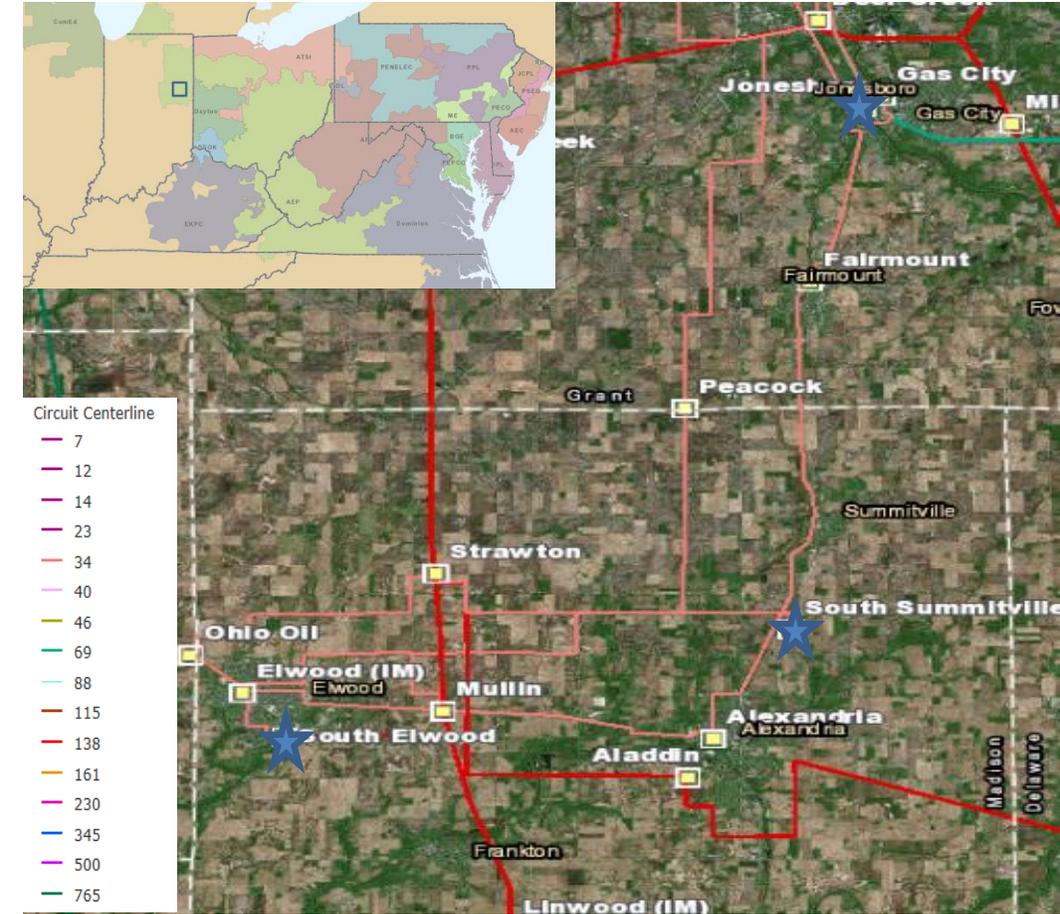
- 1951 FK oil type with no oil containment
- Fault Operations: CB C(19) – Recommended (10)

Transformer 1 – 1955 vintage

- Type O Westinghouse bushings
- Increasing power factor
- Increasing Carbon Monoxide
- Failed internal heater circuit.
- Physically obstructs other station assets.

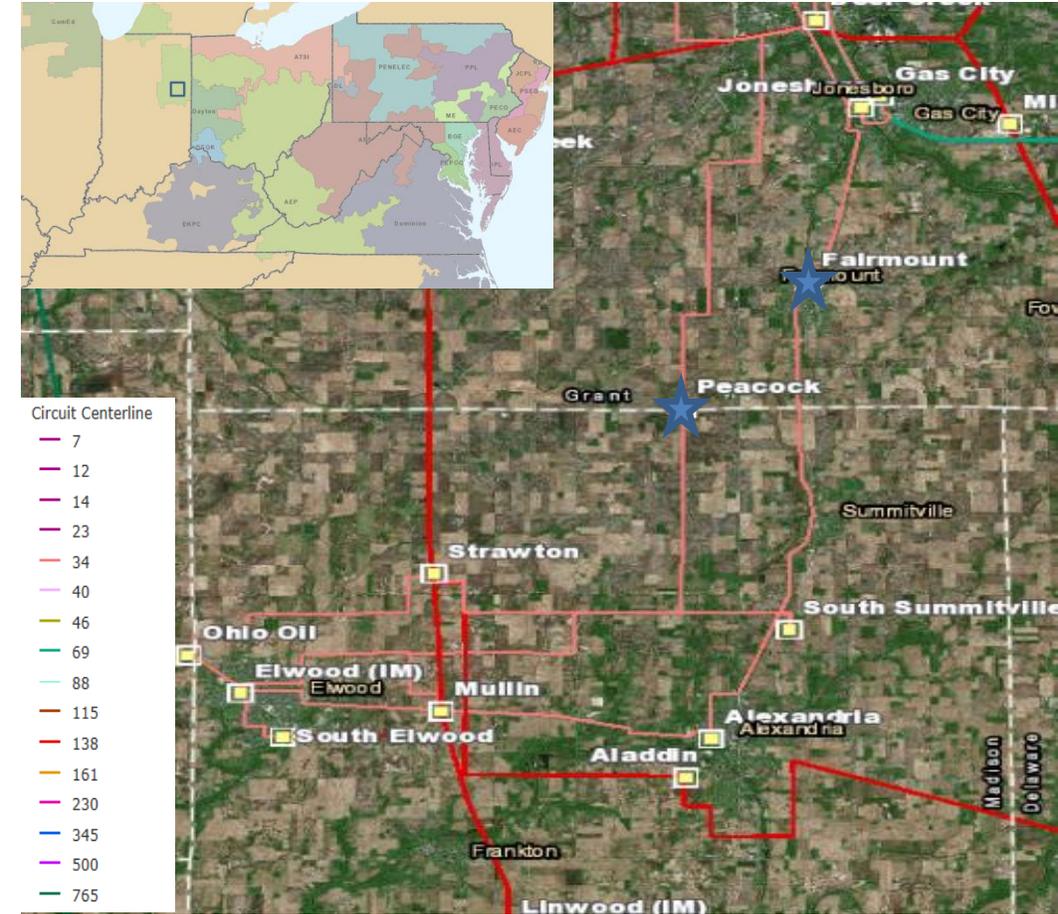
- 1969 PR Oil breaker without containment
- Fault Operations: A(154) – Recommended(10)

Transformer 1 – 1951 Vintage

- High levels of Ethane, Methane, and CO2.
- Increasing Insulation power factor.

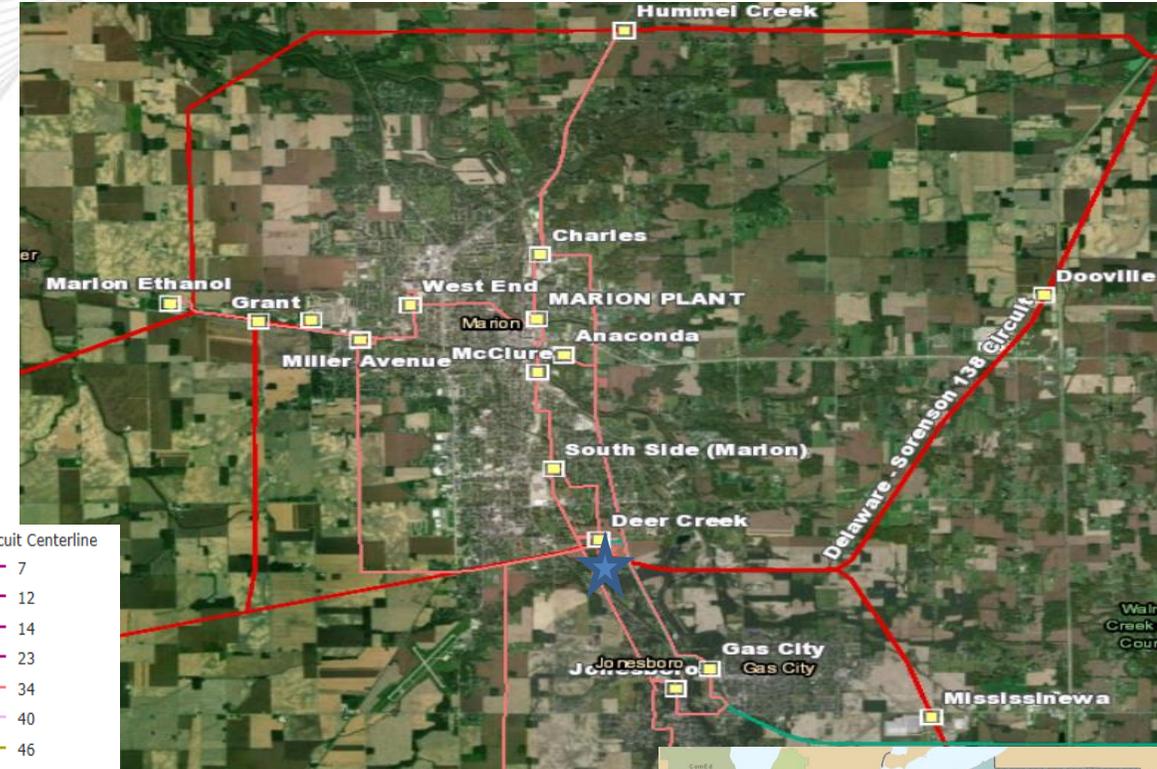
Deer Creek 34.5 kV

- Breakers “U”
 - 1950 vintage FK oil breakers without containment
 - Fault Operations: CB U(38)– Recommended(10)

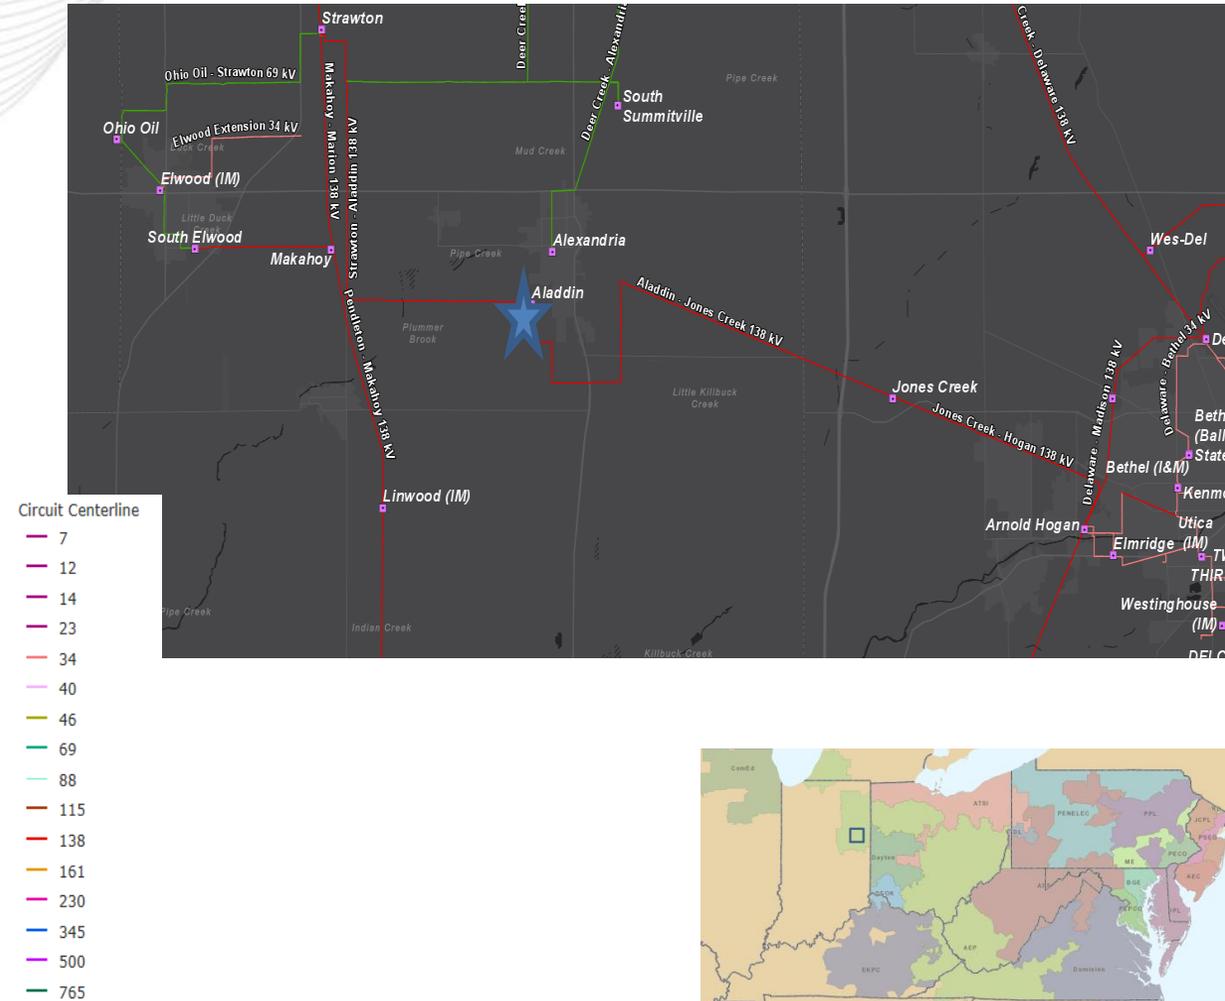
Strawton – Arnold Hogan 138 kV

- This line currently has 4 MOABS in series (2 at Aladdin and 2 at Jones Creek) which is above AEP's max of 3.

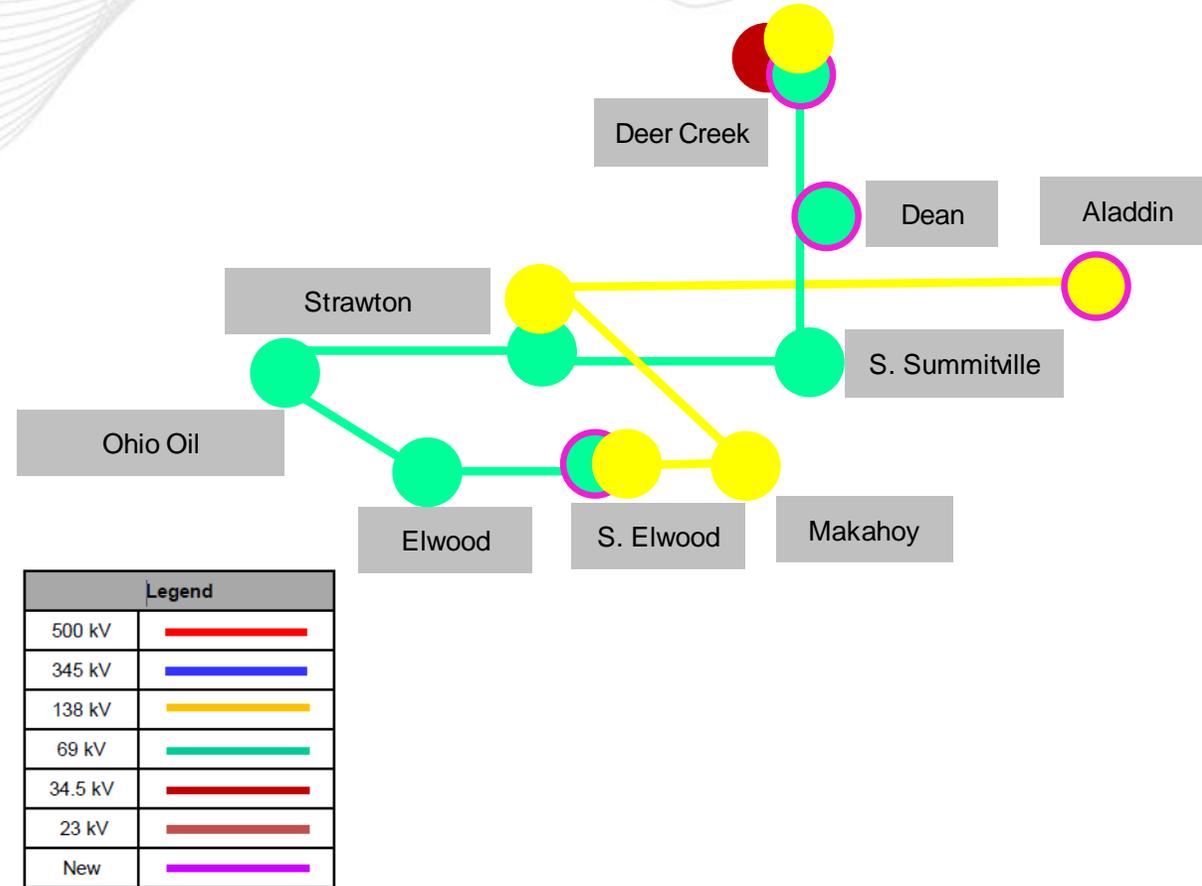
Install the new 69 kV Dean station with a single bus tie breaker to take replace the 34.5 Fairmount and Peacock stations

Replace the 138/34.5 kV XFR 1 and the existing 34.5 kV breaker with a 138/69 kV XFR and a 69 kV rated breaker

Install a 3 breaker 69 kV ring bus In the clear to enable the connection of the now 69 kV rated South Summitville line. Add a 138 kV breaker to the high side of XFR 1 to replace the moab.

Aladdin 138 kV station:

Install a 138 kV bus tie breaker at Aladdin station to breaker up the 4 MOABS in series

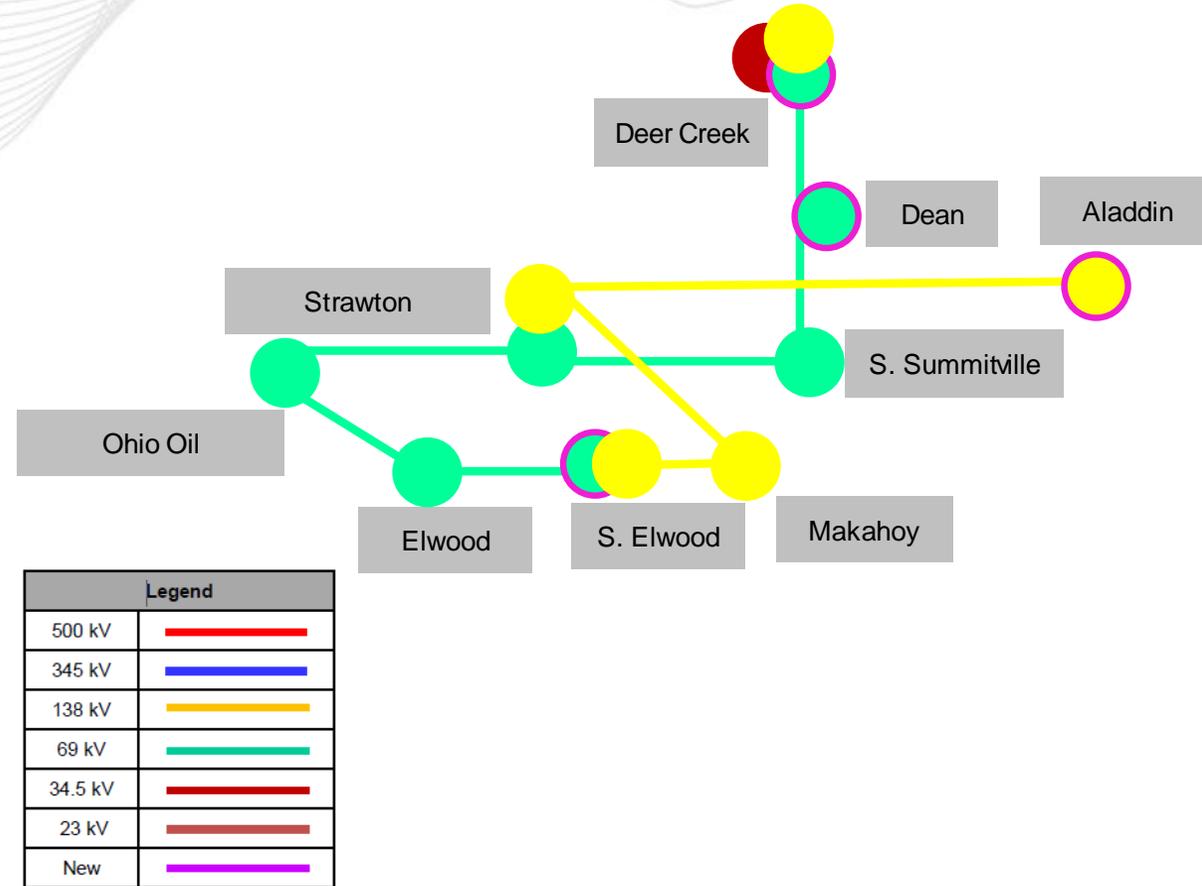
Alternatives:

Re-use both breakers at Elwood and keep the original configuration. While this configuration protects Elwood’s load from line faults, it doesn’t allow for AEP to take bus outages for maintenance. With the removal of the Cap Bank, full line protection becomes no longer needed. Changing the configuration to a single breaker improves distribution’s reliability, reduces the station footprint and saves money.
