SRRTEP Committee: Western AEP Supplemental Projects

April 20, 2020

Needs

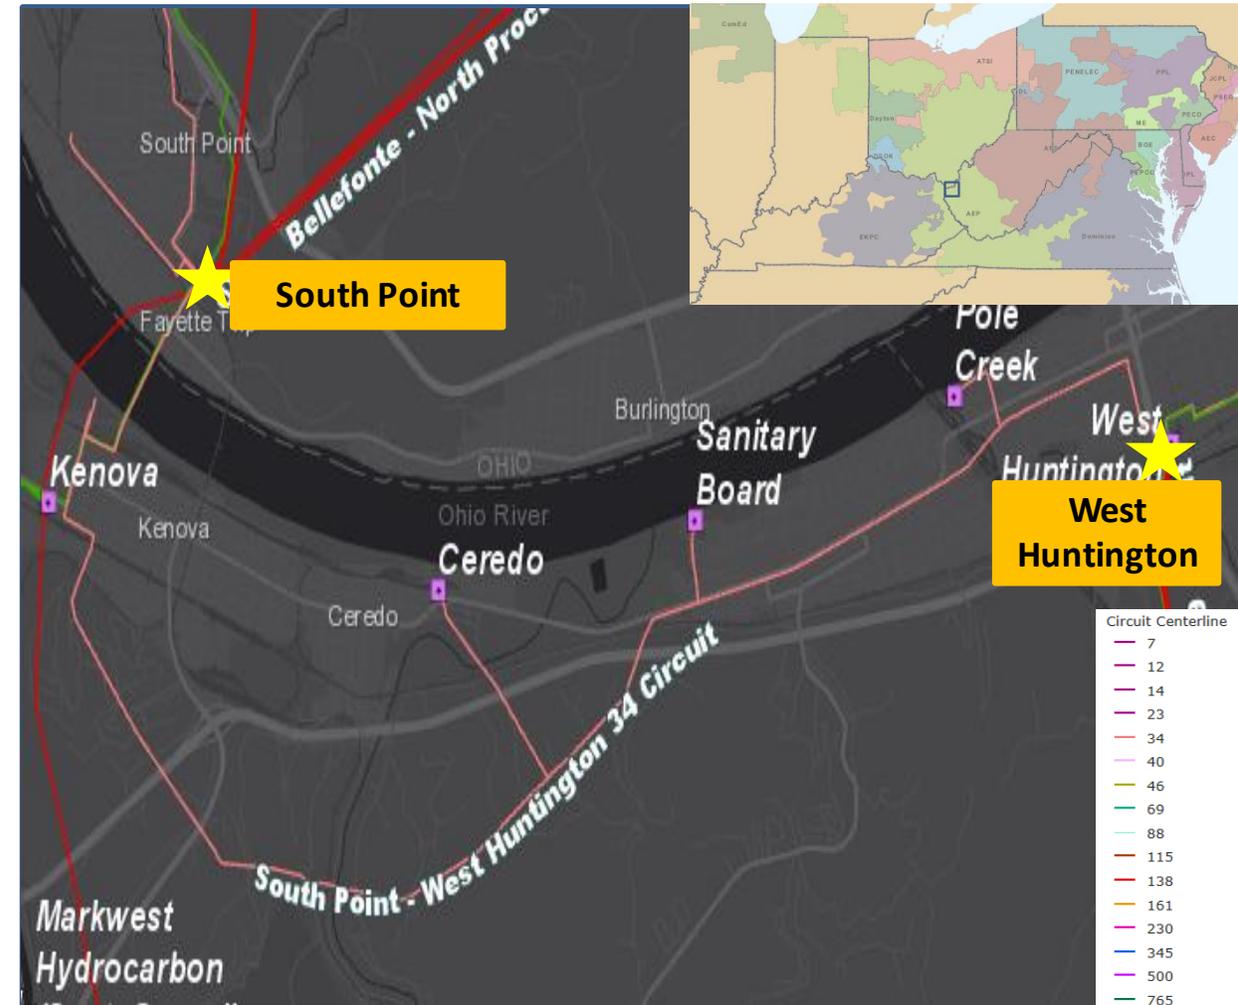
South Point – West Huntington 34.5 kV Line (~11 miles)

- The line consists of mainly wood pole (79%) structures in addition to steel (12%) and lattice steel (9%) structures.
- The line was originally built in 1926 (69%) and 1930 (10%) primarily with 4/0 copper conductor.

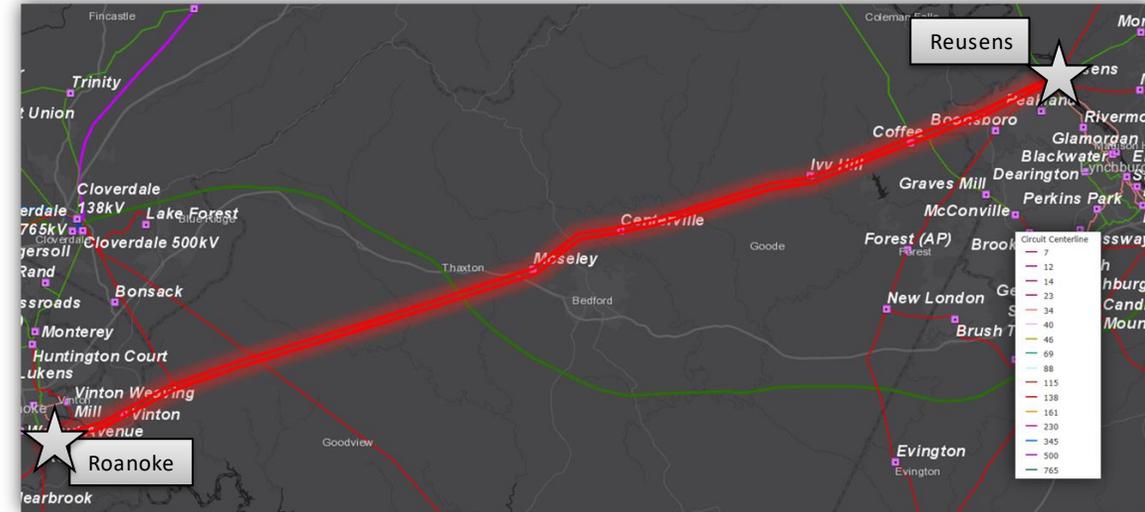
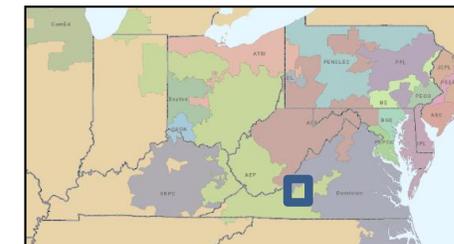
- **Reusens-Roanoke 138 kV Double Circuit Line Asset (43 mi.)**
 - Installed between 1926 and 1933 using double circuit steel lattice towers
 - Recent field assessments have identified severe ovalization of holes at hanger bar connections and severe cross arm and hanger rusting as well as uniform corrosion, pitting, and deformation of steel members below grade. Evidence of steel corrosion at joints and on upper steel members was also documented.

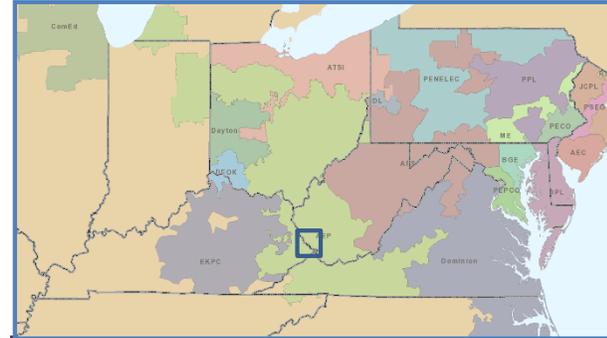
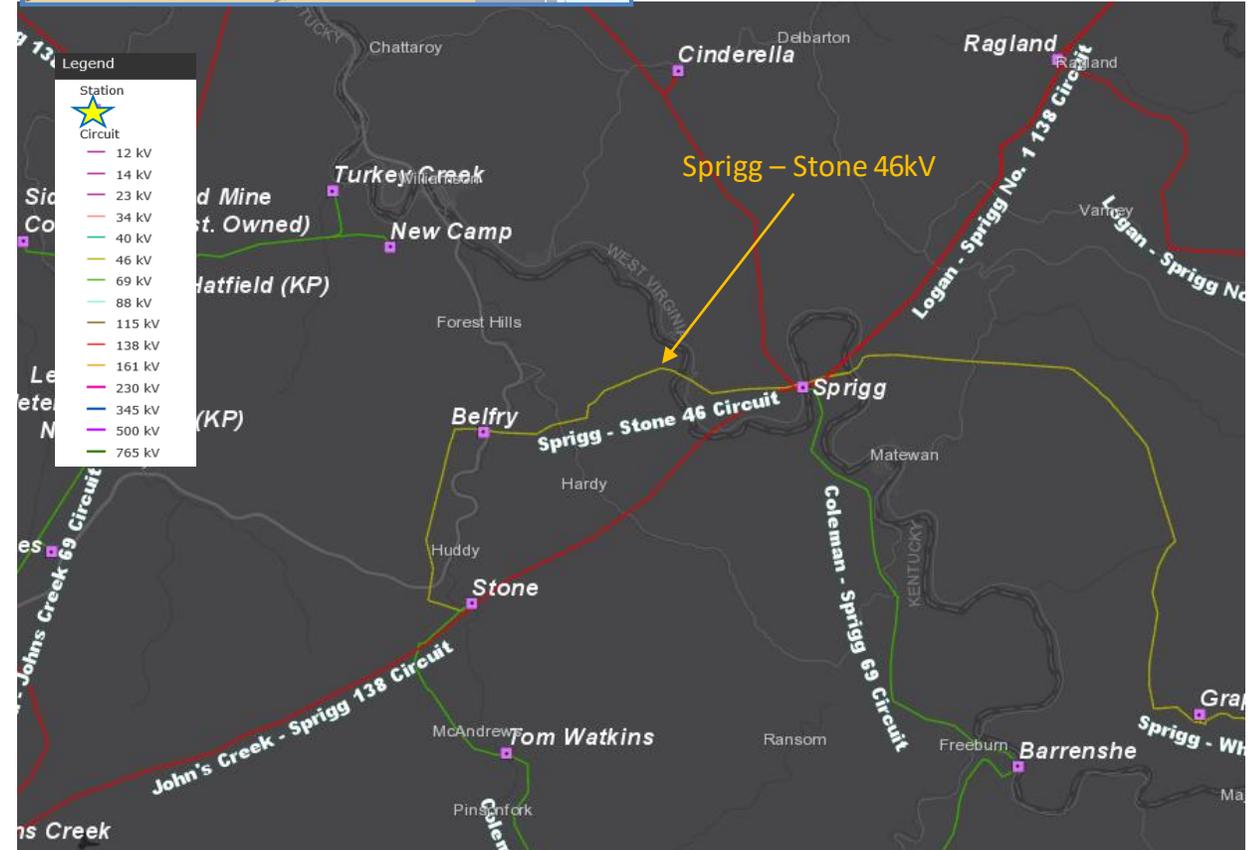
Line Name: Sprigg – Stone 46kV

- 35 structures with at least one open condition, 64% of the structures on this circuit
- 98 structure related conditions: rotted poles, crossarms and braces, woodpecker damage, bowed braces and loose braces, affecting the crossarm, knee/ vee brace, or pole including rot, split, woodpecker, damaged, loose, and bowed conditions
- 1 open conditions related to the broken strands on a jumper conductor
- 9 hardware related open conditions loose or broken guy wires

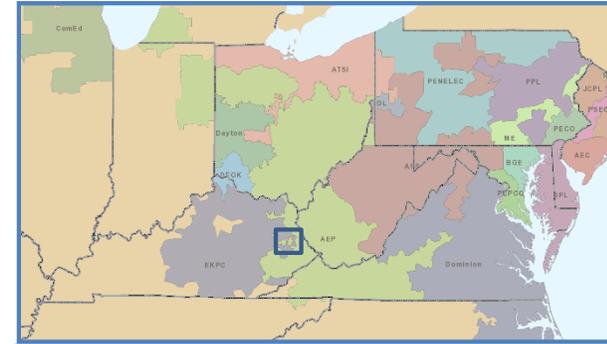
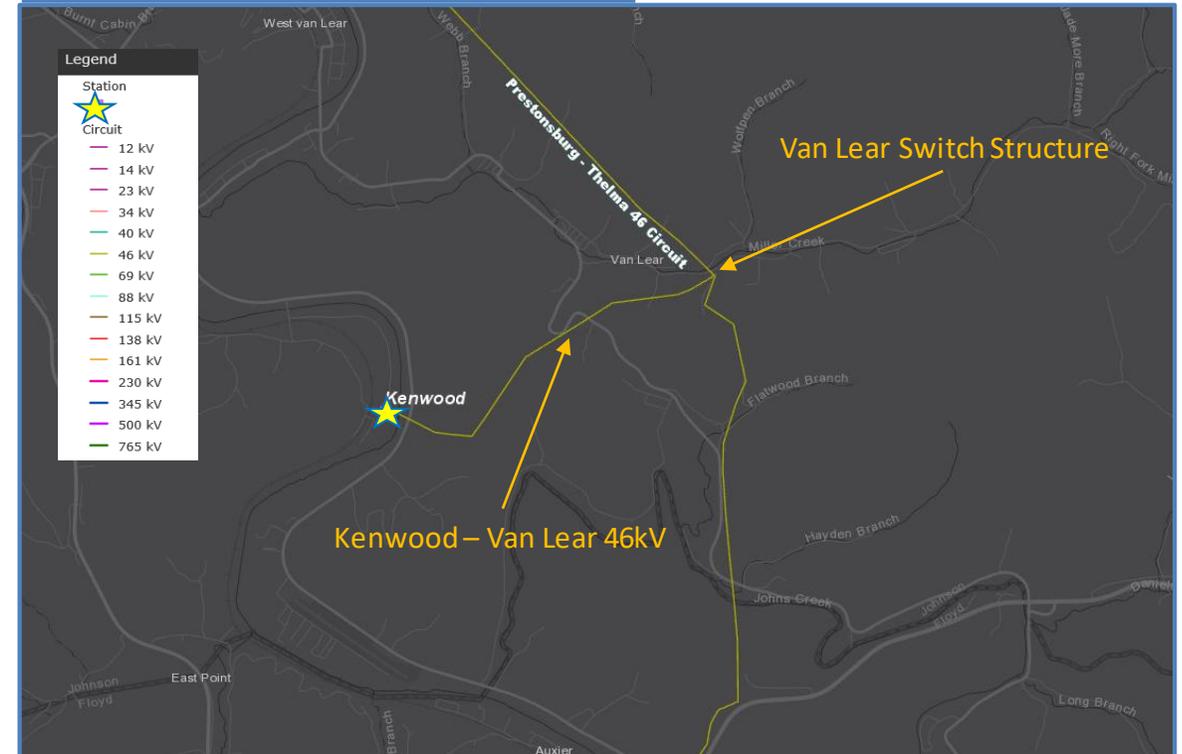
Line Name: Kenwood – Van Lear 46kV

- The switches at Van Lear have been tagged as inoperable and unsafe to operate. The old hydraulic type mechanism on these switches does not operate properly, arcing horns are burnt off, and operating rod supports are damaged.

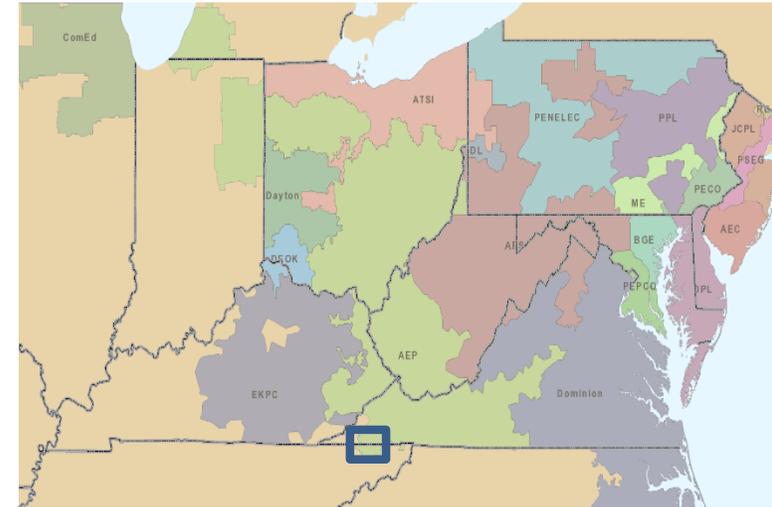
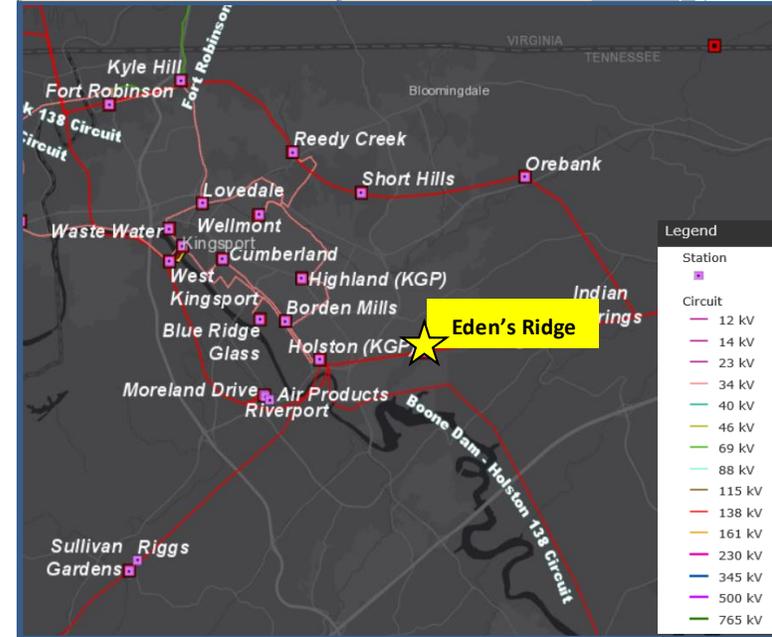
Appalachian Power Co. (Distribution) has requested adding a new 25 MVA 138/12KV transformer at Eden’s Ridge Station to serve growing load in the Kingsport area.

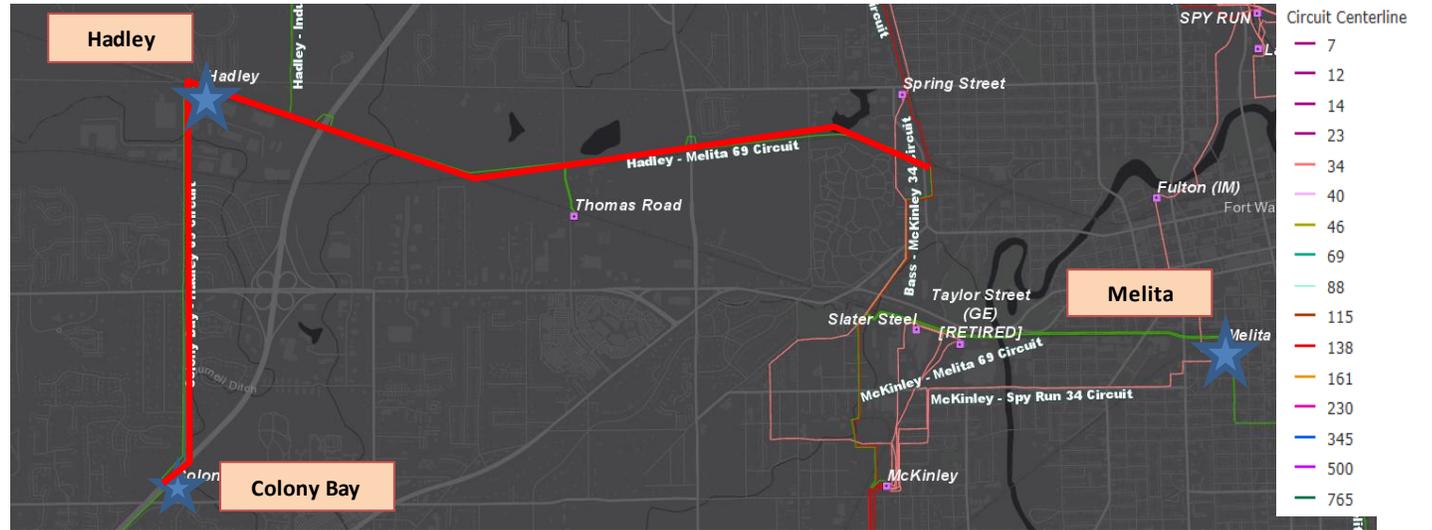
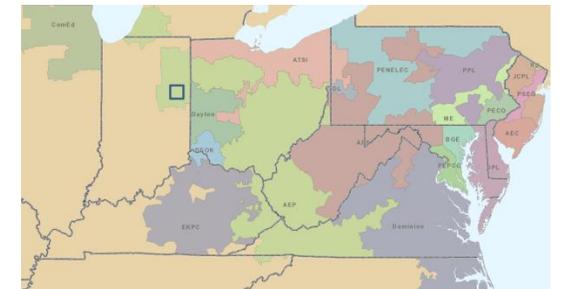
Colony Bay – Melita 69kV (5.8 miles)

- The Colony Bay – Melita circuit has ~5.8 miles of primarily 1960 wood pole structures
- This section has 34 open conditions across 26 unique poles (~17% of line). These conditions include, but aren't limited to Stolen/broken ground leads, broken insulators, damaged and rotting poles.
- An additional 23 poles on this section (~15%) were found to be decayed to the point of failure. These poles had steel reinforcers installed to allow them to last until a more permanent fix was available.
- The 2014-2019 5 year period this line was subject to 3 momentary outages and 3 permanent outages.

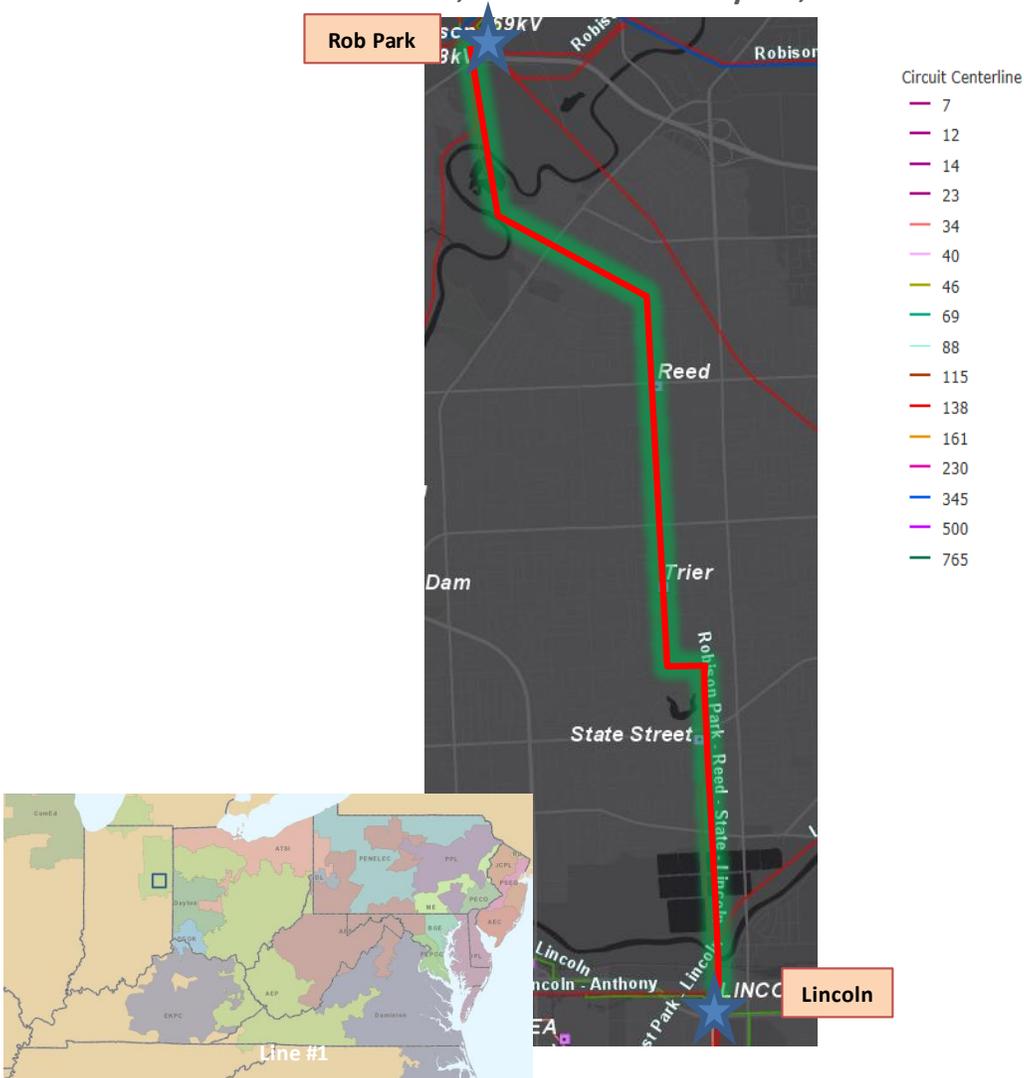
Robison Park – Lincoln 138kV (~10.9mi)

- 44 structures with an open condition (~67%) with most revolving around rusted legs, broken/chipped insulators and rusted shield wire
- Fails to meet current AEP structural strength requirements
- Fails to meet AEP shield angle requirements
- Top half of towers were replaced and re-conducted in 1968 to allow for 138kV voltage operation, but the bottom half and foundations are original 1928 installation
- 4 MOABS in series currently which is over the AEP max of 3.

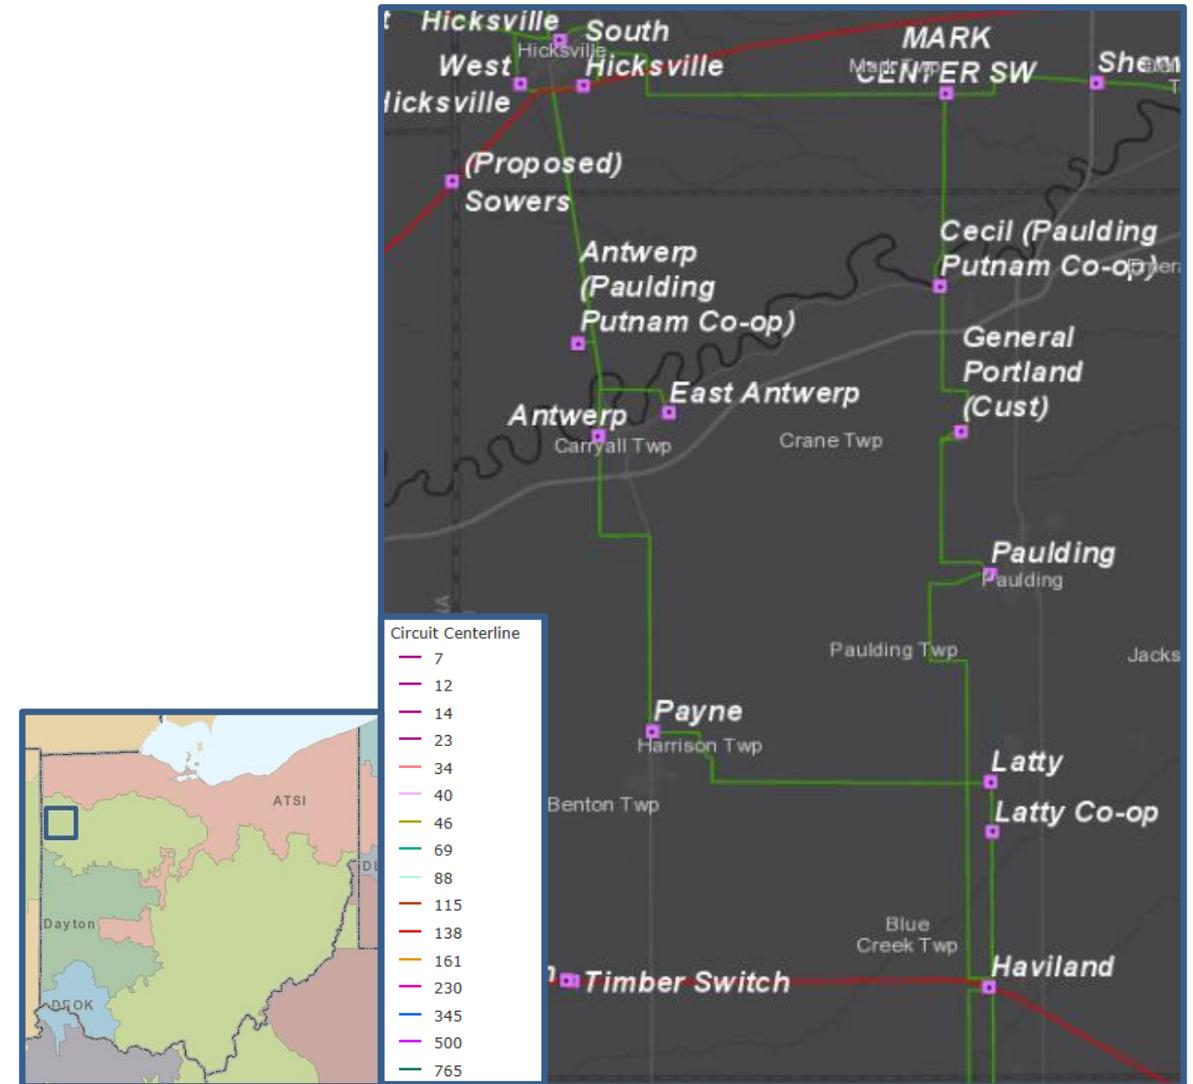
Haviland – South Hicksville 69kV

- **Length of Line:** 26.15
- **Total structure count:** 560
- **Original Line Construction Type:** Wood
 - 16% of structures recently replaced (~2.5 miles)
 - Wooden Cross Arms
 - Horizontal Ceramic insulators
- **Conductor Type:** 336.4 KCM ACSR 18/1 Merlin (original 1927 install)

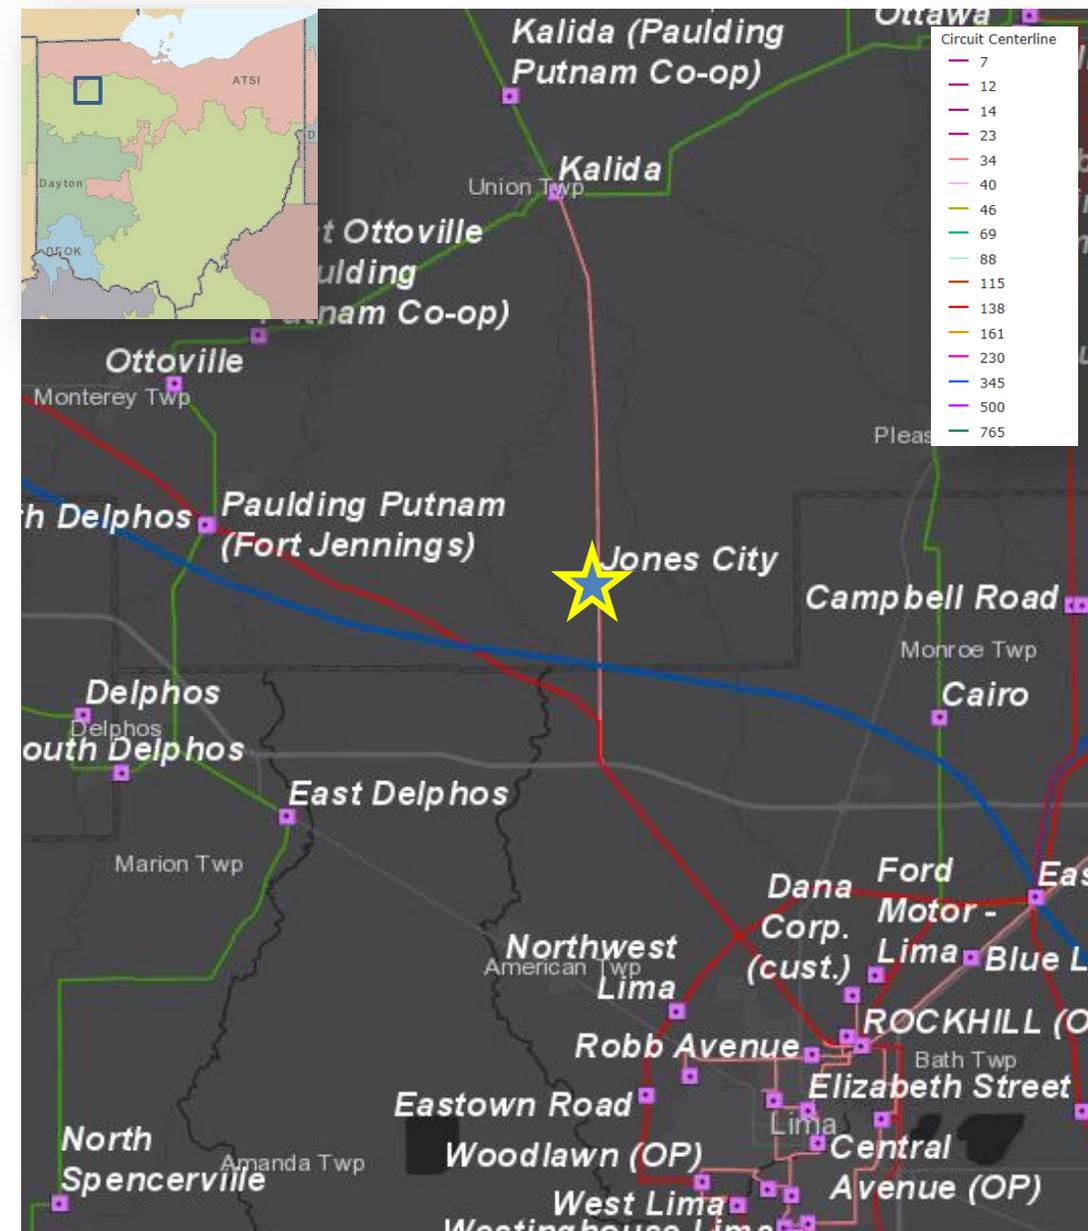
Line Name: Kalida – Rockhill 34.5 kV

- The line shielding angle on the typical tangent structure is measured at 45 °, which is inadequate for AEP current shielding angle requirements.
 - The wood structure's current age is 191% of the 95% Probability of Failure (POF) of 51 years. The shield wire's current age is 134% of the 95% POF of 72 years. The insulator's current age is 111% of the 95% POF of 87 years. The POF values are based on CEATI Report No T144700-3257

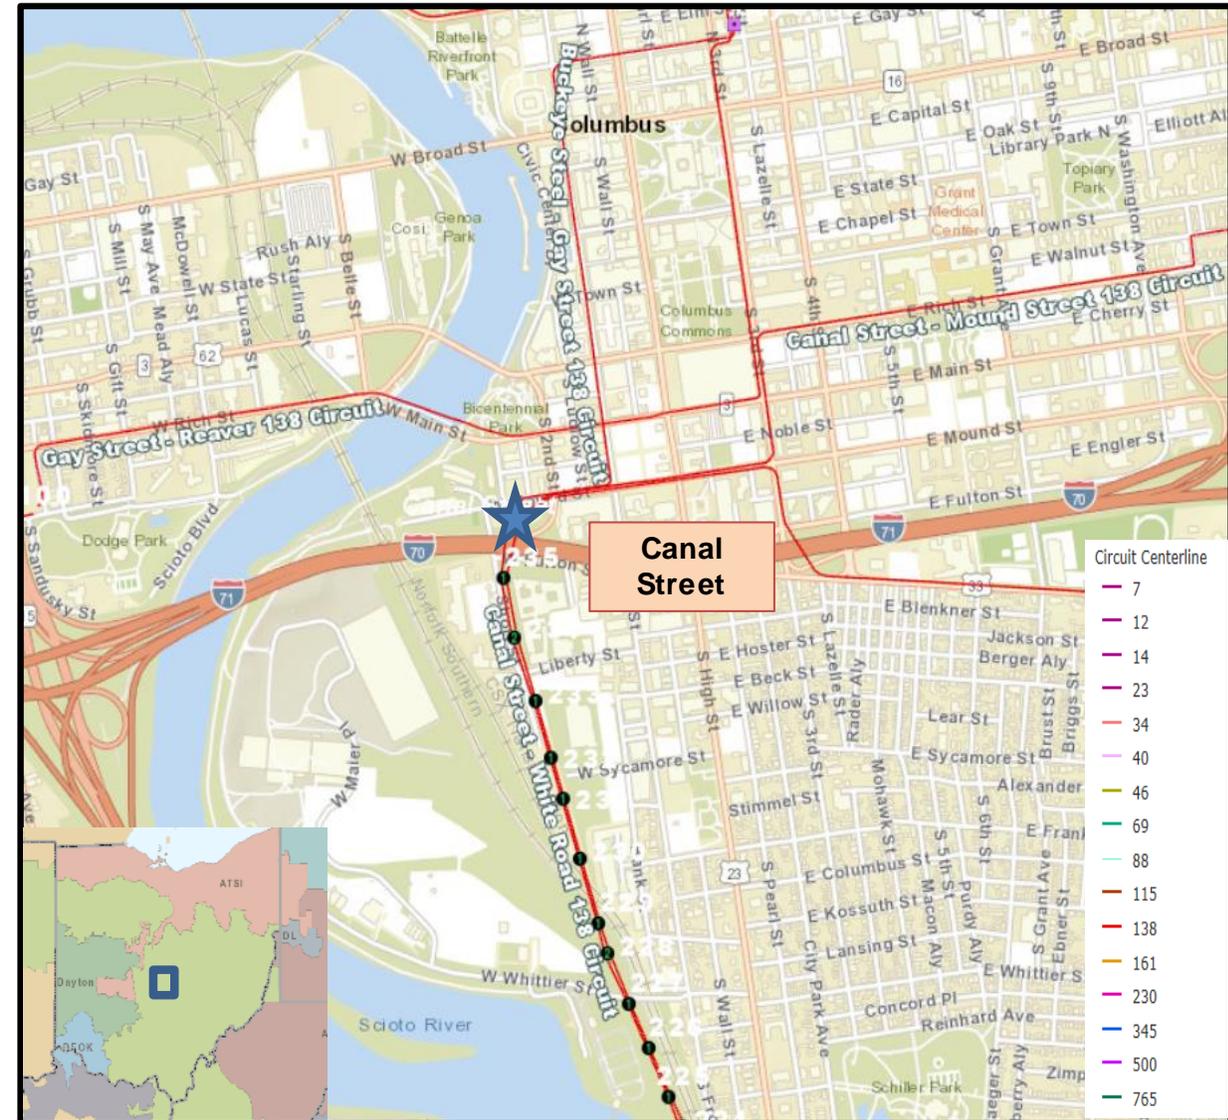
138 kV Circuit Breaker (4):

- Install Date: 1969
- Interrupting Medium: Oil
- Additional Information:
 - Interrupting Capability: 37kA
 - Fault Operations:
 - Number of Fault Operations: 15
 - Manufacturer recommended Number of Operations: 10
 - Oil breaker maintenance has become more difficult due to the oil handling required to maintain them. Oil spills are frequent with breaker failures and routine maintenance and can become an environmental hazard. This is the last remaining oil breaker at Canal Street station.

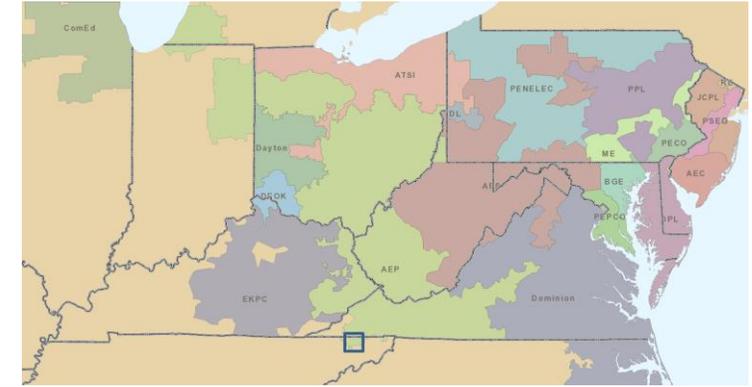
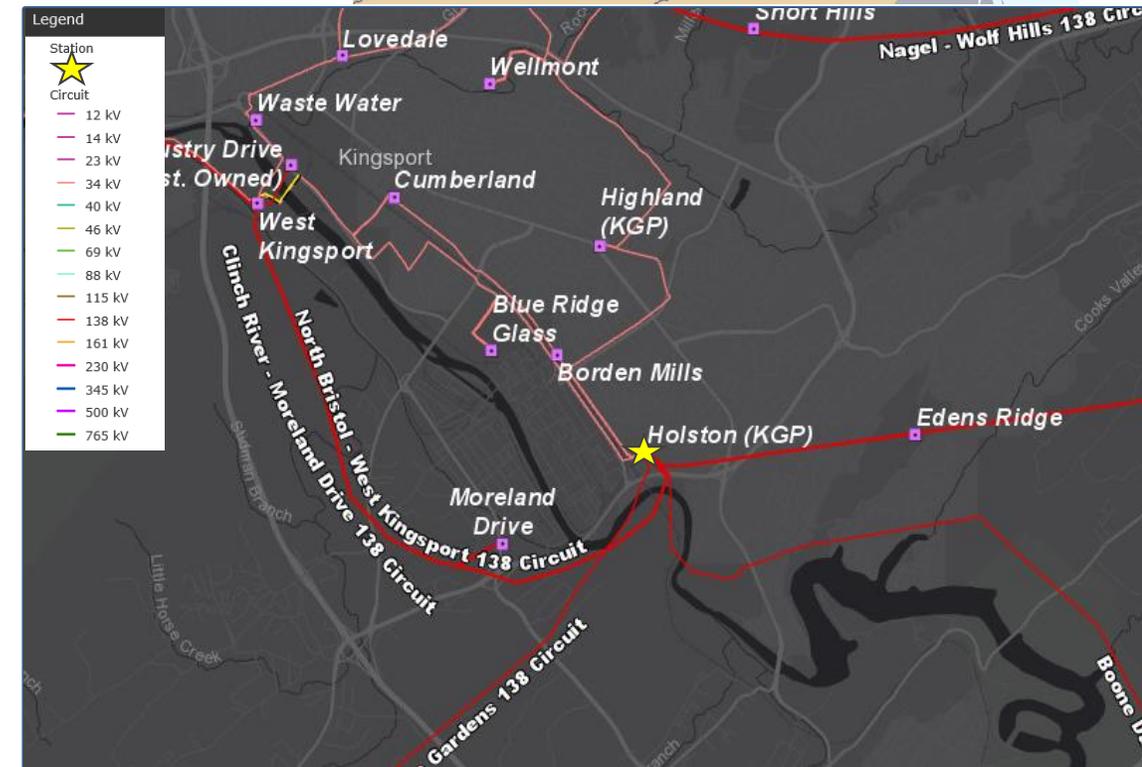
Holston Station

- 138/34.5 kV Transformer #1
 - Manufactured in 1979.
 - Showing signs of dielectric breakdown (insulation), accessory damage (bushings/windings), and short circuit breakdown (due to through faults).
 - Currently tied directly to 138 kV bus #1 via a MOAB on high side.
- 34.5/23-2.4 kV Transformer #8 (GND Bank)
 - Manufactured in 1954.
 - Showing signs of dielectric breakdown (insulation), accessory damage (bushings), and short circuit breakdown (due to through faults).

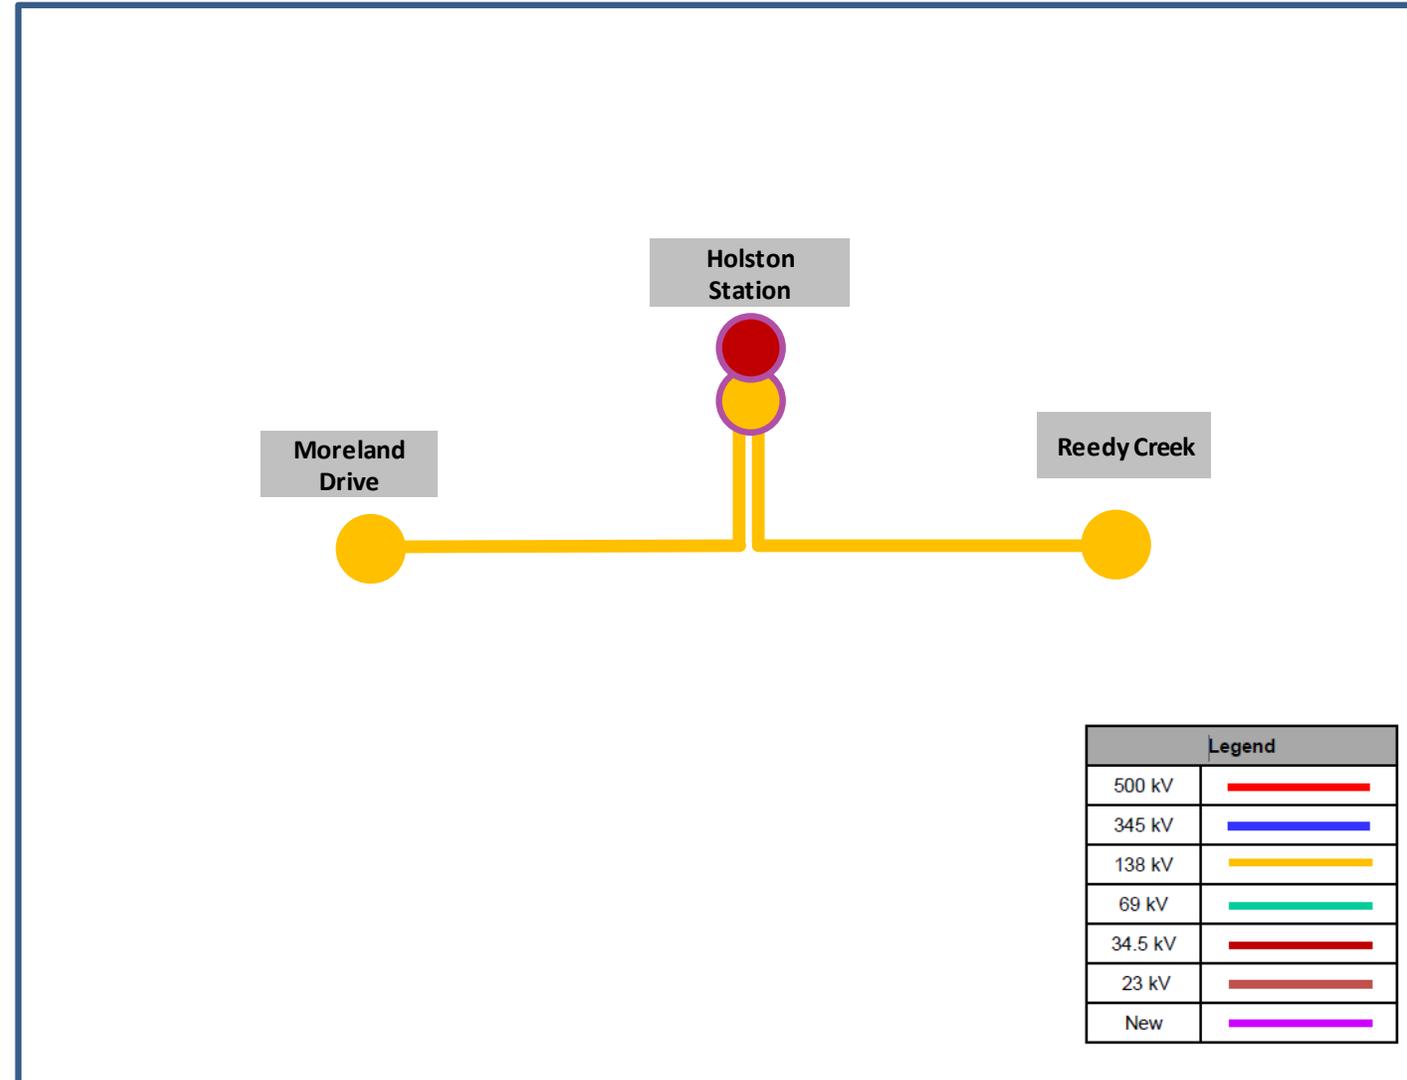
Replace existing 138/34.5 KV 45 MVA transformer #1 with a new 138/69/34.5 KV 90 MVA transformer. Replace existing high side MOAB switches on transformer#1 with new 138 KV 3000 A 40 KA circuit breaker. Replace existing ground transformers #8 and #9 with new ground banks. Reconfigure the existing 34.5 kV into a ring bus configuration with five new 34.5 kV breakers.
