# Sub Regional RTEP Committee: Western AEP Supplemental Projects

March 19, 2021

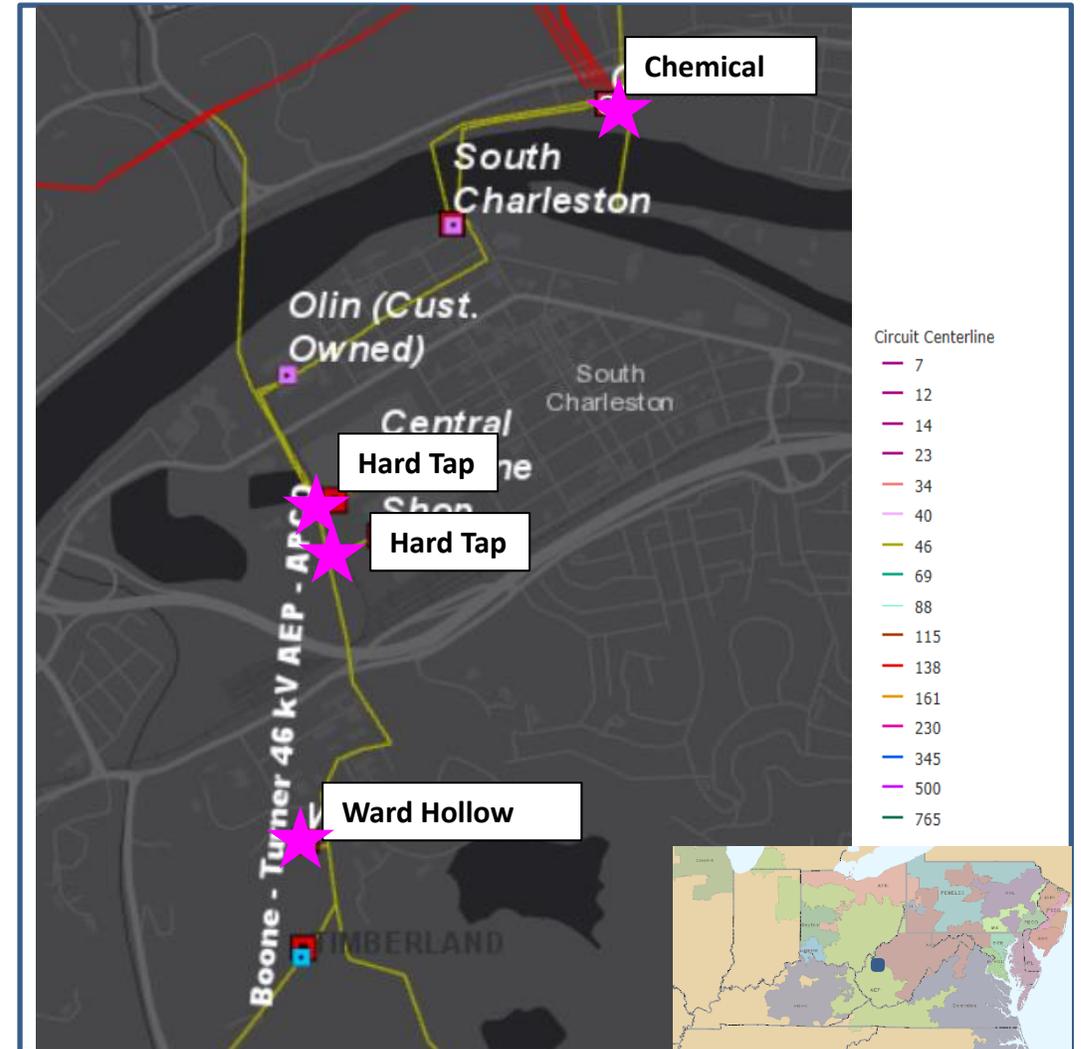
- The 3 mile Chemical – Ward Hollow 46 kV line has two delivery points that are connected via hard taps. The hard taps complicate restoration activities and extend outages.
- Customers served at the hard taps have communicated concerns regarding continuation of service due to upcoming outages scheduled for ongoing projects at Chemical (B3100, S2348), South Charleston (S2348) and Turner (S2165)

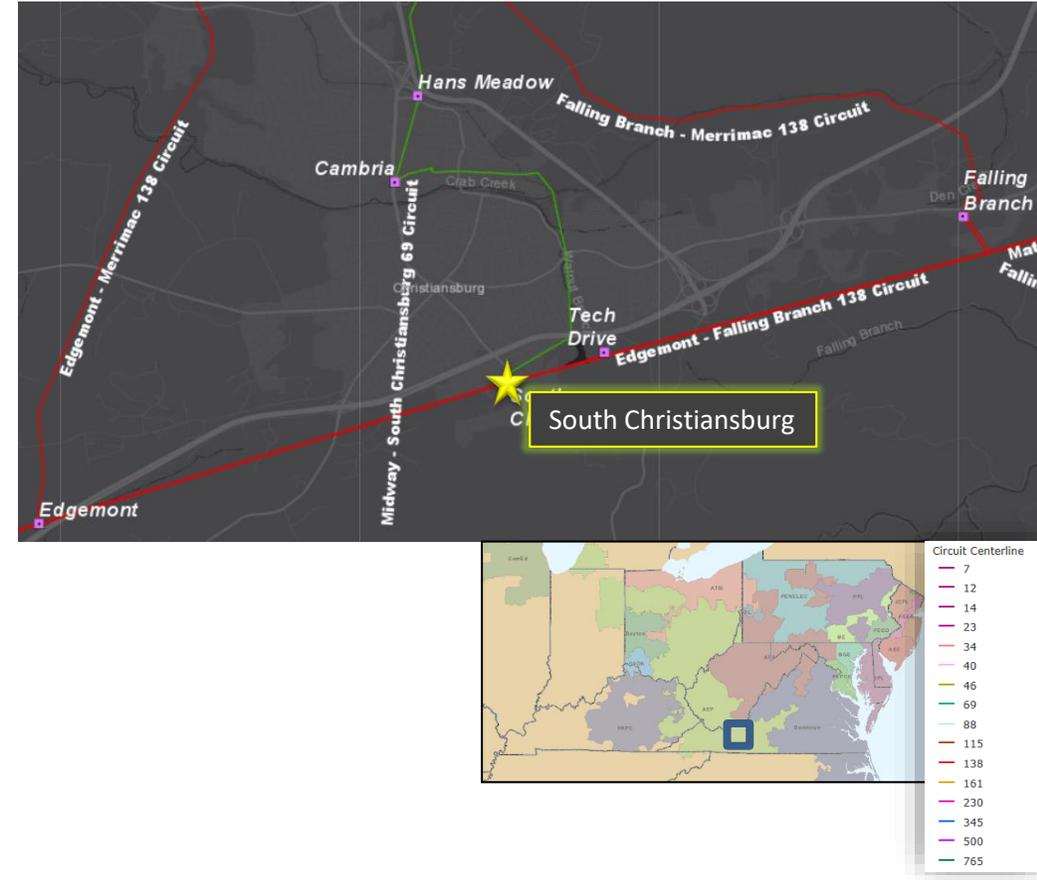
- The 13.2 Mvar 69 kV capacitor bank at South Christiansburg station has failed.

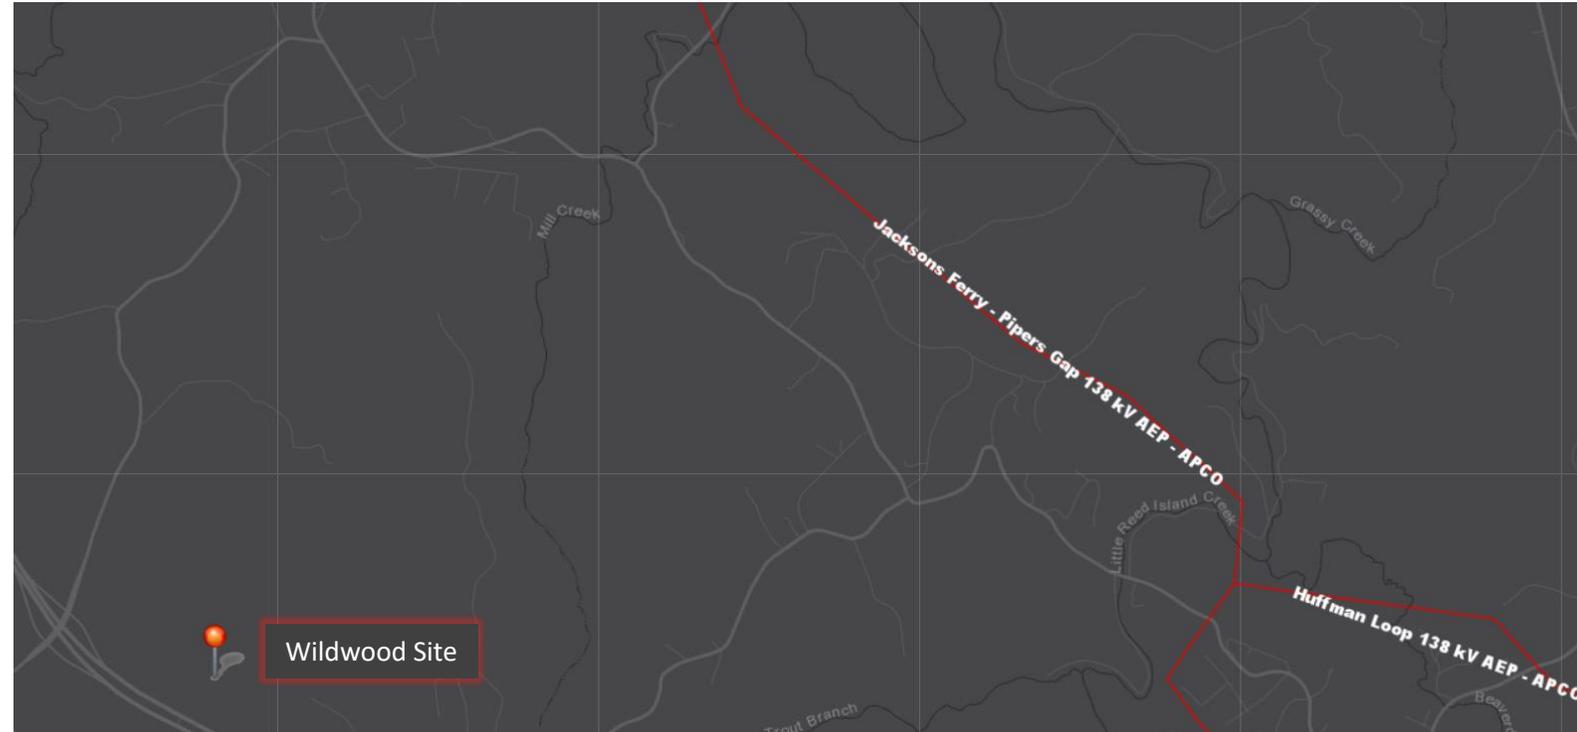
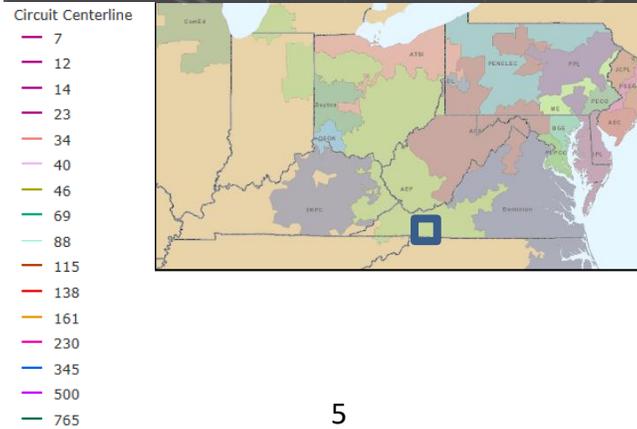
- A customer has requested service for the establishment of a new distribution station in anticipation of a future industrial customer(s) located at the Wildwood Commerce Park site in Hillsville, VA.
- This station is the result of VA House Bill 1840 (HB1840) (Electric Utilities: Pilot Programs for Transmission Facilities Serving Business Parks).

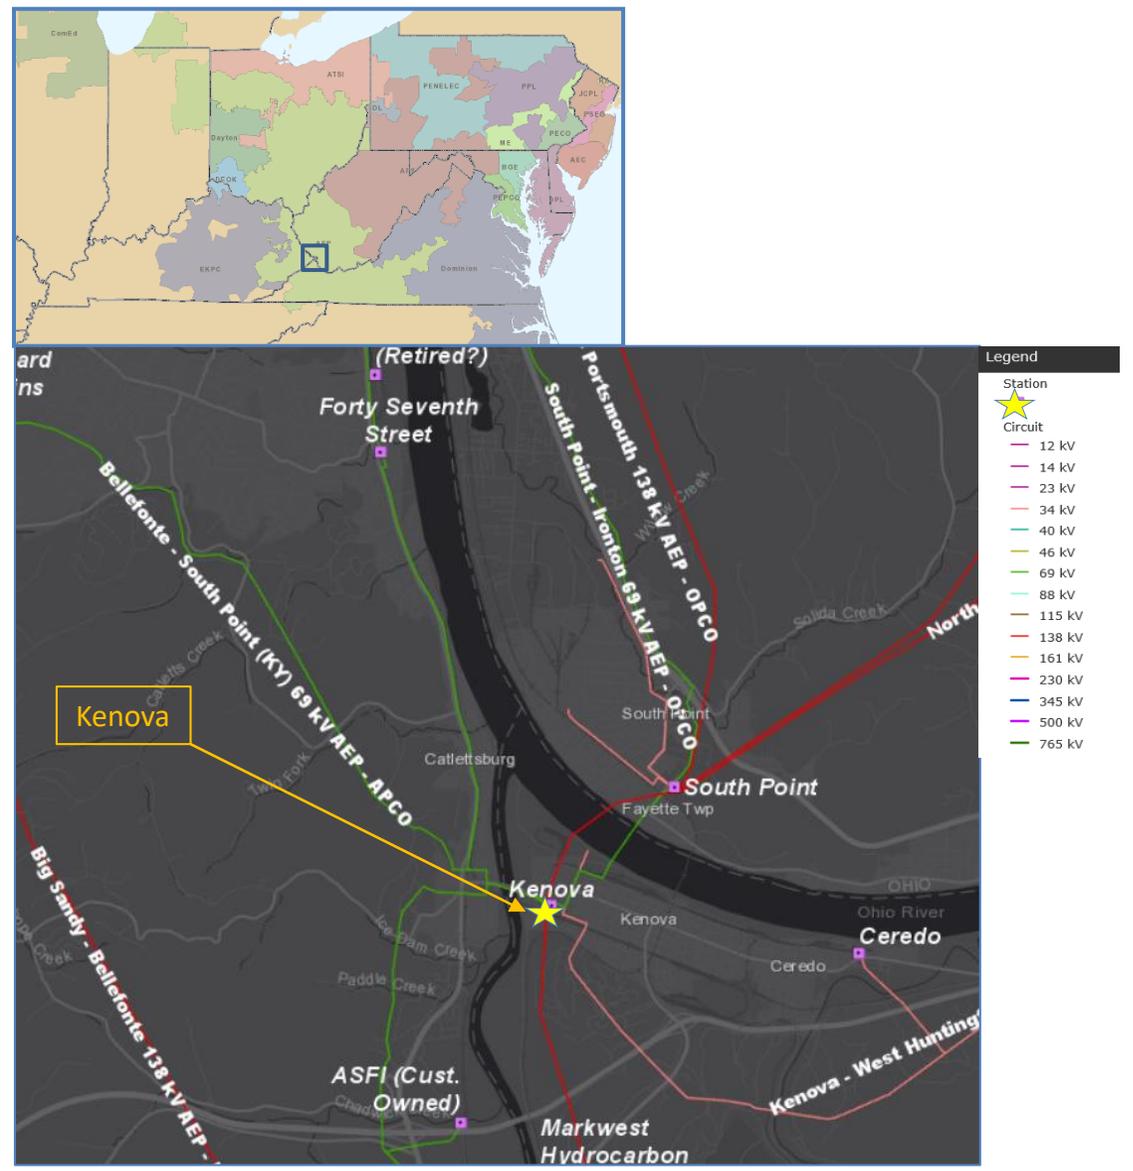
The 14.4 Mvar 69 kV capacitor bank at Kenova substation has failed.

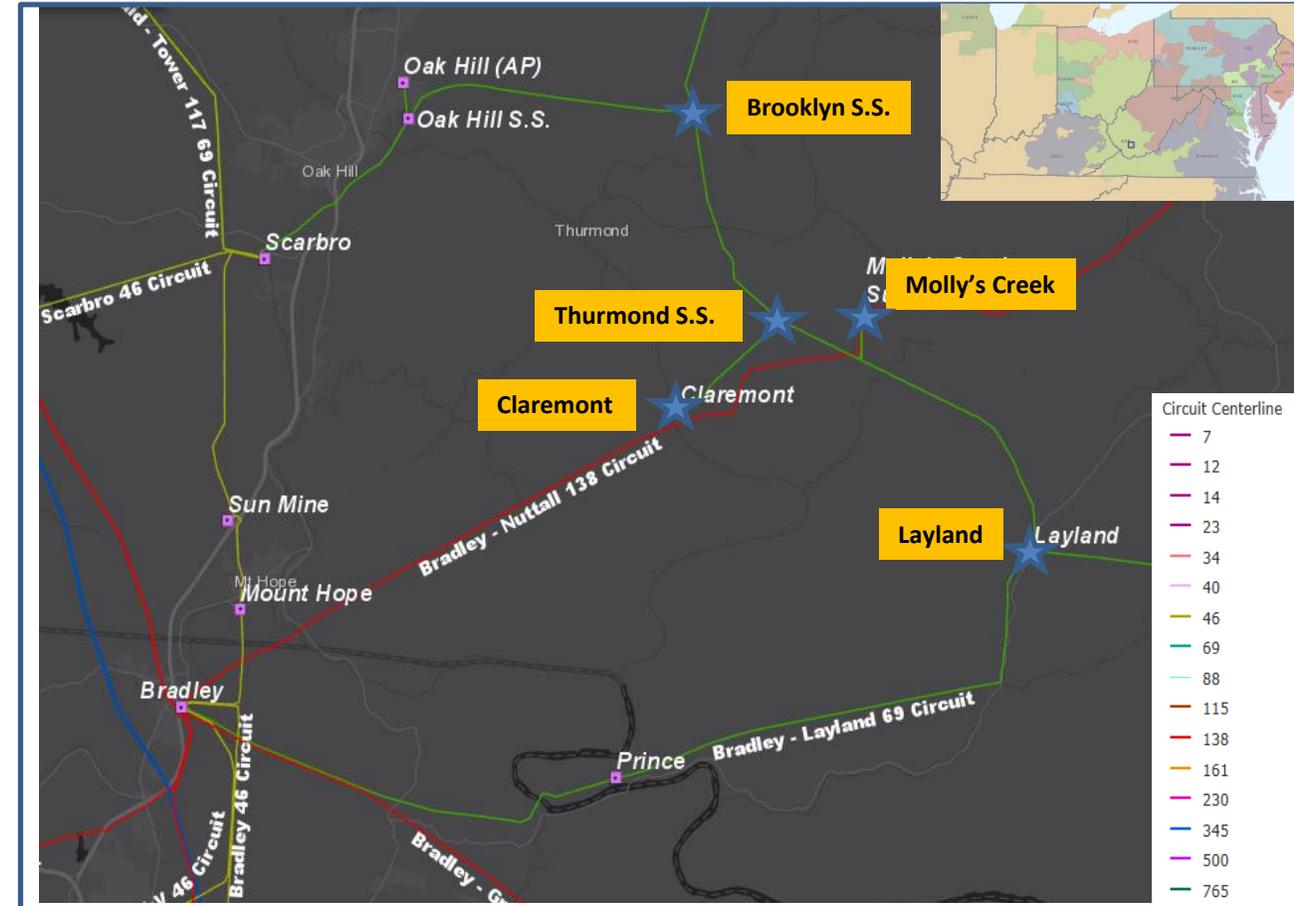
Thurmond SS – Claremont 69 kV (~2 miles)

- Circuit is comprised of wood pole structures
  - 1972 vintage structures (100%)
  - Circuit fails to meet 2017 NESC Grade B loading criteria and AEP structural strength requirements, and fails to meet ASCE structural strength requirements
  - 4-bell porcelain insulators do not meet current AEP Standards
- 5 structures with at least one open structural condition (17% of the structures)
  - There are 5 structural open conditions related to woodpecker damage and rot and 3 hardware conditions related to cracked insulator assembly and broken guys
  - Outage statistics included in the data above

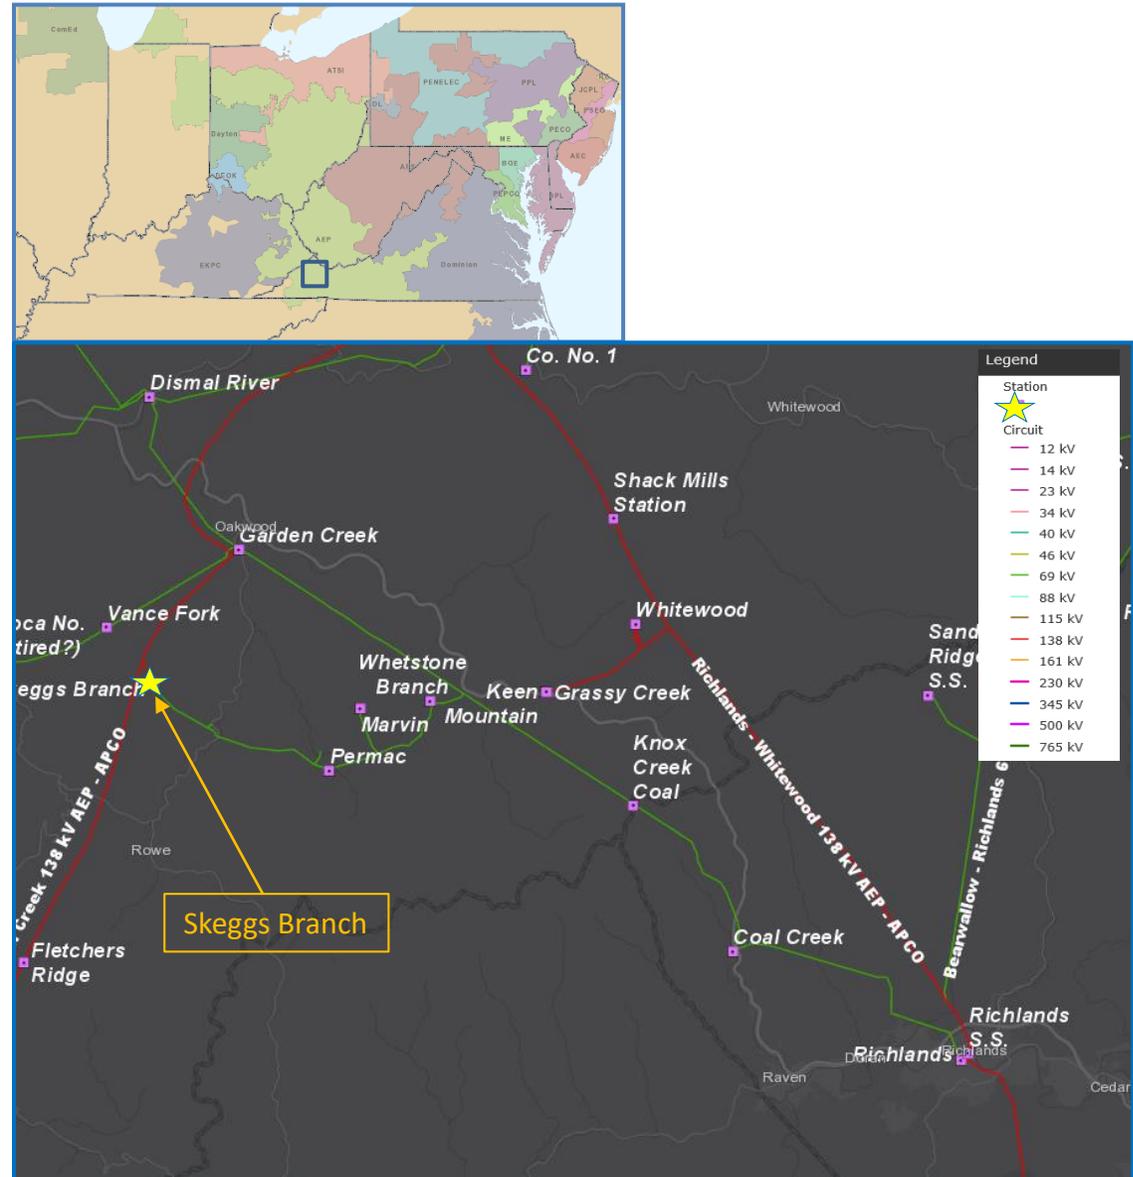
- 138/69/4 kV Transformer #1
  - 1950s Vintage Transformer , originally manufactured in 1952
  - The Transformer has elevated levels of Carbon Monoxide, Carbon Dioxide, Ethane, Methane, and Ethylene. There is an indication of overheating faults occurring in the main tank which have further degraded the insulating paper materials. One of the oil cooling pumps has developed a leak.

- 138kV Circuit Switcher A
  - Mark V type SF-6 filled ( 1970s vintage ) manufactured by S&C.
  - This CS has experienced 37 Fault Ops
  - No gas monitor; sister units on the AEP system have a history of gas loss, interrupter failures, and operating mechanism failures.

- Other:
  - The lack of a transformer low side/69kV line exit circuit breaker means that the 138kV circuit switcher operates for both 138kV and 69kV line faults.

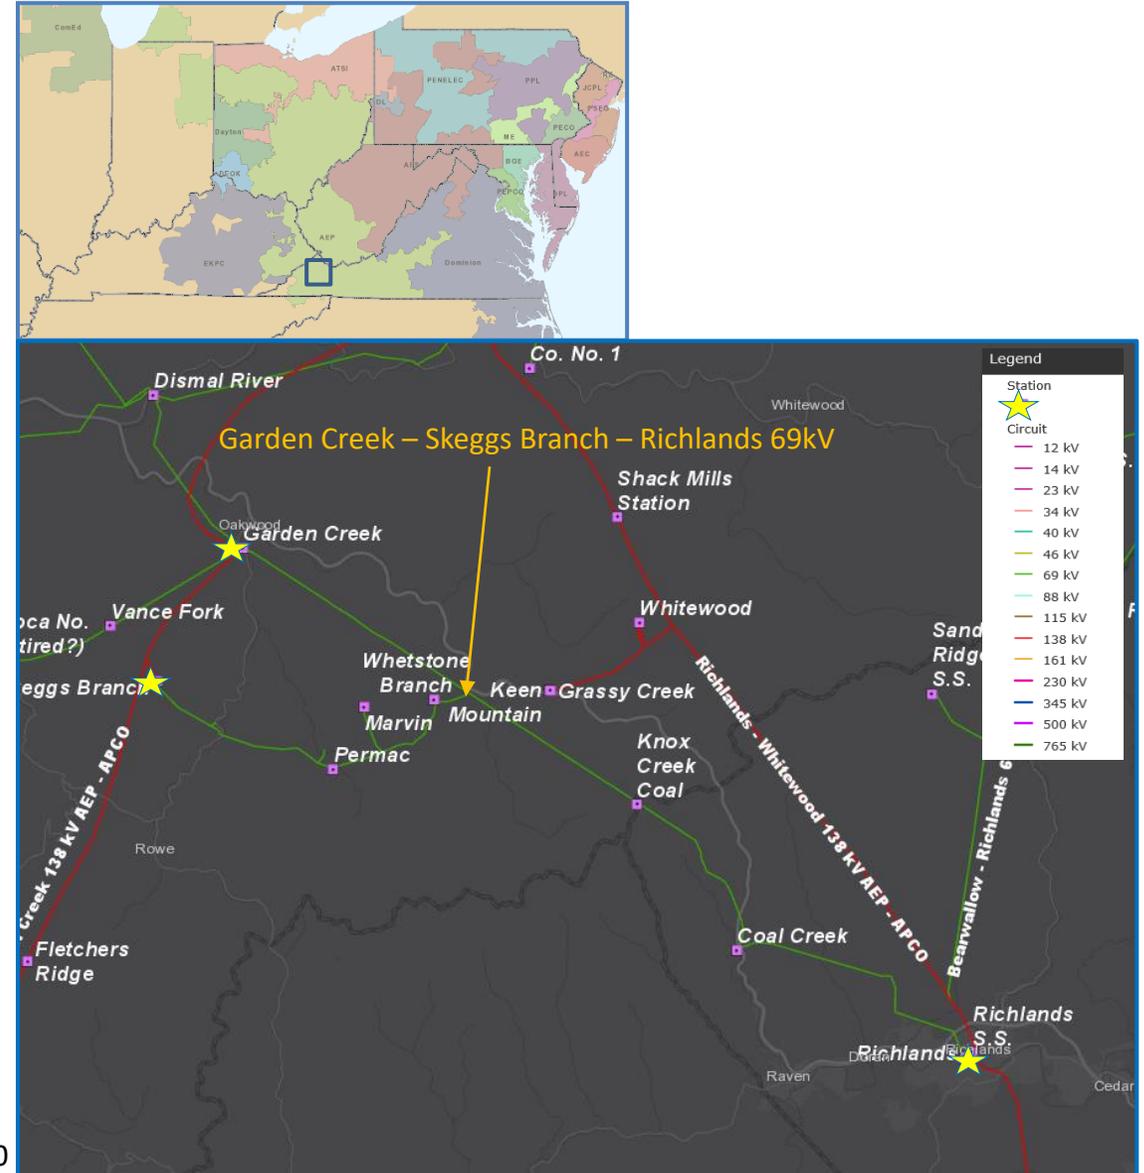
- 42 structures with at least one open structural condition, 23% of the structures on this circuit.
- 73 structure related open conditions impacting wooden poles, lattice steel towers, crossarms, braces, and filler blocks including rot, bowing, woodpecker holes, insect damage, cracked, split, and heavy rust/corrosion.
- 1 open conditions related to broken strands
- 8 hardware related open conditions related to broken or chipped insulators and a buried guy.

- This circuit is operated normally open at Permac station
- Lack of sectionalizing capability due to multiple stations (Twin Valley SS, Marvin, Clell) being hard tapped to 69kV Line or operated radially
- Whetstone Branch is a 3 terminal switching station with no 69 kV line breakers.
- Only 11.6 miles of this line are currently shielded.

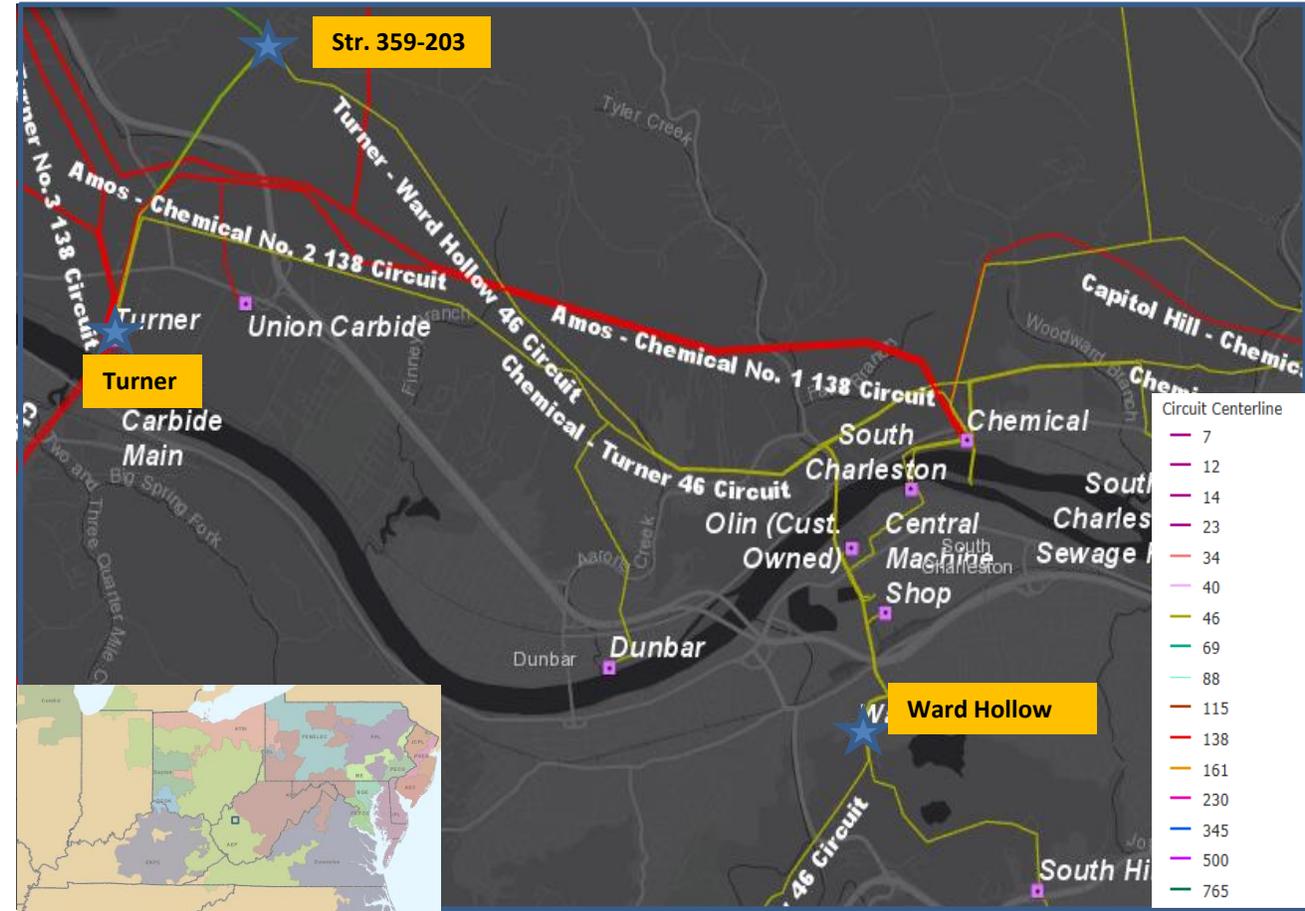
- Circuit fails to meet 2017 NESC Grade B loading criteria and AEP structural strength requirements and fails to meet the current ASCE structural strength requirements

- 8 structures with at least one open condition (30% of the structures)
  - 28 Structural conditions are related to poles and crossarms including rot top, woodpecker and rot heart.

- Since 2015, there have been 5 momentary and 11 permanent outages on the Turner – Ward Hollow 46 kV circuit
  - Momentary outages were due to wind, lightning and animal bus causes

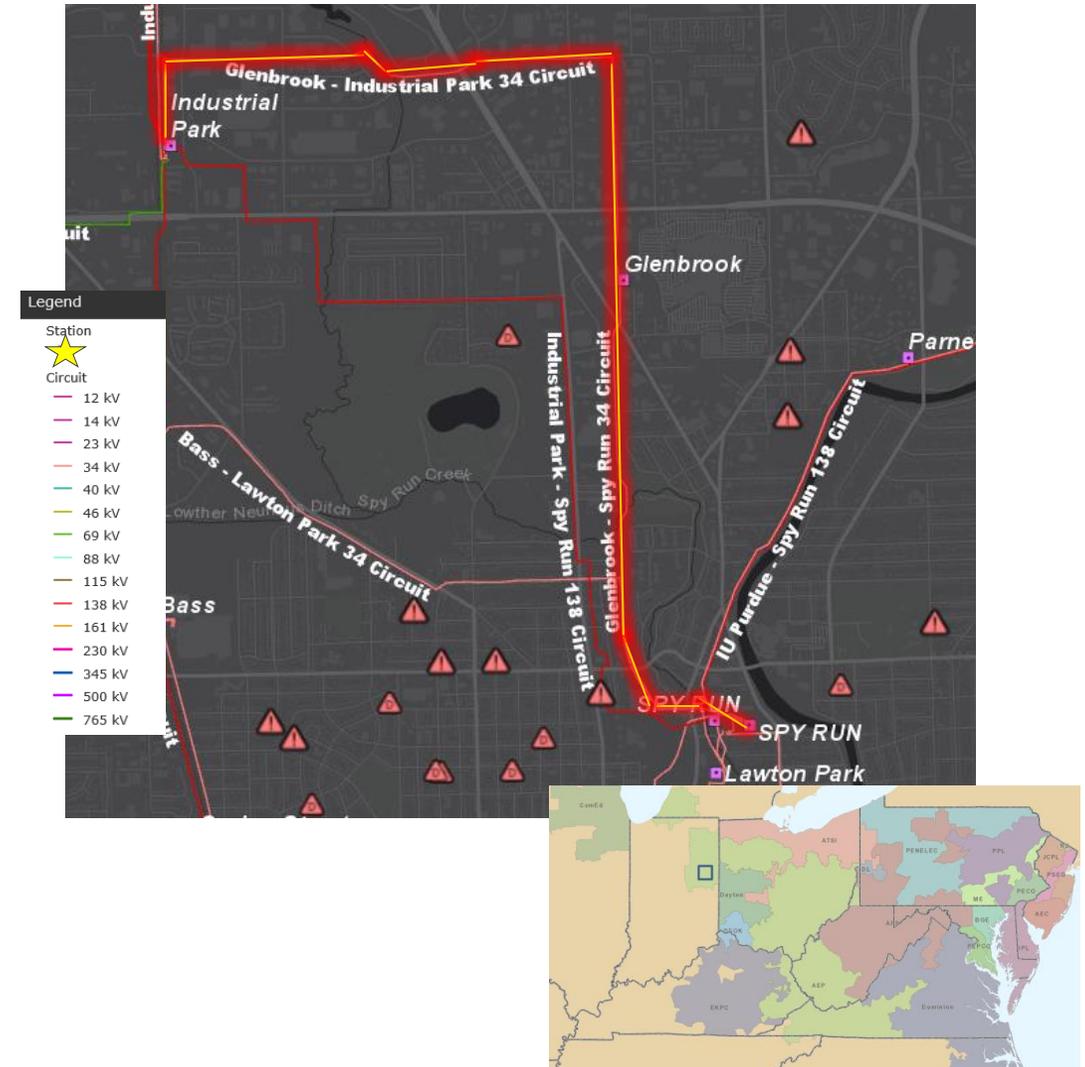
- Wood pole line originally constructed in 1965
- 45 structures have at least one open condition (37% of line) including Rot Top, Insect Damage and Woodpecker holes
- 18 structures were assessed by an aerial drone and 12 assessed by ground crew. 6 structures had heart rot, 12 structures had insect/woodpecker damage.
- 121,563 CMI over the past 5 years with 2 outages
- Structures do not meet 2017 NESC Grade B loading criteria, do not meet current AEP structural strength requirements, and do not meet the current ASCE structural strength requirements.

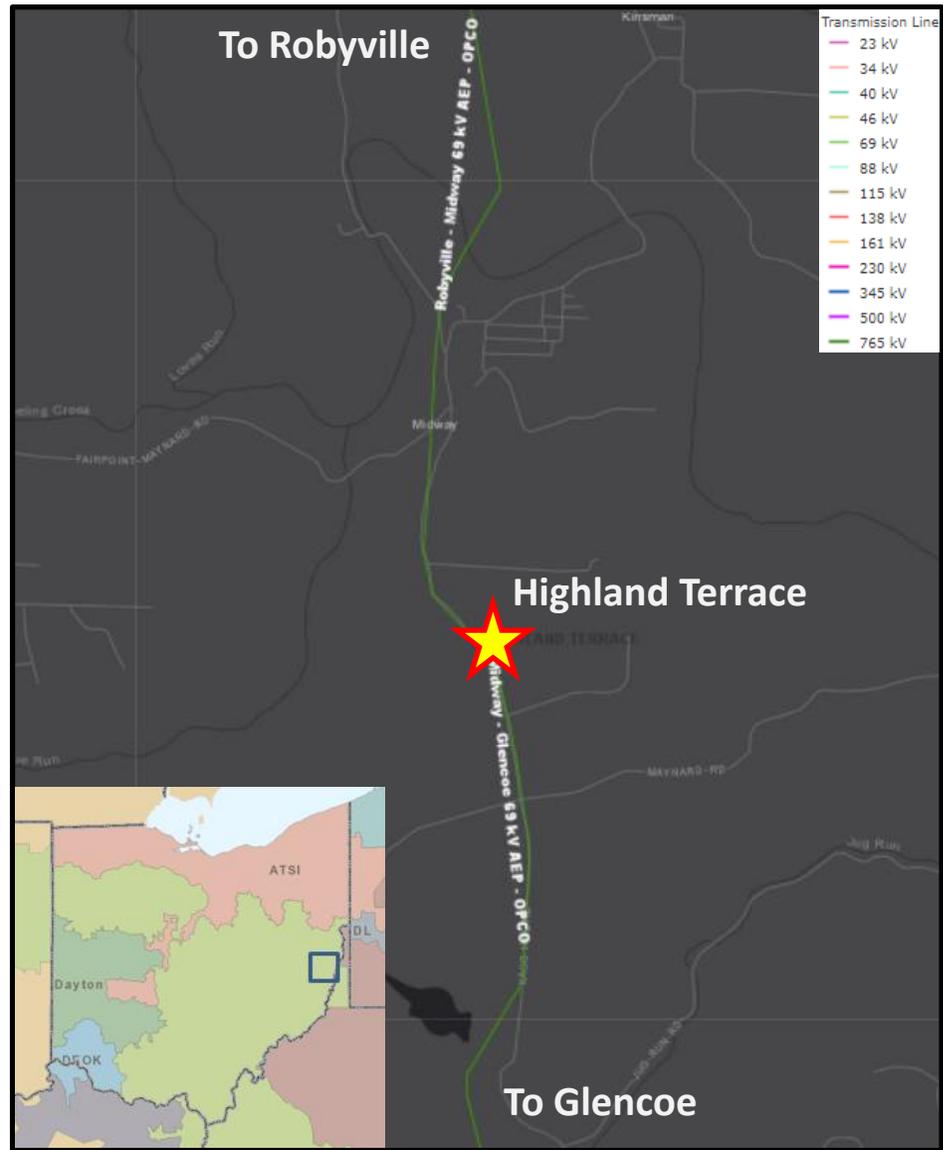
The Highland Terrace 69-12kV distribution substation north of St. Clairsville, Ohio is a unique 1975-vintage modular station (“station in a box”). The indoor station had a major failure in August 2019 and has been bypassed with a mobile since that time.

- Breaker Age:
  - 1973
- Interrupting Medium: (Vacuum)
- Additional Information: This switcher has failed and is no longer in working condition. The vacuum bottles have failed and there are no replacement parts available for this unit. The vacuum interrupter bottles have suffered flashovers and the switch is currently inoperable.

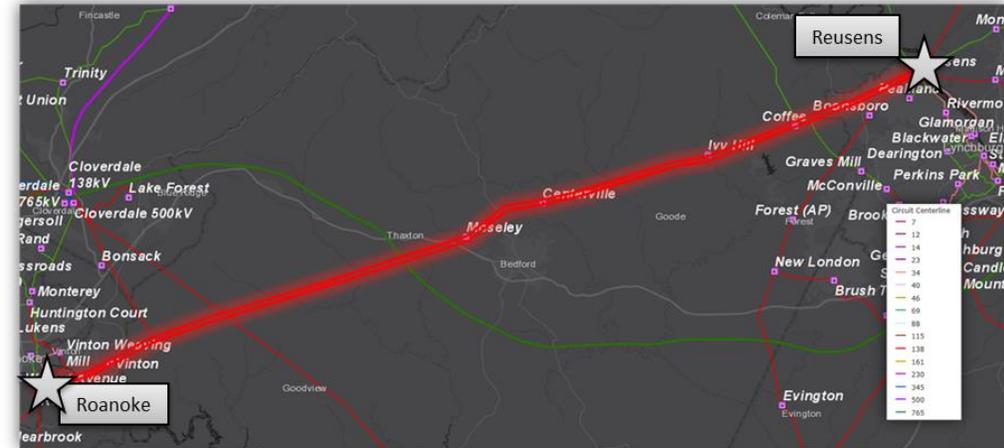
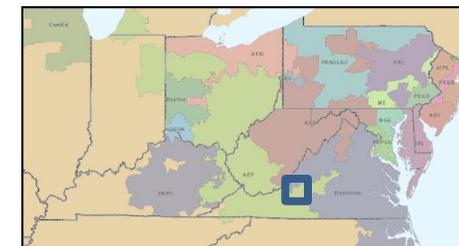
- **Reusens-Roanoke 138 kV Double Circuit Line Asset (43 mi.)**
  - Installed between 1926 and 1933 using double circuit steel lattice towers
  - Recent field assessments have identified severe ovalization of holes at hanger bar connections and severe cross arm and hanger rusting as well as uniform corrosion, pitting, and deformation of steel members below grade. Evidence of steel corrosion at joints and on upper steel members was also documented.

- Ferrous clamps are present on this line asset; these types of clamps can cause accelerated degradation of conductor at connection points due to excess heat generated even when operated at acceptable, rated levels.

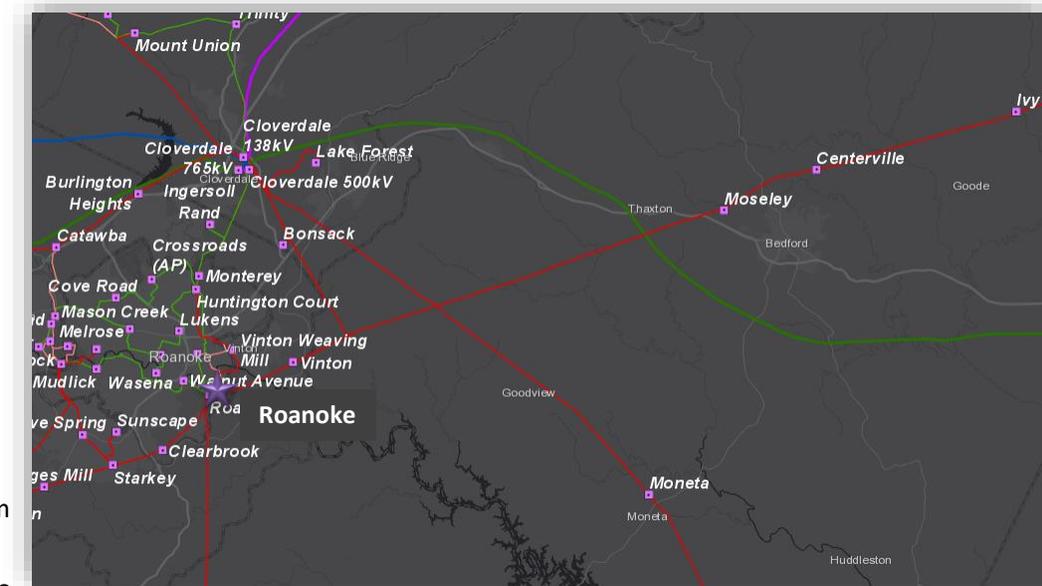
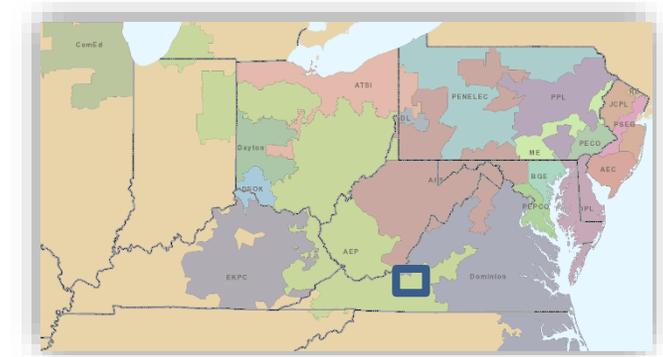
- 138 kV Circuit Switchers BB and CC
  - Both are 1990’s vintage
  - The Mark V family of circuit switchers have no gas monitor and currently in-service units on the AEP system have experienced 110 malfunctions from May 2000 to August 2019. Failed operational components including high contact resistance, gas loss, and interrupter failure represent half of these malfunctions. Two malfunctions of note were catastrophic equipment failures involving failures to trip.

- 138 kV Capacitor Bank CC and 34.5 kV Capacitor Bank AA
  - Leaking around bushings on both banks
  - 6 cans are failed on bank CC

- 69 kV Circuit Breakers U and V
  - 1970’s Vintage Circuit Breakers
  - These breakers are oil filled without oil containment; oil filled breakers have much more maintenance required due to oil handling that their modern, SF6 counterparts do not require
  - Circuit breaker U has each exceeded the manufacturer’s designed number of full fault operations (12)

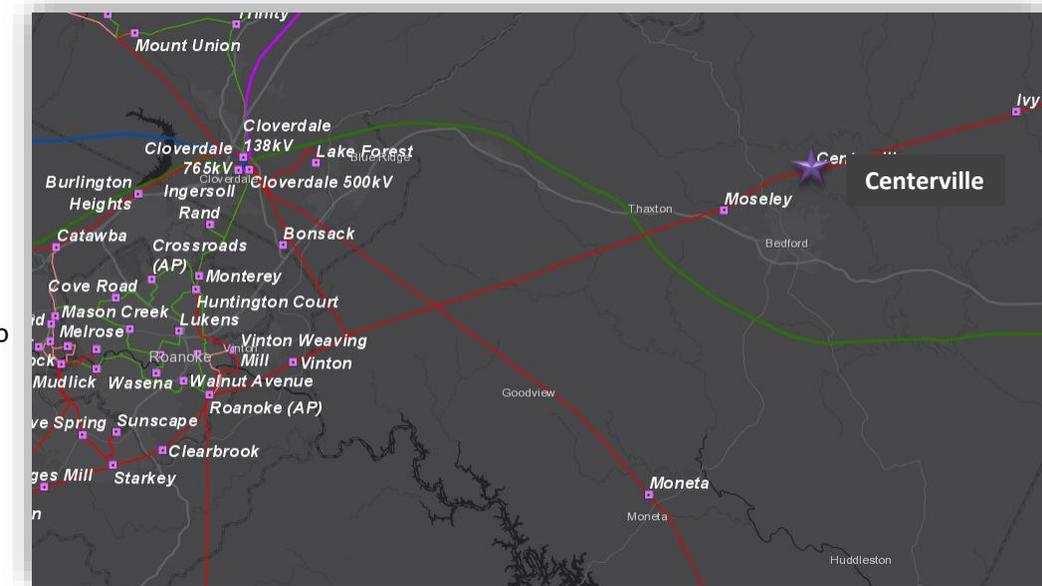
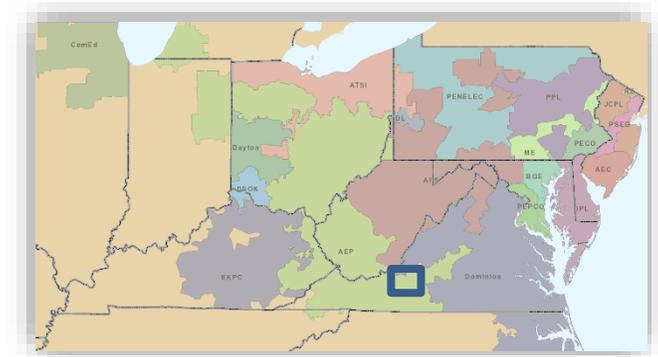
- There is a three terminal line configuration through the Town of Bedford 69 kV loop.
- The flip-flop configuration connection to the double circuit 138 kV line that runs adjacent to the station is a source of operational and protection challenges when faults occur.

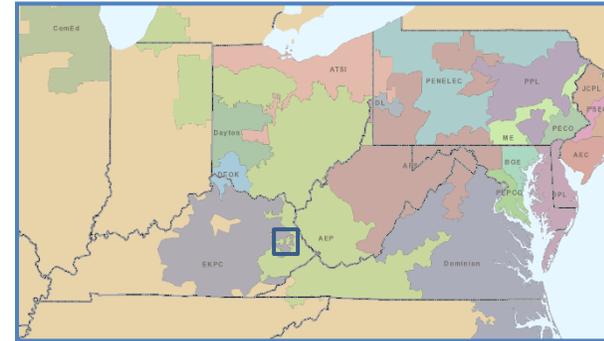
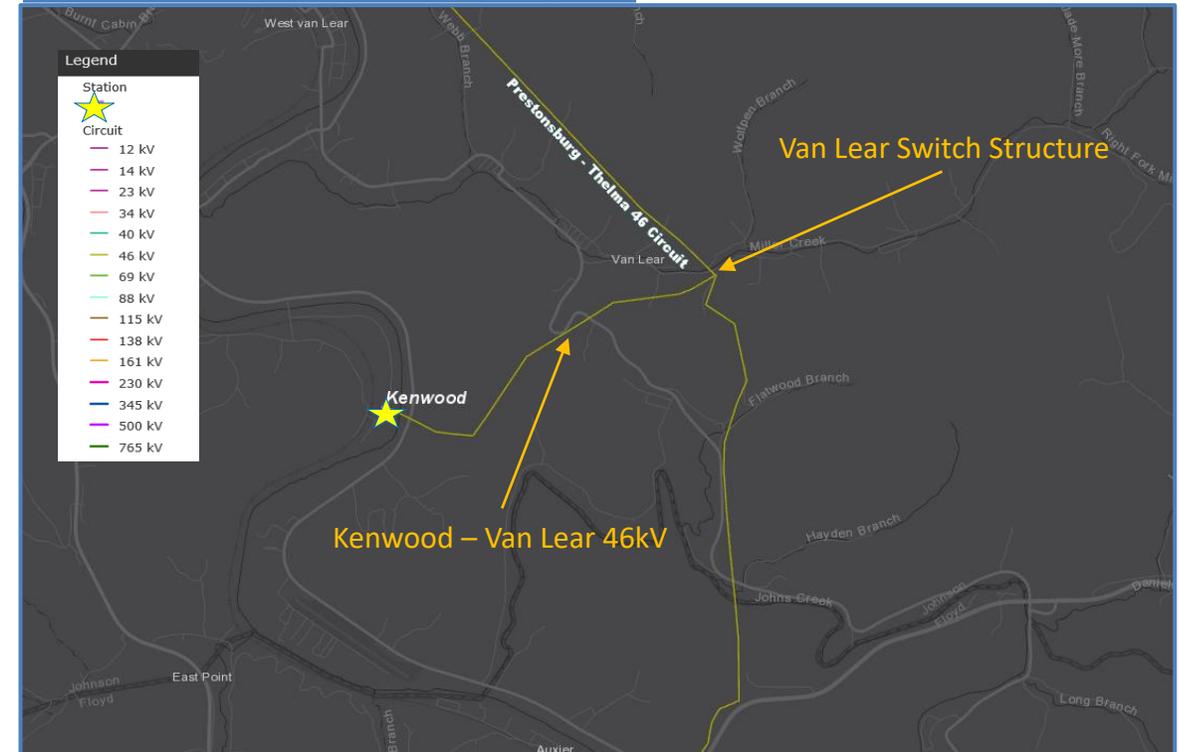
- 3 of the 11 structures have conditions that comprise 27% of the line section.
- Open conditions include: rot and woodpecker damage.
- Kenwood Station is currently radially fed with a peak load near 22 MVA.

- The switches at Van Lear have been tagged as inoperable and unsafe to operate. The old hydraulic type mechanism on these switches does not operate properly, arcing horns are burnt off, and operating rod supports are damaged.

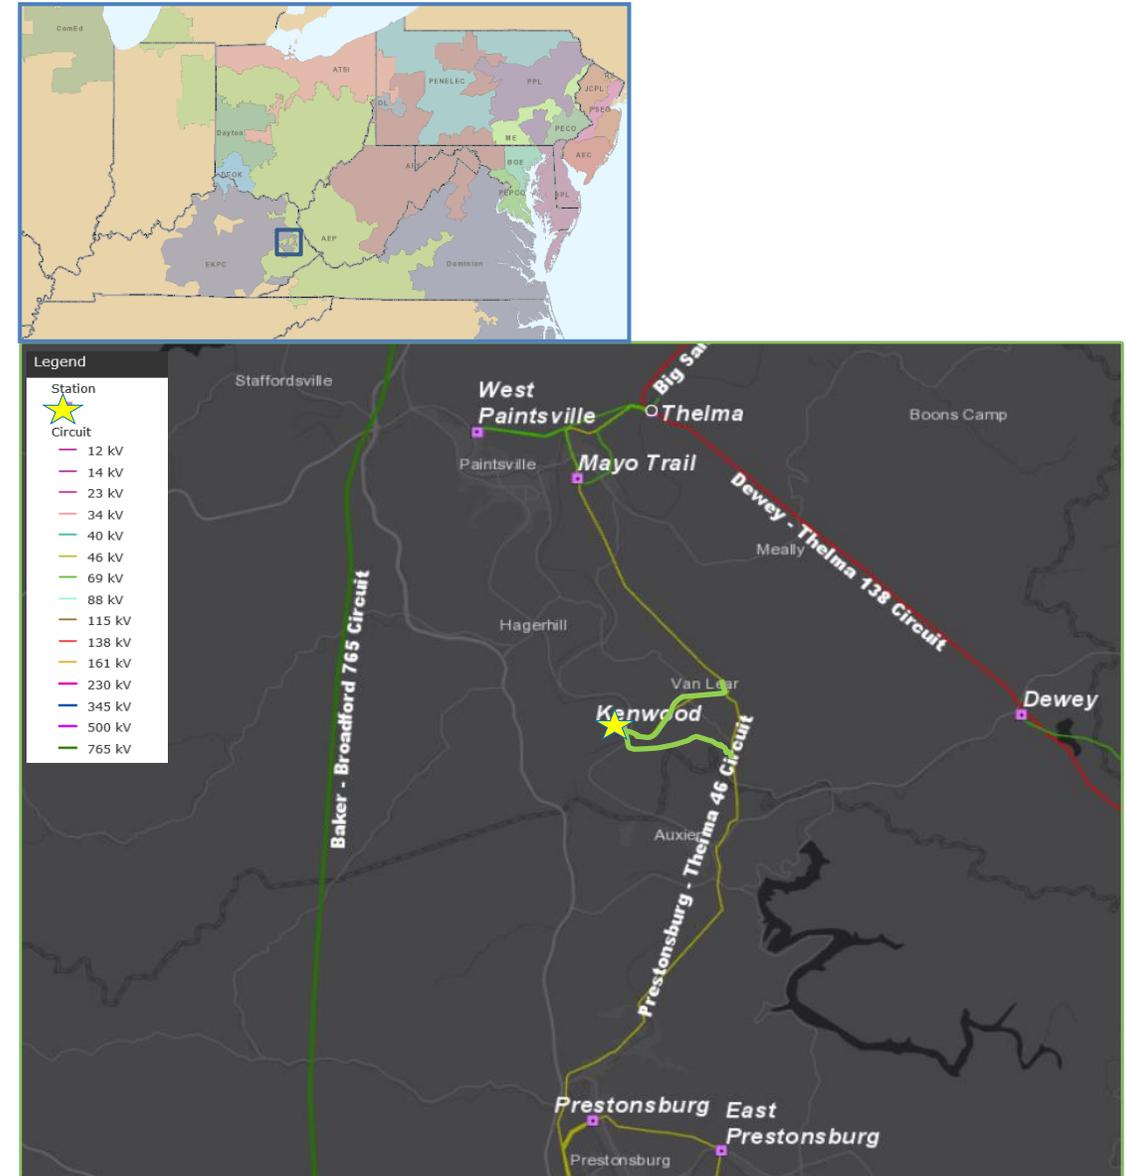
- At Kenwood substation, Extend the walk bus and add second 46KV line to set up Kenwood station as a looped station with MOABS protecting each exit. Add new H-Frame dead end with MOAB and single phase CCVT. Add MOAB and single phase CCVT to existing line. Relocate 3 phase CCVT's from cap bank AA to 46KV Bus. Add 3-bay transclosure, and separate battery enclosure. Replace Battery and Charger. **Estimated Cost: \$0 M (Distribution costs only)**

- Retire Van Lear SS. **Estimated Cost: \$0.1 M**
- Remote end work at Prestonsburg substation. **Estimated Cost: \$0 M (Distribution costs only)**
- Retire the ~1.5 mi 46kV line section from str. 52 to Van Lear SS. This line section is part of the Prestonsburg – Thelma 46kV line need (AEP-2018-022). **Estimated Cost: \$1.2 M**

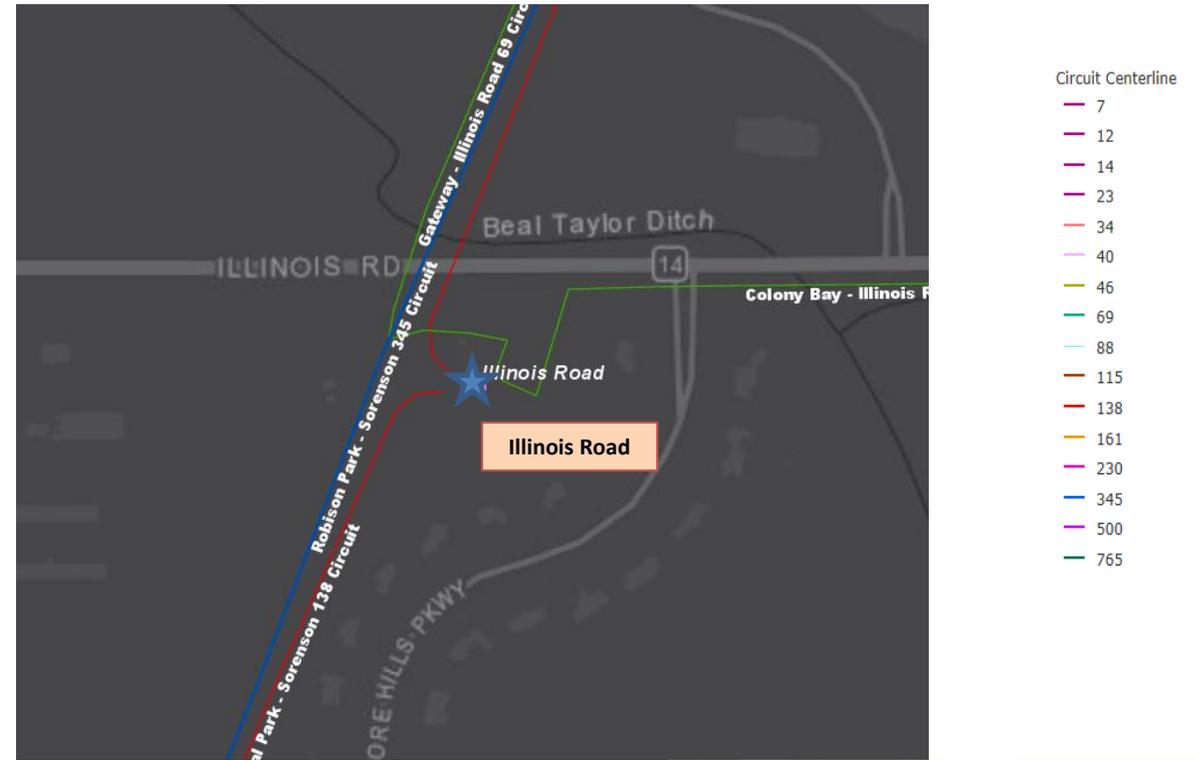
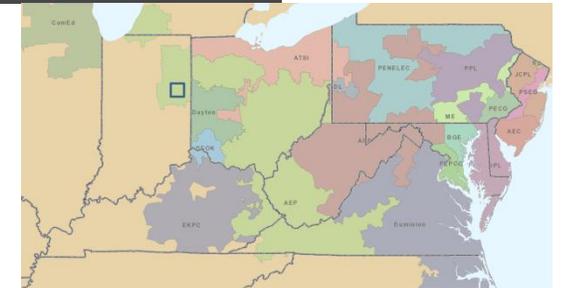
138/69/12kV Transformer 1

- Manufactured in 1980
- Transformer is showing elevated moisture levels, low levels of Interfacial Tension and an increasing trend in Power Factor.
- This level of moisture is an indication of gasket leaks and breakdown in oil or paper insulation.
- The low level of Interfacial Tension is an indication acid has coated the insulation and sludge is ready to deposit within the main tank.
- The upward trend in PF indicates that there is an increase in particles in the oil.

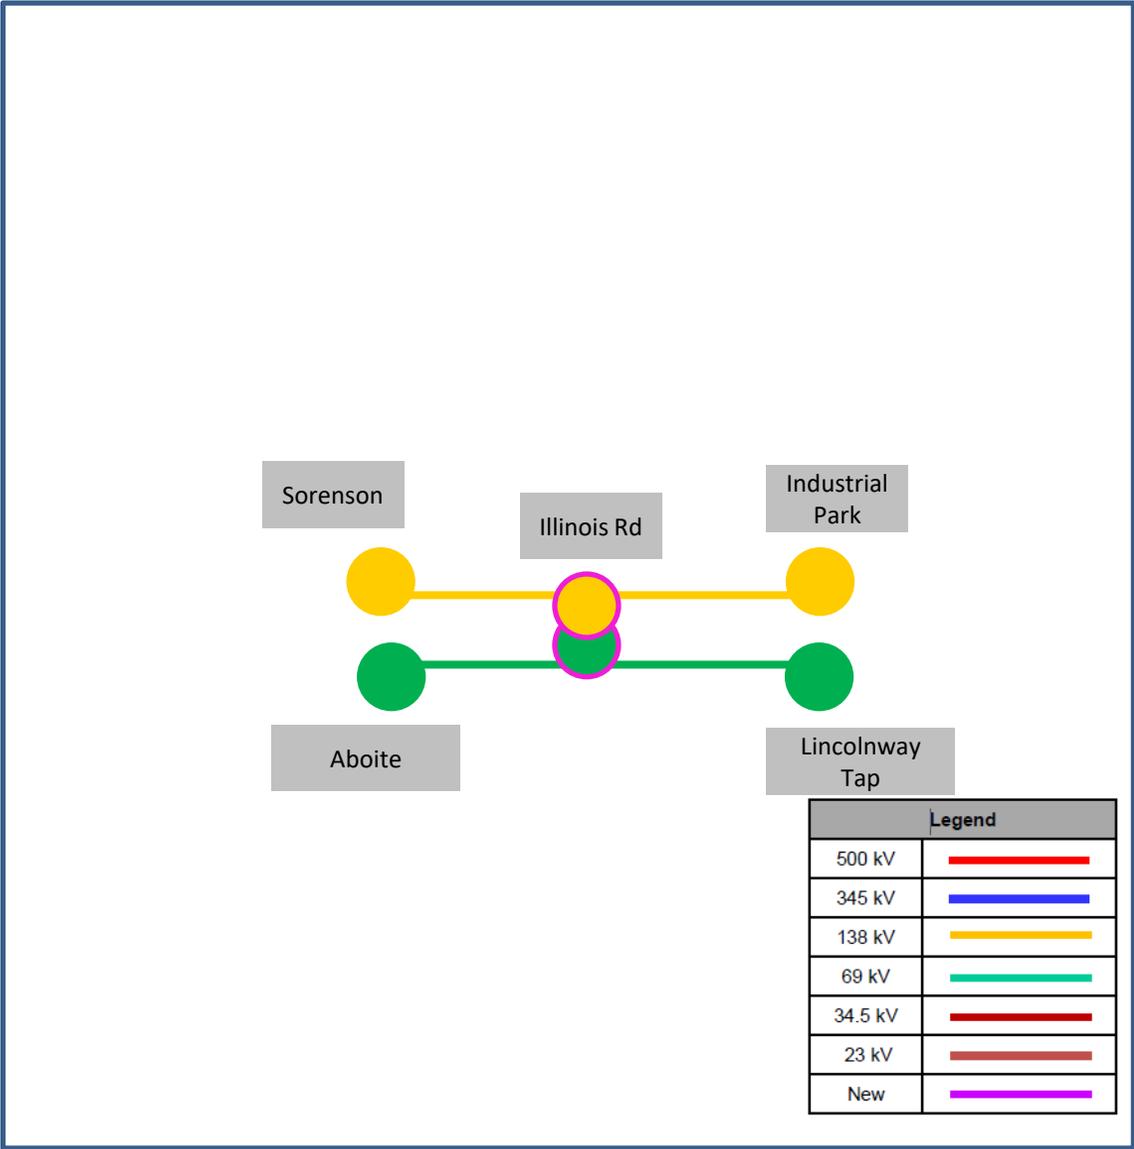
Replace the 138/69kV Transformer with a 90MVA 138/69kV Transformer.
