# Sub Regional RTEP Committee: Western AEP Supplemental Projects

June 15, 2021

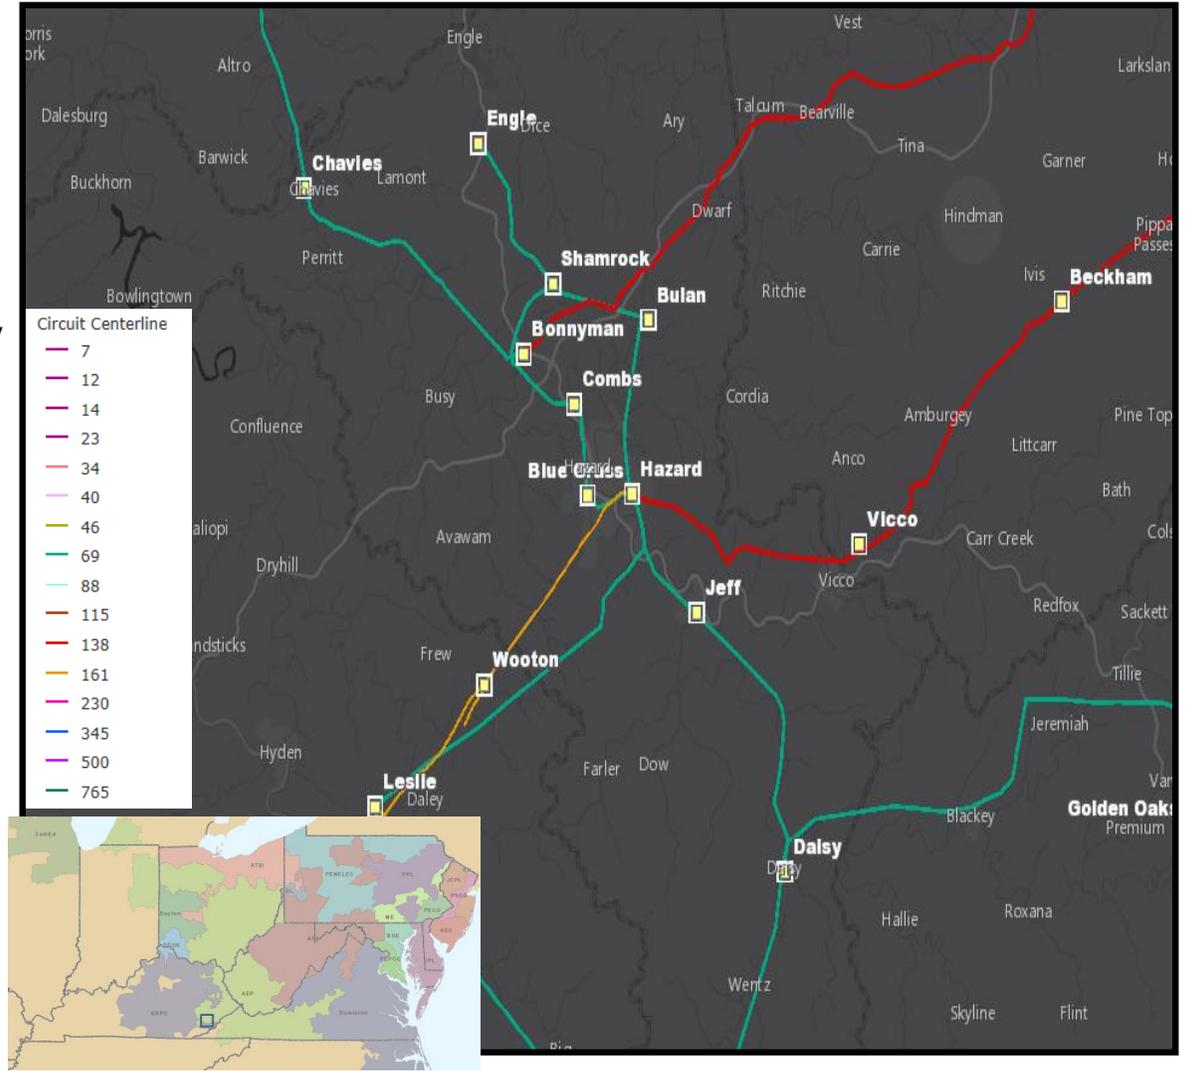
- Install a new 3000A 40 kA 138 kV circuit breaker at Hazard station on the line exit towards Beckham station. Add a 138 kV circuit switcher to the high side of transformer #4. **(s1412.1)**

- Replace 138 kV capacitor bank and switcher BB with a new switcher and 43.2 MVAR capacitor bank. **(s1412.2)**
- Replace 138/69 kV transformers #1 and #2 with new 138/69 kV 130 MVA transformers with 138 kV circuit switchers on the high side and 3000A 40 kA 69 kV breakers on the low side. **(s1412.3)**

- Replaces 69 kV circuit breakers S, E, and F with 3000A 40 kA 69 kV circuit breakers with a bus tie 3000A 69 kV circuit breaker being installed between the existing 69 kV box bays. **(s1412.4)**

- ~~Retire Replace existing~~ 69 kV capacitor bank and switcher CC ~~with a new switcher and 28.8 MVAR capacitor bank.~~ 69 kV capacitor bank and switcher AA will be retired. **(s1412.5)**

**Reason for Revision:** Removal of the cap bank from the overall station scope mitigates the need to expand the substation. This project proposes connecting the two 69kV buses with a bus tie breaker. Once the 69kV buses at Hazard station are tied together this cap bank is no longer needed for voltage support.

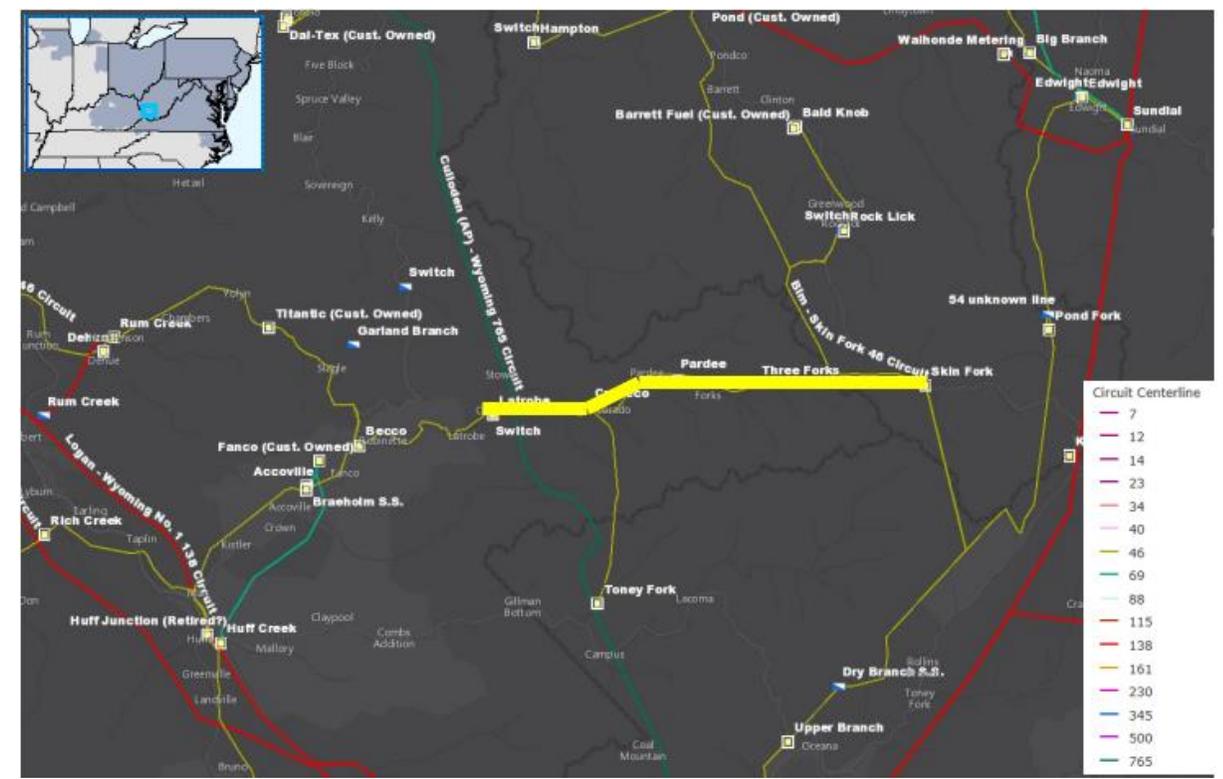
**S1292:** Rebuild Latrobe – Craneco 46kV line section (approximately 2.3 miles) utilizing 795 26/7 ACSR conductor.

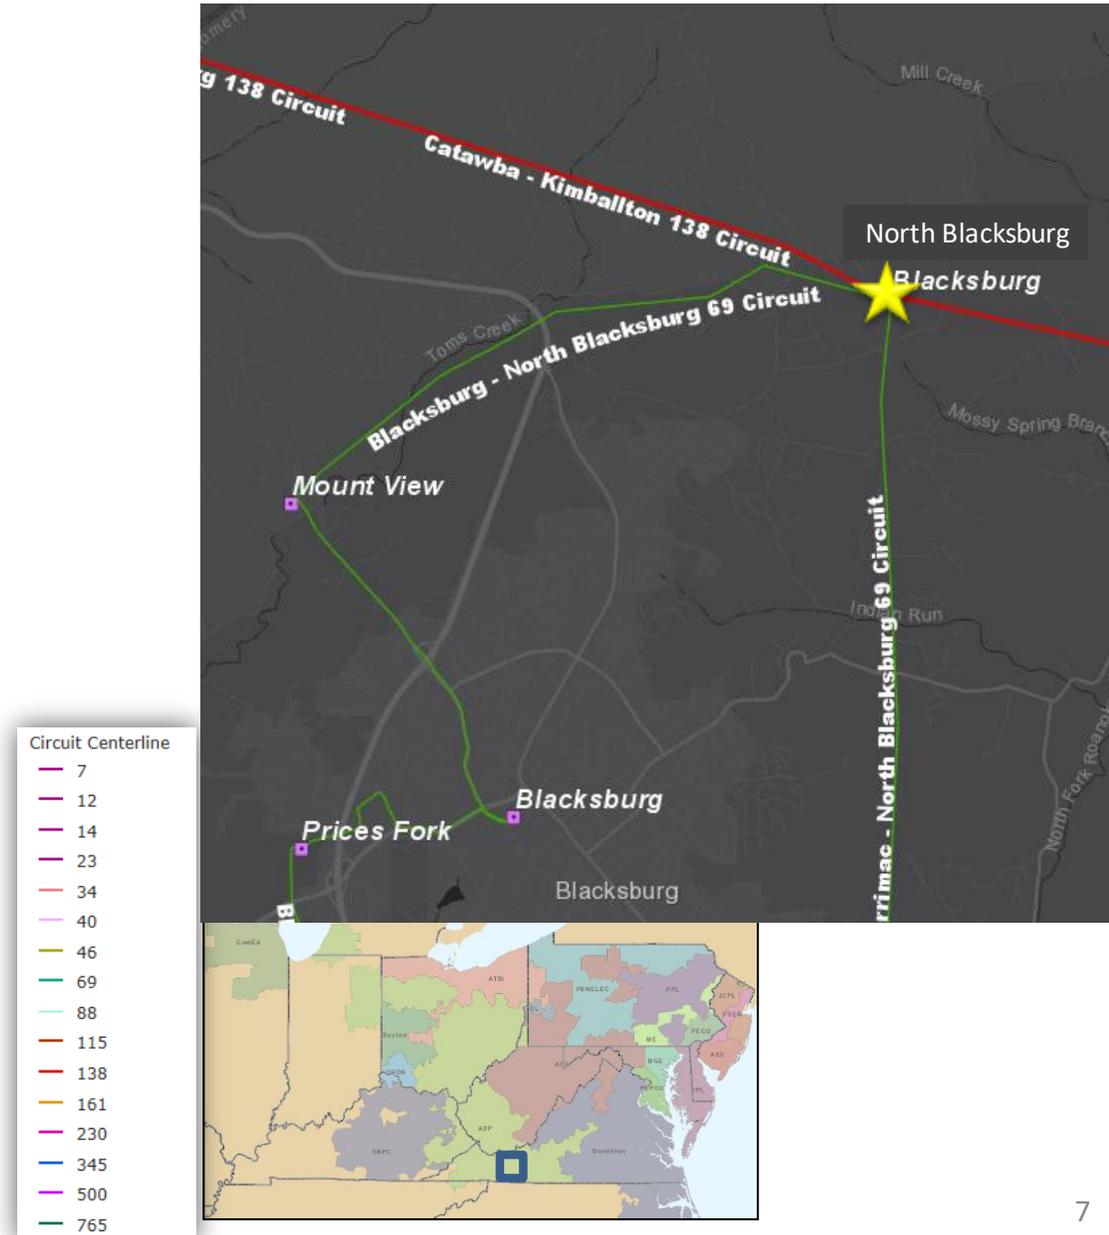
North Blacksburg Station:

- 138/69-12 kV Transformer #1
  - 1972 Vintage Transformer
  - The presence of Ethane, along with the indication of overheating faults, indicates decomposition of the paper insulation that impairs the unit’s ability to withstand future short circuit or through fault events.
  - The dielectric is driven by the upward trend in insulation power factor, which indicates an increase in particles within the oil.
  - The transformer has had issues with proper oil flow.

- 138/12 kV Transformer #2
  - 1967 Vintage Transformer
  - The presence of Acetylene, confirms the insulation system (oil and paper) is in poor condition and also indicates electrical discharge faults of low energy have occurred within the main tank causing electrical breakdown of the unit.
  - The transformer has significant rust spots and weld leaks.
  - This is allowing voltage phase imbalances, specifically high voltage, to pass through to distribution customers served from North Blacksburg station.

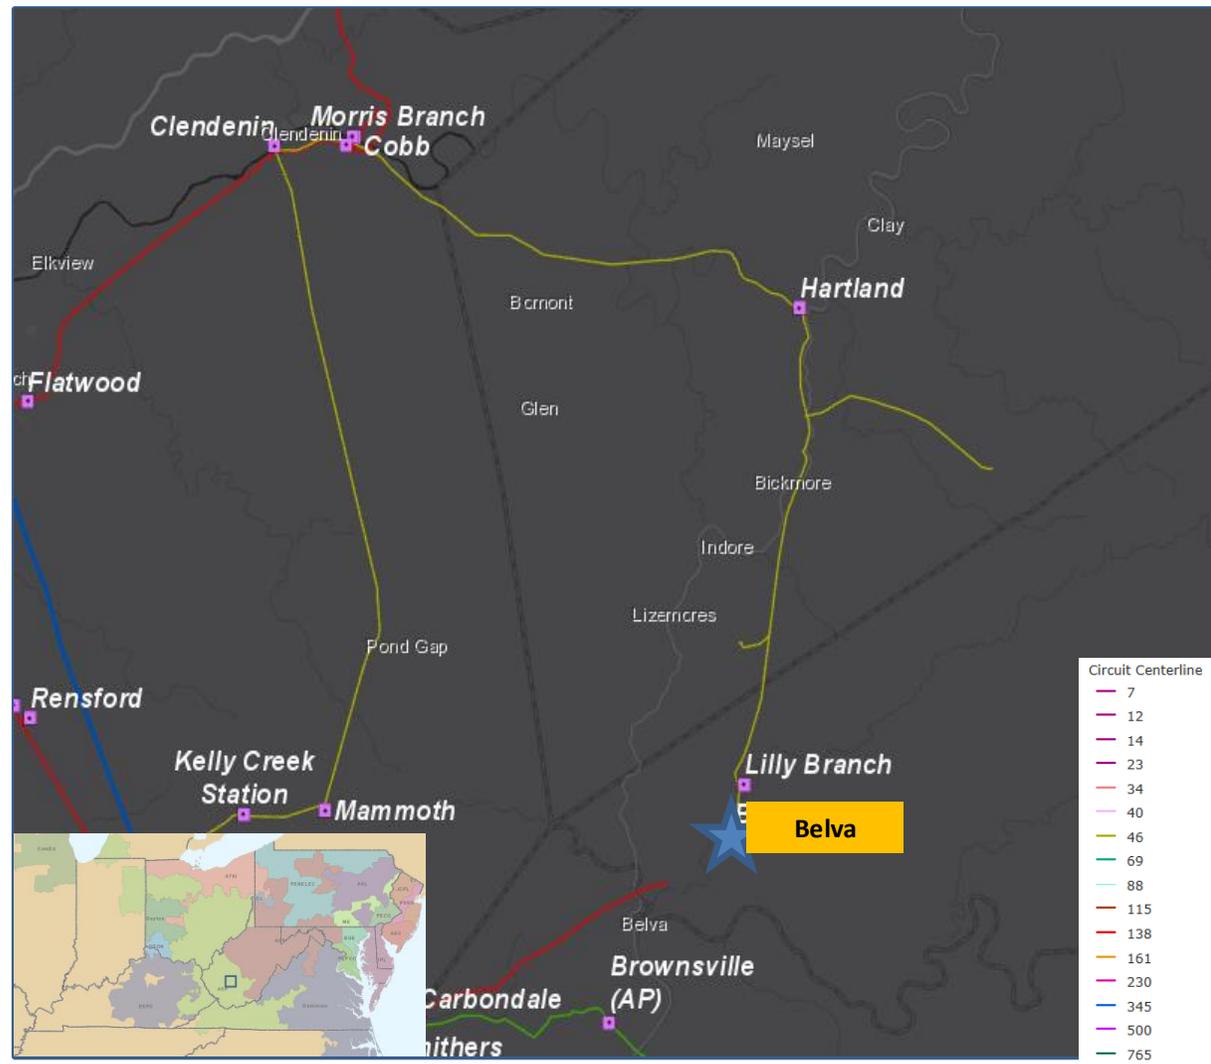
Belva 138/46 kV Station

- The transformer protection includes an obsolete MOAB-ground-switch system, which relies on remote station fault clearing.
- The lack of sectionalizing at the station creates dissimilar zones of protection (line, bus, and transformer) which can cause over tripping and mis-operations.
- Belva Station deploys 40 relays and currently 36 of the 40 (90%) are in need of replacement. 35 are electromechanical and 1 is static type, which have significant limitations with regards to part availability and fault data collection/retention.

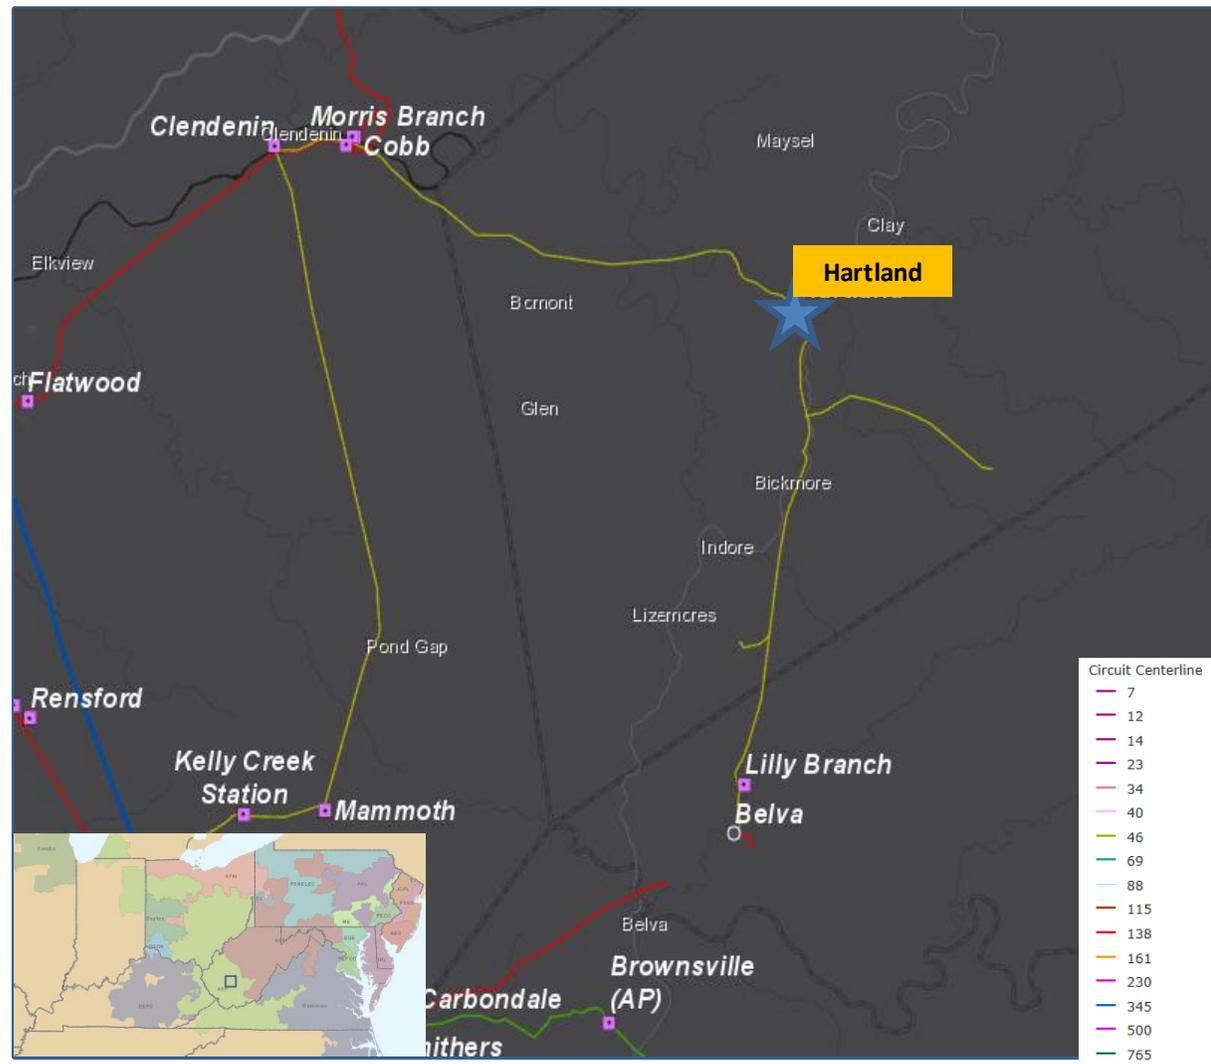
Hartland 46 kV Station

- Circuit switcher AA is a 2030-69 type SF6 filled switcher. The S&C 2030 family of circuit switchers have no gas monitor and currently in-service units on the AEP system have experienced 80 malfunctions from May 2002 to August 2019.
- Vacuum bottles on MOABs 'W' and 'Y' show signs of damage.

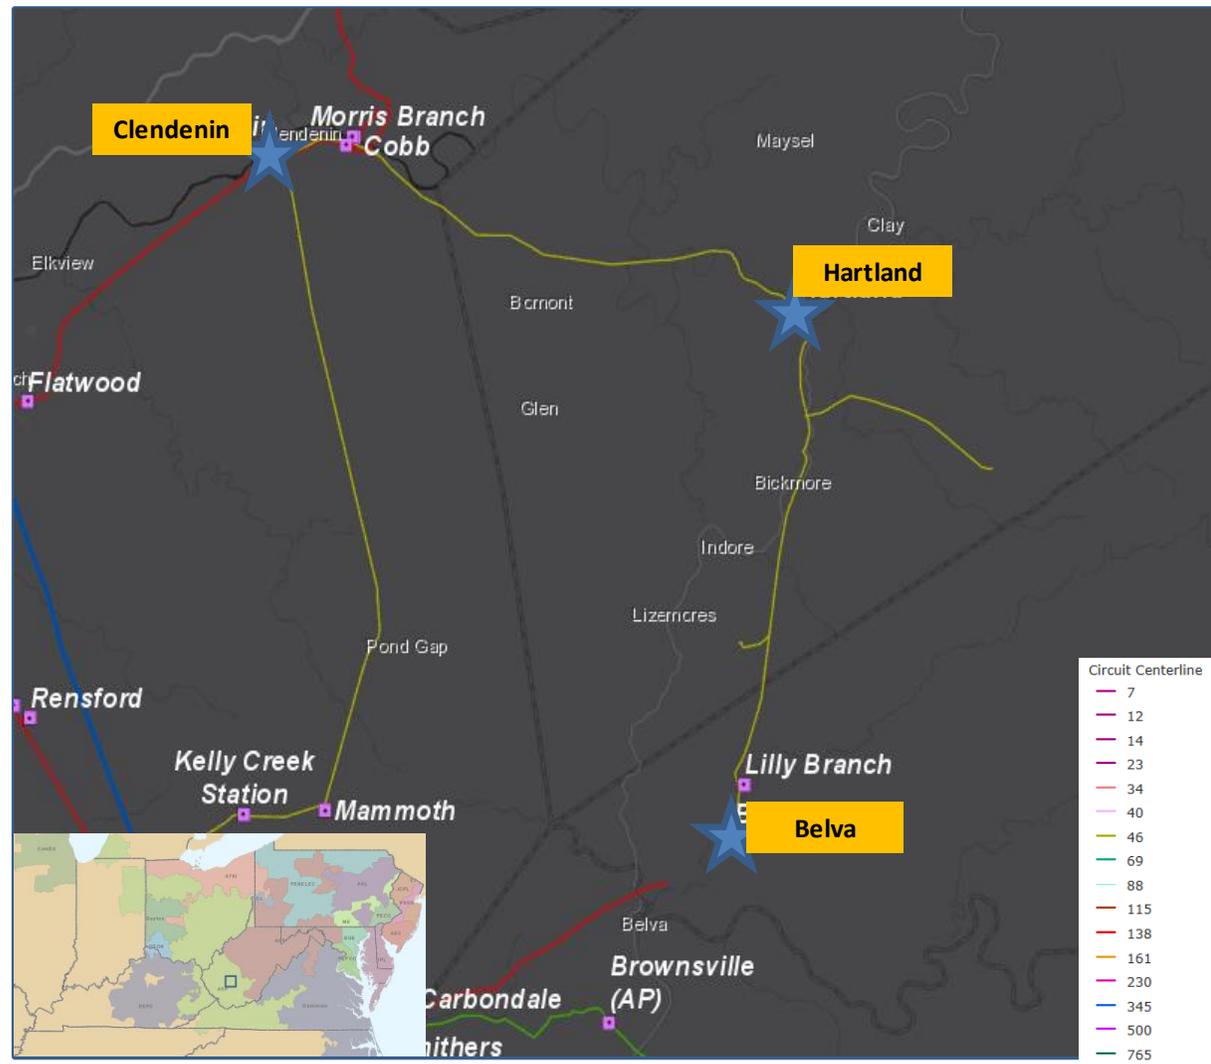
Belva – Clendenin 46 kV Circuit (~27 miles)

- Circuit is comprised mostly of vintage wood pole structures.
  - Original vintage wood structures from 1940
  - The Belva – Clendenin 46kV Line uses primarily original vintage conductor including 2/0 Copper, 4/0 ACSR and 336 ACSR.
