Submission of Supplemental Projects for Inclusion in the Local Plan

AEP Local Plan - 2024

AEP Transmission Zone M-3 Process Southern Fort Wayne

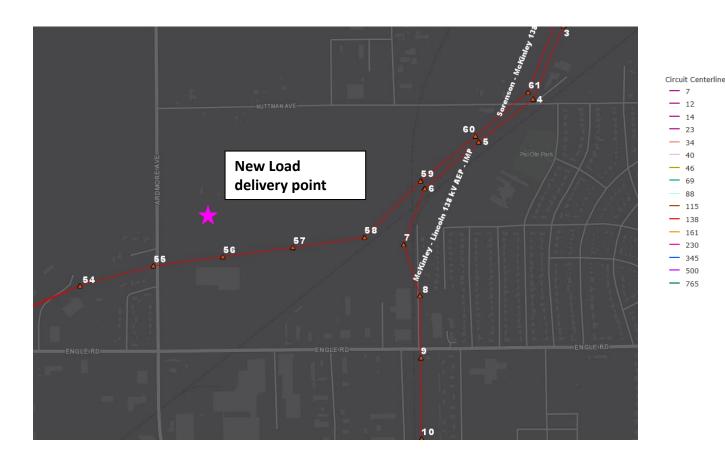
AEP I&M distribution has requested a new delivery point on the southern side of Fort Wayne to serve 13MW of load, transferred from McKinley

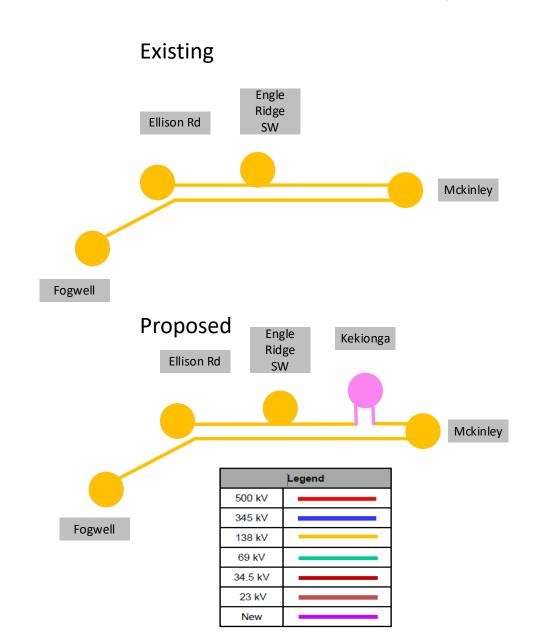
AEP Transmission Zone M-3 Process Kekionga Station

Install a 138kV/12kV distribution station named Kekionga on the Mckinley-Ellison Road 138kV line. Install 138kV line extension from Mckinley-Ellison 138kV line with fiber (~0.15 miles from the 138kV line), install 138kV bus with 2-138kV switches and 138kV MOAB.

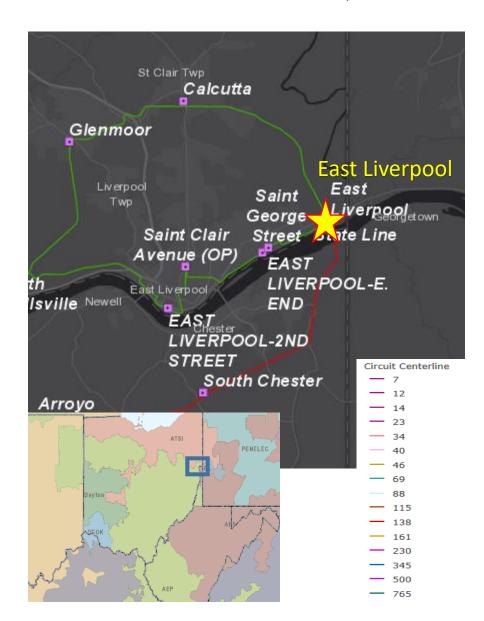
AEP Transmission Zone M-3 Process East Liverpool, Ohio

- The East Liverpool Second Street 69kV circuit protection uses electromechanical relays and a legacy pilot wire communications channel. These relays have significant limitations with regard to spare part availability, SCADA functionality, and fault data collection and retention. In addition, these relays lack vendor support. Pilot wire cables are showing increased rates of failure and signal degradation across the AEP system.

- The 138kV tie-line to FirstEnergy uses electromechanical relays. The power-line-carrier equipment at East Liverpool was installed in 1962, presenting a failure risk. FE has indicated a future project is planned to upgrade relays on their side.

- The 138-69kV transformer protection system also utilizes outdated electromechanical relays.
- The 1962-vintage control house has various issues of concern: lead-based paints, asbestos, no air conditioning or exhaust fans, and small roof leaks.

- The station PT's are original to the station (1962) and are in poor condition with rusting. The AC station service system is in poor condition and uses a corner-ground connection which is a safety concern.

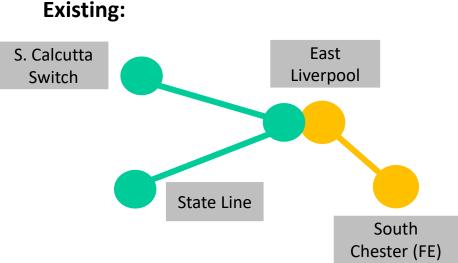
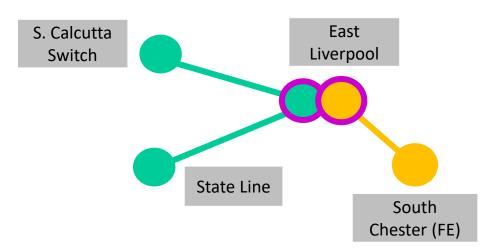
AEP Transmission Zone M-3 Process East Liverpool Station Upgrade

• At East Liverpool station, replace the 138kV MOAB/ground switch system with a circuit breaker and new relays. Install a 69kV breaker on the low side of the 138-69kV transformer. Upgrade tie-line metering, relays, and expand SCADA functionality at the station. Replace the control house with a new prefabricated control building. \$3.0 Million (s3145.1)

• At the 69kV remote end station of Second Street, replace the electromechanical relays and pilot wire communications with microprocessor-based relays, to coordinate with East Liverpool. Install new 69kV CCVT's. \$0.3 Million (s3145.2)

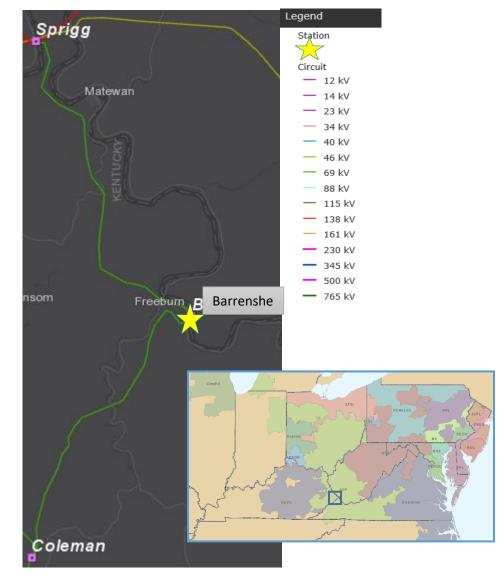
AEP Transmission Zone M-3 Process Pike County, Kentucky

- All 15 relays at Barrenshe station are in need of replacement. There are 11 electromechanical relays which have significant limitations with regards to fault data collection and retention. These relays lack vendor support and have little to no access to spare parts. Also, the remaining 4 microprocessor relays were commissioned from 2006-2007 and are at the end of their useful life.

- The station bay was constructed using wood poles that were installed in 1953. The poles are very rotten and there is concern that any type of stress on the poles could cause the station to fail completely. The poles closest to the transformer are leaning and have twisted the bus.

- In 1977, flood waters were over 3/4 up the control cabinet. There has been repeated wash out in the rear of the station causing the fence post foundations to wash away. The station lies in the 100 year flood plain between mountainous terrain and highway 194 making expansion at the existing site extremely difficult.

- 69 kV MOAB W is 1973 vintage and needs replaced due to wear and lack of available parts.

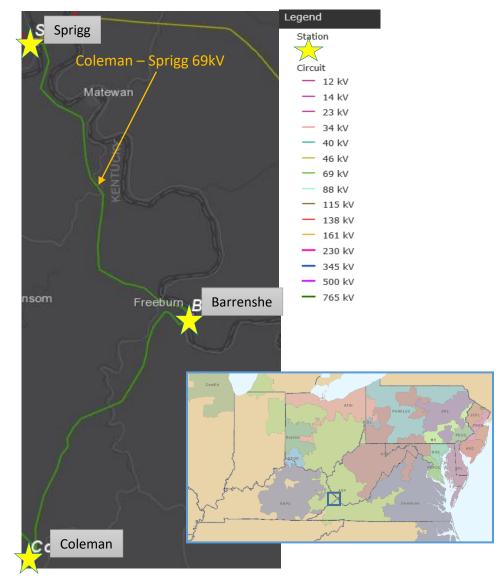
AEP Transmission Zone M-3 Process Pike County, Kentucky

- The 10 permanent outages caused 2.6M minutes of interruption for distribution customers
- The line structures fail to meet 2017 NESC Grade B loading criteria, current AEP structural strength requirements, and the current ASCE structural strength requirements.

- Currently, there are 44 structures with at least one open condition, which relates to 43% of
 the structures on the circuit specifically affecting the crossarm, knee/ vee brace, or pole
 including rot, damaged, insect damage, and bowed conditions.

- 39 of 101 (39%) structures are 1920s vintage
- 53 of 101 (52%) are 1970s vintage. The Barrenshe Coleman segment was rebuilt in the early 1970s. On the Sprigg Barrenshe segment, 17 structures were also rebuilt in the 1970s. These 1970s structures are also showing signs of pole cracking, weathering, rot, and woodpecker damage. The crossarms and braces show signs of mold as well as signs of rot, cracking, splitting, bowing, and weathering.

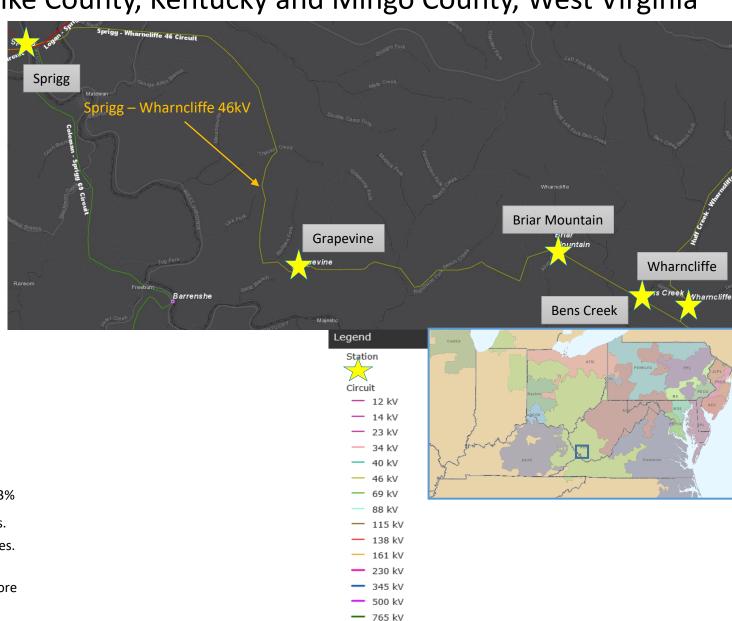
AEP Transmission Zone M-3 Process Pike County, Kentucky and Mingo County, West Virginia

- The 10 permanent outages caused 481k minutes of interruption for distribution customers
- The line structures fail to meet 2017 NESC Grade B loading criteria, current AEP structural strength requirements, and the current ASCE structural strength requirements.

- Currently, there are 39 structures with at least one open condition, which relates to 33% of the structures on the circuit specifically affecting the crossarm, knee/ vee brace, or pole including rot, damaged, insect damage, woodpecker holes, and bowed conditions.

- 32 of the 120 structures are 1930s vintage or older accounting for 27% of the structures. Another 33 of the 120 structures are split almost evenly between 1940s, 50s, and 60s vintage, accounting for 28% of the structures. An additional 22 of 120 structures are spread between the 1970s and 90s (18%). The described structures, including 11% more are all wood structures, with only 16% of the line made up of steel structures.

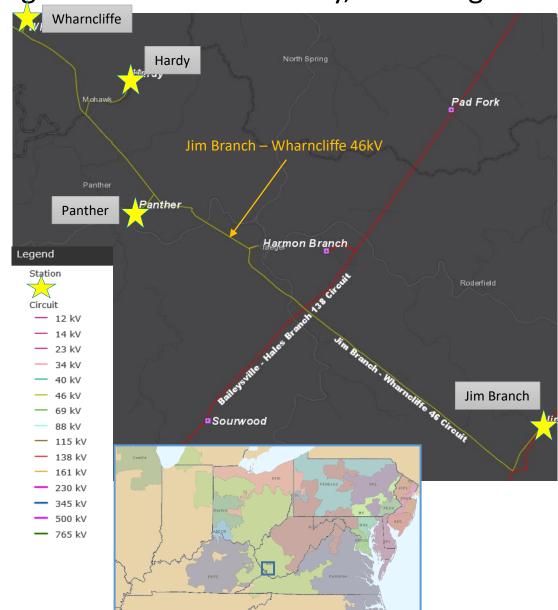
AEP Transmission Zone M-3 Process Mingo and McDowell County, West Virginia

- The momentary outages were attributed to lightning (24), wind (3), relay mis-operation (1), unknown (1), and distribution (1) causes. The permanent outages attributed to vegetation contacts from outside the AEP ROW (12), lightning (4), pole failure (1), failed insulator (1), ice/snow (1), and relay mis-operation (1) causes. The large number of lightning caused outages is due to 65% of the circuit lacking shield wire.

- The permanent outages caused 2.62M minutes of interruption for 11,744 customers at Panther and Hardy substations.
- The line structures fail to meet 2017 NESC Grade B loading criteria, current AEP structural strength requirements, and the current ASCE structural strength requirements.

- 134 of the 162 structures are 1930s vintage or older accounting for 83% of the structures. These structures have conditions like top rot, Woodpecker damage, split top, heart rot, base rot, bowing, and corroded hardware.

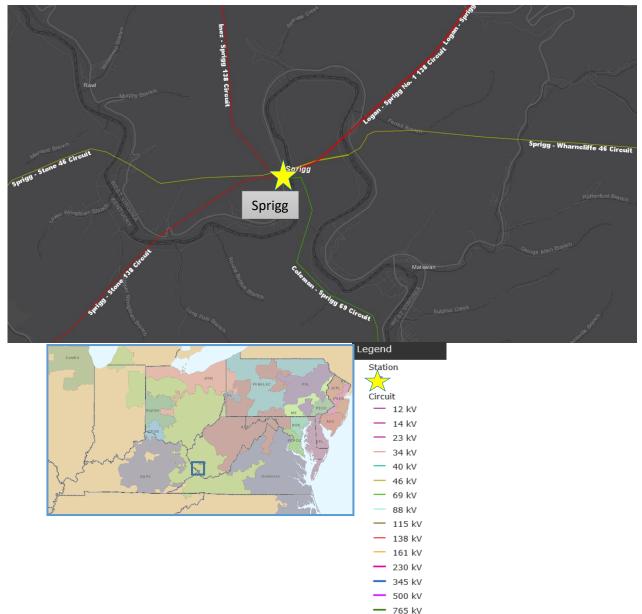
AEP Transmission Zone M-3 Process Mingo County, West Virginia

- 1971 Vintage Transformer
- The presence of Ethane, along with the indication of overheating faults, indicates decomposition of the paper insulation that impairs the unit's ability to withstand future short circuit or through fault events.
- The dielectric is driven by the upward trend in insulation power factor, which indicates an increase in particles within the oil.
- The transformer has elevated moisture levels that are a result of gasket leaks or breakdown in oil or paper/pressboard insulation.

- 1972 Vintage Transformer
- The elevated levels of Acetylene indicate increased decomposition of the paper insulating materials. The dielectric is driven by the upward trend in insulation power factor, which indicates an increase in particles within the oil.
- The transformer has elevated moisture levels that are a result of gasket leaks or breakdown in oil or paper/pressboard insulation.

• There are 82 electromechanical and 3 static relays which have significant limitations with regards to fault data collection and retention. These relays lack vendor support and have little to no access to spare parts.

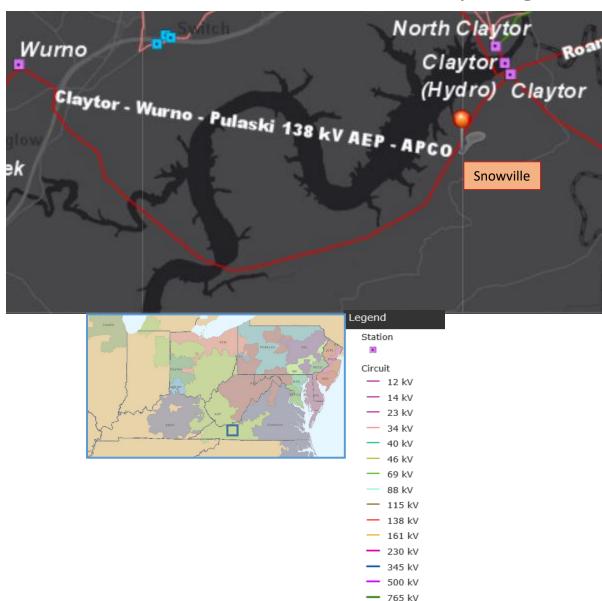
AEP Transmission Zone M-3 Process Pulaski County, Virginia

- The Distribution customers south of Claytor Lake are fed by one 34.5kV distribution circuit out of Wurno station and the circuit has one lake crossing. This circuit is currently 187-line miles long and has no other 34.5kV distribution circuit ties. Over the past five years, there were 223 distribution outages resulting in 5.9 million CMI.
- The greenfield Snowville station will pick up 6.5 MVA from Wurno station.

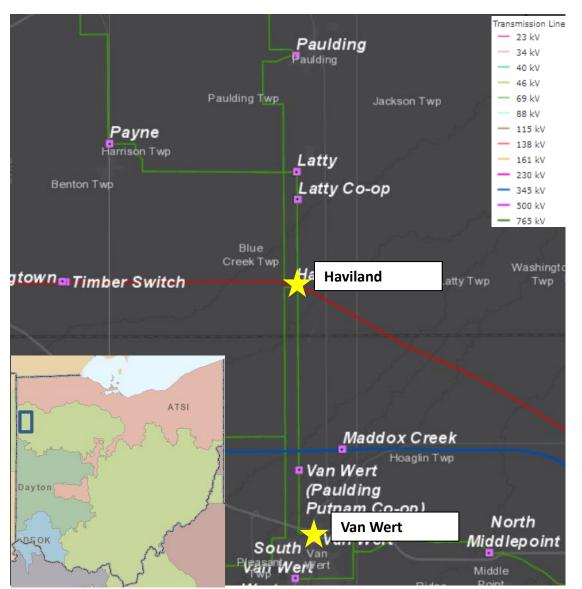
AEP Transmission Zone M-3 Process Paulding & Van Wert Co., OH

- Conductor Types: 556.5 ACSR 18/1 (Osprey), 4/0 COOPER, 556.5 ALUMINUM 19 (Dahlia),795 ACSR 26/7 (Drake)
- Outage History: 1 Momentary and 2 Permanent outages average duration of 38.72 hours, 66.6K CMI between 2015 and 2020
- Open Conditions: 19, including splice/dead end conductor issues, damaged/missing ground lead wires, broken shield wire, disconnected grounding mat and chipped insulators
- The Van Wert Haviland line fails to meet 2017 NESC Grade B loading criteria, current AEP structural strength requirements, and the current ASCE structural strength requirements. The line is insulated with vertical post insulators that do not meet current AEP standards for CIFO and minimum leakage distance requirements.

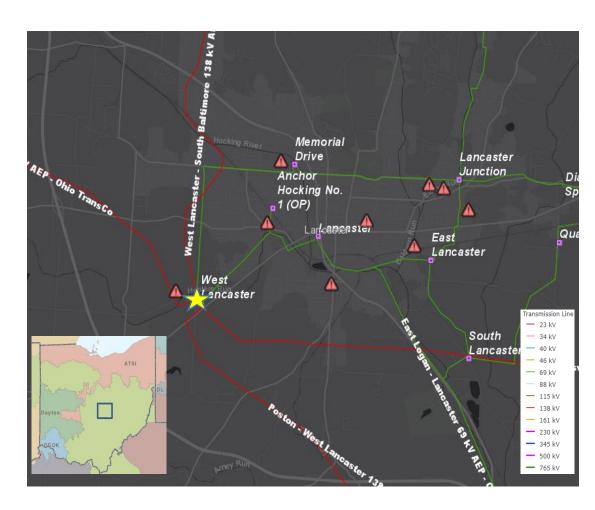
AEP Transmission Zone M-3 Process Lancaster Area Improvements

• Additional Info: This switcher is a Mark V type that has no gas monitor and currently in-service units on the AEP system have experienced 110 malfunctions from May 2000 to August 2019. Failed operational components including high contact resistance, gas loss, and interrupter failure represent half of these malfunctions. Two malfunctions of note were catastrophic equipment failures involving failures to trip.

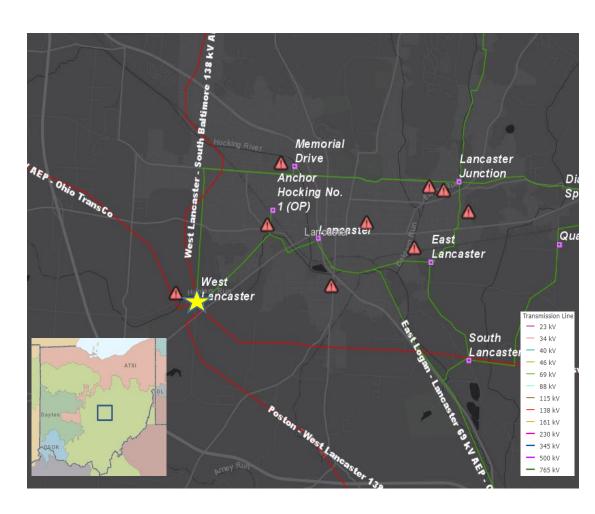
AEP Transmission Zone M-3 Process Lancaster Area Improvements

- Asbestos on walls, roof and cables
- Structural Integrity is in question this needs replaced as soon as possible.
- Relays systems are not set up for dual battery configuration
- Cable entrance is 100% full

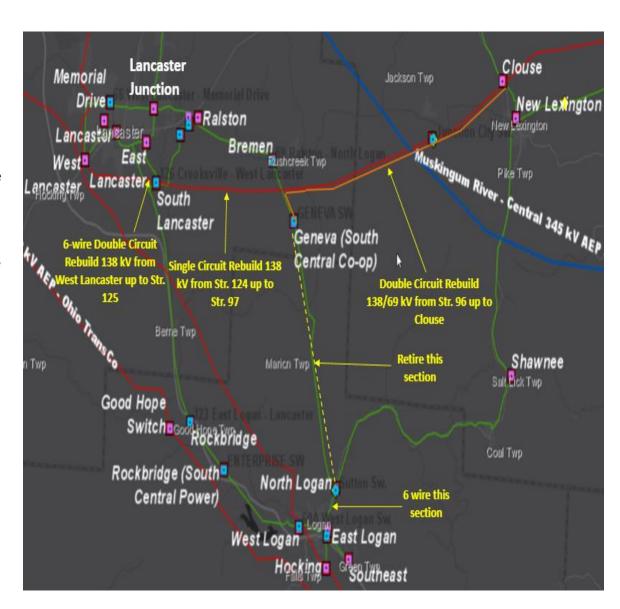
<u>Geneva Sw 69 kV</u>: Replace & relocate the existing PoP Switch with a 3-way 1200A PoP Switch. Cost: \$0.95M (s3133.7)

Junction City 138 kV: Replace the existing 2-way POP with a 3-way 2000A POP. Cost: \$1.15M (s3133.8)

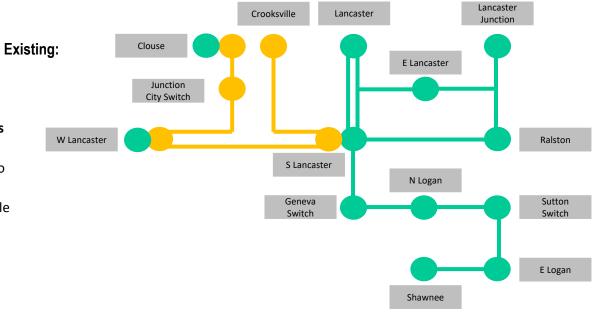
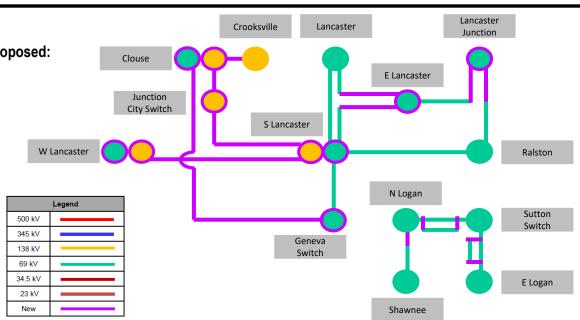
AEP Transmission Zone M-3 Process Lancaster Area Improvements

West Lancaster 138 kV & 69 kV: Replace T2 with a 90MVA bank. Replace 138 kV CB-D with 1 - 138 kV, 3000 A, 40 kA circuit breaker, 69 kV CB-C & CB-J with 2 - 69kV 3000 A, 40 kA circuit breakers, 69 kV CS-BB with 1 - 69 kV 2000A 31.5 kA circuit breaker and, the control building with DICM & new relays. Retire 138 kV CB-E. Replace 69 kV Bus 1 PT's. Cost: \$10.83M. Note: Work will be coordinated with previously proposed upgrades at station captured under \$2857.9. (s3133.9)

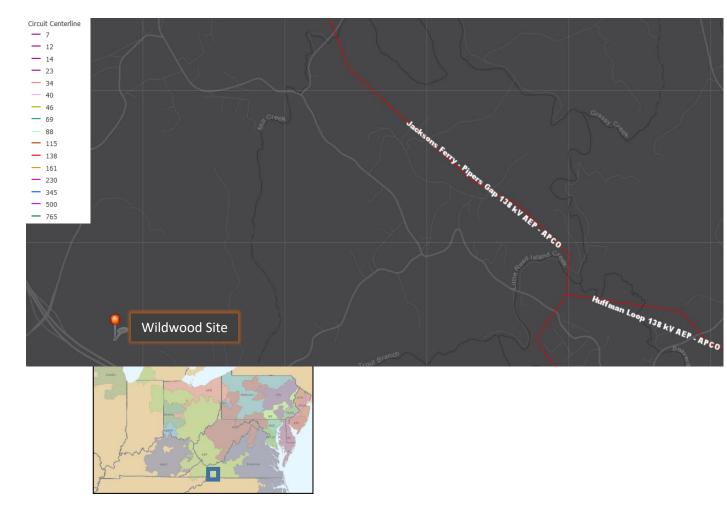
AEP Transmission Zone M-3 Process Carroll County, VA

- A customer has requested service for the establishment of a new distribution station located at the Wildwood Commerce Park site in Hillsville, VA.
- This station is the result of VA House Bill 1840 (HB1840) (Electric Utilities: Pilot Programs for Transmission Facilities Serving Business Parks).

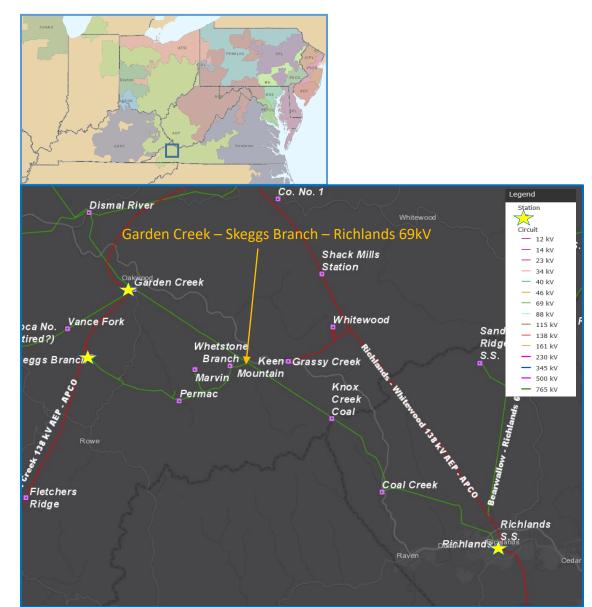
AEP Transmission Zone M-3 Process Buchanan County, VA

• 42 structures with at least one open structural condition, 23% of the structures on this circuit.

- 73 structure related open conditions impacting wooden poles, lattice steel towers, crossarms, braces, and filler blocks including rot, bowing, woodpecker holes, insect damage, cracked, split, and heavy rust/corrosion.
- 1 open conditions related to broken strands
- 8 hardware related open conditions related to broken or chipped insulators and a buried guy.

- This circuit is operated normally open at Permac station
- Lack of sectionalizing capability due to multiple stations (Twin Valley SS, Marvin, Clell) being hard tapped to 69kV Line or operated radially
- Whetstone Branch is a 3 terminal switching station with no 69 kV line breakers.
- Only 11.6 miles of this line are currently shielded.

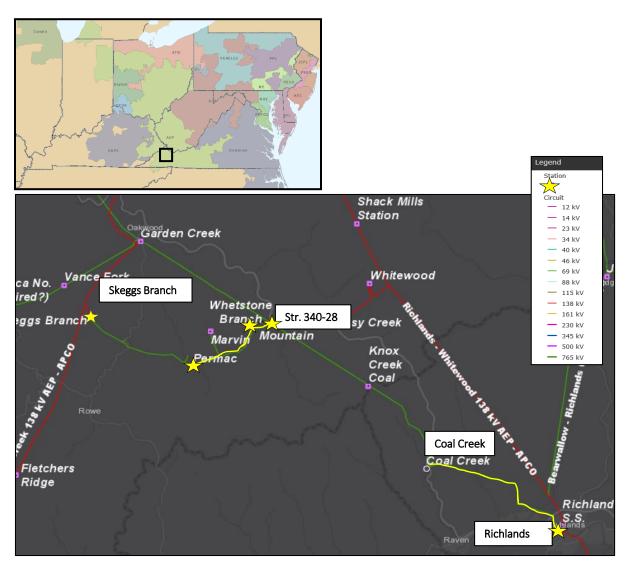
- At Whetstone Branch Station, replace circuit switcher "AA" with a new, standard, 69kV circuit switcher, replace all metering CTs and PTs with CT/PT combo metering units, and replace the existing single phase CCVT with a new standard three phase CCVT. Estimated Transmission Cost: \$1.55 M (s3135.2)

- At Coal Creek substation, reconductor the 69kV bus, replace 600A Switchers with new MOAB switches on new steel structures. Switch "33" towards the customer will be replaced to allow for the new structure to fit into the existing station footprint. **Estimated Transmission Cost: \$0 M (s3135.3)**

- Remote end work at Richlands substation. Estimated Transmission Cost: \$0.05 M (s3135.4)
- Provide transition fiber on the Garden Creek Richlands Skeggs Branch 69kV Line for connectivity at Mount Heron Station and at Whetstone Branch Station to support CES networking and SCADA connectivity. **Estimated Transmission Cost: \$0.40 M (s3135.5)**

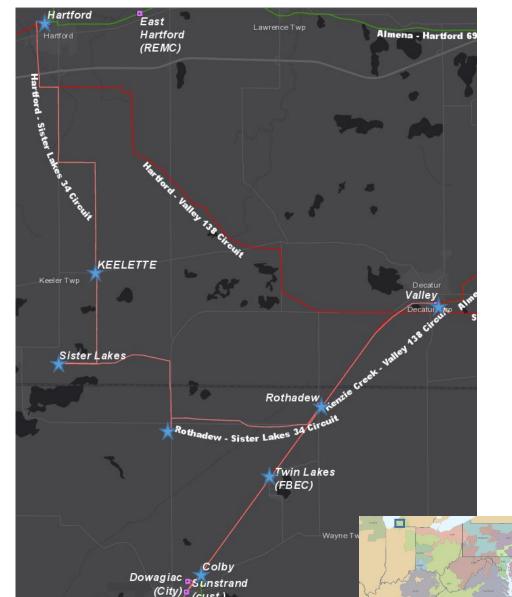
AEP Transmission Zone M-3 Process Rothadew Area Improvements

- The customer served from Rudy Tap 34.5kV Sw has requested a load increase.
- The customer has indicated a demand of 28MW at their existing delivery point with plans to expand and increase load significantly

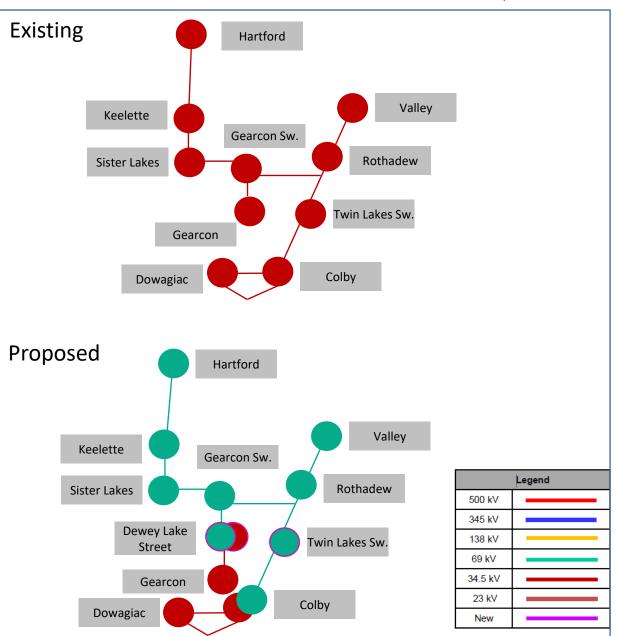
AEP Transmission Zone M-3 Process Rothadew Area Improvements

Further, AEP is moving away from the 34.5kV transmission voltage class where there are issues with drop and pick operations. The 34.5kV voltage delivery points are out of phase from delivery at 69kV or 138kV and switching load from one 34.5kV source to another, higher voltage source requires the customers to be dropped and then picked up from the new source. Utilizing 69 or 138 kV as a standard delivery voltage eliminates the initial drop requirement for the load.

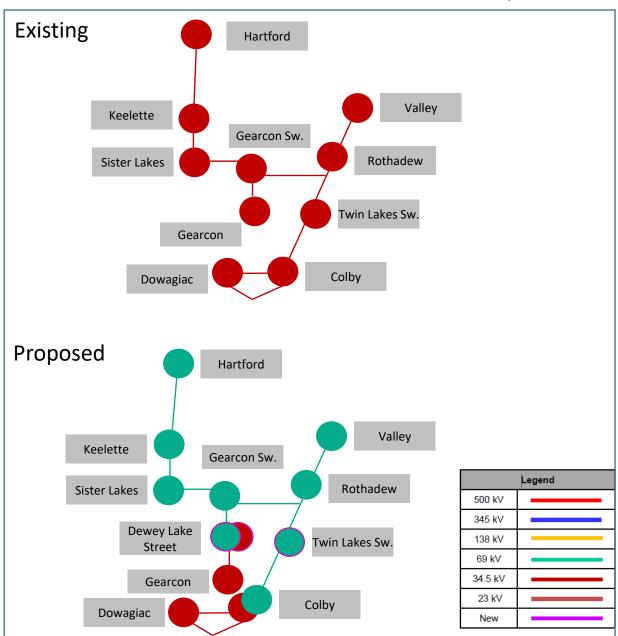
AEP Transmission Zone M-3 Process Rothadew Area Improvements

- Sister Lakes: Replace both transformers with 9.375MVA 69/12kV units and install a high side switcher on transformer 1. Estimated Transmission Cost: \$0M (s3136.2)

- Twin Lakes Sw.: Replace Switch. Estimated Transmission Cost: \$0.83M (s3136.6)
- Keelette, Sister Lakes, Gearcon Sw., Rothadew,: Energize to 69kV. Estimated Transmission Cost: \$1.01M (s3136.7)

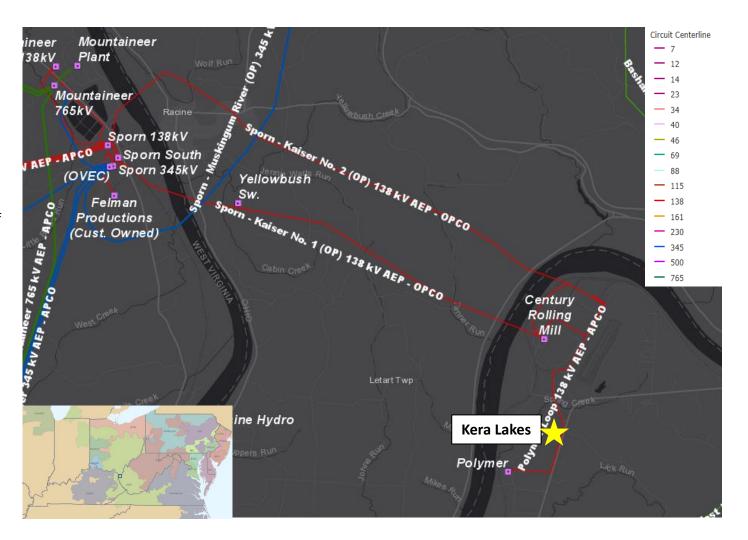
A new industrial customer has requested service in Jackson County, WV by the end of 2024.

Projected load: 30 MVA initial load, upwards to a maximum of 80 MVA

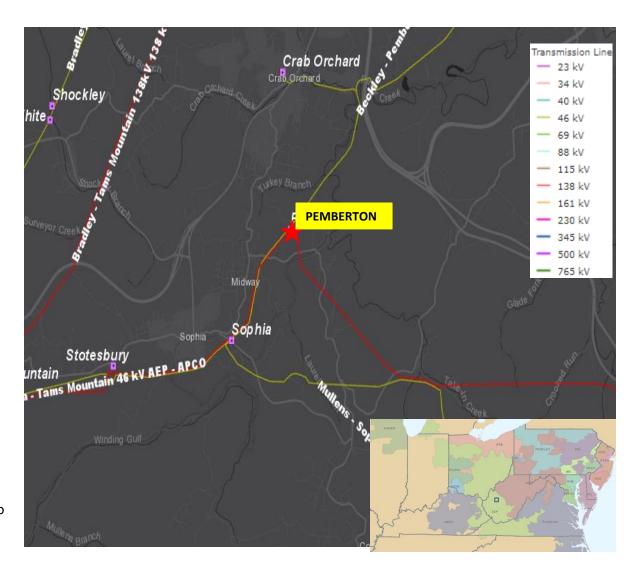
These breakers have exceeded the manufacturer's recommended number of fault operations

Multiple oil and nitrogen leaks

Bushings are in poor physical condition

Cooling controls, cooling fans and internal wiring are obsolete and in need of replacement

• 11 of the 25 relays at the station are in need of replacement

4 relays are electromechanical type which have significant limitations with regards to fault data collection and retention.

7 microprocessor relays with legacy firmware

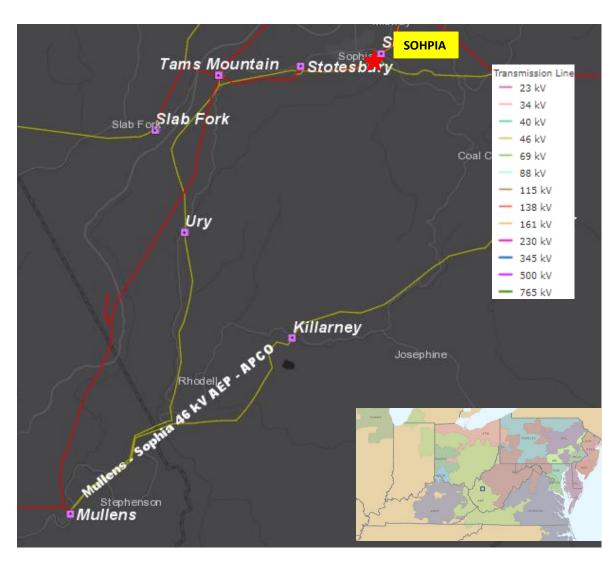
AEP Transmission Zone: Supplemental Beckley, WV

These breakers have exceeded the manufacturer's recommended number of fault operations

• 23 of the 33 relays at the station are in need of replacement

7 microprocessor relays with unsupported firmware.

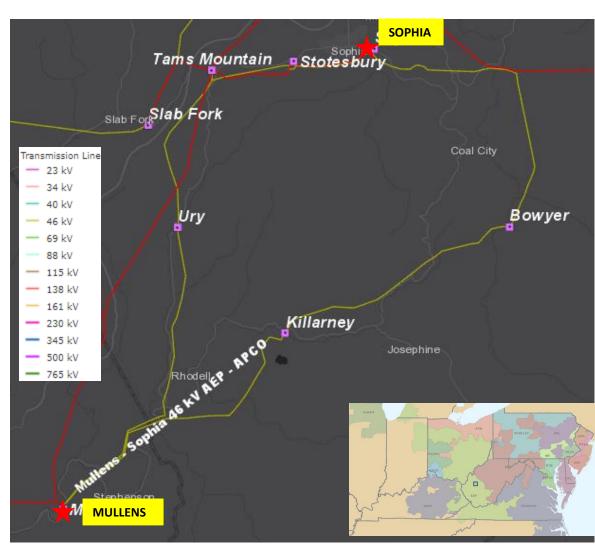
AEP Transmission Zone: Supplemental Beckley, WV

Permanent outages due to vegetation fall-in outside AEP ROW, ice/snow, crossarm failure and distribution

• Currently there are 50 structures (30% of the line) with at least one open structural condition

Currently 77 structural open conditions including rotted poles, crossarms, brace, insect damaged poles, crossarms, brace and woodpecker damaged poles.

- Towers: Typical life of galvanizing is 70 years. The towers are all supported by steel grillage foundations buried in the ground. The tower leg is subject to significant risk of corrosion where it enters the ground. Lattice tower structures have little structural redundancy. A failure of one member of the structure will impact the integrity of the structure and may cause the entire tower to collapse.

- Insulator & Hardware Corrosion: The connecting elements including the tower attachment hole and the insulator hook have experienced serious section loss due to corrosion and wear. This loss of metal cross-section significantly reduces the capacity of the connection. The insulator caps and connecting hardware have experienced heavy to complete loss of galvanizing. When the protective galvanized coating is gone or is significantly compromised, the bare steel corrodes at an accelerated rate.

- Broken Insulators: Broken, cracked and otherwise damaged insulators lead to premature flashover causing permanent outages. When the insulator assembly breaks, the wire falls to the ground potentially damaging other conductors, and presents an increased public safety concern.

- · Conductor: Aluminum Conductor Steel Reinforced (ACSR) conductor consists of aluminum strands wrapped around a core of galvanized steel strands. The steel provides the structural strength. Like other steel elements, the strands of the core have also lost the galvanized coating and steel section. The degraded state results in significant loss of tensile strength and potential risk to the public if the conductor was to fail and fall to the ground. Conductor damage is usually not visible in a field inspection. Specific conductor samples, from the belly of the sag (lowest point) and/or inside the clamps at the insulators, have confirmed significant corrosion. During the restoration or construction activities, conductors often break at adjacent locations due to handling, introducing a potential safety risk and increase public safety concern.

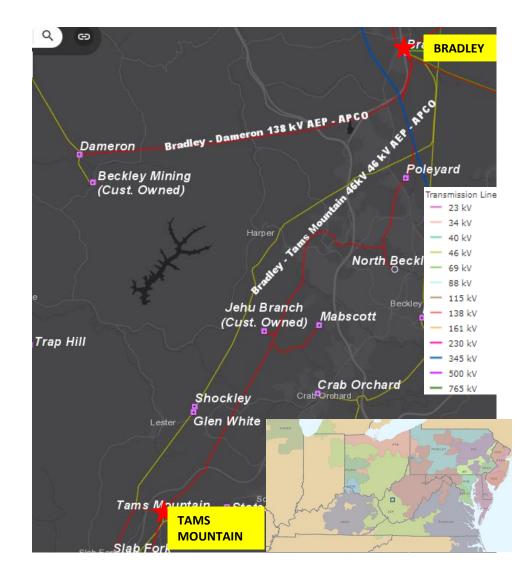
AEP Transmission Zone: Supplemental Beckley, WV

Permanent outages due to vegetation fall-in outside AEP ROW, lightning, ice/snow, non-AEP tree removal, splice failure and vandalism

- Currently there are 30 structures (19% of the line) with at least one open condition
 - 64 Open conditions affecting poles, crossarms, knee braces, woodpecker holes, insect damage, rot
 - 4 hardware conditions related to broken insulators

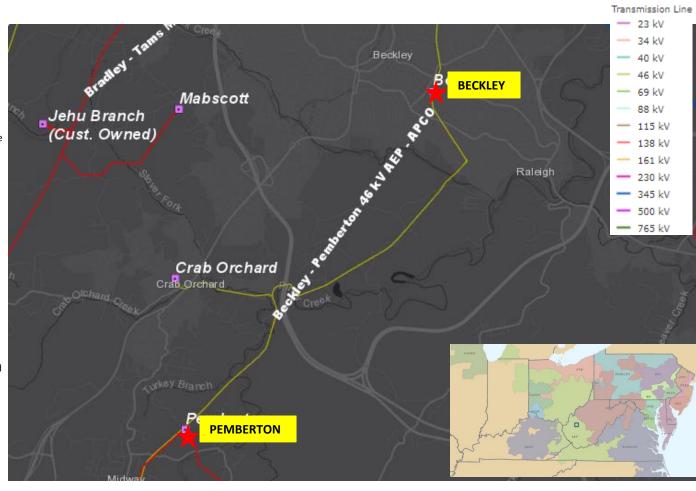
AEP Transmission Zone: Supplemental Beckley, WV

- Towers: Typical life of galvanizing is 70 years. The towers are all supported by steel grillage foundations buried in the
 ground. The tower leg is subject to significant risk of corrosion where it enters the ground. Lattice tower structures have
 little structural redundancy. A failure of one member of the structure will impact the integrity of the structure and may
 cause the entire tower to collapse.

- Insulator & Hardware Corrosion: The connecting elements including the tower attachment hole and the insulator hook have experienced serious section loss due to corrosion and wear. This loss of metal cross-section significantly reduces the capacity of the connection. The insulator caps and connecting hardware have experienced heavy to complete loss of galvanizing. When the protective galvanized coating is gone or is significantly compromised, the bare steel corrodes at an accelerated rate.

- Broken Insulators: Broken, cracked and otherwise damaged insulators lead to premature flashover causing permanent outages. When the insulator assembly breaks, the wire falls to the ground potentially damaging other conductors, and presents an increased public safety concern.

- Conductor: Aluminum Conductor Steel Reinforced (ACSR) conductor consists of aluminum strands wrapped around a core of galvanized steel strands. The steel provides the structural strength. Like other steel elements, the strands of the core have also lost the galvanized coating and steel section. The degraded state results in significant loss of tensile strength and potential risk to the public if the conductor was to fail and fall to the ground. Conductor damage is usually not visible in a field inspection. Specific conductor samples, from the belly of the sag (lowest point) and/or inside the clamps at the insulators, have confirmed significant corrosion. During the restoration or construction activities, conductors often break at adjacent locations due to handling, introducing a potential safety risk and increase public safety concern.

Currently there are 7 structures (10% of the line) with at least one open condition

2 conditions related to rust on lacing and leg, 1 condition affecting broken strand on conductor, 5 conditions related broken insulators and 2 forestry related conditions

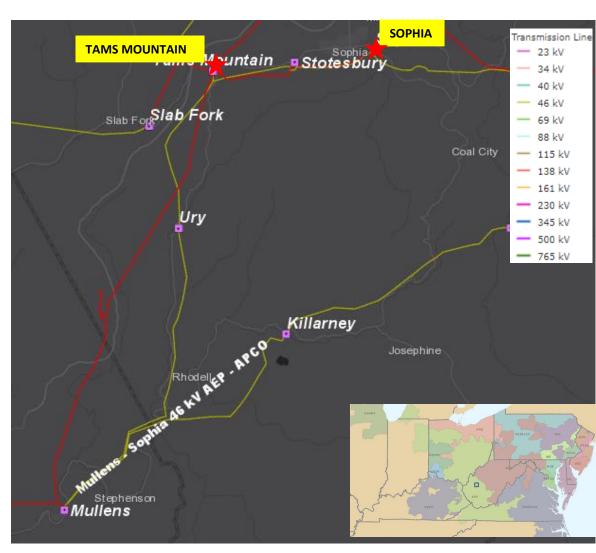
AEP Transmission Zone: Supplemental Beckley, WV

• Currently there are 6 structures (15% of the line) with at least one open structural condition

6 structural open conditions affecting pole, knee/vee brace and crossarms including corroded, broke, split and rot top

- Towers: Typical life of galvanizing is 70 years. The towers are all supported by steel grillage foundations buried in the ground. The tower leg is subject to significant risk of corrosion where it enters the ground. Lattice tower structures have little structural redundancy. A failure of one member of the structure will impact the integrity of the structure and may cause the entire tower to collapse.

- Insulator & Hardware Corrosion: The connecting elements including the tower attachment hole and the insulator hook have experienced serious section loss due to corrosion and wear. This loss of metal cross-section significantly reduces the capacity of the connection. The insulator caps and connecting hardware have experienced heavy to complete loss of galvanizing. When the protective galvanized coating is gone or is significantly compromised, the bare steel corrodes at an accelerated rate.

- Broken Insulators: Broken, cracked and otherwise damaged insulators lead to premature flashover causing permanent outages. When the insulator assembly breaks, the wire falls to the ground potentially damaging other conductors, and presents an increased public safety concern.

- Conductor: Aluminum Conductor Steel Reinforced (ACSR) conductor consists of aluminum strands wrapped around a core of galvanized steel strands. The steel provides the structural strength. Like other steel elements, the strands of the core have also lost the galvanized coating and steel section. The degraded state results in significant loss of tensile strength and potential risk to the public if the conductor was to fail and fall to the ground. Conductor damage is usually not visible in a field inspection. Specific conductor samples, from the belly of the sag (lowest point) and/or inside the clamps at the insulators, have confirmed significant corrosion. During the restoration or construction activities, conductors often break at adjacent locations due to handling, introducing a potential safety risk and increase public safety concern.

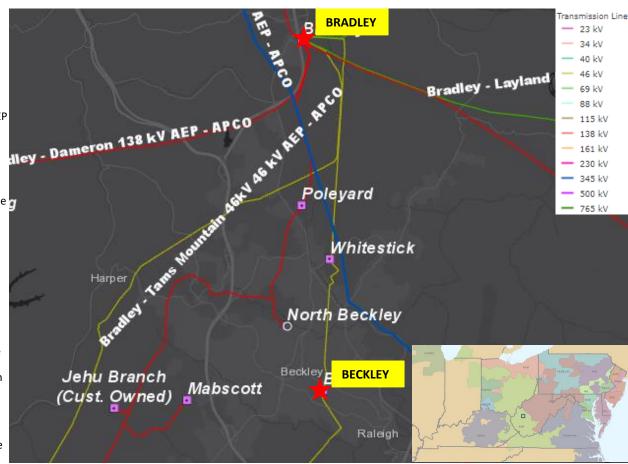
AEP Transmission Zone: Supplemental Beckley, WV

- Towers: Typical life of galvanizing is 70 years. The towers are all supported by steel grillage foundations buried in the ground. The tower leg is subject to significant risk of corrosion where it enters the ground. Lattice tower structures have little structural redundancy. A failure of one member of the structure will impact the integrity of the structure and may cause the entire tower to collapse.

- Conductor: Aluminum Conductor Steel Reinforced (ACSR) conductor consists of aluminum strands wrapped around a core
 of galvanized steel strands. The steel provides the structural strength. Like other steel elements, the strands of the core
 have also lost the galvanized coating and steel section. The degraded state results in significant loss of tensile strength and
 potential risk to the public if the conductor was to fail and fall to the ground. Conductor damage is usually not visible in a
 field inspection. Specific conductor samples, from the belly of the sag (lowest point) and/or inside the clamps at the
 insulators, have confirmed significant corrosion. During the restoration or construction activities, conductors often break at
 adjacent locations due to handling, introducing a potential safety risk and increase public safety concern.

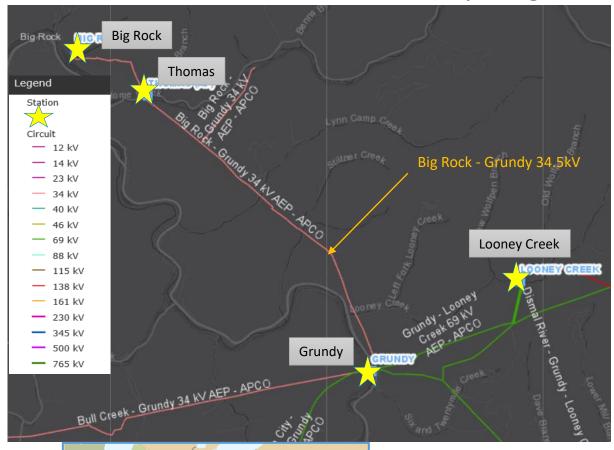
AEP Transmission Zone M-3 Process Buchanan County, Virginia

- The line structures fail to meet 2017 NESC Grade B loading criteria, current AEP structural strength requirements, and the current ASCE structural strength requirements.
- 67 of the 70 structures are 1930s vintage accounting for 96% of the structures.
- The line is insulated in some segments with Distribution class cap and pin insulators which do not meet current AEP standards for CIFO and minimum leakage distance requirements. Shield wire is not present on significant segments of this line.
- The line is radial and serves a peak nontransferable load of 2.63 MVA at Thomas and 1.8 MVA at Big Rock substations.

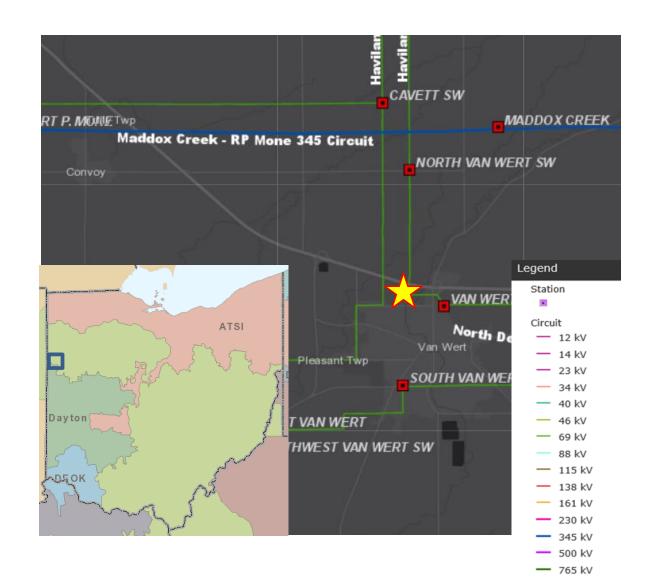
AEP Transmission Zone M-3 Process Van Wert, OH

- AEP Ohio has requested a 69kV delivery near Northern Van Wert.
- The anticipated load is 15MVA
- AEP Ohio has requested an in-service date of 12/31/2024

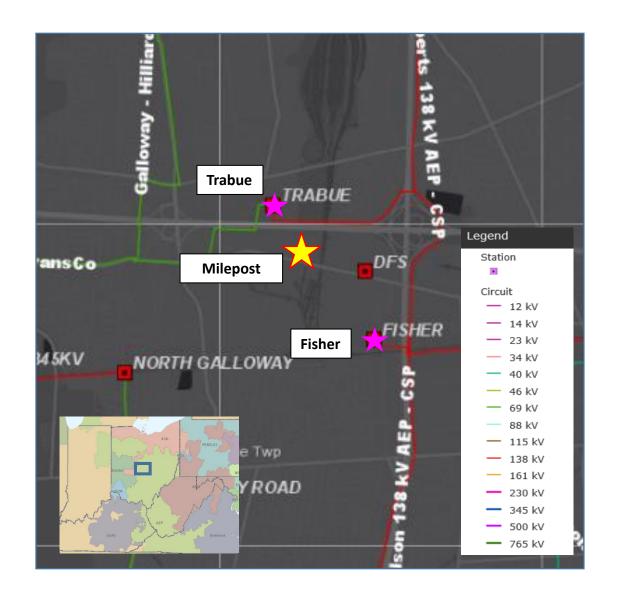
AEP Transmission Zone M-3 Process Columbus, OH

- Four customers have requested distribution service at a site South of AEP's existing Trabue station in Columbus, OH.
- The customers have indicated a total peak demand of 33.5 MVA of new capacity and 5.5 MVA of alternate capacity at the site.
- The customer has a requested an in-service date of 2/29/2024.

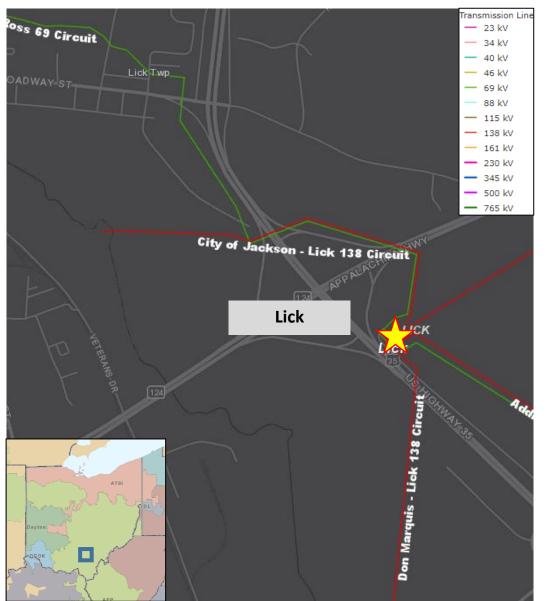
AEP Transmission Zone M-3 Process Jackson County, Ohio

The City of Jackson has requested a new transmission feed for their Veterans station separate from their existing 138 kV feed from AEP's Lick station. The city of Jackson currently serves approximately 25 MW of load via Lick station.

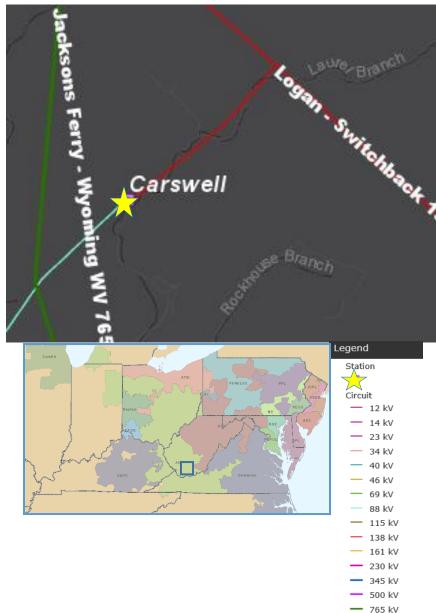
- The Northwest corner of the station has had significant washouts in the past and has damaged the perimeter fence. The washouts have exposed the control cables for the 88kV circuit breaker.

- Carswell is the one of the last two stations that have an operating voltage of 88kV.

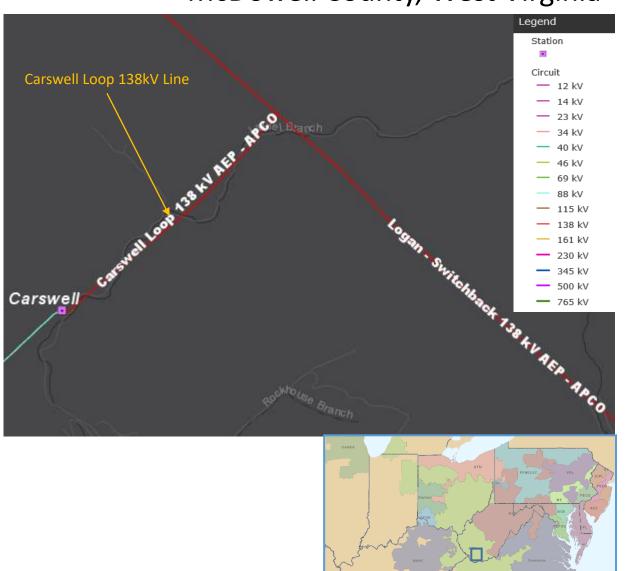
- The inadequate shielding angle on this line asset leads to potential poor lightning performance.
- The porcelain insulators on the line do not meet current AEP standards for CIFO and minimum leakage distance requirements.

- Access for this line is extremely difficult due to the steep, mountainous terrain.

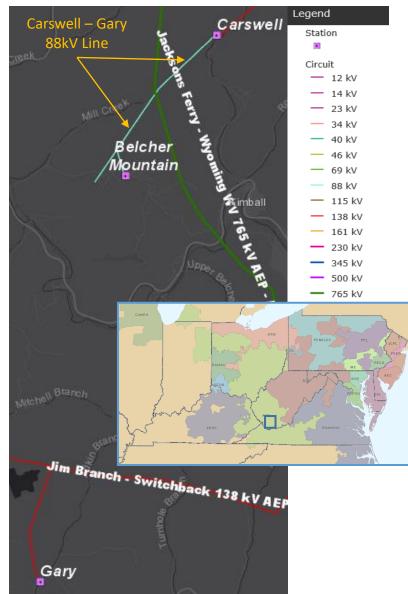
- The structures on the Carswell Gary 88kV Line fail to meet 2017 NESC Grade B loading criteria, fail to meet current AEP structural strength requirements, and fail to meet the current ASCE structural strength requirements.

- The porcelain insulators on the line do not meet current AEP standards for CIFO and minimum leakage distance requirements.

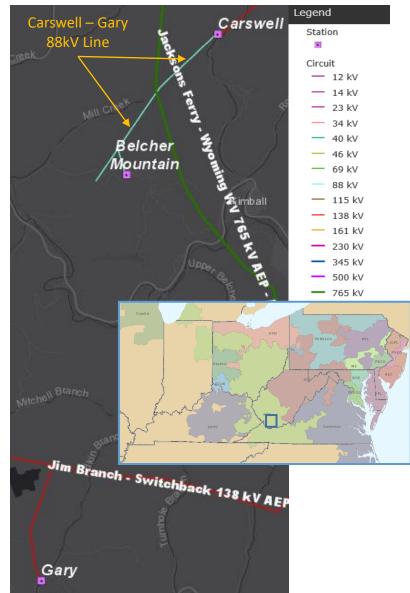
Customers are radially served at Belcher Mountain by this line from Carswell.

- The butt wrap grounding and typical shield angle is inadequate per current AEP Standards and can cause poor lightning performance. The current grounding system, poor shielding angle, and the electrical strength of the insulators do not meet current AEP and industry accepted criteria, making the line susceptible momentary and permanent outages, affecting customer reliability.
 - The inadequate grounding limits the available path to ground during any type of line fault, increasing the intensity the conductor and related hardware have to withstand during the fault. The reduced electrical strength of the insulators could lead to electrical damage to structures and hardware during a fault if the insulator were to fail from elevated electrical stresses.
 - The line serves a peak load of 4.5 MVA at Belcher Mt. station.

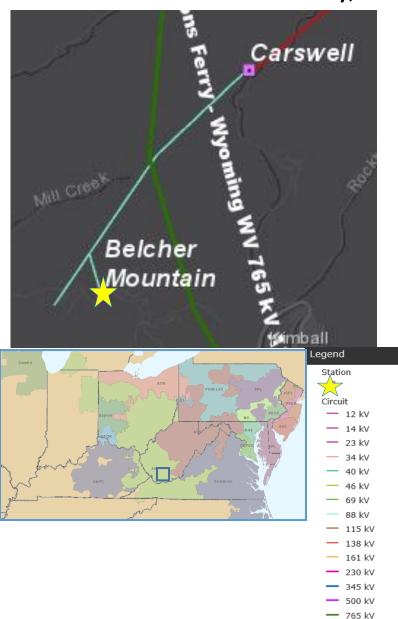
- Currently, all 10 relays (100% of all station relays) are in need of replacement. All 10 of these are of the electromechanical type which have no spare part availability and fault data collection and retention. In addition, these relays lack vendor support.

- A small sink hole is developing near the 13kV Bay.
- No remote monitoring of assets is available due to the lack of an RTU.
- Belcher Mountain is the last of two stations that have an operating voltage of 88kV.
